Subject: Transmit Electric Power Research Institute NEI 03-08 Interim Guidance MRP 2021-005  
Related to B&W-Designed Core Barrels to NRC for Information

Subject: NEI “Needed” Interim Guidance regarding MRP-227-A and MRP-227, Revision 1-A B&W Core Barrel Cylinder Top Flange Circumferential Weld Heat-Affected Zone Inspection

**CUSTOMER SERVICE BULLETIN NO. 21-04**

SUBJECT: Post Stress Relief Weld Repairs in the B&amp;W Core Barrel and Impact on SCC Susceptibility

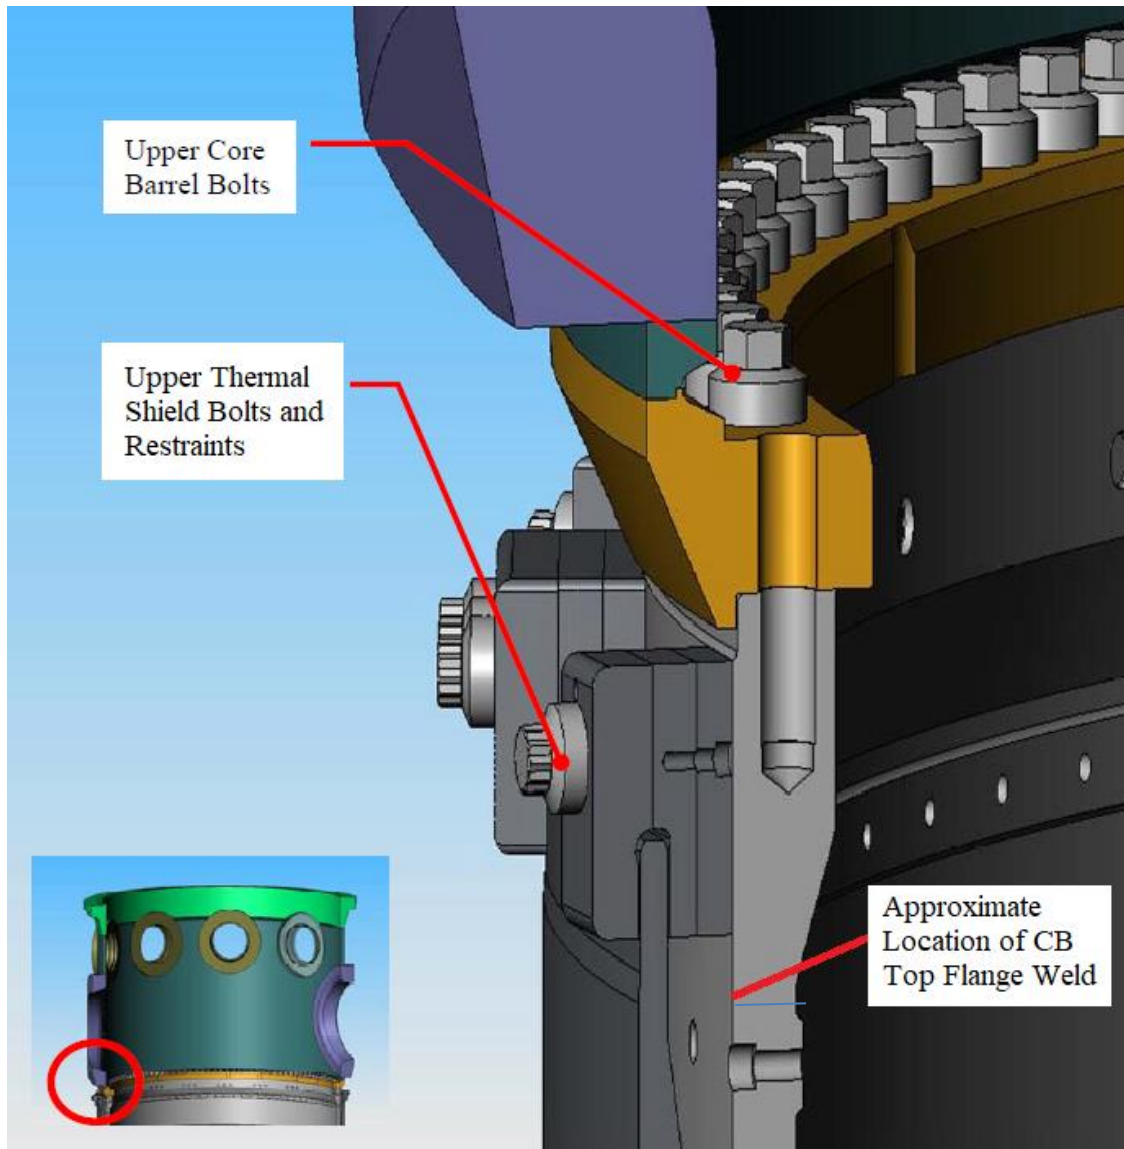
**Figure 1: Location of CB Cylinder Top Flange Circumferential Weld – B&W-Designed PWRs**

The CB cylinder top flange circumferential weld HAZ shall be the Primary item for SCC for units that had weld repairs performed on their top flange circumferential weld after the stress relief. There are no associated Expansion items.

The CB cylinder top flange circumferential weld HAZ is “Primary” because this location is screened as susceptible to SCC (as well as irradiation embrittlement), an indication could become functionally significant, and there are no other locations that could act as a leading indicator. The base metal adjacent to the weld (i.e., HAZ) is the focus because the weld metal was screened out for SCC because of the ferrite content.

Primary Item: CB cylinder top flange circumferential weld HAZ; see Figure 1

Effect (Mechanism): Cracking (SCC, IE), including detection of surface-breaking crack-like indications

Examination Method: Enhanced visual (EVT-1), volumetric (UT), or eddy current (ECT) examination

Initial Inspection: At the time of the next planned RV internals removal (i.e., coinciding with the next 10-year in-service inspection [ISI] of the RV internals)

Examination Coverage: 100% of the accessible outer diameter (OD) surfaces of  $\frac{3}{4}$ ” of the adjacent base metal to the top flange circumferential weld, as defined in MRP-228 [Reference 5]. Examination coverage requires a minimum of 50% of the length of the specified surface of the weld being examined due to the potential obstruction of the upper thermal shield restraints at the top of the core barrel cylinder.
