**Braidwood Unit 1 Justification for the Deviation from MRP 2019-008,  
Technical Evaluation 635273**

The evaluation applies to the 1A Residual Heat Removal Suction line (1RC04AA) from the Reactor Coolant System Hot leg. The evaluation documents the acceptability of extending the inspection for the 1A RH suction line welds/pipe/elbow from the Spring of 2021 (A1R22) to the Fall of 2022 (A1R23).

SUBJECT: Interim Guidance for NEI 03-08 Needed Requirements for US PWR Plants  
for Management of Thermal Fatigue in Non-Isolable Reactor Coolant  
System Branch Lines

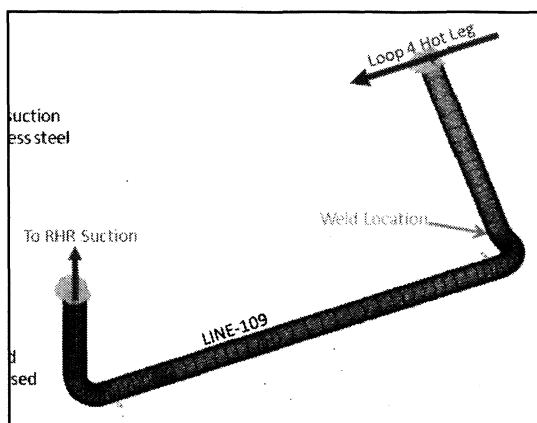
Figure 1A: I.G. #2 Sample Hot Leg RHR Suction Line

IG#	Interim Guidance	Basis for Interim Guidance
	<p>required (as represented on Figure 1A). As a minimum, the inspection volume shall include the base metal and welds represented in Figure 1B.</p> <p>Note: credit may be taken for previous exam if:</p> <ul style="list-style-type: none"> <li>▪ Previous exam volume requirements bound those of this IG</li> </ul>	<p>degree elbow weld on the upstream end of the elbow. This pipe line previously was exempt from examination since it was screened out as “HOT” per MRP-146 guidelines and MRP-170 software. Using an array of thermocouples at the flaw location and at additional downstream locations, high-frequency temperature oscillations were recorded at 100% power operations. An extent-of-condition examination on the sister unit in Spring 2017 revealed a similar (though less extensive) crack depth in a similar location.</p> <p>Sample RHR Hot Leg Suction Line - See Figure 1</p>

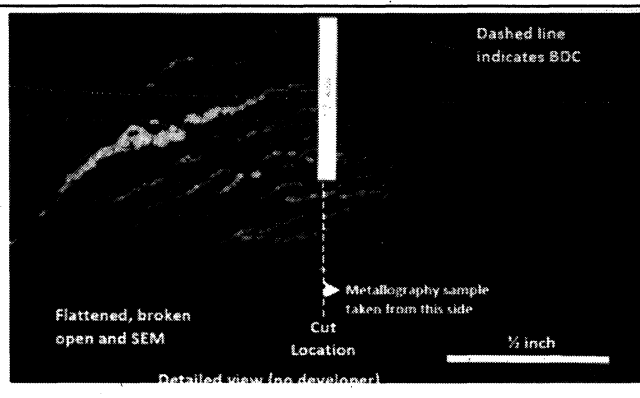
Figure 2: IG #4 Examination Volume Width Increase to 1 Inch

4	<p>Future fatigue examinations of the bottom inner third thickness of base metal as indicated in Figure 2-20 of MRP-146, Rev. 2 shall be 1” wide.</p> <p>See Figure 2 below.</p>	<p>For the Boron Injection leakage event at a 4-loop Westinghouse-designed plant in 2017, the Metallurgical Examination showed cracking extending beyond the 1/2” width bottom dead center, as indicated in Figure 2 below. Therefore, TFFG recommends an increase to 1” width.</p>

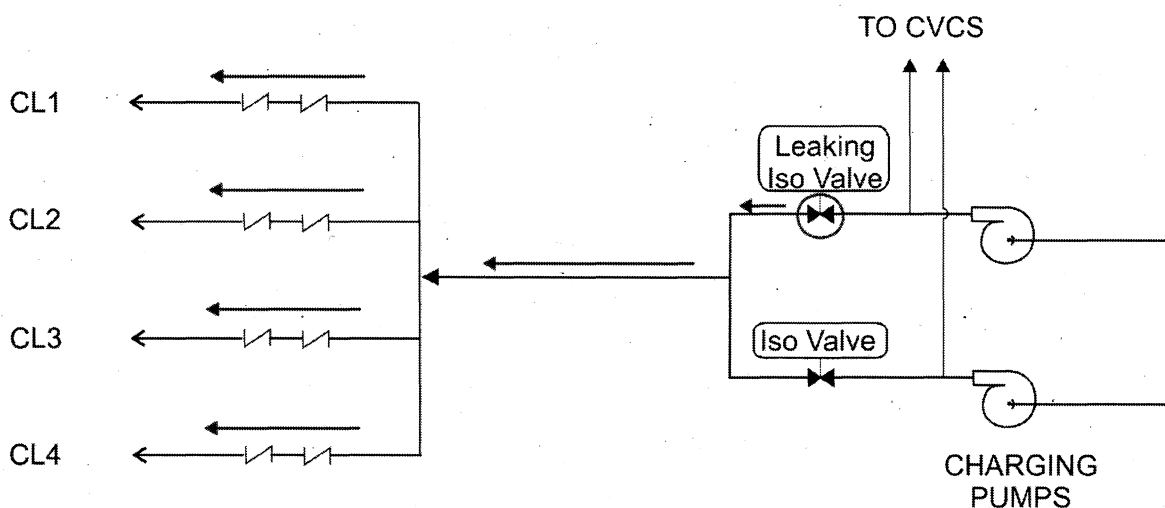
**Figure 1: Schematic of a PWR 4-Loop Safety Injection System with Leaking Isolation Valve**

MRP-146 [1] provides guidance and identifies "Needed" NEI 03-08 [2] requirements for the management of thermal fatigue in stagnant, non-isolable reactor coolant system (RCS) branch lines. For branch lines attached to the tops or sides of RCS piping, in-leakage (unintended fluid movement toward the RCS main loop) may interact with hot swirl penetration (generated from the RCS high speed flow) and result in thermal fatigue cycling. Typically, this in-leakage results from a leaking isolation valve that allows fluid from the charging system (high pressure source) to enter the stagnant safety injection system during normal operation (see Figure 1).

Thermal cycling due to in-leakage can result in rapid thermal fatigue damage that can lead to cracking. Dampierre-1 (a French PWR) experienced a through-wall leak in non-isolable safety injection piping attributed to swirl penetration and in-leakage in December 1996. After replacement in-kind of the affected piping, a follow-up examination in October 1997 revealed new thermal fatigue cracking of as much as 33% through-wall depth due to continued in-leakage. Refer to MRP-85 [3] on thermal fatigue OE in RCS piping for additional details.

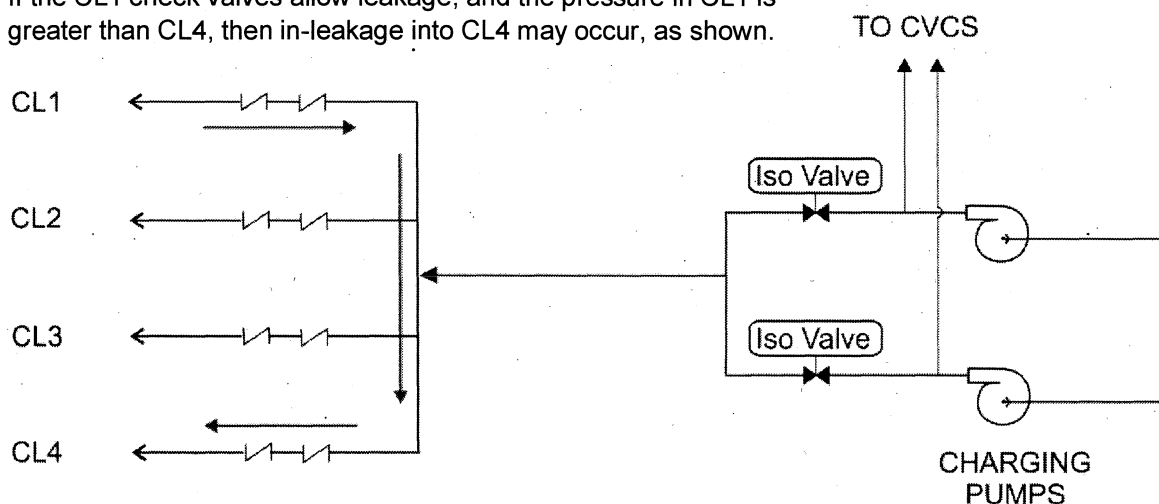
**Figure 2: Schematic of Cross-Flow In-Leakage**

Subsequent investigation into the cause of the February 2017 through-wall cracking revealed another in-leakage source – cross-flow of reactor coolant into the affected Loop 4 safety injection branch line from one of the adjacent safety injection branch line (Loops 1, 2 or 3). Cross-flow (or cross-leakage) can occur when there is a common header serving multiple trains of a system. If a slightly higher-pressure exists in the RCS loop, and any of the check valve(s) in adjacent loops of the connected piping are leaking, in-leakage may occur into one or more of the other RCS loops (see Figure 2).

If the CL1 check valves allow leakage, and the pressure in CL1 is greater than CL4, then in-leakage into CL4 may occur, as shown.

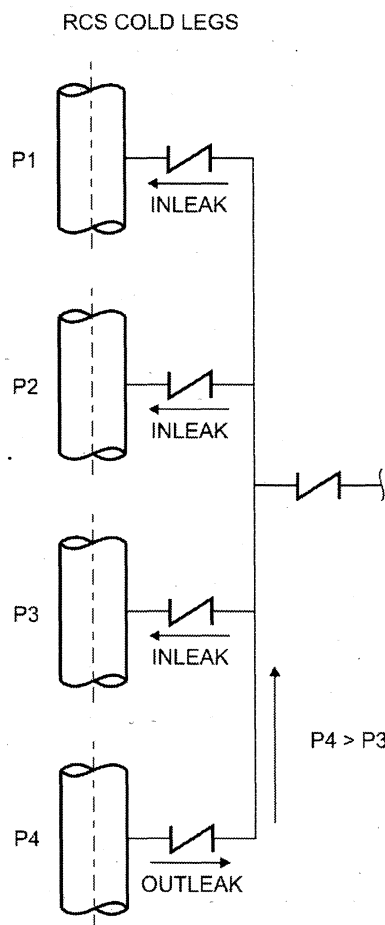
**Figure 3: Schematic of Cross-Flow Potential During Startup or Shutdown with Loop 4 RCP Idle**

The cross-flow phenomenon is not new to the industry, but it has been observed under different circumstances. MRP-85 [3] and the EPRI Fatigue Management Handbook (MRP-235) [4] both discuss cross-flow; however, it has typically only been seen during plant startup or cooldown when less than the full number of reactor coolant pumps are operating. The accompanying rise in static pressure in conjunction with a leaking check valve allows reactor coolant to flow from the loop with the idle RCP, through the check valve, and back toward the

other loops, resulting in potential thermal cycling in both the forward and reverse flow lines (see Figure 3). However, the number of cycles from this scenario is limited since this generally occurs only temporarily during startup or shutdown conditions when a RCP is idle and the available temperature difference is low.
