Regulatory Conference Related to Davis-Besse EDG FFSS Finding

February 1, 2022

Summary of EDG#1 FFSS Failure

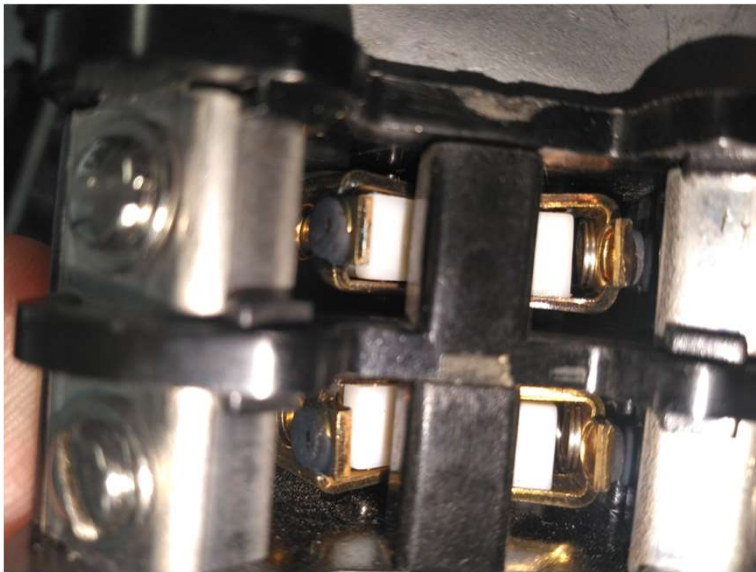
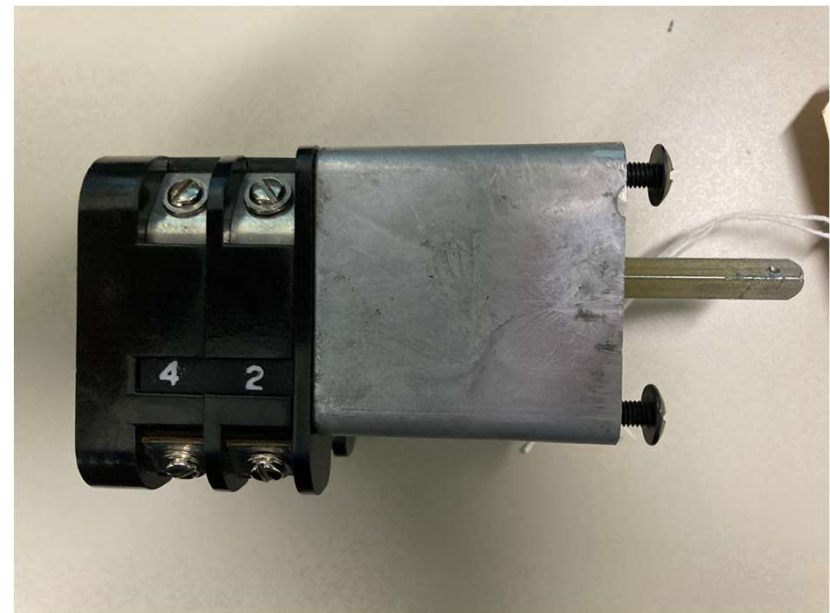
- Discovered intermittent open contact on the FFSS 400 RPM contacts
 - Initial in-situ check showed closed contact
 - The switch was cycled 5 times in-situ, 2 of 5 times open contact observed
- Replaced FFSS and tested satisfactorily on 5/28/21
- Surface contamination is visually observed on the FFSS contacts
- The vendor manual recommended inspection and cleaning to remove sulfide buildup and contact pitting – no periodicity specified
 - No PM existed to inspect/clean the FFSS

- Replaced old FFSS with a new FFSS - complete
- Test procedure enhancement - perform continuity checks following switch manipulation – complete (interim action)
- Procedure enhancement - Field Flash Pushbutton use added to the Emergency Use section of the operating procedure - complete
- Initiated enhancement PMs to Inspect/Replace FFSS – complete
- EDG Reliability Assessment - complete
- Modifications being considered:
 - Install an indicating light for the switch contacts when returned to the 400 RPM position to provide positive indication of circuitry integrity.
 - Redesign of the field flash circuit to remove the dependence on the 400 RPM contact functioning and eliminate the vulnerability.

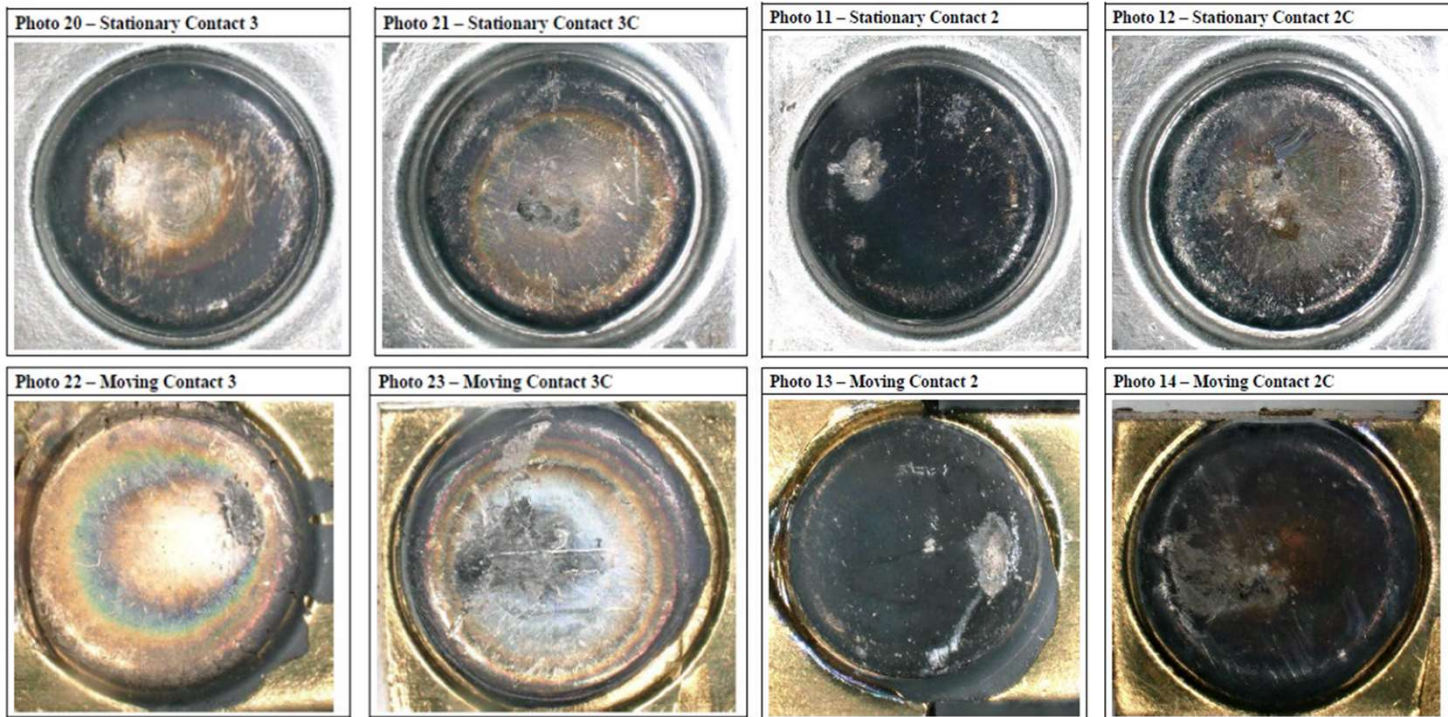
400 RPM
Emergency Start
Normally Closed

800 RPM
Idle Start
Normally Open

- Based on the evaluation of the contact contamination and resistance measurements, MPR concluded the surface contamination was not the cause of the FFSS Failure.
- The black substance on the switch contacts is silver sulfide. This forms when silver reacts to sulfur found in the environment, such as Sulfur Oxides found in diesel exhaust.
- Silver sulfide buildup can cause electrical failures, especially on switches that are infrequently cycled, due to buildup. It is crumbly and does not flake off in large pieces.
- Contacts that are open have a greater buildup than the normally closed contacts, as observed with the FFSS.
- The GE SBM switch does have a self-cleaning wipe feature and the monthly cycling would help maintain acceptable surface conditions.

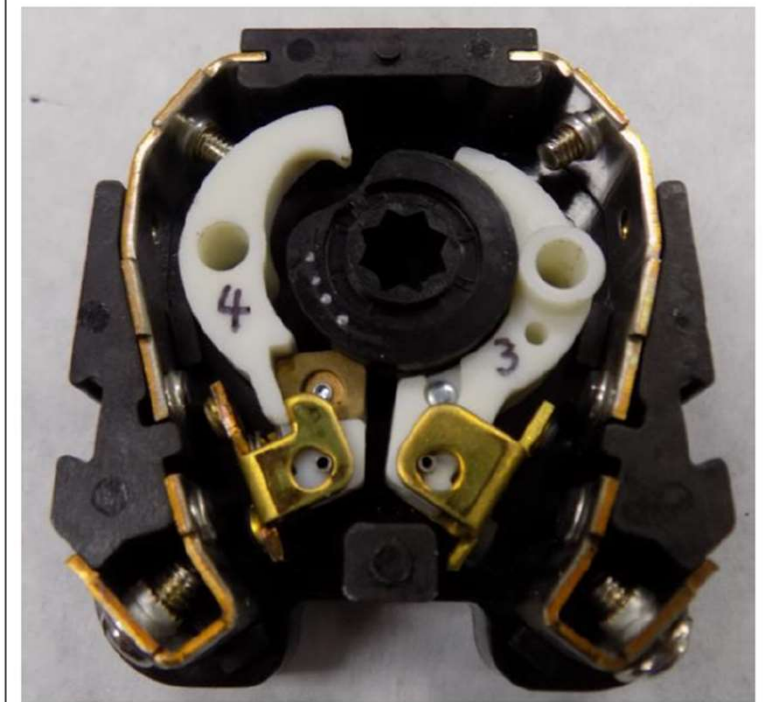
Photo 7 – Switch Contact Stage 3/4

- Examination by SEM/EDS identified foreign material on a contact surface
- Contact 2-2C (800 rpm) was visually the worst of the set with the black substance covering nearly all four contacts
 - Identified black substance as sulfur. The silver-plated contacts are succumbing to silver sulfidation.
- Contact 3-3C (400 rpm) did not have as much sulfur cover as the even numbered contacts
 - There was no wear or unusual scarring on the mating surfaces that would identify it as having a potential for poor electrical connection
 - Stationary Contact 3C (mating area) – Detected nickel (Ni) [**Discovery - Cause – Foreign Material**]
- Material Identification of Switch Parts
 - A transverse cross section of the stationary Contact 4C was completed. The silver on the contact surface was attached to a copper-zinc-tin (Cu-Zn-Sn) alloy. No nickel (Ni) was detected.

- Internal Inspection and Material Analysis
 - All contact surfaces were found to be in good shape, but with some surface sulfidation present (worse for 800 rpm contacts). 400 rpm contacts had little to no sulfidation at mating areas.

- Switch operating mechanism and contact mechanisms were in good operating condition
 - One moving contact, 3C, had nickel deposits on surface, mostly in the mating area. Contacts are silver plated, and nickel should not be present (i.e., it is foreign material)

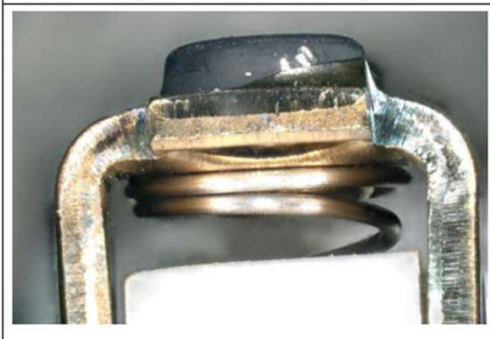
Photo 2 – Typical Contact Carrier Spring

- Observed proper switch alignment and spring compression
- All 4 moving contact springs were inspected prior to disassembly
 - These conical springs were installed correctly with the larger end nearest the contact and centered over the contact carrier nub
 - The contacts aligned consistently with each switch operation and appeared to be centered on each other. No issues were observed with contact alignment.

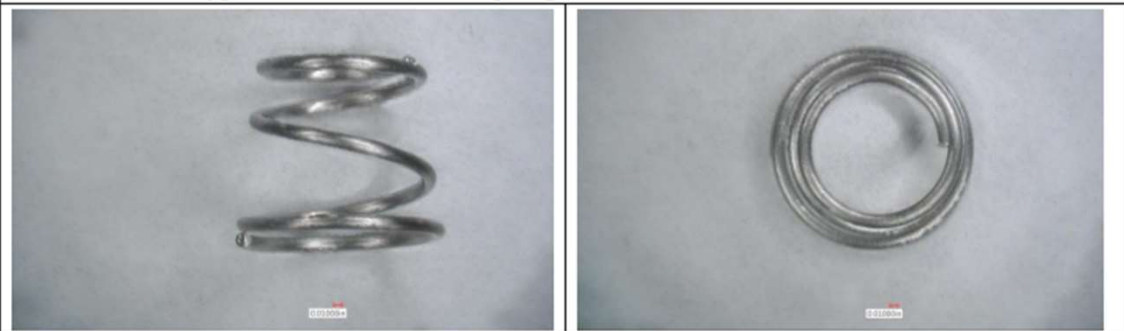
Photos 3 & 4 – Typical Contact Carrier Spring

- Following disassembly, spring compression testing was performed with the moving contacts still connected to the cam followers
 - The values of all 4 contacts were consistent with each other and very repeatable from trial to trial

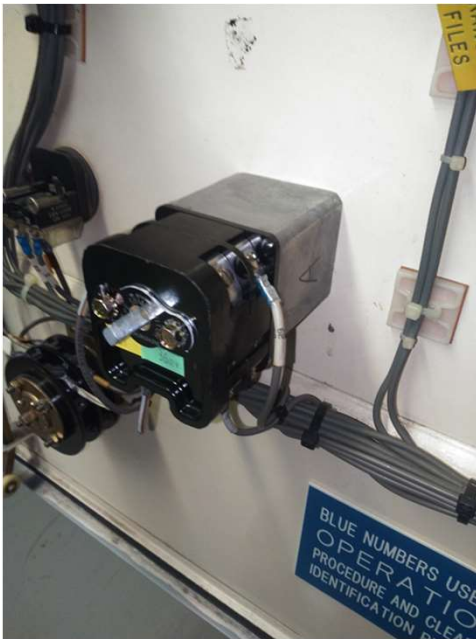
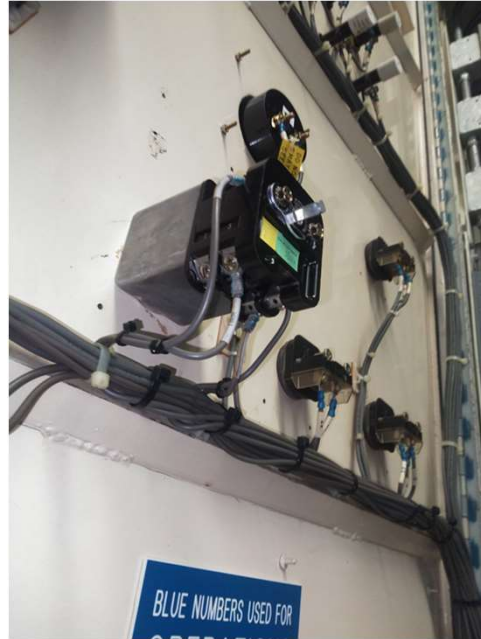
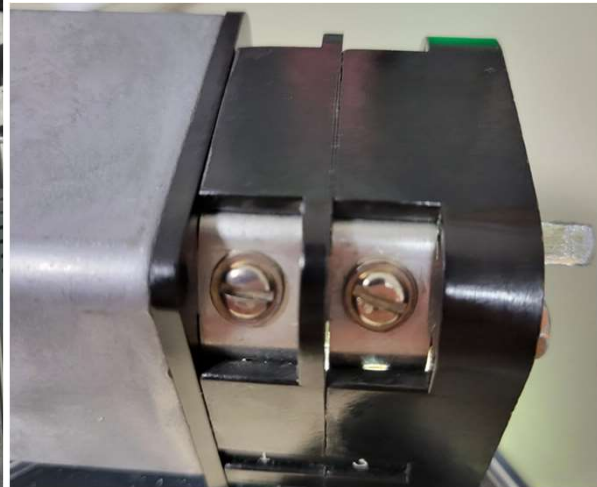
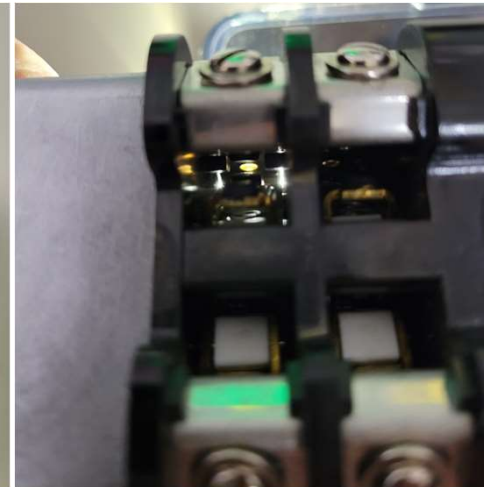
- Source of Foreign material is indeterminate
- The foreign material most likely came from within the switch (terminal screw)
 - Additional testing identified nickel on the FFSS terminal screws
 - Small openings exist that could allow material from the terminal screws to fall onto the switch contacts.
 - Switch is open to environment, but switch is configured so opening faces down
 - There is no forced air flow within the cabinet
 - A visual inspection of the cabinet was performed and the cabinet was found to be clean
