# Turkey Point Unit 3

## Relief Request No. 10

### ICW Pipe Leak Repair Modification Update

NRC NRR Turkey Point PM and Tech Staff Briefing  
Public Pre-Submittal Meeting Presentation  
February 17, 2022

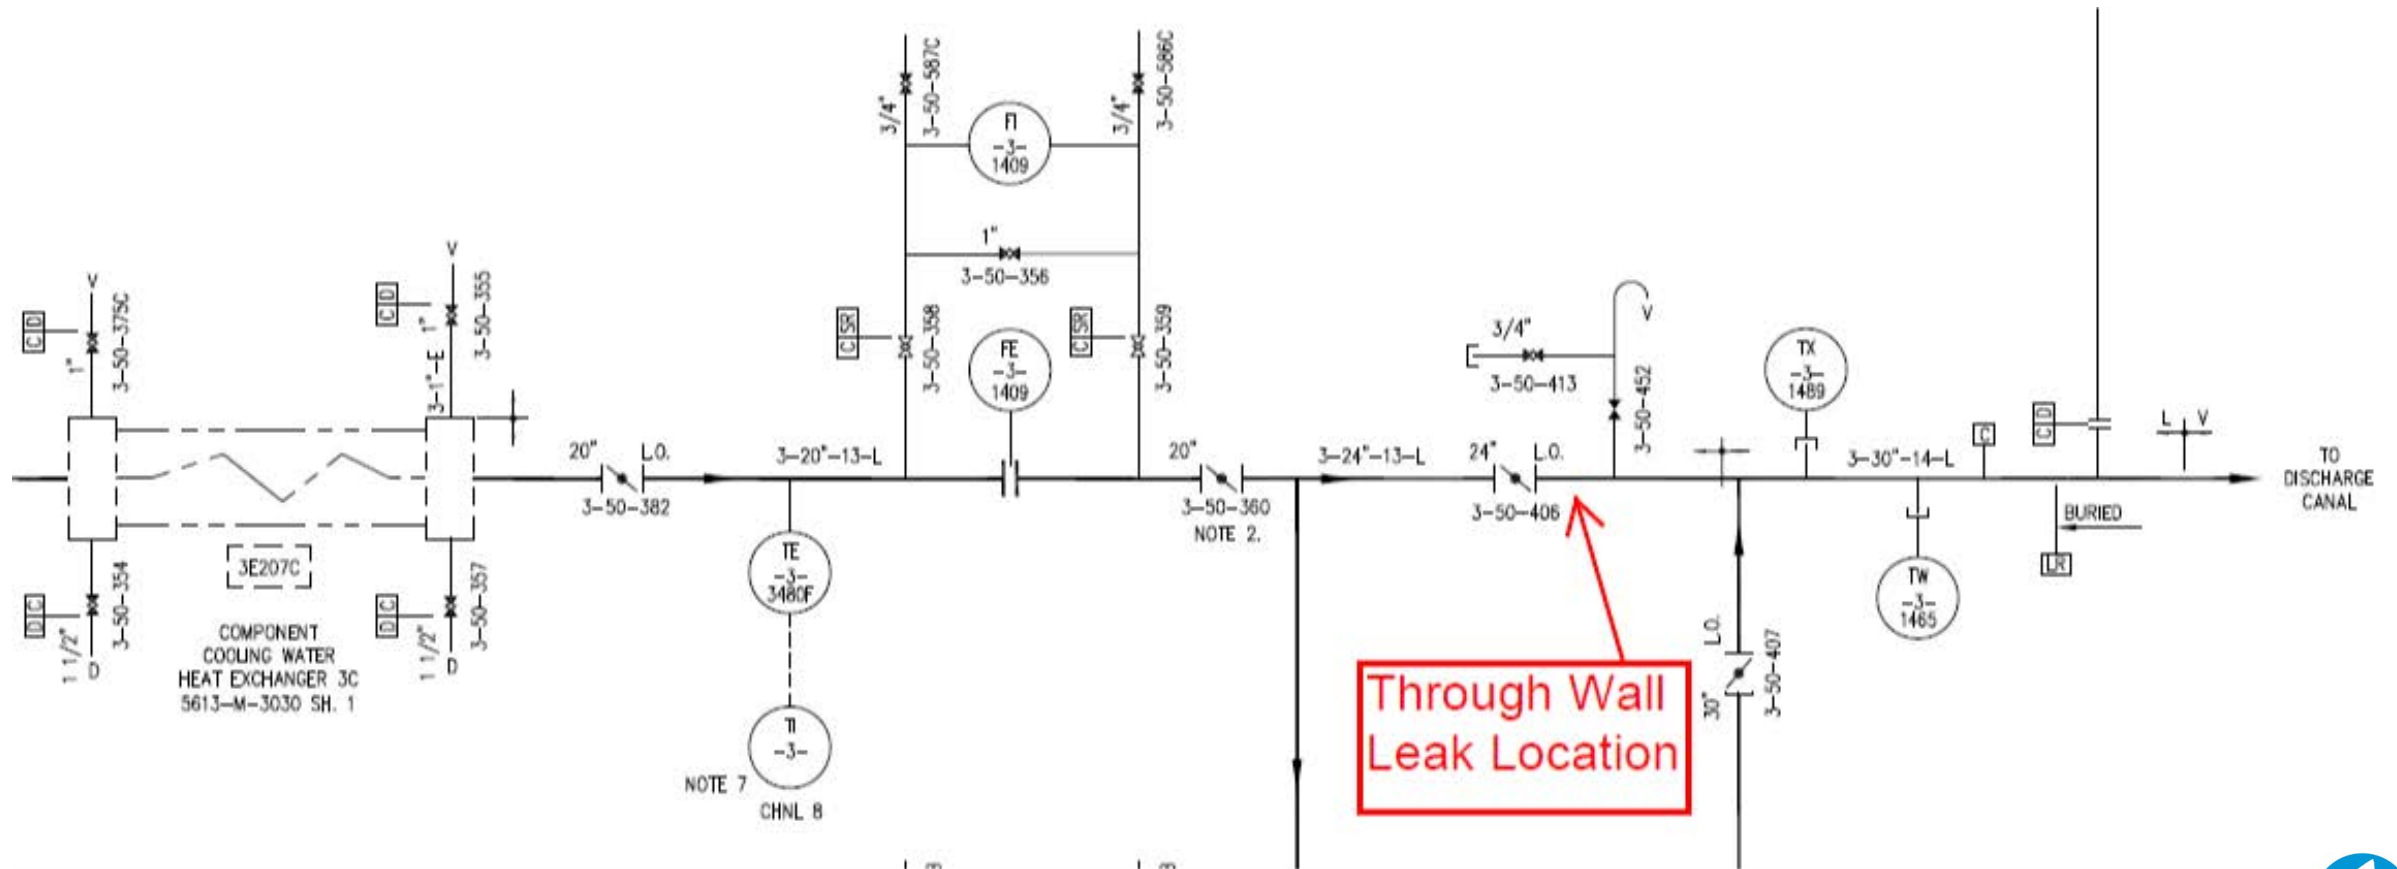
- The flaw is approximately 12 feet from the underground piping directed to the discharge canal and is located in the Unit 3 CCW heat exchanger room.
- This section of piping directs the water exiting the CCW heat exchangers back to the discharge structure and the ultimate heat sink. It does not include any valves or any other components that could possibly fail and prevent delivery of the ICW fluid back to the discharge location.
- The safety significance of this section of pipe is low as the safety significant heat removal function is complete as the ICW fluid exits the CCW heat exchangers.

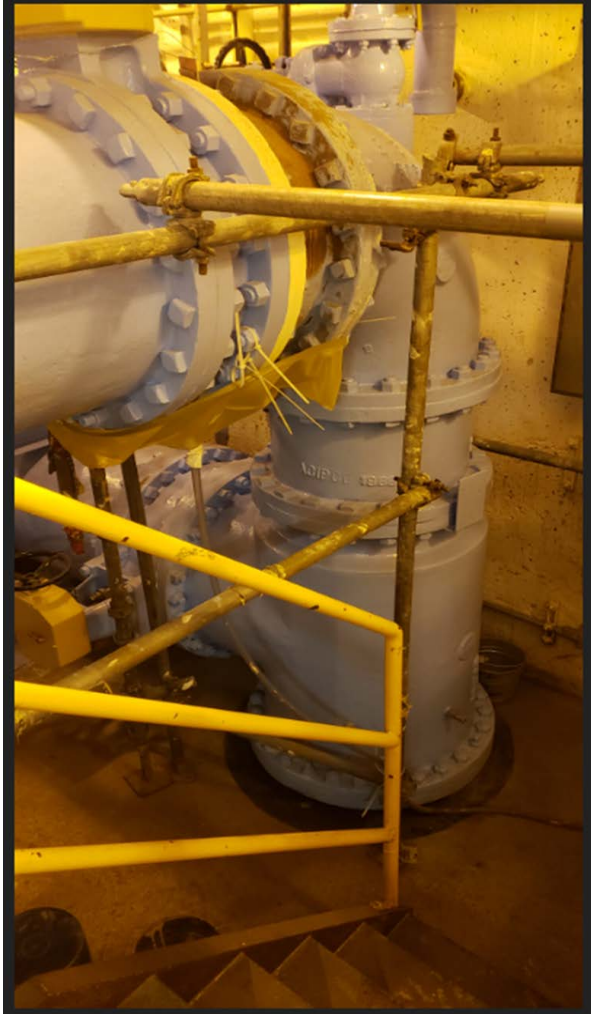
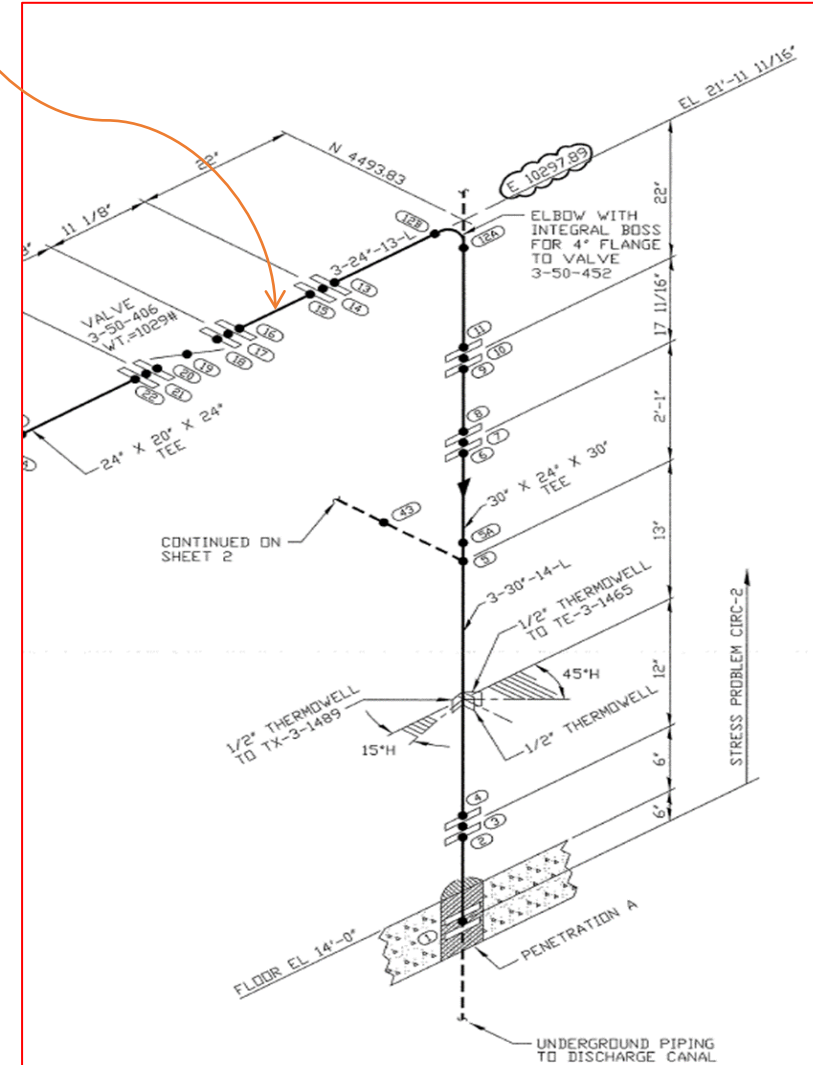
11-1/8 inch-Long spool piece Directly Downstream of Valve 3-50-406

- On 3/5/2020, during surface preparation for metalizing / coatings applications, a through-wall leak was discovered on a 24" diameter Intake Cooling Water (ICW) safety related piping.
- The non-planar wall loss was identified under the pipe coatings, downstream of valve 3-50-406, the ICW manual isolation valve from the CCW heat exchangers.

- The Pipe Spool will be restored by encapsulation using a 2-piece split Restoration Hardware Assembly with interfacing gaskets at the circumferential edge faces of the Pipe Spool end flanges and the axial edges of the Restoration Hardware Assembly.

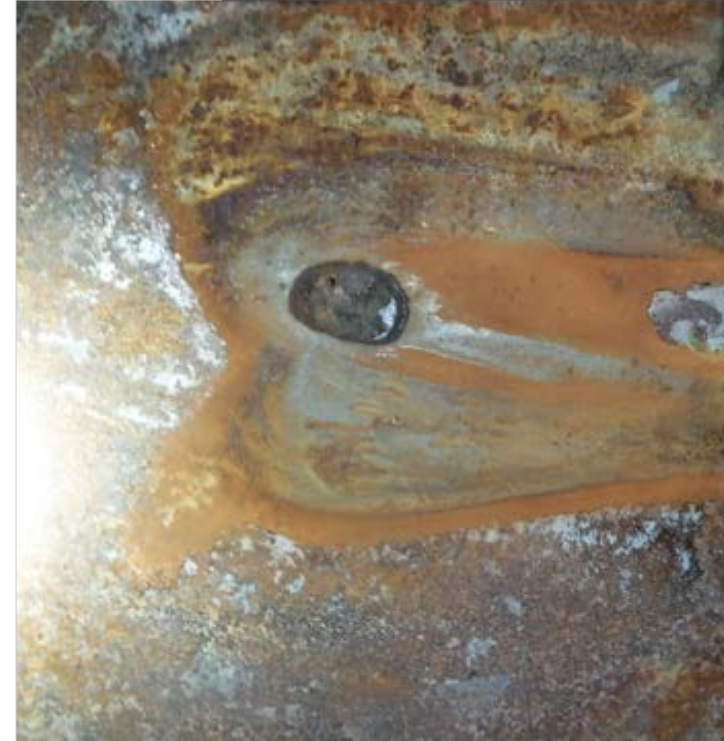
- The ICW safety related piping affected is classified as Quality Group C and treated as ASME Section XI Class 3 piping, 24" nominal diameter, with nominal wall thickness of 0.73".
- The pipe is Cast Iron ASA 21.6-1955, Cement Lined ASA 21.4 with .25" thickness. Maximum operating parameters are  $T = 120 \text{ degF}$  and  $P = 25 \text{ psig}$
- The flaw is shaped like a crater with two small, through-wall weep holes inside. The size of the flaw OD is  $9/16"$  longitudinal and  $13/16"$  circumferential.

- The subject ICW pipe spool piece is confirmed as being an original installation, being in operation from initial plant startup.
- Prompt Operability Determination concluded “Operable but Degraded”.
- Our initial assessment concluded that the reason for the thru-wall was due to a combination manufacturer’s casting defect and ID wall loss.
- Turkey Point performed a flaw evaluation utilizing Code Cases N-513-3 and N-513-4 when the through-wall leak was initially discovered to validate the structural integrity of the as found condition and to justify continued system operation until a repair could be performed.
- Historical site OE was not able to find a same or similar condition regarding this physical anomaly.
