VIRGINIA ELECTRIC AND POWER COMPANY
SURRY POWER STATION UNIT 2
STEAM GENERATOR TUBE INSPECTION REPORT
FOR THE FALL 2021 REFUELING OUTAGE

SURRY UNIT 2
STEAM GENERATOR TUBE INSPECTION REPORT
FOR THE FALL 2021 REFUELING OUTAGE

SURRY UNIT 2 STEAM GENERATOR TUBE INSPECTION REPORT FOR THE FALL 2021 REFUELING OUTAGE

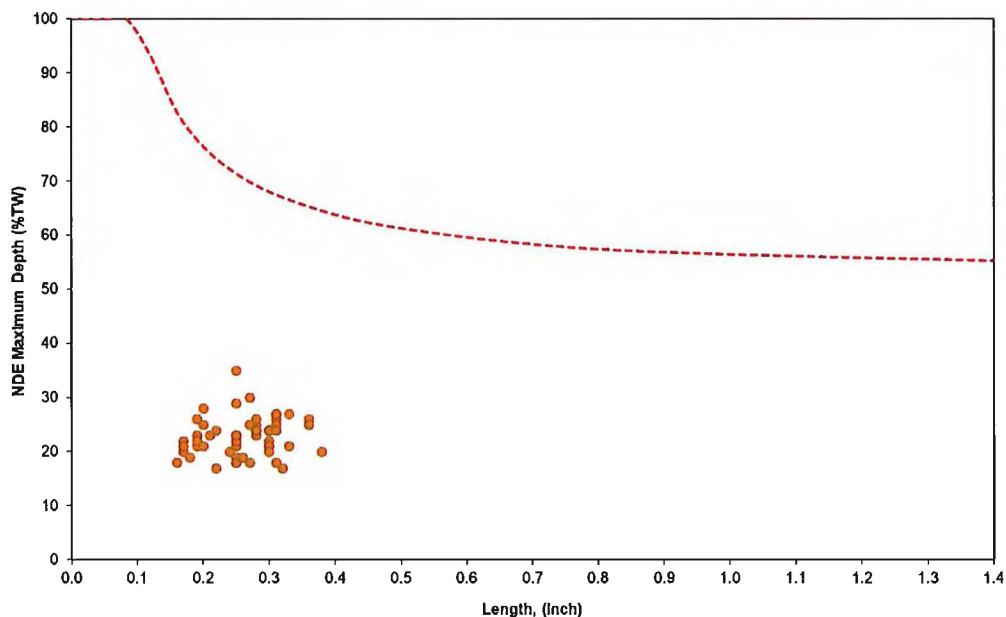
Figure 1: CM Curve for Flaws Sized w/ETSS 27901.1 – Model: Axial Thinning w/Limited Circumferential Extent

As indicated above, a Monte Carlo methodology was used for CM of the volumetric indications not attributed to AVB wear. Figure 1 through Figure 4 provide the 95/50 CM limit curves for flaws sized with ETSS 27901.1, 27902.1, 27905.1, and 96910.1 respectively.
