February 3, 2021 Alert at the NIST Center for Neutron Research

Tom Newton
Deputy Director
Chief of Reactor Operations and Engineering
NCNR

Root Cause Investigation of
February 2021 Fuel Failure

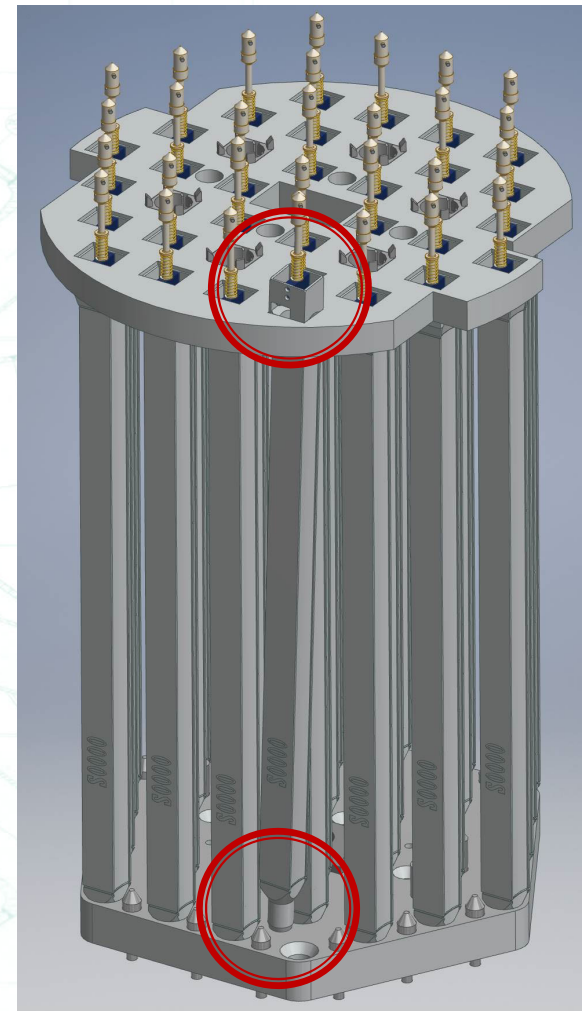
Dislocated Fuel Element in Full Core

- Latching and latch checks were done after a refueling on Jan 4.
- After-the-event review showed these checks were done incorrectly.
- Startup was delayed ~1 month because of COVID concerns
- Routine starting and stopping of primary pumps “pushed” the element into an area outside of flow.

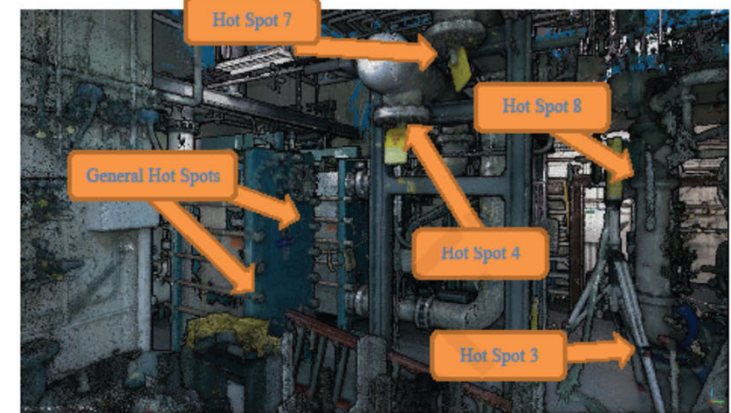
(1.4.a bare image of HS 3, HS 4, HS 7, HS 8, and general hot spots)

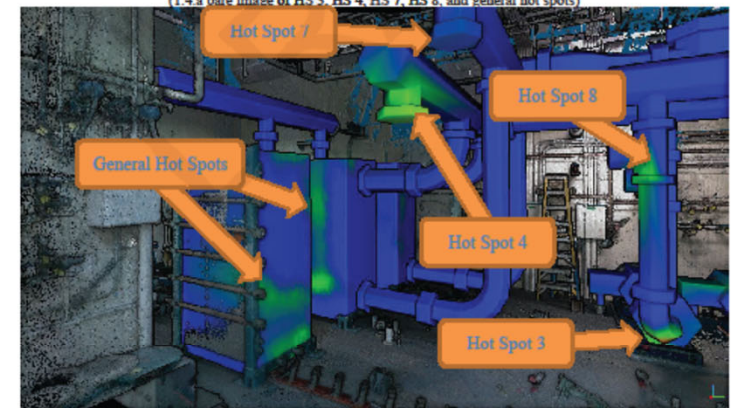
(1.4.b source overlay image of HS 3, HS 4, HS 7, HS 8, and general hot spots)

Gamma scan of primary piping
