Subject: NBSR restart request

Ref: Docket 50-184, TR-5 Facility License

## Impact on Reactor Vessel, Reactor Vessel Internals and Fuel assemblies

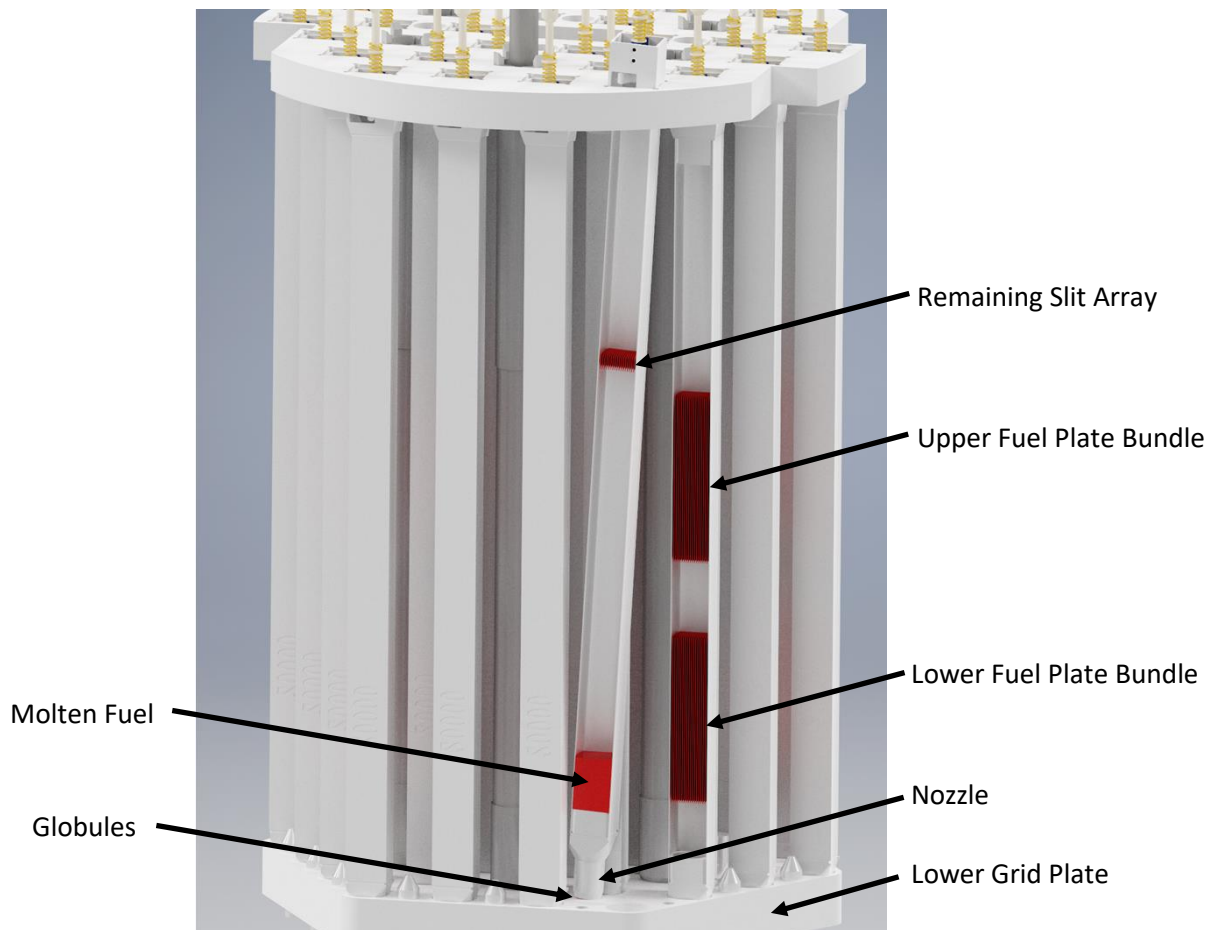
It is assumed that when the fuel melted, most of the melt gathered in the volume that is bounded by the inside of the cylindrical nozzle of the element and the lower grid plate onto which the cylindrical nozzle rested (and the top of the liquid column). Since the cylindrical nozzle was somewhat inclined with respect to the lower grid plate, some of the molten material made its way out and solidified under water, thereby obstructing further molten material flow between the nozzle and the lower grid plate. It is also assumed that the extent of the melting of the fuel plates comprises the entire fuel plates except the upper one inch of the upper fuel plate bundle, which does not contain any Uranium Oxide (and therefore generates no heat). After the bulk of the fuel element had melted, the part that was left standing formed an array of slits. Video observation of the top of the damaged element confirms the presence of this array.
