AEP-NRC-2022-42
10 CFR 50.4

Docket No.: 50-316

Donald C. Cook Nuclear Plant
Unit 2 Updated Steam Generator Tube Inspection Report to Reflect
TSTF-577 Reporting Requirements

Updated Steam Generator Tube Inspection
Report for Cook Nuclear Plant U2C23
Refueling Outage

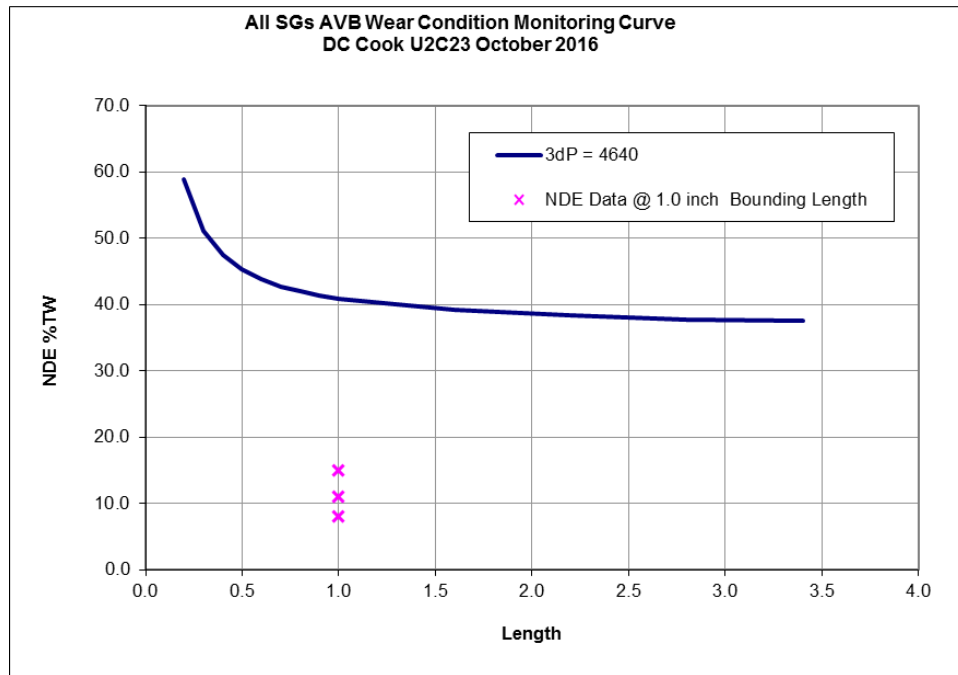
Figure 1: CM Curve for AVB Wear (ETSS 96004.1)

All AVB and TSP wear indications were characterized as axial partial through-wall degradation less than 135° in circumferential extent. As shown in Figure 1 and Figure 2, all wear indications were below the CM limit for structural integrity. Since wear indications will leak and break at essentially the same differential pressure, leakage integrity was also satisfied.

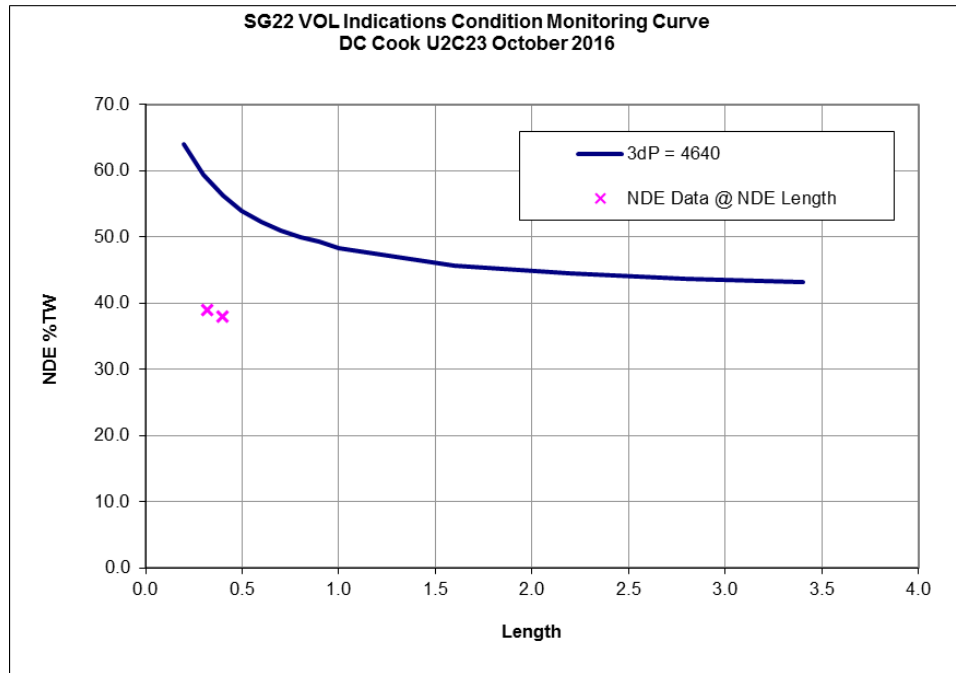
Figure 3: CM Curve for VOL Indications (ETSS 27904.1)

All volumetric indications measured less than 135° in circumferential extent. Therefore, the indications were treated as axial partial through-wall degradation less than 135°. As shown in Figure 3, all volumetric indications were below the CM limit for structural integrity.

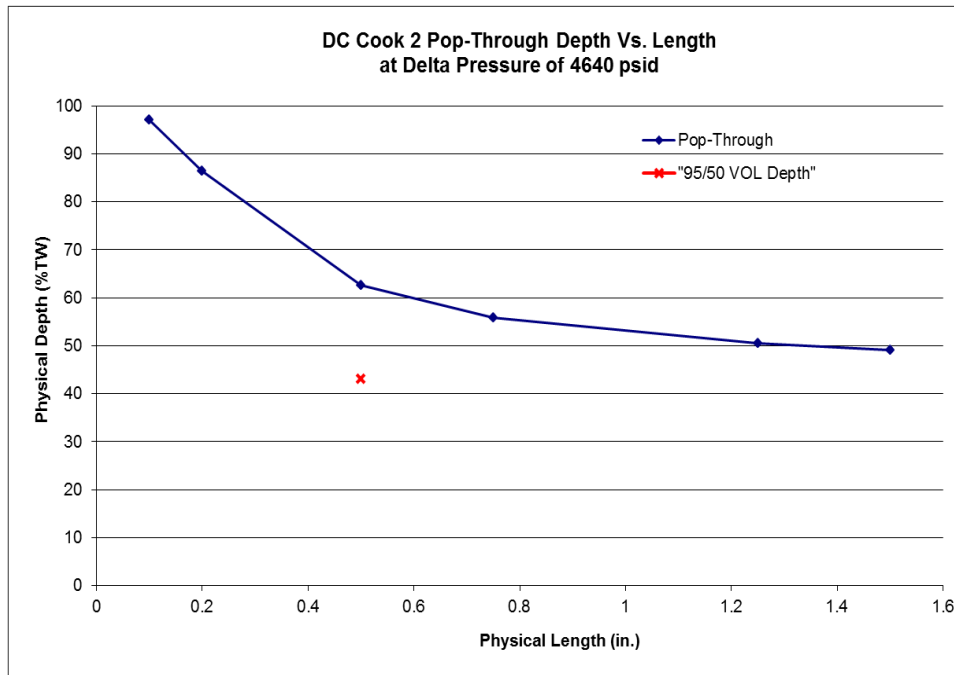
Figure 4: Pop-Through Curve with Largest VOL Indication

If the volumetric indications are treated as a form of wear-like indication, leak and break will essentially occur at the same differential pressure, thus demonstrating leakage integrity. Since the volumetric indications resemble an elliptical patch of degradation, leakage due to pop-through was also considered. When considering the worst-case accident pressure differential, the largest volumetric indication (after being recast into its 95/50 depth of 43% TW) continues to remain bounded by the pop-through curve as illustrated in Figure 4. Therefore, leakage integrity was satisfied for both volumetric indications.
