**CAMECO RESOURCES
CROW BUTTE OPERATION**

Subject: Mechanical Integrity Test failure at I342-7

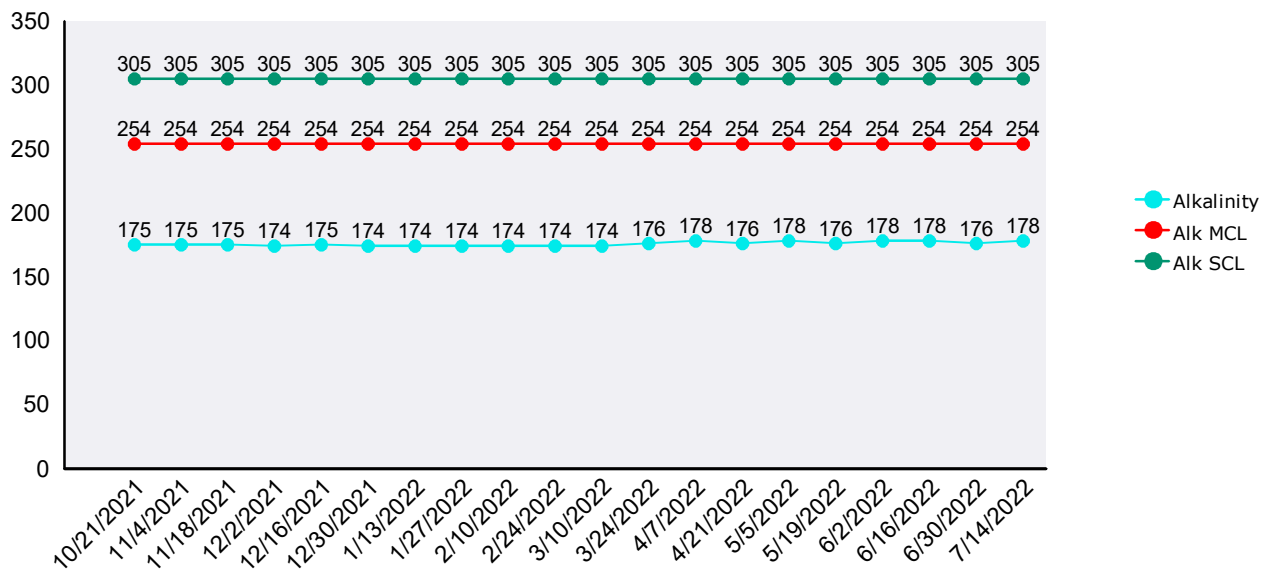
Alkalinity

Graphs of the sampling results from the nearest shallow monitor well SM3-2 are included for your review.

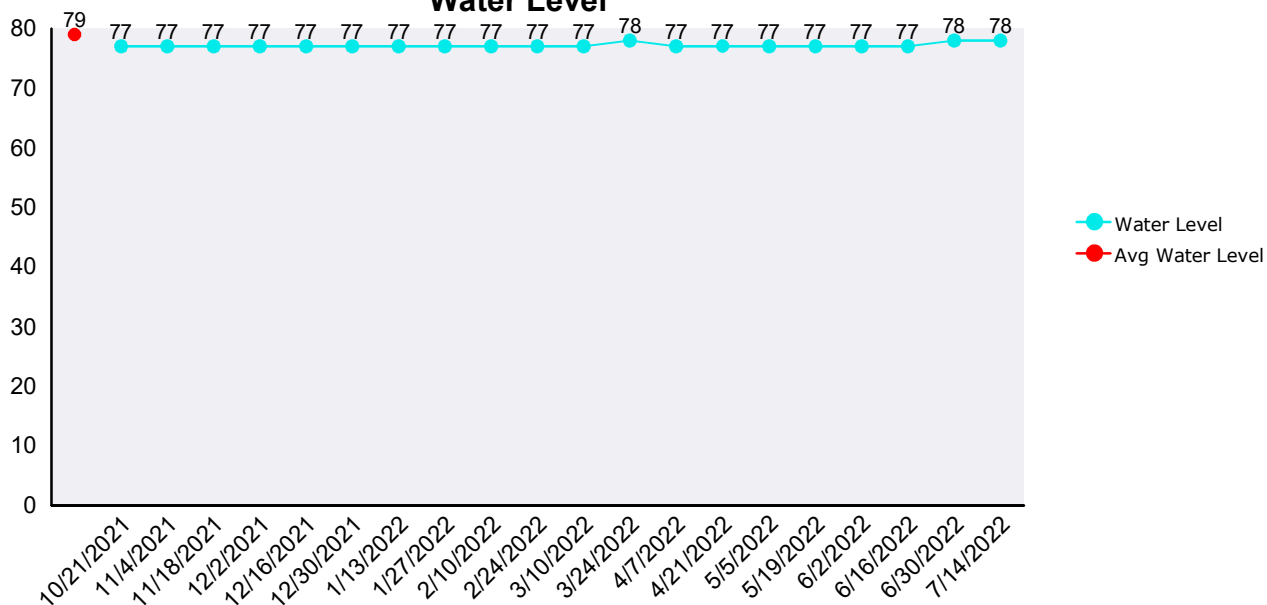
Water Level

This well is an injector and was last used in December of 1997. This well was last successfully mechanically integrity tested June 14, 2017. The well casing depth is 824 feet with a K-packer set at 765 feet. Using isolation techniques, CBO was able to isolate the failure to the 20' joint. The nearest shallow monitor well is SM3-2. The static water level of the shallow monitor well is 79 to 77 feet deep.
