Subject: Solenoid Coil Failure of Model 38878-8 Solenoid Valve at Catawba Nuclear Station for use on FWIV Actuator

**Flow Control Division***Anchor/Darling Valves**BW/IP Valves**Edward Valves**Valtek Control Products**Worcester Valves***March 3, 2022****As Found Inspection Report for Returned Valve****Order Information:**

**OHMEGA SOLENOID CO., INC.****Failure Analysis Report****Customer: Flowserve****Date: 4-11-22****NCR Number: 1539****Part Number: 3890****Information:**

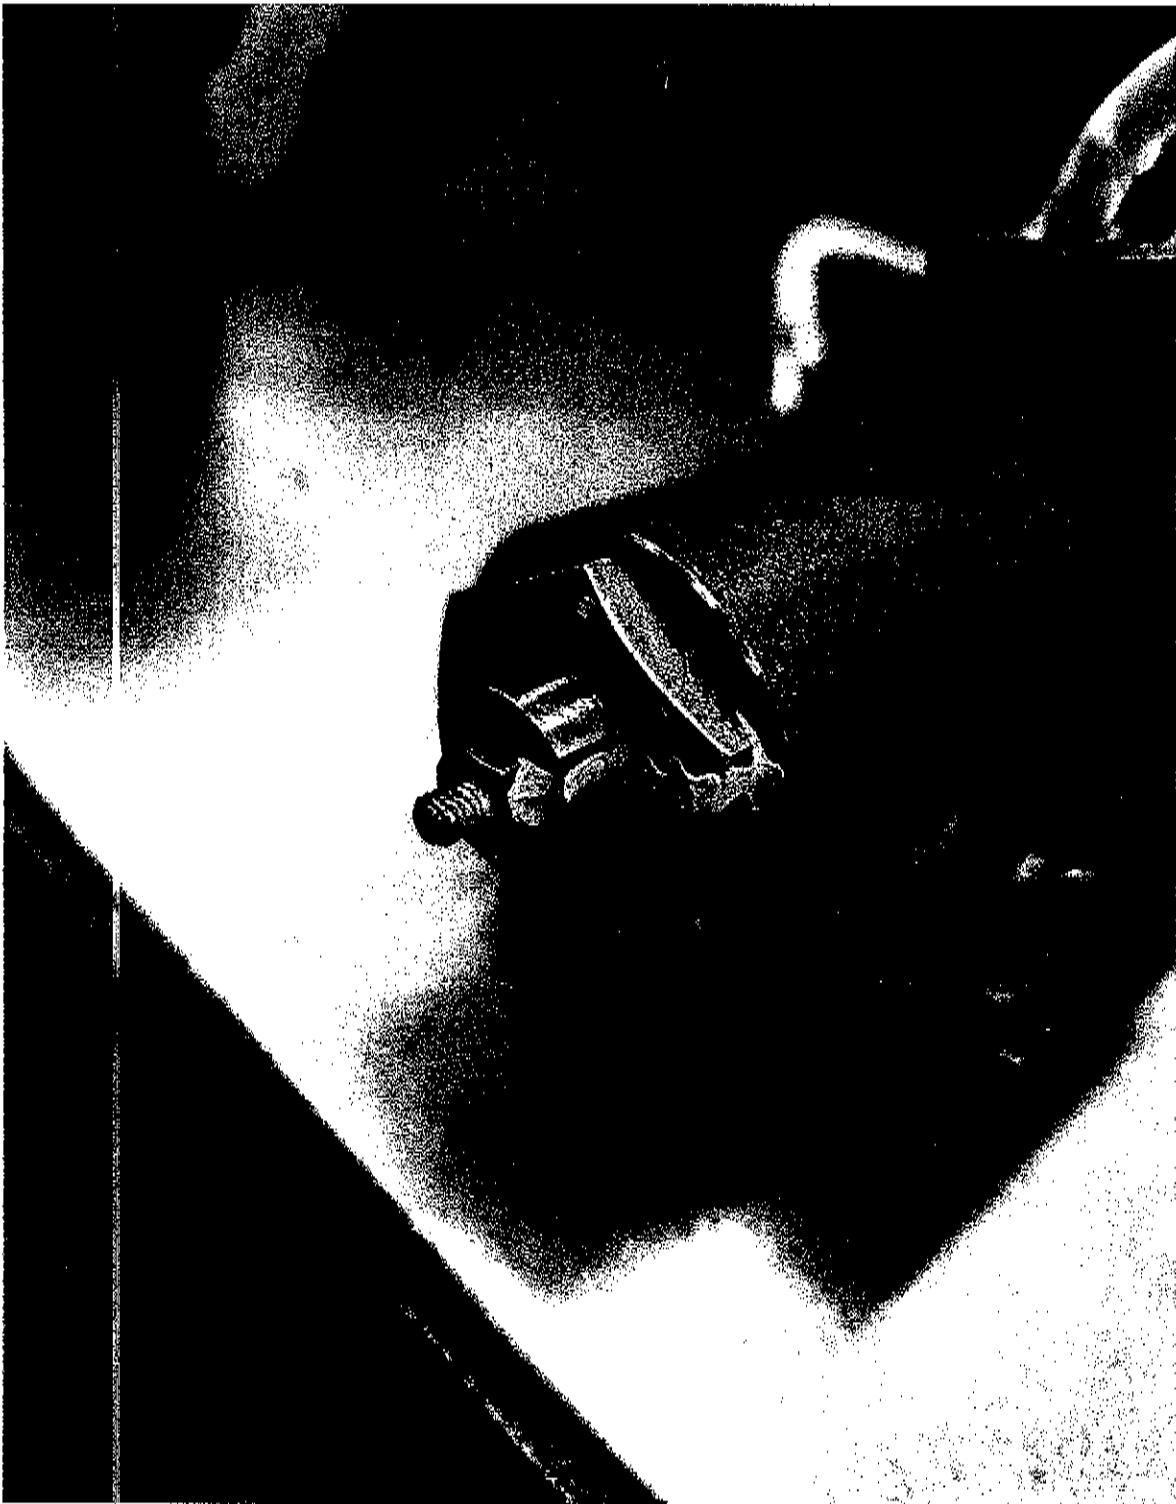
Image 2 – Tamper-Indicating Fastener Paint (2)

The solenoid was received with no apparent external damage. The tamper-indicating fastener paint was not broken indicating that coil housing had never been removed and the internal components had not been manipulated (See Attachment 1, Images 1 and 2). Resistance measurements across the solenoid coil leads resulted in a value of 26.7 Ohms (See Attachment 1, Image 3). This is consistent with the measurements obtained by Duke Energy. After the initial value was recorded, the wire was manipulated with the multimeter leads still connected. The resistance did not fluctuate, indicating that issue most is most likely in the coil itself.
