Davis Besse EDG Failure Field Flash Selector Switch May 2021

Kevin Barclay
U.S. Nuclear Regulatory Commission
2022

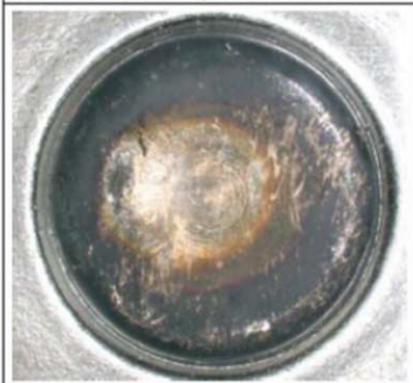
Photo 20 – Stationary Contact 3

- Switch Failure Was Not Contact Fouling From Lack of PM
- Found Nickel Contamination on Contact
- Postulated FME From Upper Terminal Screw Location
- PM Performance Deficiency Did Not Cause May 27th Event
