Callaway Energy Center Steam Generator Tube Inspection Report

1.0 PURPOSE

The purpose of this report is to document that the Callaway Unit 1 steam generator tube integrity performance criteria have been met for operating cycles 22, 23, 24, and 25 (April 2016 to April 2022 of up to 4.655 EFPY duration) and to also demonstrate that there is reasonable assurance that the performance criteria will be met for the upcoming 5-cycle operating period, consisting of cycles 26, 27, 28, 29 and 30, not to exceed 7.2 EFPY.

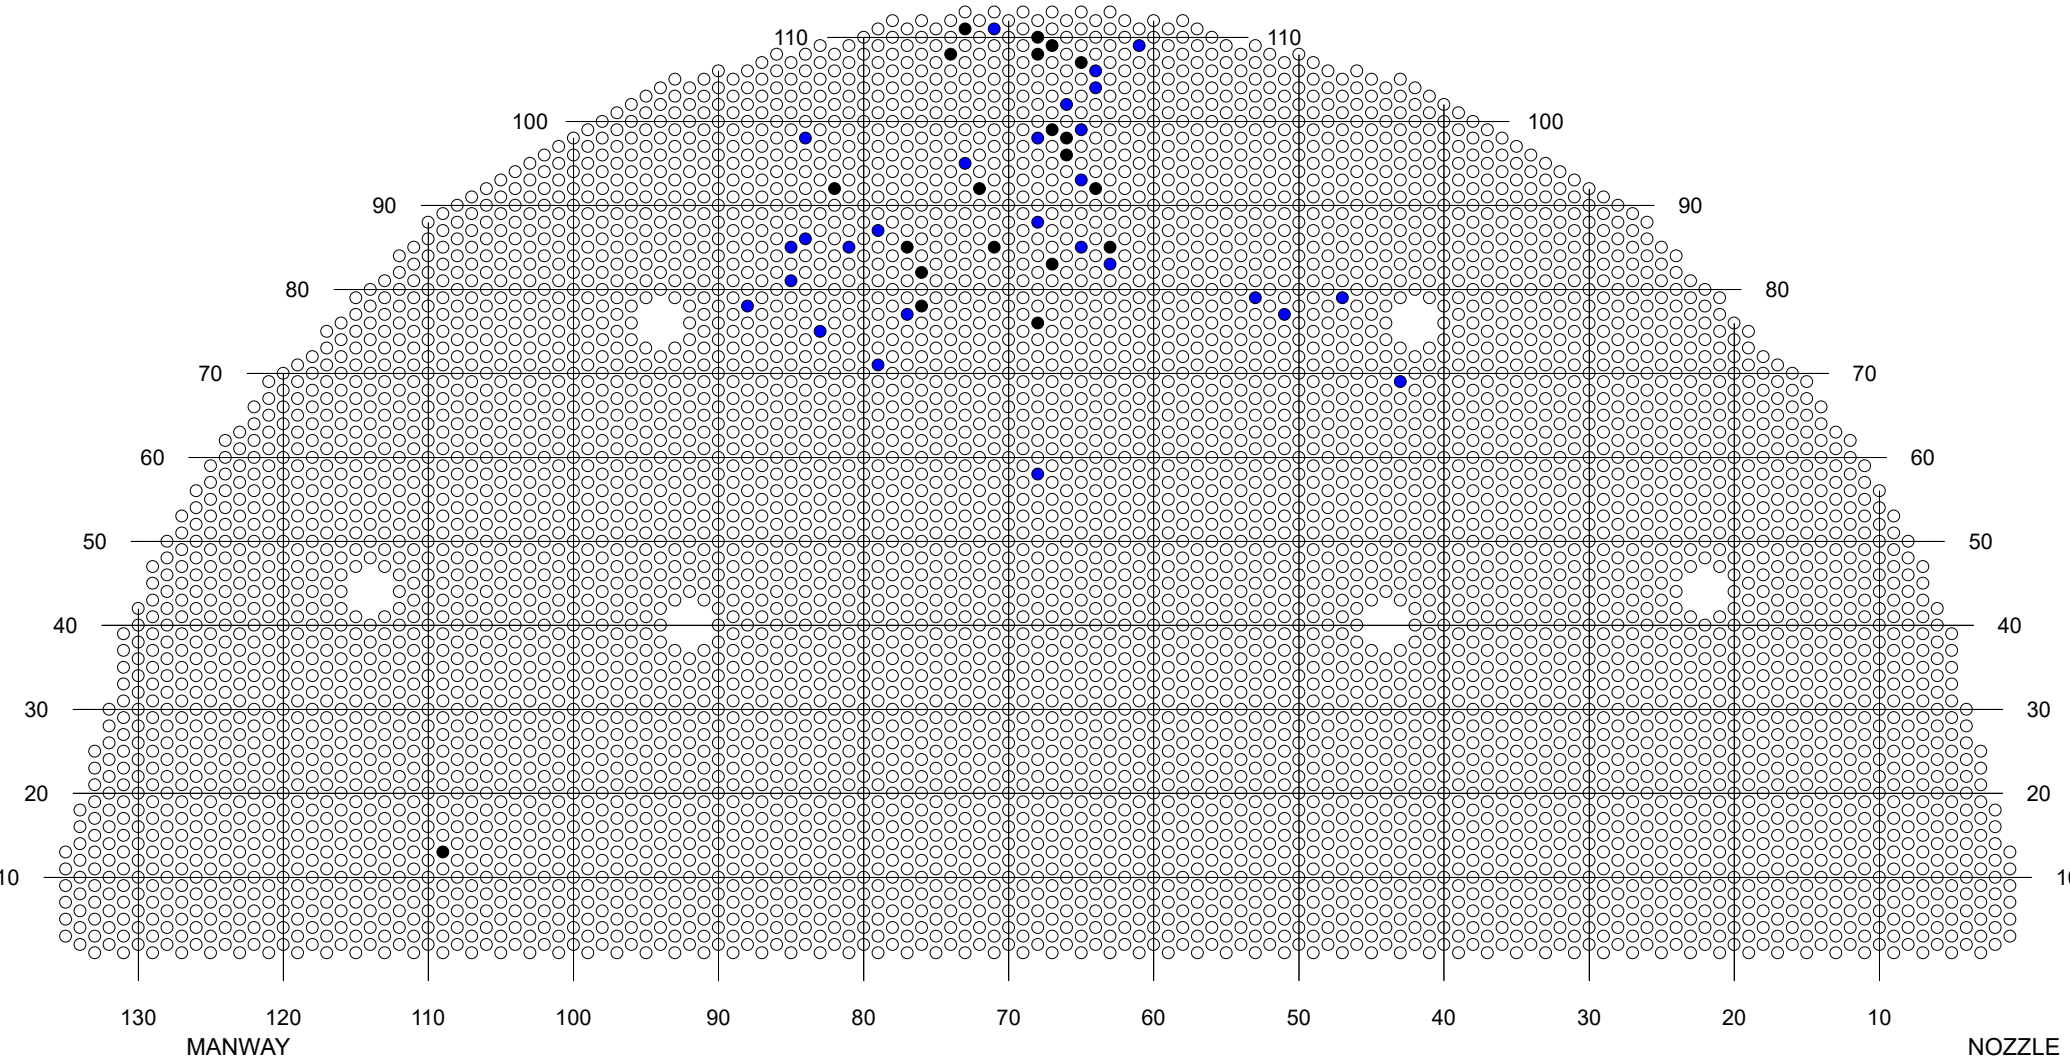
Ameren: S/G A HOT AREVA

AVB wear was reported in each of the four steam generators. A total of 459 AVB wear indications were detected. The maximum reported AVB wear depth was 36%TW. There are 91 indications in 61 tubes of <20% TW in SG-A, 66 indications in 42 tubes of <20% TW in SG-B, 136 indications in 84 tubes of <20% TW in SG-C, and 35 indications in 21 tubes of <20% TW in SG-D.

AVB Wear 20% - 39%

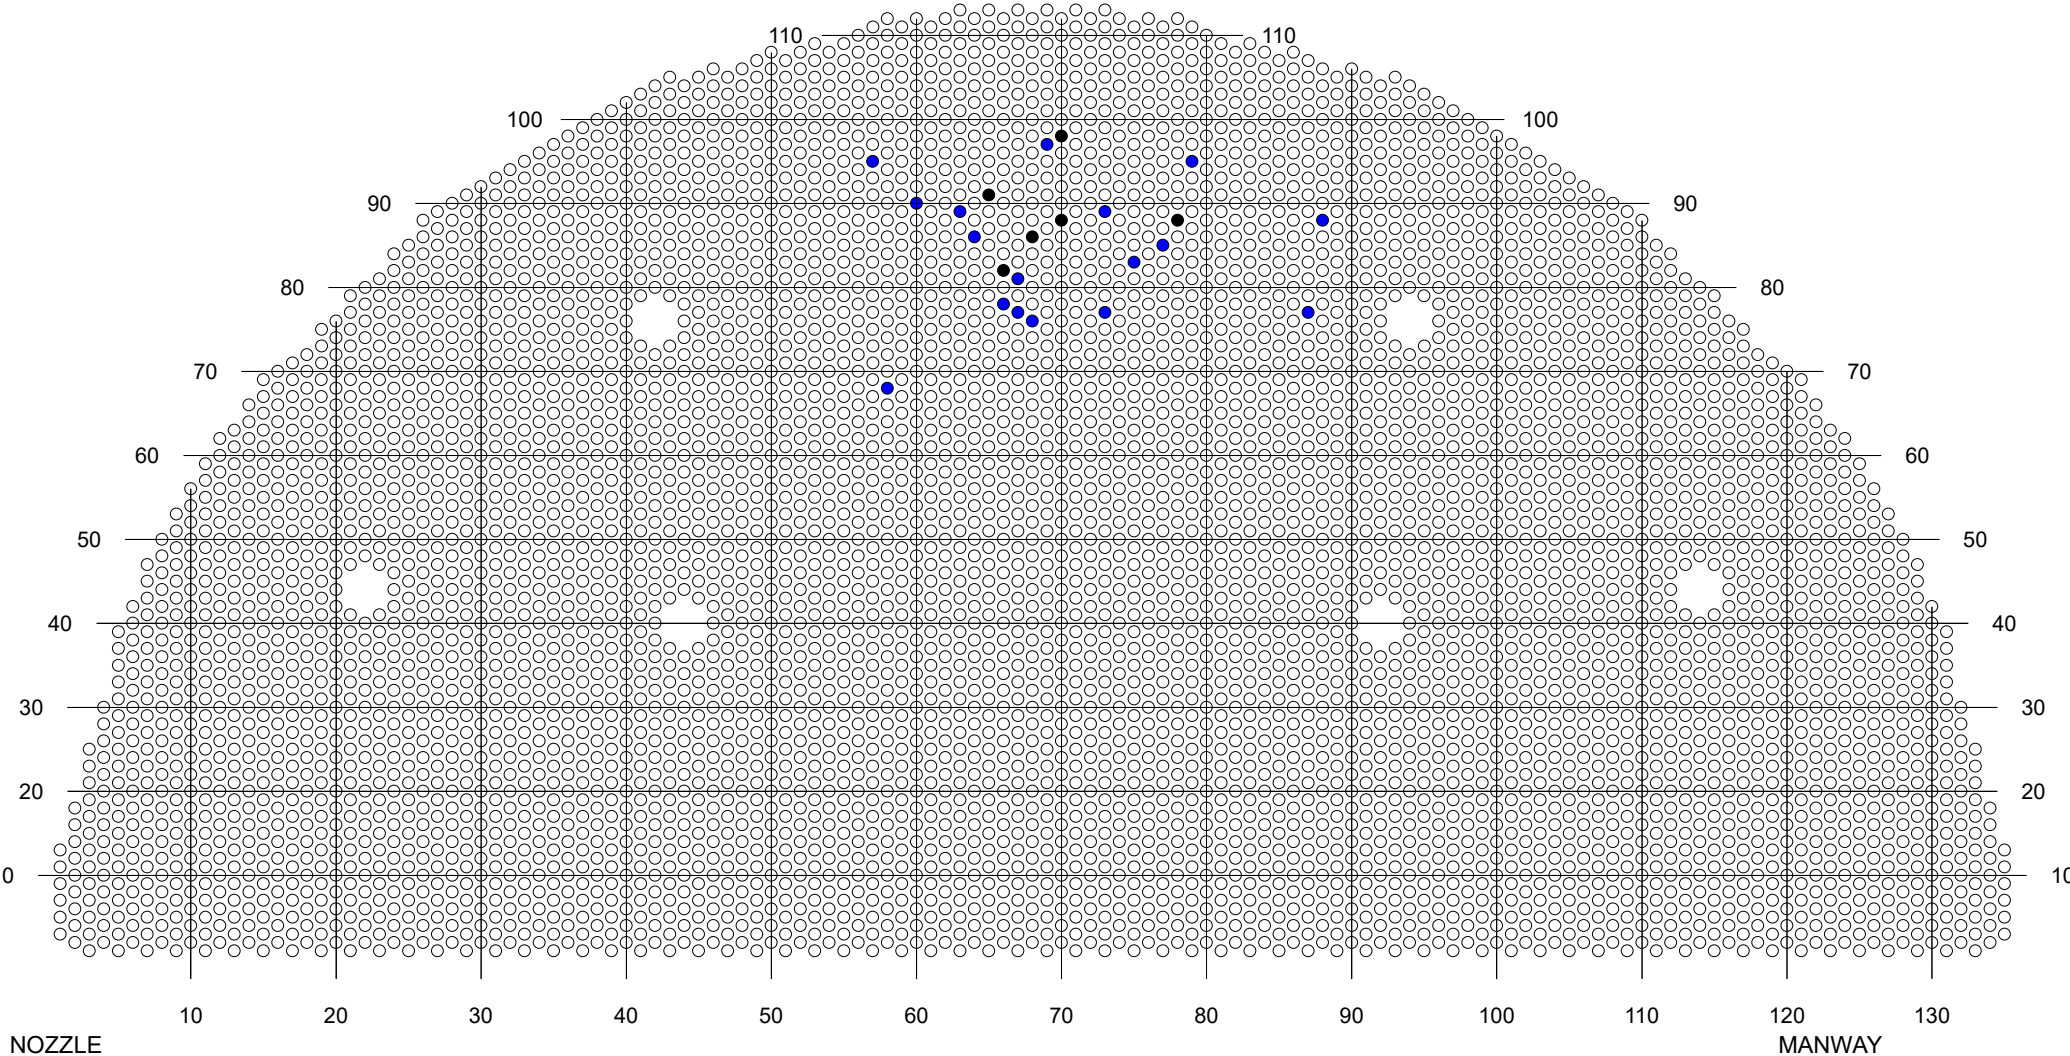
Ameren: S/G B HOT AREVA

AVB Wear 20% - 39%

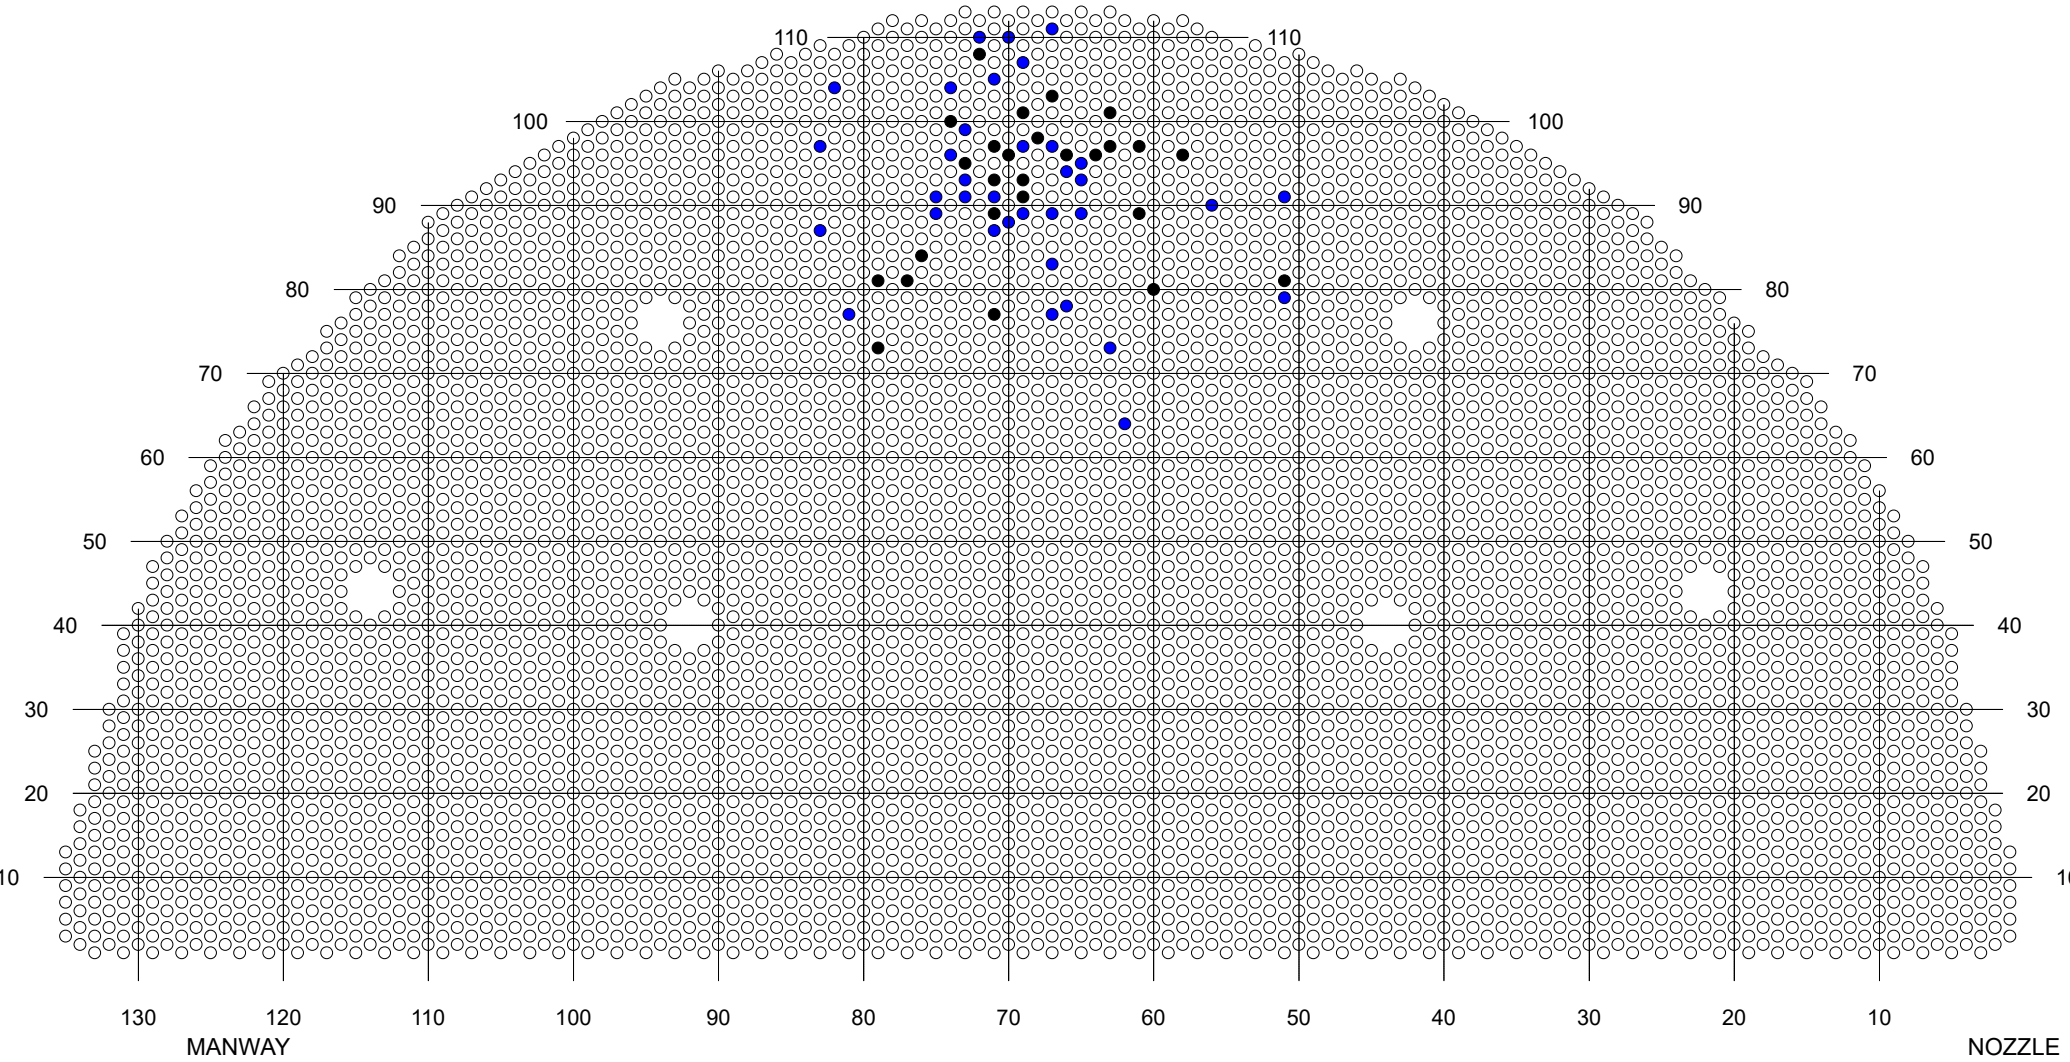
SCALE: 0.084494 X
Wed May 04 08:58:44 2022
Ameren: S/G C HOT AREVA

AVB Wear 20% - 39%

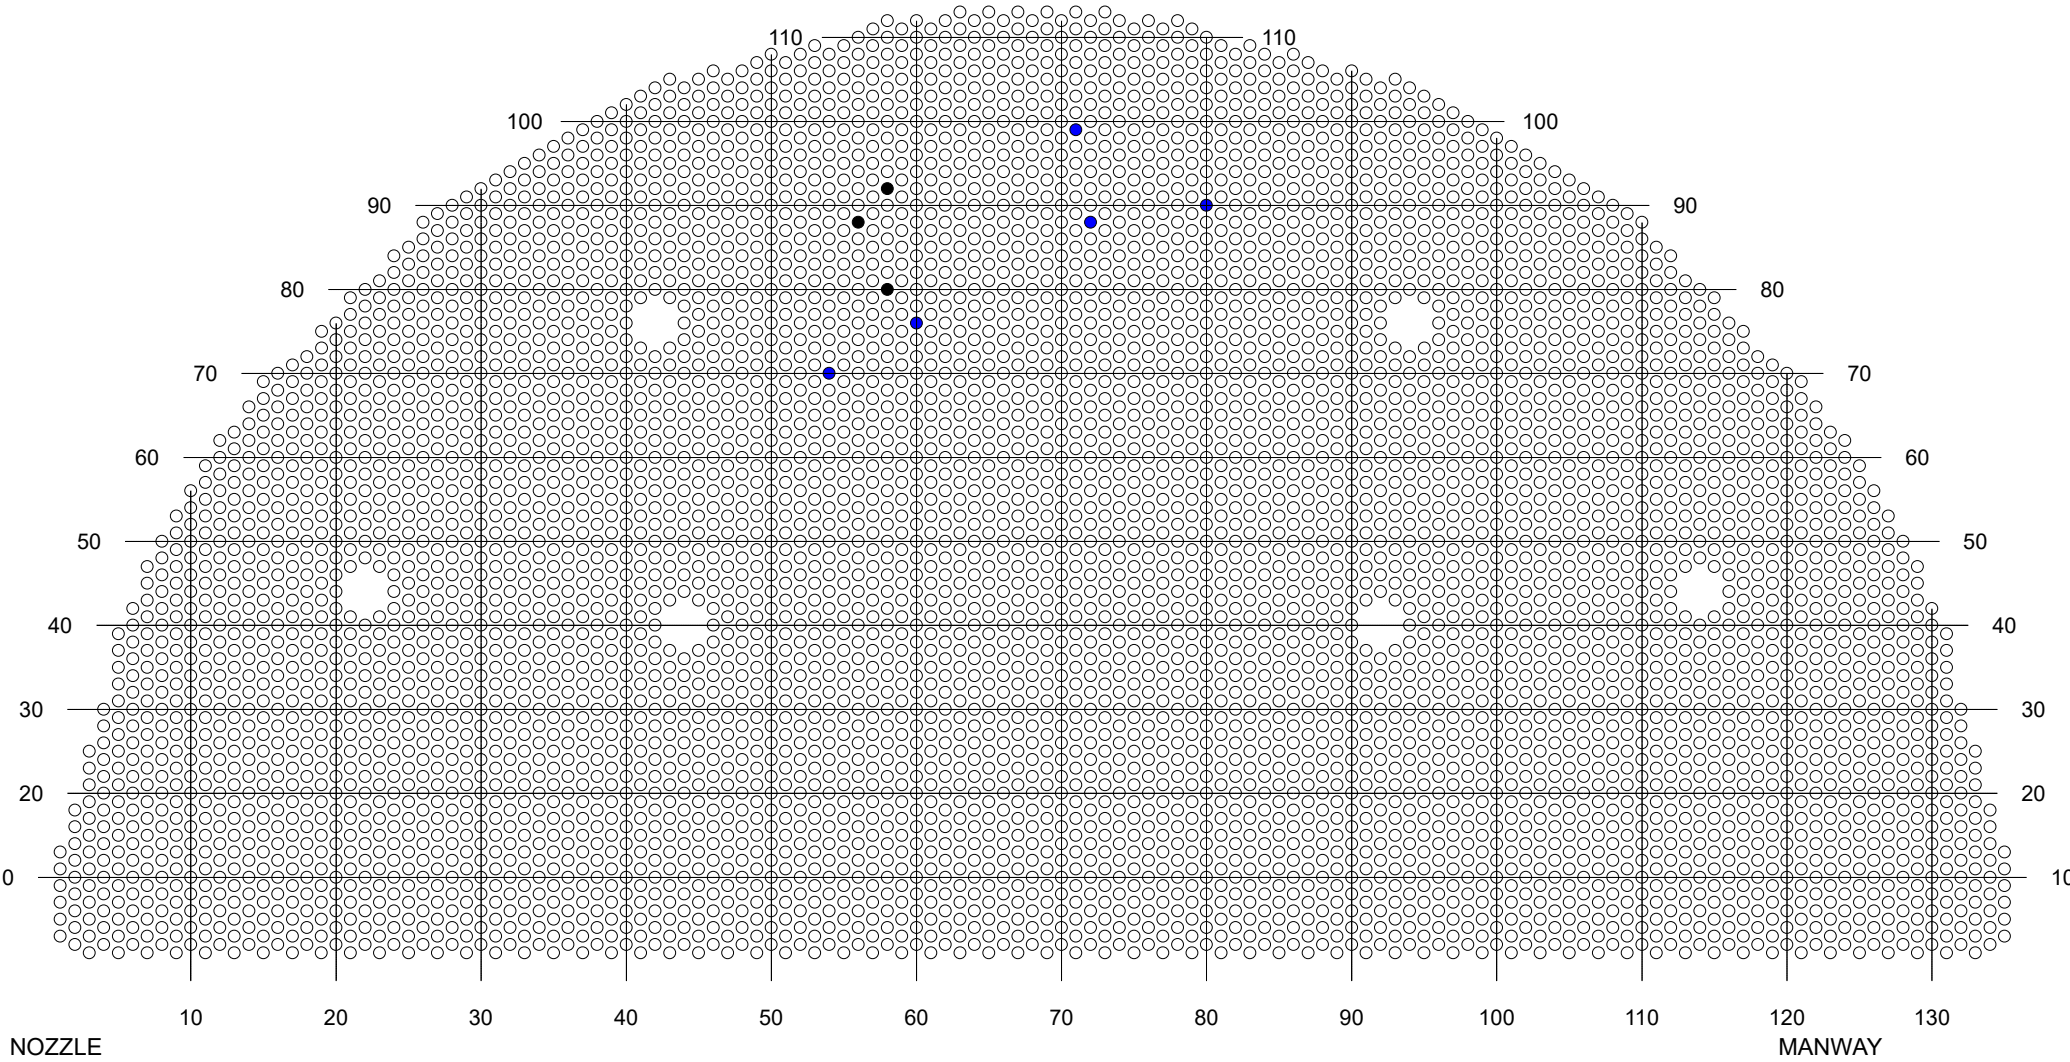
SCALE: 0.084494 X
Wed May 04 09:02:41 2022
Ameren: S/G D HOT AREVA

AVB Wear 20% - 39%
