Relief Request for Reexamination Requirements of Byron Unit 2 RPVHPN Number 75 with Mitigated Alloy 600/82/182 Peened Surfaces

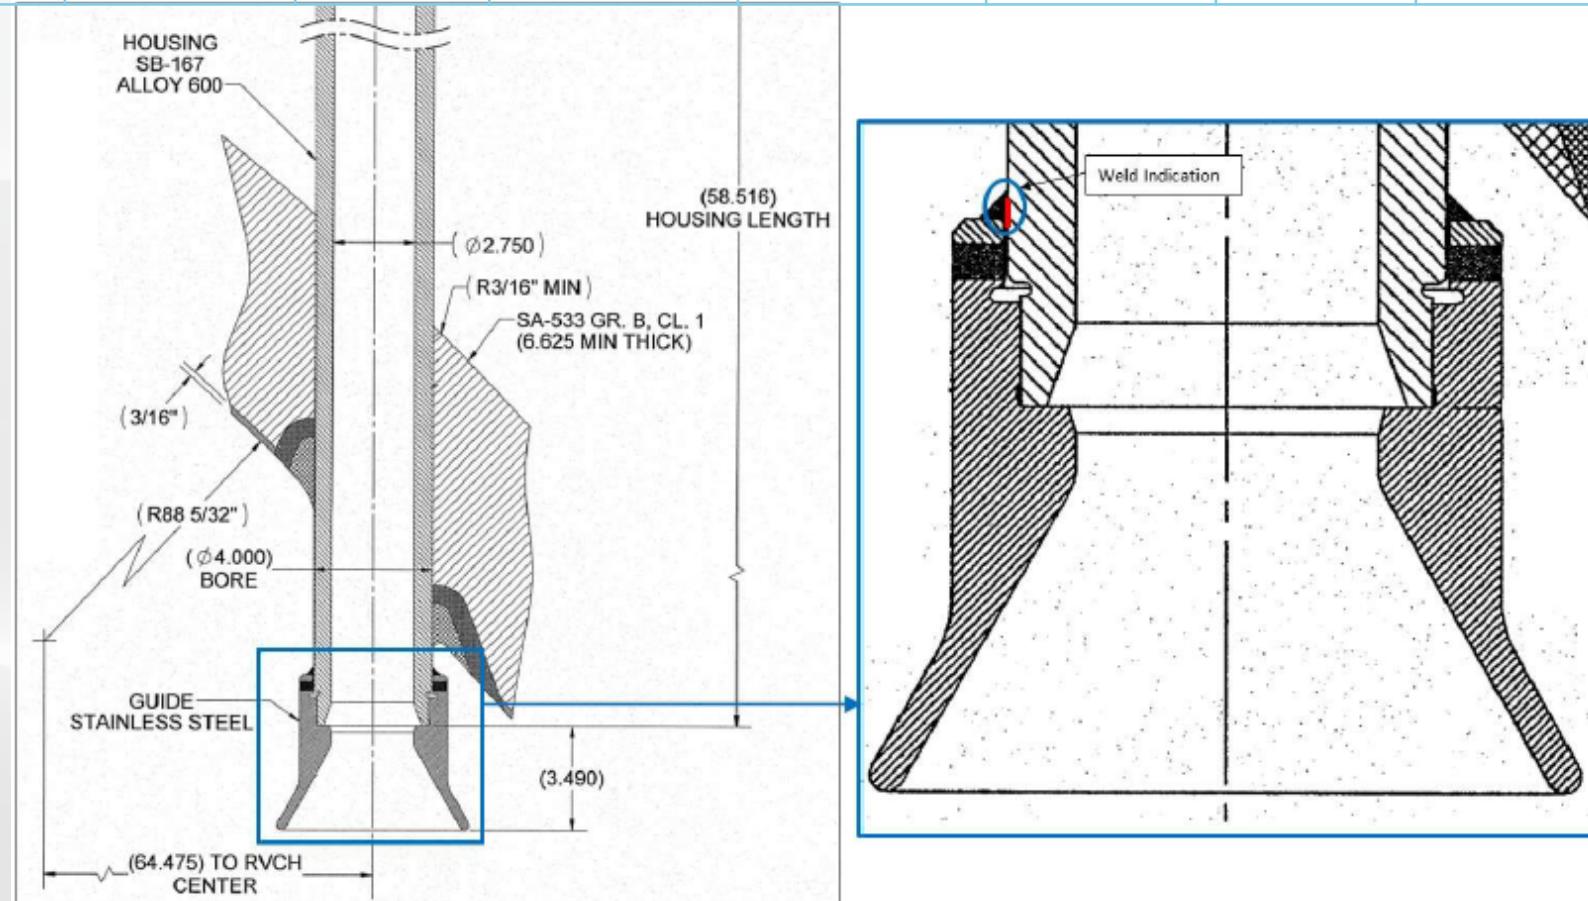
- The indication at P-75 was found outside the required peening coverage area in accordance with MRP-335, Revision 3-A. Peening had not been performed on this area due to geometry limitations where the guide funnel fillet (tack) welds, and the adjacent areas are shadowed by top of the guide funnel.

- This indication is located at 184 degrees with a length of 0.197" with a depth of 0.141" from the outer diameter (OD) surface of the CETC penetration. The indication extends from 1.498" to 1.695" from the end of the nozzle. The indication is axially oriented and is at the location of one of the guide funnel tack welds.

Pen. #	Nozzle OD/ID	Primary Flaw Orient.	Location (deg.)	End Point 1 from End of Nozzle. (in.)	End Point 2 from End of Nozzle. (in.)	Length, 2c (in.)	Depth, a (in.)	Depth-to-Thick., a/t	Distance between Top of Axial Flaw and Bottom of J-Groove Weld, (in.)
75	OD	Axial	184	1.498	1.695	0.197	0.141	23%	5.9

- A fatigue and PWSCC flaw growth evaluation was performed using finite element analysis (FEA) to establish an acceptable period of operation based on the predicted crack growth and the acceptance criteria defined by ASME Section XI IWB-3663. The acceptability of the flaw is bounded by its axial growth direction.
 - Based on PWSCC crack growth rate of ASME Section XI, Article O-3230, the acceptable period of operation is **17.4 EFPY**.
 - Based on PWSCC crack growth rate of MRP-420, Revision 1, the acceptable period of operation is **15.3 EFPY**.
 - The minimum distance between the top of the final axial flaw length and the bottom of the J-groove weld is 3.7 inches.

- The fatigue and PWSCC flaw growth evaluation provides technical justification to revert the reexamination requirement of Item No. B4.20 for P-75 back to Item No. B4.60 like the rest of the penetrations. As such, Constellation is requesting relief to perform the post-peening volumetric examinations of P-75 in accordance with Item No. B4.60 once per inspection interval like the rest of the penetrations.
- Performing this examination every other refueling outage as an Item No. B4.20 until the guide funnel tack weld flaw is repaired is a hardship due to person-rem exposure and increased outage complexity. Based on these factors, Constellation identified the performance of this volumetric reexamination as a hardship without a compensating increase in quality and safety in accordance with 10 CFR 50.55a(z)(2).
- This proposed alternative provides an acceptable level of quality and safety.
