- Automated phased array UT of weld fabrication indication in DMW at U.S. BWR/4

# **Automated Phased Array UT of Transverse Weld Fabrication Indication in DMW**

Component ID: N-2F-SE

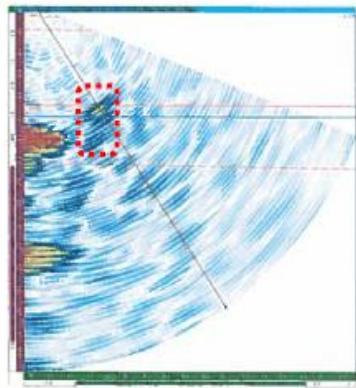
Flaw #1 - Volume-Corrected Sectorial Data Image

| Flaw No. | Flaw Start | Flaw End | Flaw Length | (S) Depth of Flaw | Depth OD to Top of Flaw | Depth OD to Bottom of Flaw | Flaw Through Wall | Component Thickness | Flaw a | Flaw b | Flaw ell | Flaw ell% | Flaw Type | Material Type | Flaw a/l | Subsurface Flaw Only Y-axis | Subsurface Flaw ell% | Subsurface Code Allowable Table | Subsurface Code Allowable ell% | Results |
|---|---|---|---|---|---|---|---|---|---|---|---|---|---|---|---|---|---|---|---|---|
| 1 | 0.00 | 0.70 | 0.70 | 0.86 | 0.97 | 0.11 | 1.20 | 0.06 | 0.08 | | | 1.58% | Subsurface | Austenitic | 0.08 | 1 | 1.58% | 10.76% | 10.76% | Acceptable |

Flaw #1 is an axially oriented fabrication flaw, which is located 5.5" clockwise from TDC when looking toward nozzle. The flaw is totally contained within the butter / butt weld material.

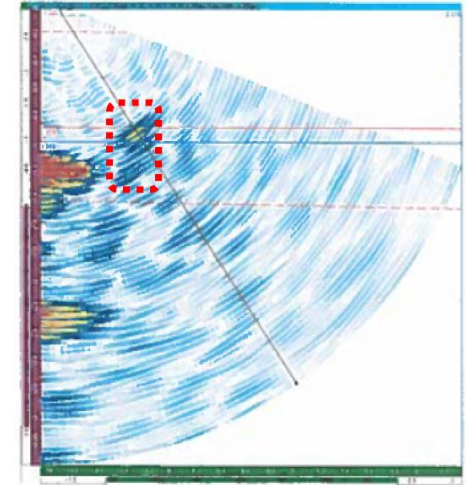
*Fabrication flaw:*

- The screenshot of the fabrication flaw was compared against screenshots of:
  - Mockup flaw responses included in the final report from site specific mockup scans for the “ditch weld” configuration
    - Scans utilized the same examination procedure, UT instrument, probe, wedge, & the DMW was of the same thickness as the N2
    - Screenshots displayed similar characteristics to shallow, inside surface connected planar cracks in the mockup. The characterization as an embedded flaw was brought into question.
  - Flaw response included in the data sheet for a reported SCC flaw that leaked during application of the weld overlay
    - A similar, but much larger stacked pattern of responses was present. The characterization as a fabrication related reflector was brought into question.

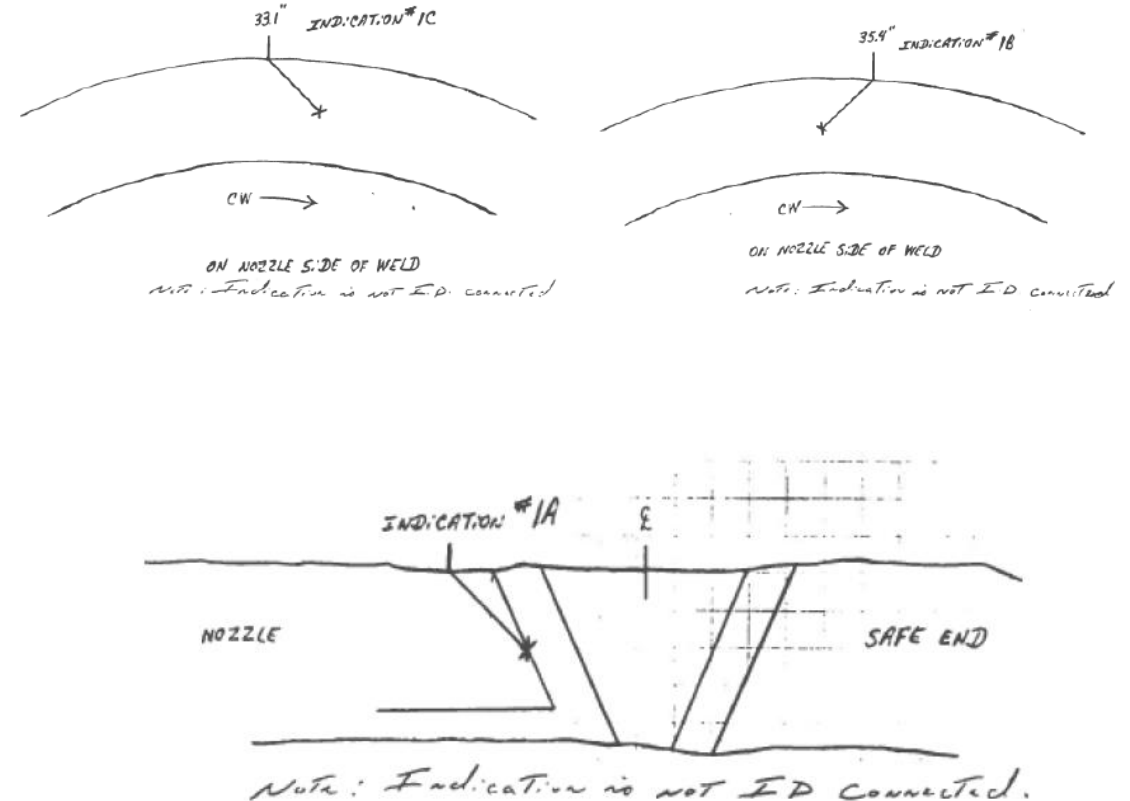
- Embedded slag inclusion recorded during 1988 examination
  - Indication detected from both circumferential scan directions, from the axial scan direction, and during a supplemental 0° scan
    - Recorded circumferential location does not match 2017 indication
    - Recorded depth position does not match 2017 indication
  - Indication characterized as a slag inclusion; datasheet states a review of construction-era radiographic film confirmed a slag inclusion was present in the area
  - Indication not likely associated with 2017 indication and appeared to be thoroughly and properly characterized

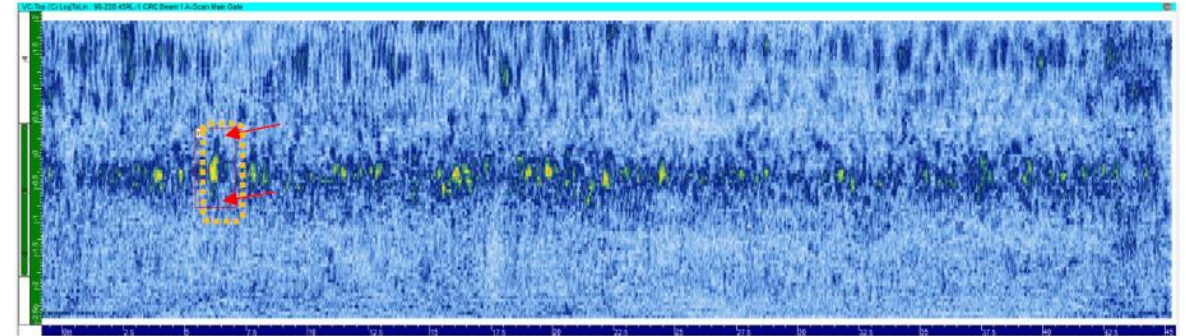
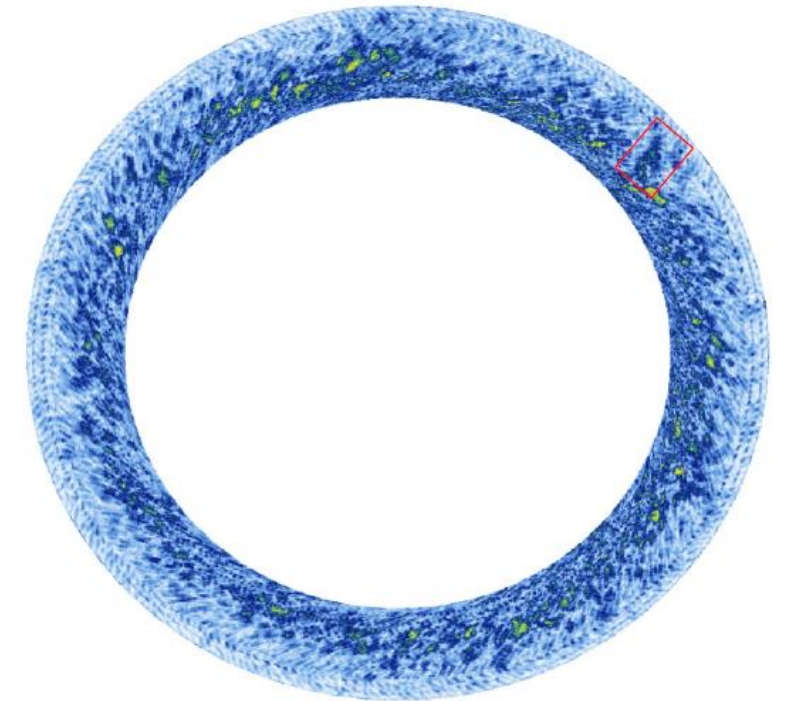
- Review of 2008 automated UT examination data showed no clear evidence of a flaw in the area of the 2017 indication
  - A faint pattern exhibiting unique characteristics was present in the area
    - Transverse orientation and approximate length as reported in 2017
- Could this indicate a transverse flaw was beginning to develop ~2008 and didn't become detectable until ~2017?

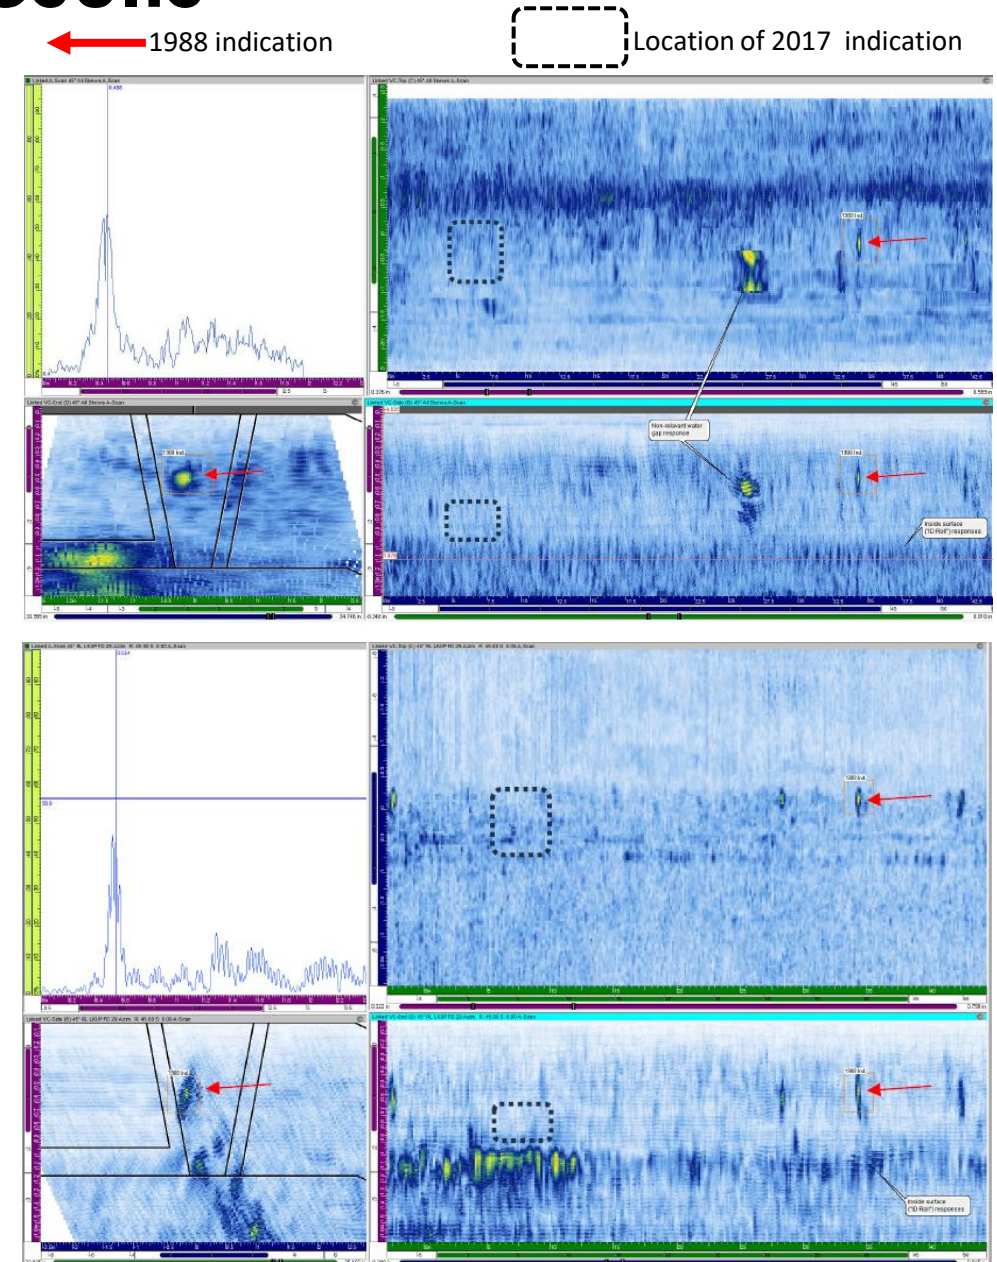
- Manual UT team reported flaw indication located only after a very meticulous manipulation of the UT probe
  - Indication difficult to repeat
  - Indication extremely short, response disappears with very little lateral movement of the probe
  - Advised automated UT team to tighten scan and index increments as reflector likely to be very small
- No immediate action taken to initiate scope expansion based on results of manual phased array UT examination
- Automated phased array UT results:
  - 1988 UT indication confirmed; same characteristics as documented by prior examiners
  - 2017 UT indication identified but much smaller than reported; recharacterized as a non-recordable indication
- Scope expansion and weld overlay not needed

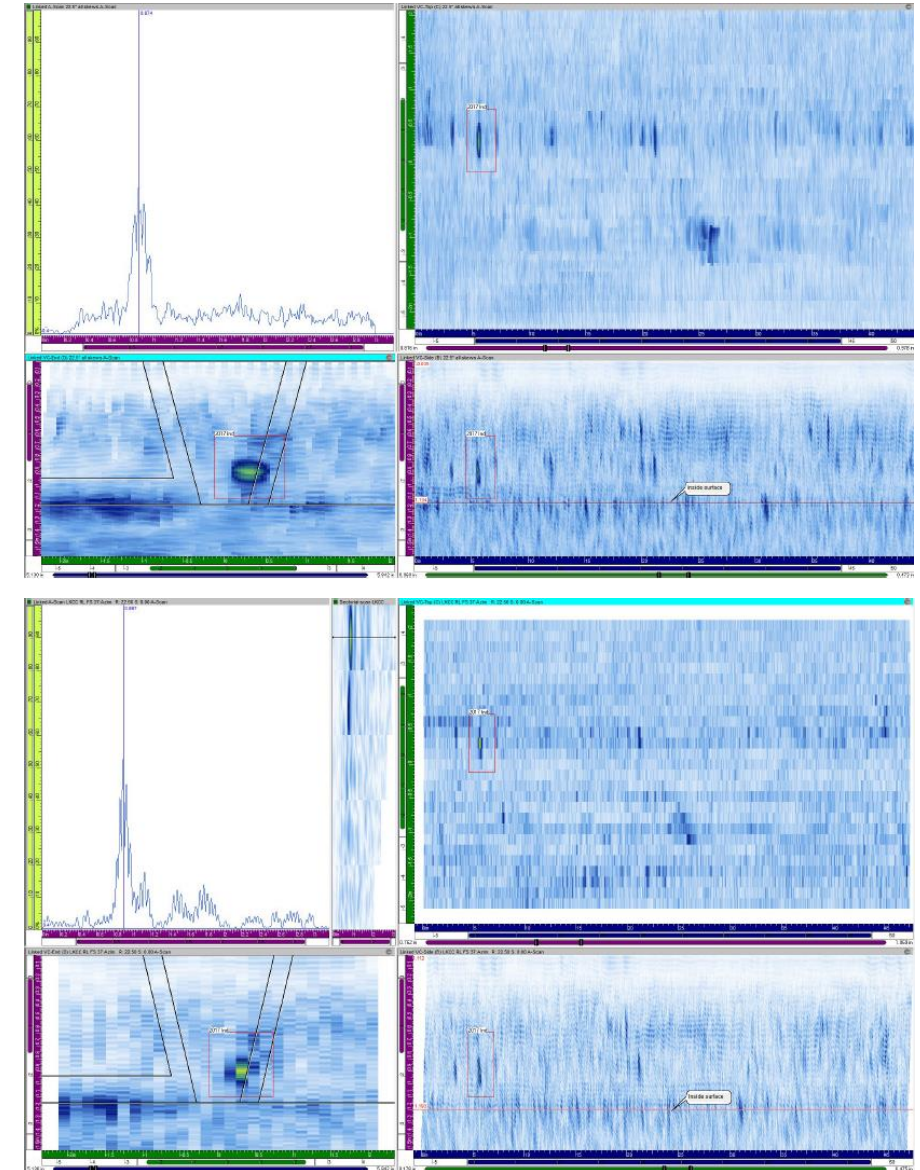
- Reflector reported as a flaw in 2017 was identified
  - Highest amplitude of all the responses which comprise the 360° weld pattern
  - A single hot-spot present along weld fusion line
    - Detected only with the counterclockwise probe orientation
    - Detected only with 22.5°, 30°, and 37.5° examination angles
      - Previous conventional UT exams utilized 45° and 60° search units – this is why it was detected for the first time in 2017
    - Discernable from weld noise pattern only along a single scan line
    - Clearly not connected to the inside surface
- 2017 indication recharacterized as a non-recordable weld discontinuity typical of the 360° weld pattern responses
