October 15, 2024

# **NRC Brief on ANO-2 2R30 Nozzle 71 Half Nozzle Repair**

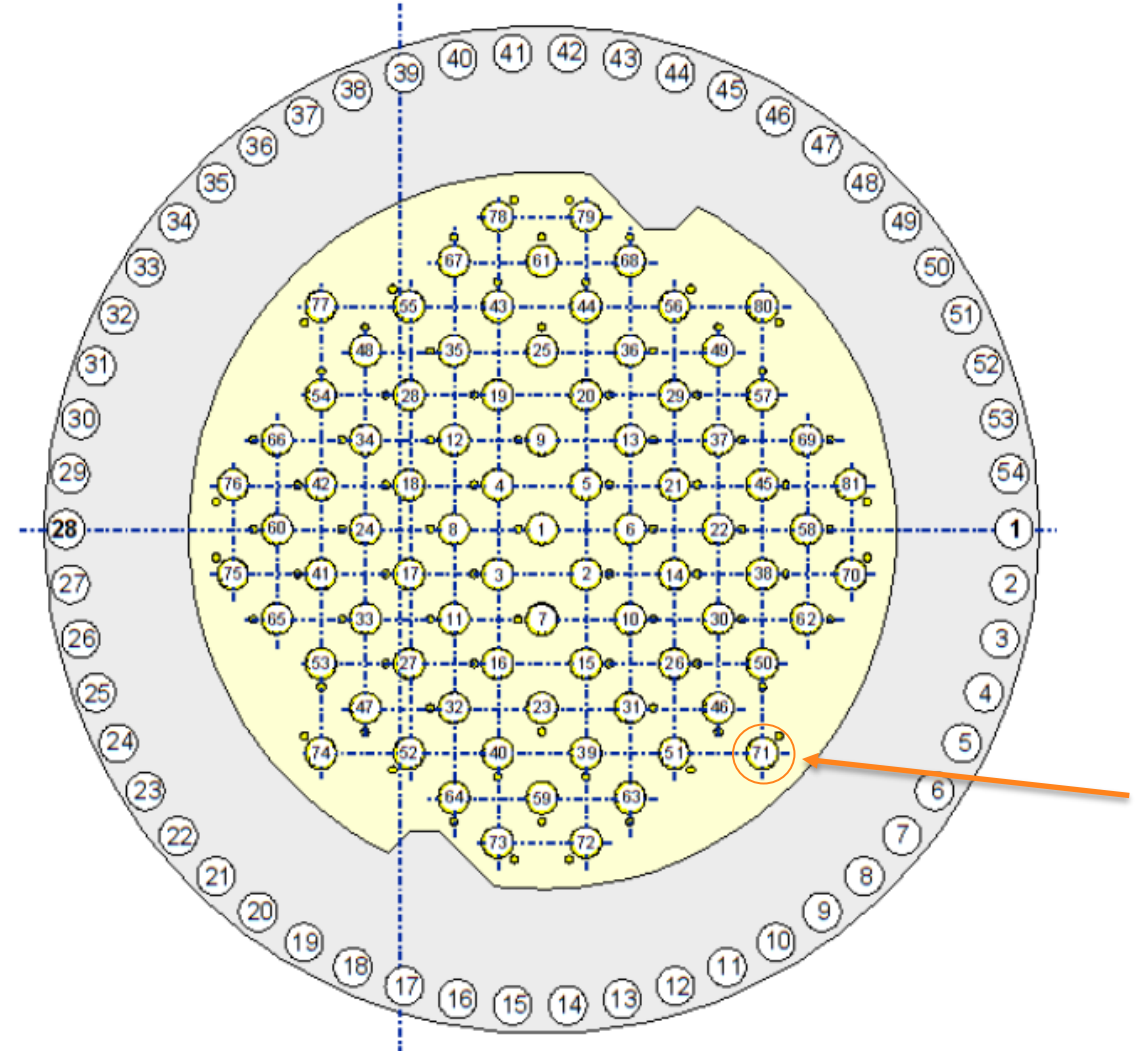
# Nozzle 71 Location

- Outermost Row
- $49.6^\circ$  angle of incidence
- No fabrication flaws or special interest indications previously noted on CEDM 71 at this location

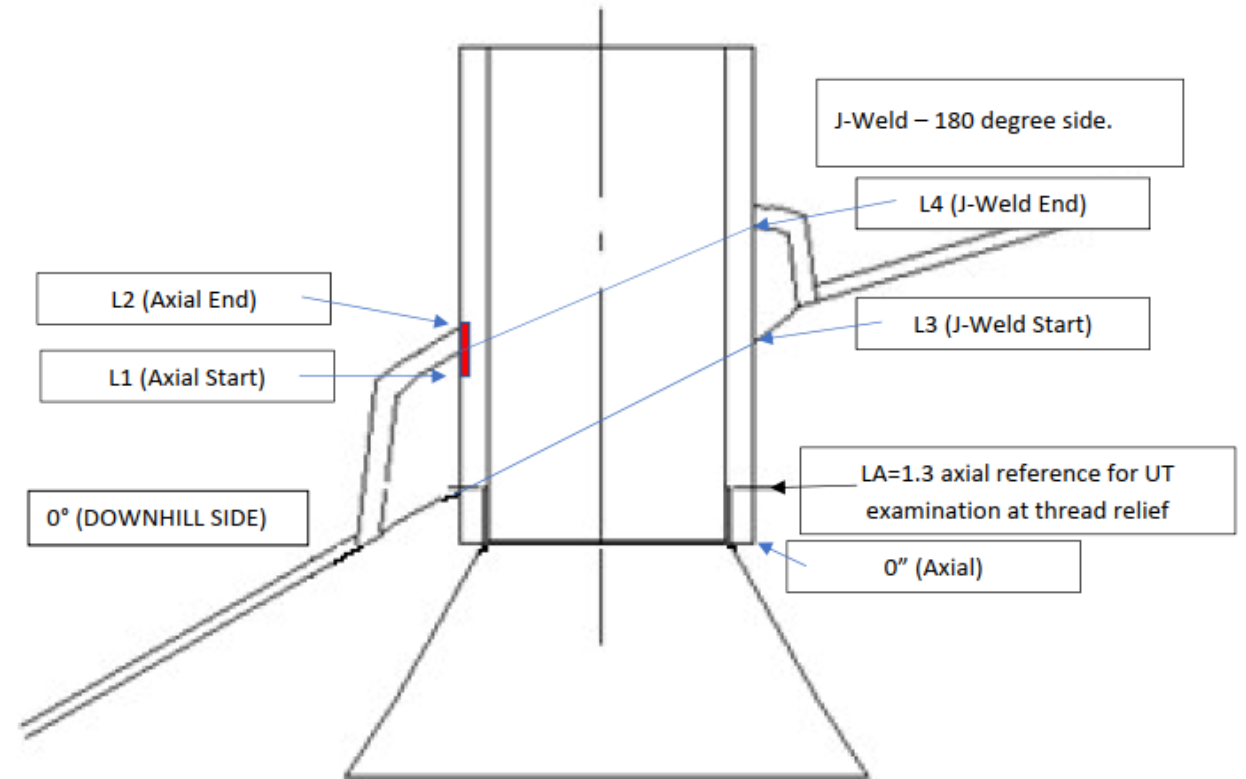
**Penetration Tube/J-weld Repair Diagram**

- Bare metal visual on top of head – No visible leakage
- Clean UT leak path assessment
- Clean Eddy Current from tube ID
- UT indication 0.44" long by 0.195" deep in tube on downhill side located along the top of the J weld
- \*Clean Eddy current on J weld surface and tube OD (augmented exam)

Indication Axial Start (L1)	Indication Axial End (L2)	J-Weld Start (L3)	J-Weld End (L4)	Indication Degree Location*	Depth of Indication into Tube Wall (from tube OD)	Comments
2.58"	3.02"	1.31"	2.78"	2°	0.195"*** in the tube wall	Axial Indication on Downhill Side

- Rapid appearance and growth suggested PWSCC
- Fatigue crack considered but concluded to be unsupported
- Potential surface connection using PT
- Undetected growth of cracks thru welds supported by internal OE at Indian Point 2 in 2018

Decision made to proceed with half nozzle repair with Framatome
