# Comanche Peak Moisture Barrier

June 17, 2025

## Moisture Barrier Cap- As-Found Condition Unit 1

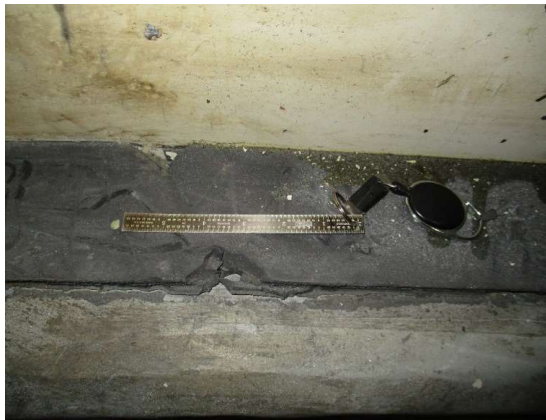
Azimuth 35: 2- 1" x 1" triangles

- The moisture barrier was inspected in 1RF24 (Spring 25). The following items were found during the inspection. All the damaged areas were repaired prior to start up. The damage was limited to the protective cap.

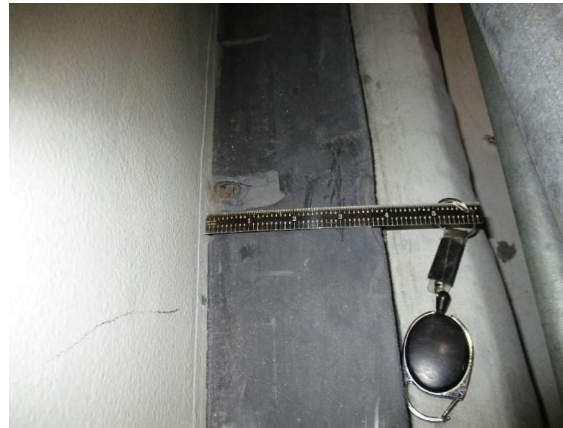
Azimuth 285: 1" x 2"

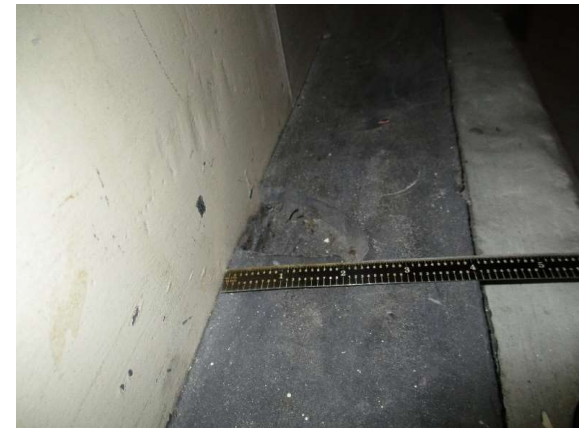
Azimuth 190: 2" x 2 1/2"  
Moisture barrier not exposed

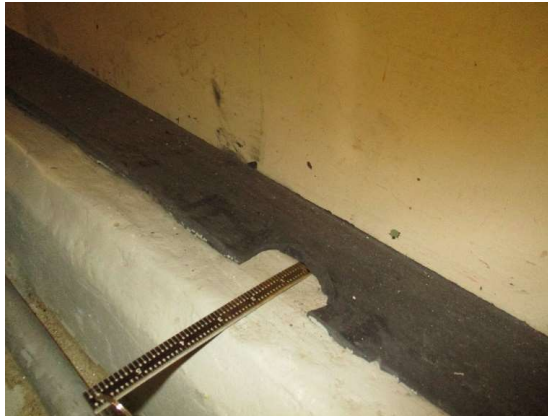
Azimuth 135: 3" x 1 ½"  
Moisture barrier not exposed

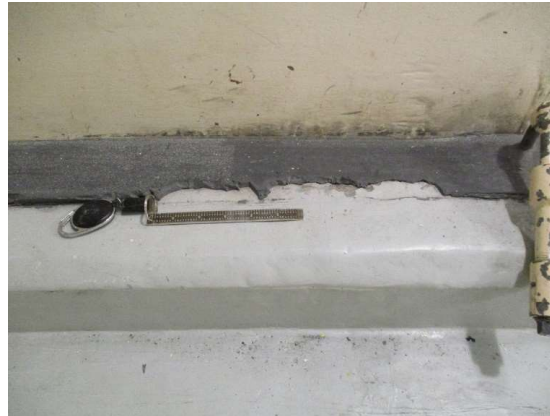
Azimuth 79: 1" x 12"  
Moisture barrier not exposed

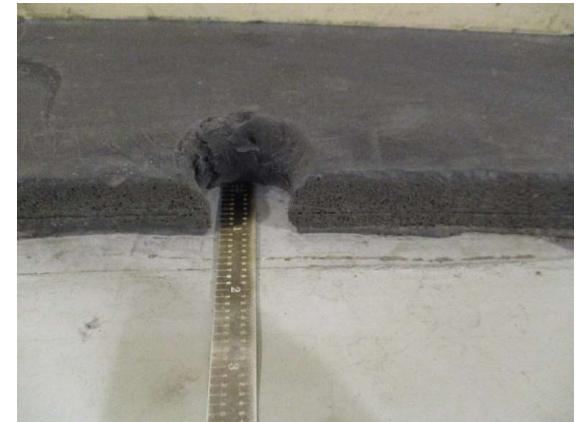
Azimuth 45: 1" x 1"  
Moisture barrier not exposed

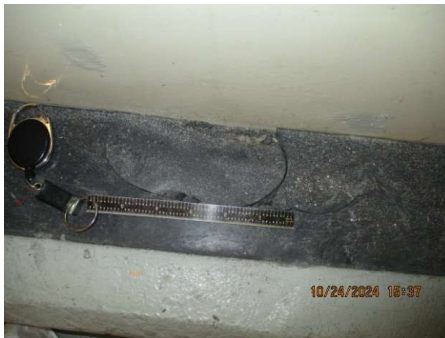
Azimuth 327: 5"x2.6"

- The moisture barrier was inspected in 2RF21 (Fall 24). The following items were found during the inspection. WO 24-583978 was generated to repair the items in 2RF22. The damage was limited to the protective cap.

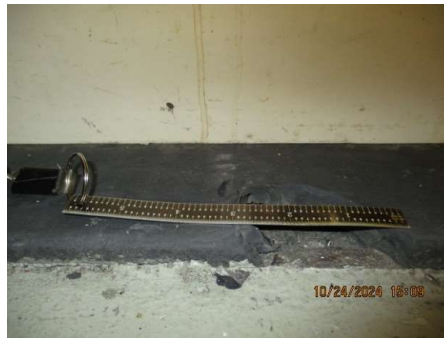
Azimuth 180: 3"x1.8"

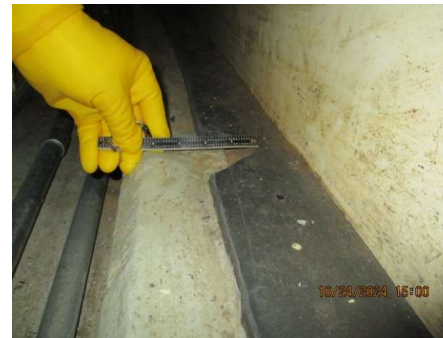
Azimuth 215: 3"x 2"  
(Moisture barrier exposed no  
damage seen)

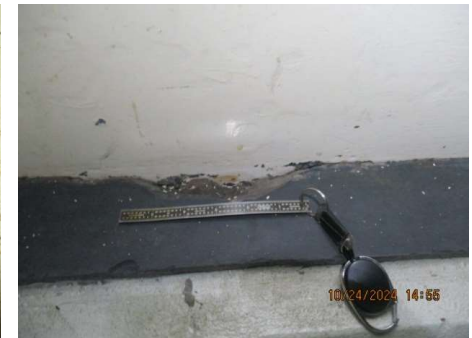
Azimuth 207: 6"x 1.4"
