SUBJECT: NRC AUGMENTED INSPECTION TEAM - REACTOR TRIP WITH  
COMPLICATIONS - REPORT NO. 50-247/99-08

On September 27, 1999, the NRC completed an Augmented Inspection Team (AIT) at the Indian Point Unit 2 (IP2) Station. The enclosed report (Enclosure 1) presents the results of that inspection.

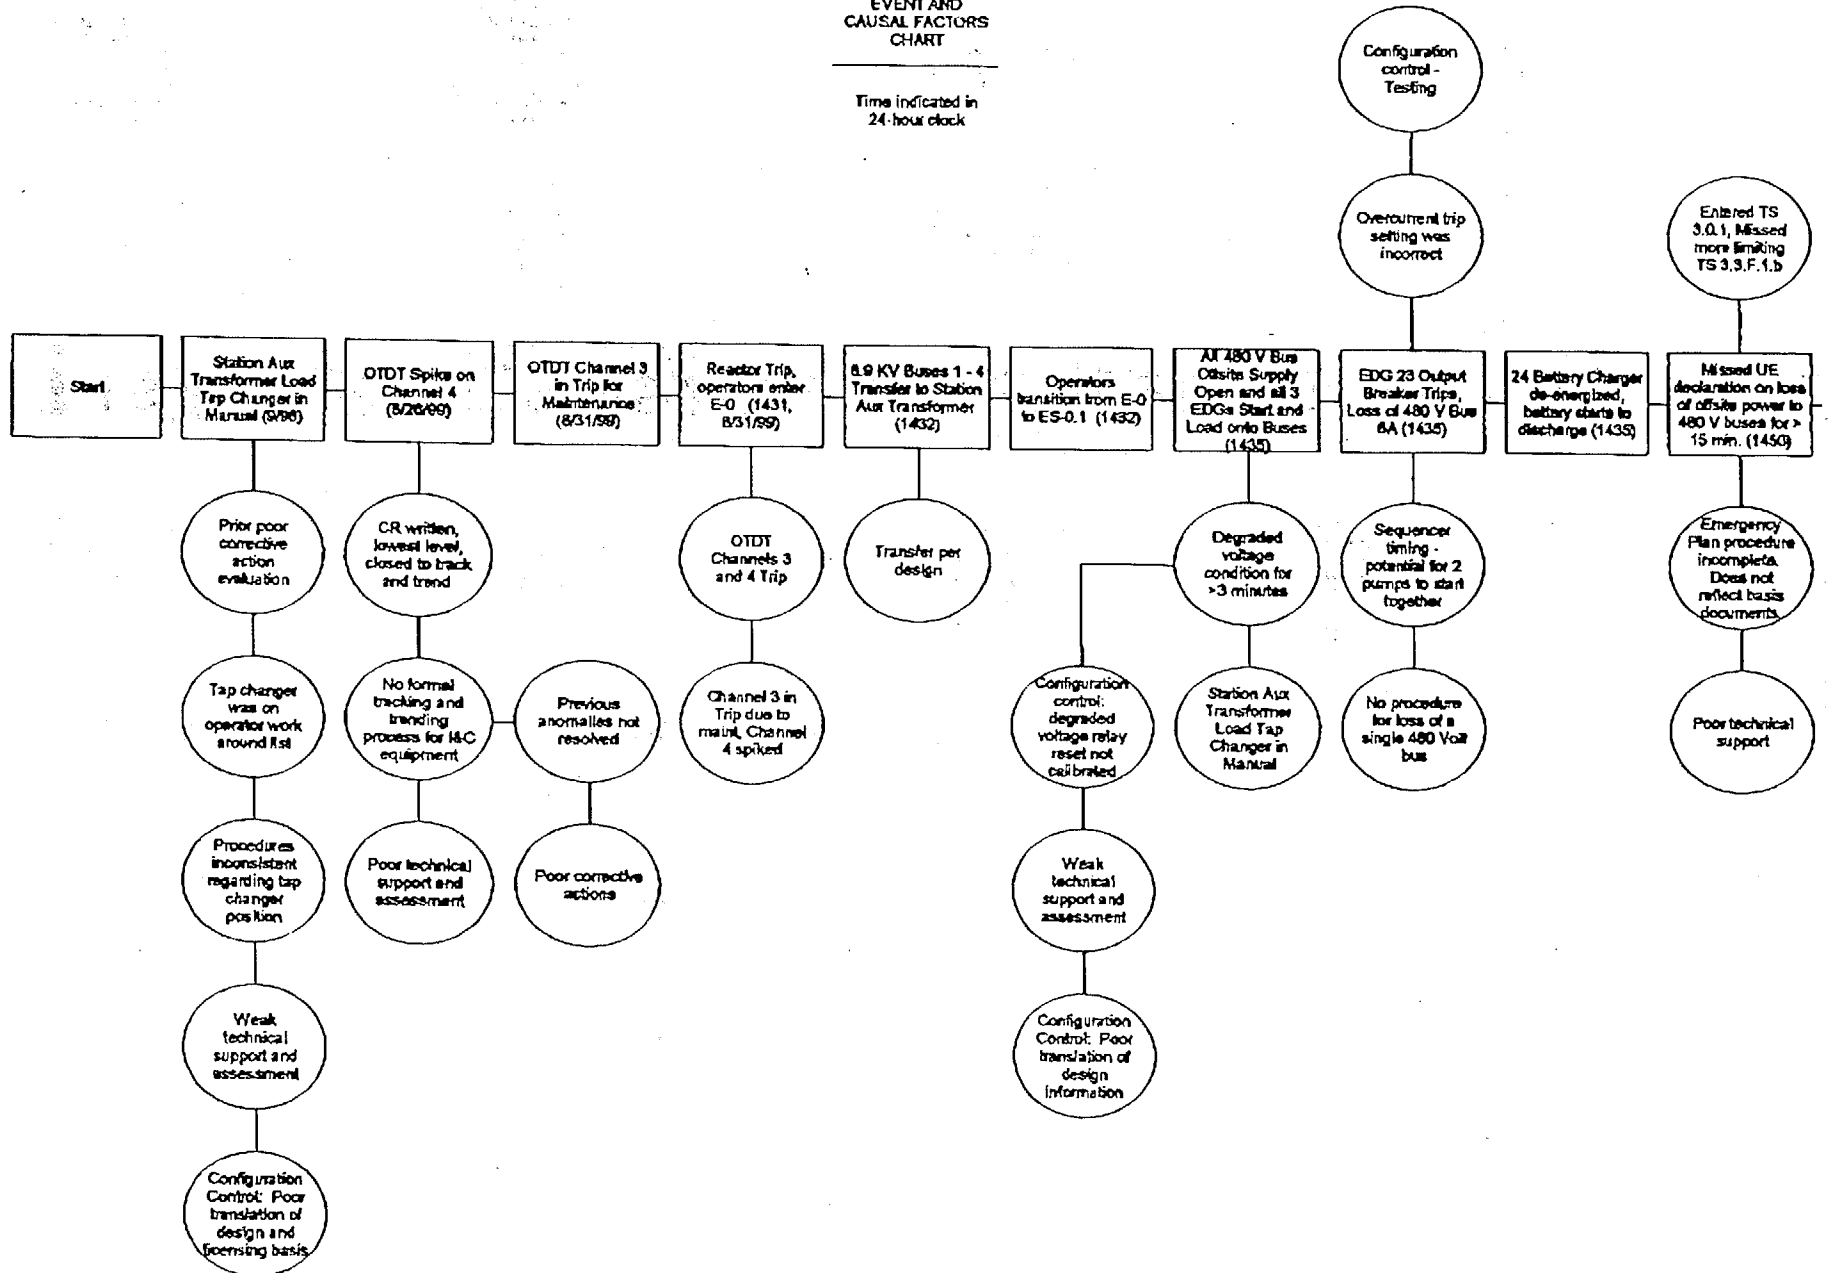
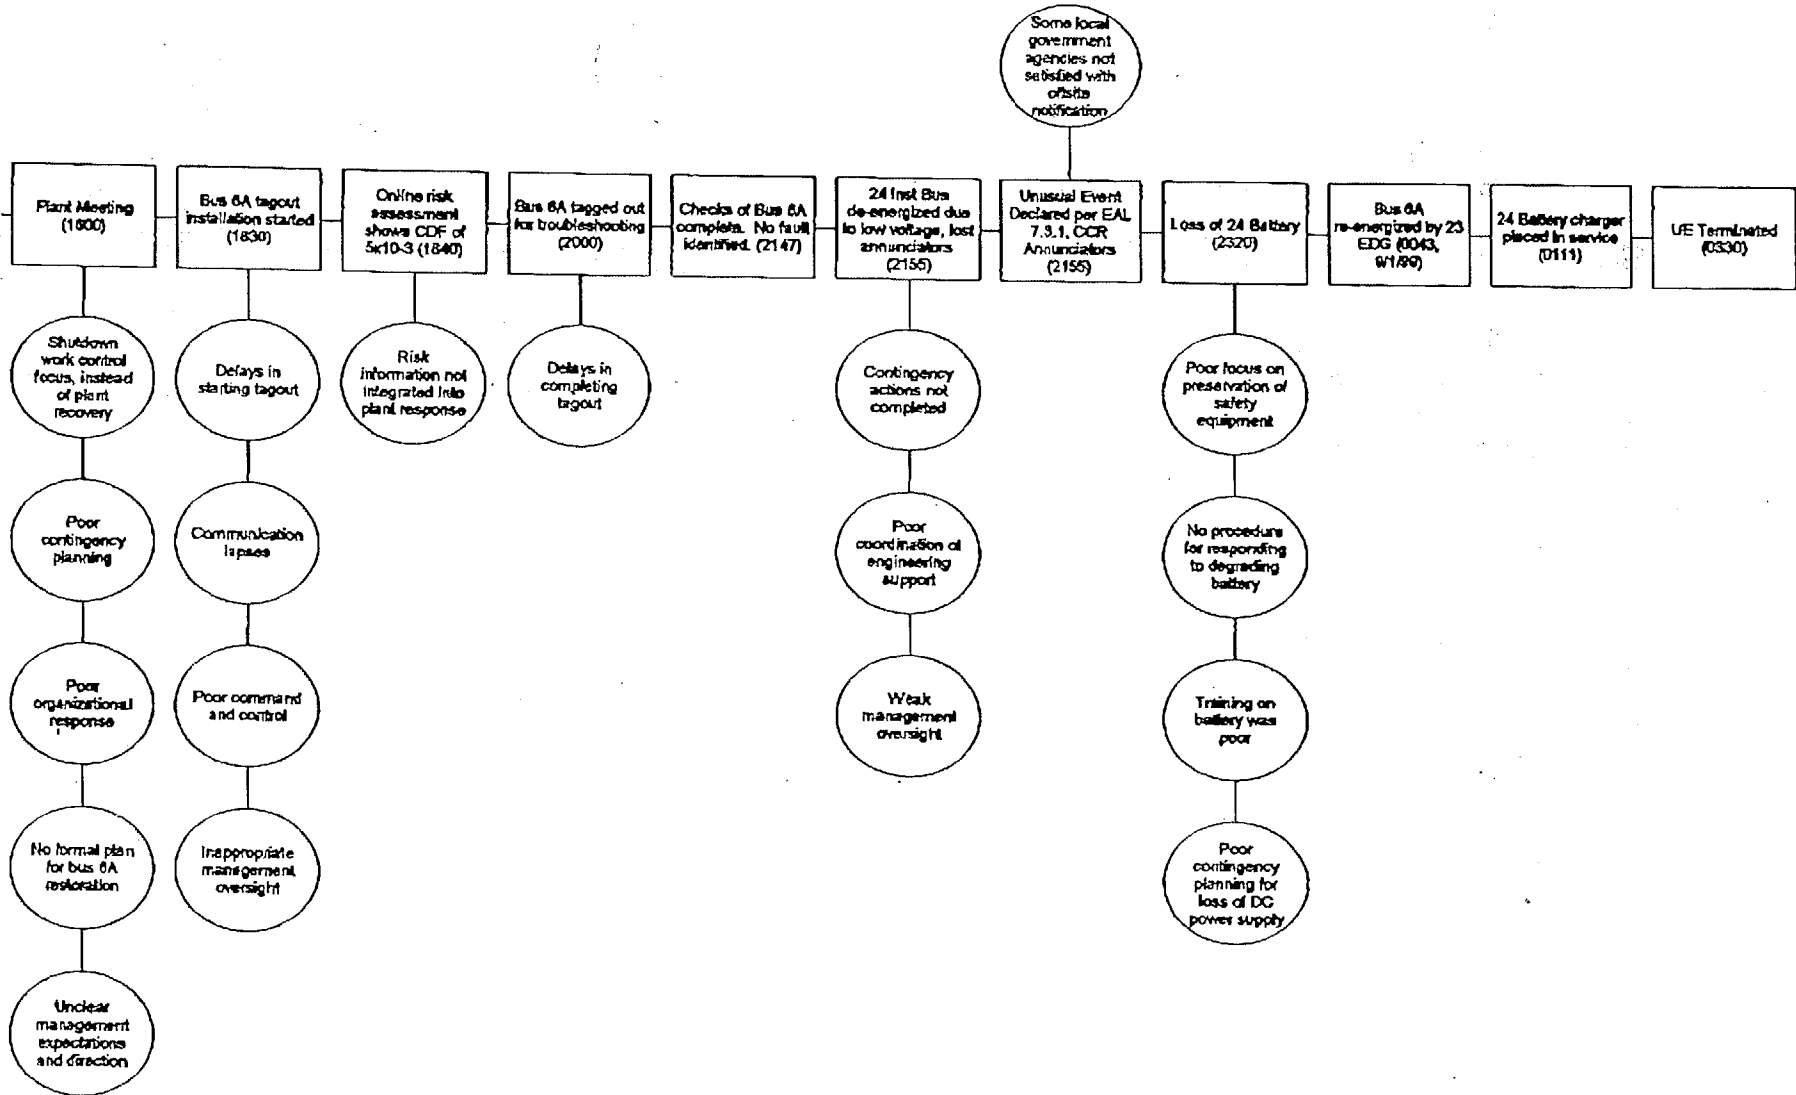
EVENT AND CAUSAL FACTORS CHART

The team independently analyzed the event using "Event Causal Factors and Root Cause Analysis" techniques to determine the primary and contributing causes. The team used an event and causal factors charting methodology as a tool for its assessment. The event and causal factors chart is provided in Attachment 2.
