Subject: 10CFR21 Reporting of Defects and Non-Compliance -  
Engine Systems, Inc. Report No. 10CFR21-0098, Rev. 0

Amot Thermostatic Valve Element  
P/N: 9760X

**Report No. 10CFR21-0098**

### 10CFR21 REPORTING OF DEFECTS AND NON-COMPLIANCE

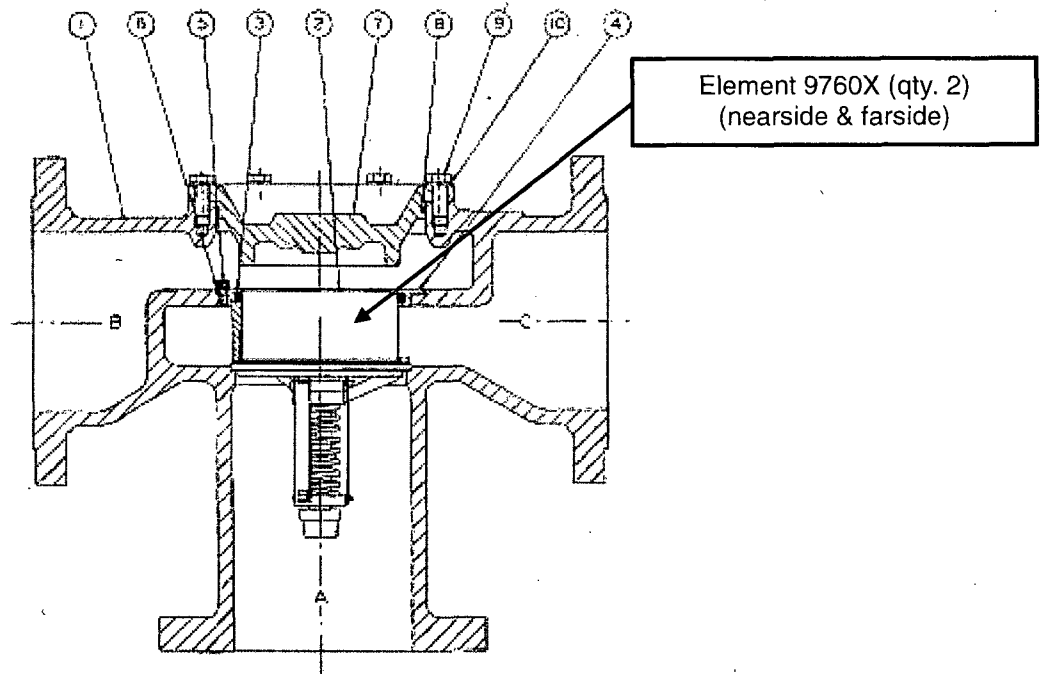
**FIGURE 1: AMOT THERMOSTATIC VALVE**

Each valve uses 2 thermostatic elements, Amot type 9760X (item 2 in Figure 1). The element being investigated for the Palo Verde application has a nominal temperature setting of 160°F and therefore the element part number is 9760X-160.

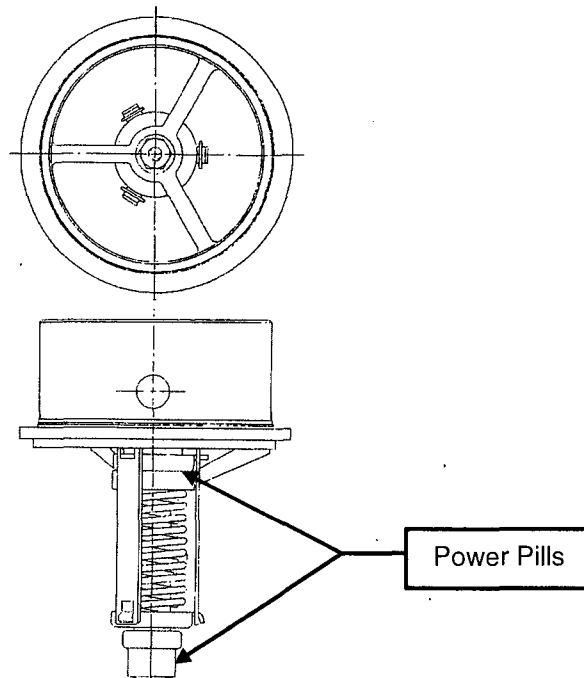
**FIGURE 2: VALVE ELEMENT 9760X**

The Palo Verde failure analysis determined that one of two elements within the valve was defective. The element failure was attributed to wax leakage past the diaphragm seal on one of two power pills within the element. Evidence of mechanical binding of the piston is believed to have caused the wax leakage. If the piston was jammed, the expanding wax could have over-pressurized the diaphragm seal leading to wax leakage. The failure analysis noted the following to support piston binding:

- The primary cause of the failure is believed to be the gouge found in the pill stem. The gouge could have occurred during the conversion process as the stem is removed and handled at that time.

The 9760X element contains two power pills (Figure 2). The power pills contain a temperature sensitive wax that expands with increasing temperature and provides the motive force to lift the element off of its seat.

The element failure at Palo Verde is considered to be an isolated incident related to a gouge in the pill stem. Thus, there is no recommended corrective action for users of the Amot 9760X element.

The evaluation also indicated a weakness in Amot's manufacturing process for the element pill which introduced machining debris. While not believed to be the cause of the Palo Verde element failure, machining debris within the element pill is undesirable and increases the potential for failure in the future. Users with thermostatic valves containing Amot P/N 9760X elements should be aware of this issue so that they can monitor their systems for any indications of thermostat element problems.
