Docket: FirstEnergy Nuclear Operating Company, Davis-Besse Nuclear Power Station, Unit 1,
 Docket No. 50-346-LR

SUBJECT:
Davis-Besse Nuclear Power Station, Unit 1
Docket Number 50-346, License Number NPF-3
Submittal of Shield Building Root Cause Evaluation

Root Cause Analysis Report

Concrete Crack within Shield Building
Temporary Access Opening

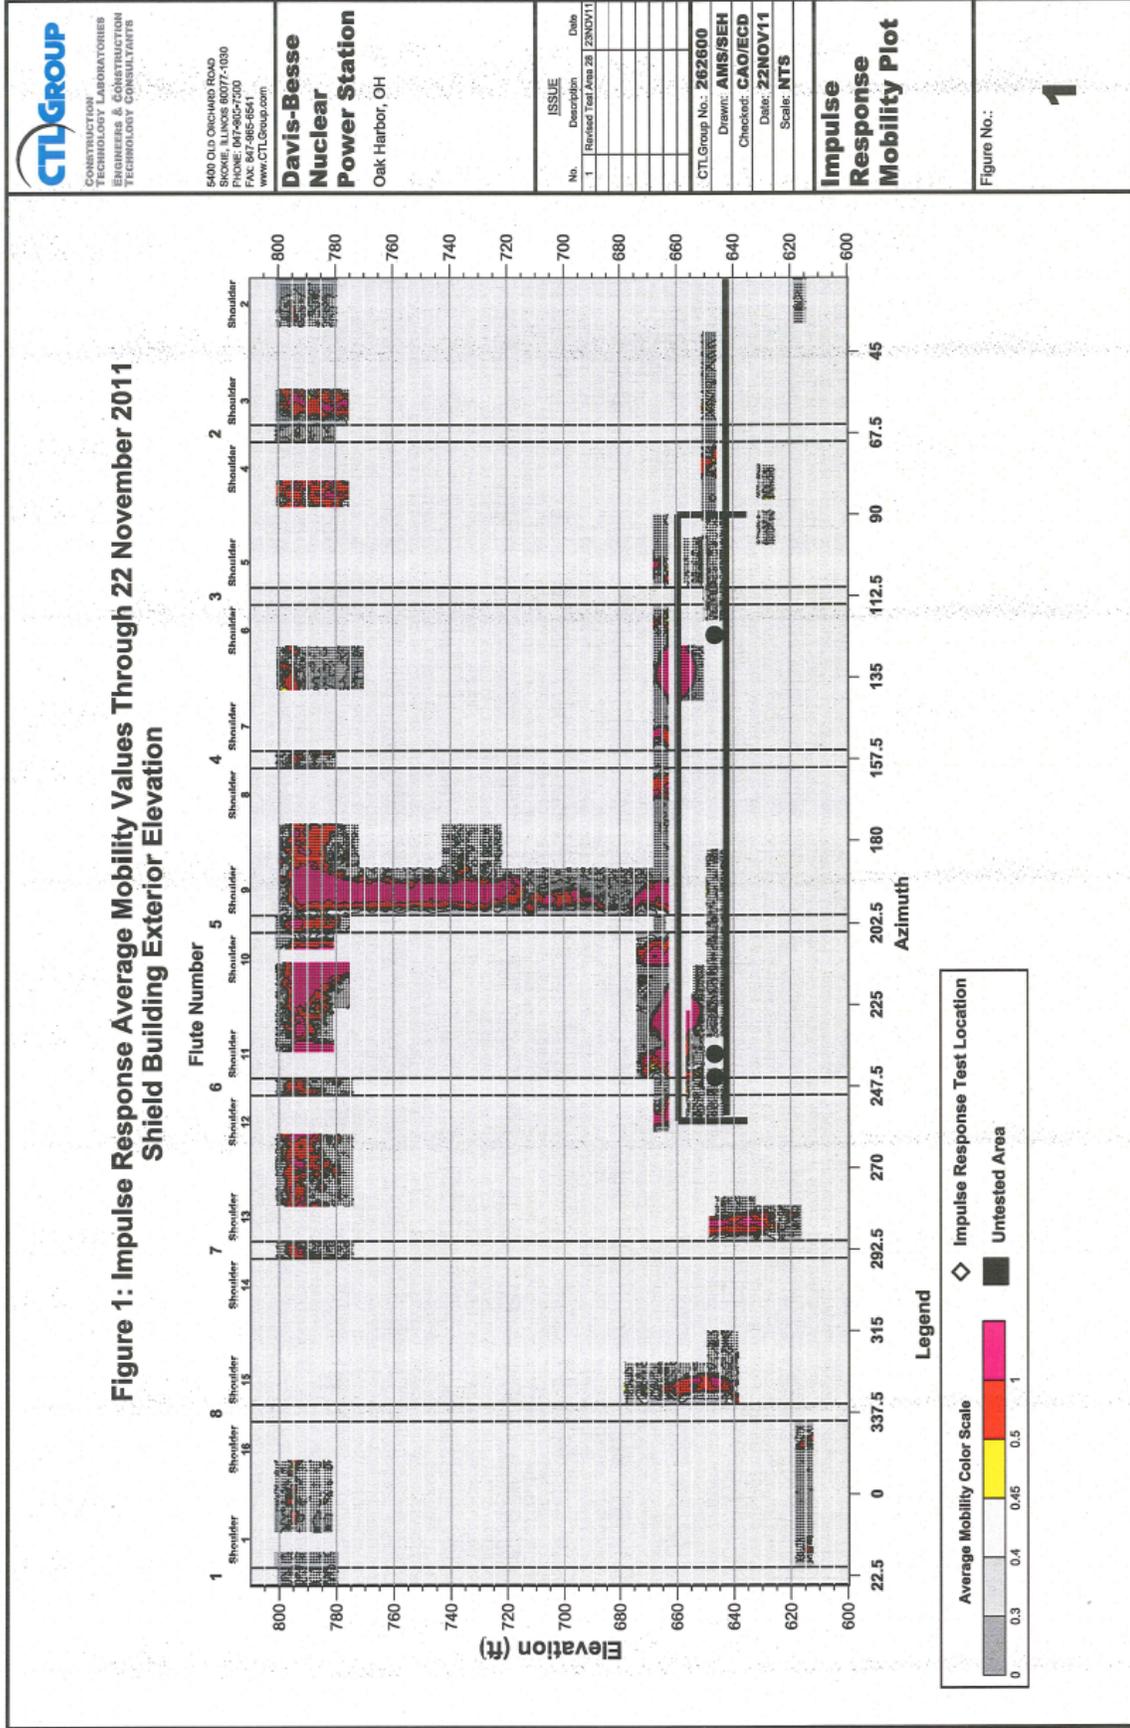
Attachment 2, Shield Building Impulse Response Average Mobility Values

The results of the Impulse Response test data above the temporary construction opening indicated the presence of a concrete crack vertically within the central portion of the architectural flute shoulder region. The edge of the architectural flute extends approximately 18 inches and indicated no cracking. On October 18, both 2-inch diameter core bores S15-645.5-3 ("A") and S15-653.5-3 ("D") confirmed a concrete crack in the architectural flute shoulder region that extended approximately 7 feet and 15 feet directly above the top-left corner of the shield building temporary access opening. Both of these cores were sent off-site for further independent petrographic examination.

The Impulse Response testing pattern was expanded horizontally to include a grid 10 feet above the entire temporary access opening. Impulse Response testing established that the concrete crack was confined within the architectural flute shoulder 15, as confirmed by core bore S15-646.5-8 ("E") on October 21. Next, increasing the height of the Impulse Response testing pattern vertically to include a grid 40 feet high total and 10 feet wide established the top of the concrete crack as confirmed by core bore S15-674.5-3 ("G"). The concrete crack in shoulder 15 had a laminar orientation located near the outer face of structural reinforcing steel in the architectural flute shoulder region, bounded within an area 8 feet wide by 38 feet above the temporary access opening on the northwest side of the shield building, with a crack width measured at less than 0.010 inches.
