In the Matter of  
FirstEnergy Nuclear Operating Co.  
(Davis-Besse Nuclear Power Station, Unit 1)  
Docket No. 50-346-LR

**SUBJECT: DAVIS-BESSE NUCLEAR POWER STATION REACTOR VESSEL HEAD  
REPLACEMENT AND SHIELD BUILDING CRACKING INSPECTION REPORT  
05000346/2012007(DRS)**

IR 05000346/2012007(DRS); 07/18/2011 - 04/17/2012; Davis-Besse Nuclear Power Station; Reactor Vessel Head Replacement and Shield Building Cracking.

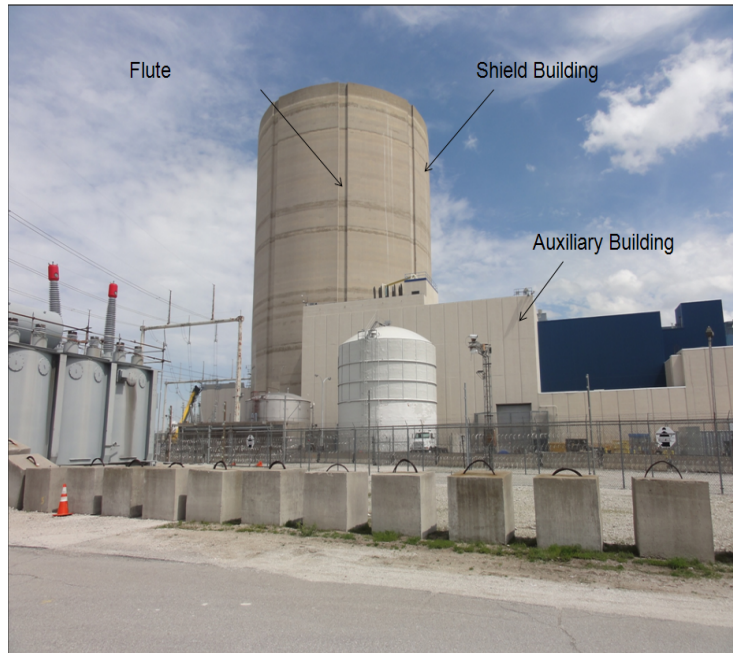
**Figure 2: Davis-Besse Shield Building**

On October 31, 2011, the licensee identified additional indications of concrete cracking during IR testing towards the top of the SB wall, approximately between the 780 ft and 800 ft elevations. The licensee entered this extent-of-condition issue for the SB cracking into its CAP as CR-2011-04648, informed the NRC via the onsite Resident Inspectors' Office, and continued to investigate further to determine if any additional adverse conditions existed.

Through its extent of condition activities, the licensee determined that the cracking was laminar in nature and generally extended circumferentially along or near the outer edge of the outer rebar mat for the credited concrete (2.5 foot thick cylinder). Laminar cracking is cracking of material, including concrete, in which there is a separation of layers, or planes. The laminar cracking was primarily associated with the shoulder regions, although some cracking was identified outside the shoulder regions near the main steam lines and near the top of the SB cylinder. The cracks were very tight (meaning the gap between the crack surfaces was extremely small). No cracking was identified inboard of the outer rebar mat (deeper toward the inner wall surface) around either the equipment access opening or in the core borings. The cracking was observed

to be more severe on the south facing regions of the building. The cracking was interior to the wall surface and was not visually discernable until the licensee cut into the wall to create the access opening.

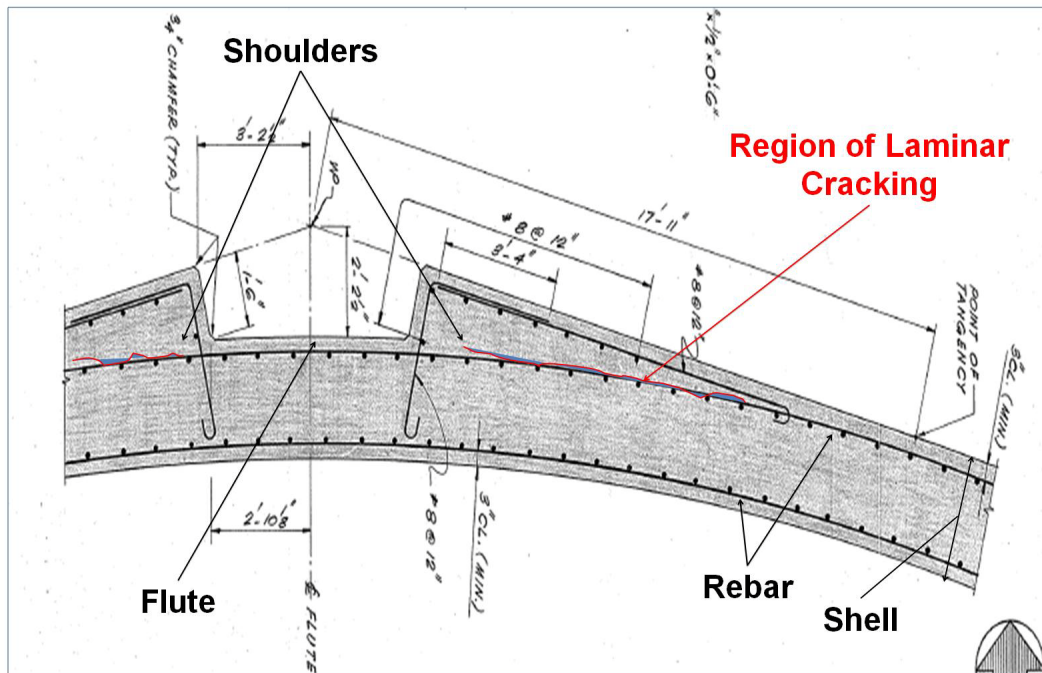
**Figure 3: Flute and Shoulder Cross-Section**

The cylindrical SB wall contains an inner and an outer rebar mat, each located approximately 3 inches into the concrete from their respective inner and outer wall surfaces. A rebar mat is a grid of reinforcing steel bars that adds strength to the concrete. In addition, the structure includes additional concrete elements (called shoulders) that extend out from the 2.5 foot thick wall to provide the appearance of 8 evenly spaced, vertical cutouts (called flutes) in the outer wall surface (Figure 2). These shoulders (16 in total) are a maximum thickness on each side of the flute (approximately 18 inches thick) and gradually blend into the 2.5 foot thick wall away from the flute. These shoulders are reinforced by additional rebar located below their concrete surfaces (Figure 3).
