Docket:        FirstEnergy Nuclear Operating Company, Davis-Besse Nuclear Power Station,  
                  Unit 1, Docket No. 50-346-LR

Davis-Besse Nuclear Power Station, Unit 1  
Docket Number 50-346, License Number NPF-3  
Submittal of Revision 1 of Shield Building Root Cause Evaluation

“Concrete Crack within Shield Building  
Temporary Access Opening”

Condition Report 2011-03346, dated 10/10/2011

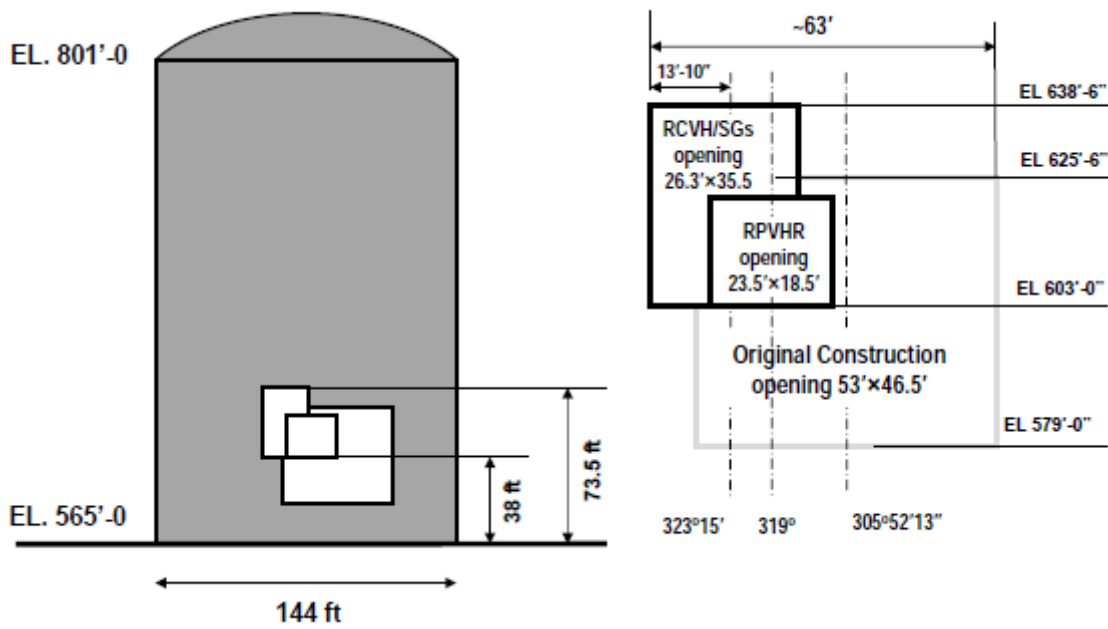
### Elevation View of Shield Building / Construction Opening & Temporary Access Openings

A temporary access opening approximately 25 feet 6 inches wide and 35 feet 6 inches high centered at approximately azimuth 323 degrees was cut through the shield building wall during the 17 Mid-cycle outage at DBNPS [Reference 10.1.3 & 10.1.4]. The left side of the temporary access opening was cut near the thickest section of the architectural flute shoulder located on the north-northwest side of the shield building between elevations 603 feet and 638 feet six inches. The temporary access opening through the shield building wall was necessary for installation of a replacement reactor pressure vessel head. The existing reactor pressure vessel head was installed in 2002 through a temporary access opening located within the boundary of the original construction opening. The current temporary access opening extended past the edge of the original construction opening into part of the previously undisturbed shield building wall.

The known extent of condition at the time of problem discovery was a concrete crack in the shield building wall that was visible on the entire 35 feet height of the temporary access opening left face. The crack was adjacent to the outer face of structural reinforcing steel, and it extended approximately eight feet into the left-top and approximately four feet into the left-bottom region of the temporary access opening progressing from the outer face of structural reinforcing steel towards the architectural flute reinforcing steel. The crack at the left-top of the temporary access opening continued to the exterior surface at the edge of the opening and extended about two and a half feet vertically upwards on the exterior surface of the shield building concrete [Reference 10.1.7]. The crack width was initially indeterminate, due to the effect of the hydrodemolition process, resulting in disintegrating the concrete aggregate and cement paste at the crack location. The hydrodemolition process was incomplete at the time of crack discovery and had been stopped to allow removal of the outer face of structural reinforcing steel.

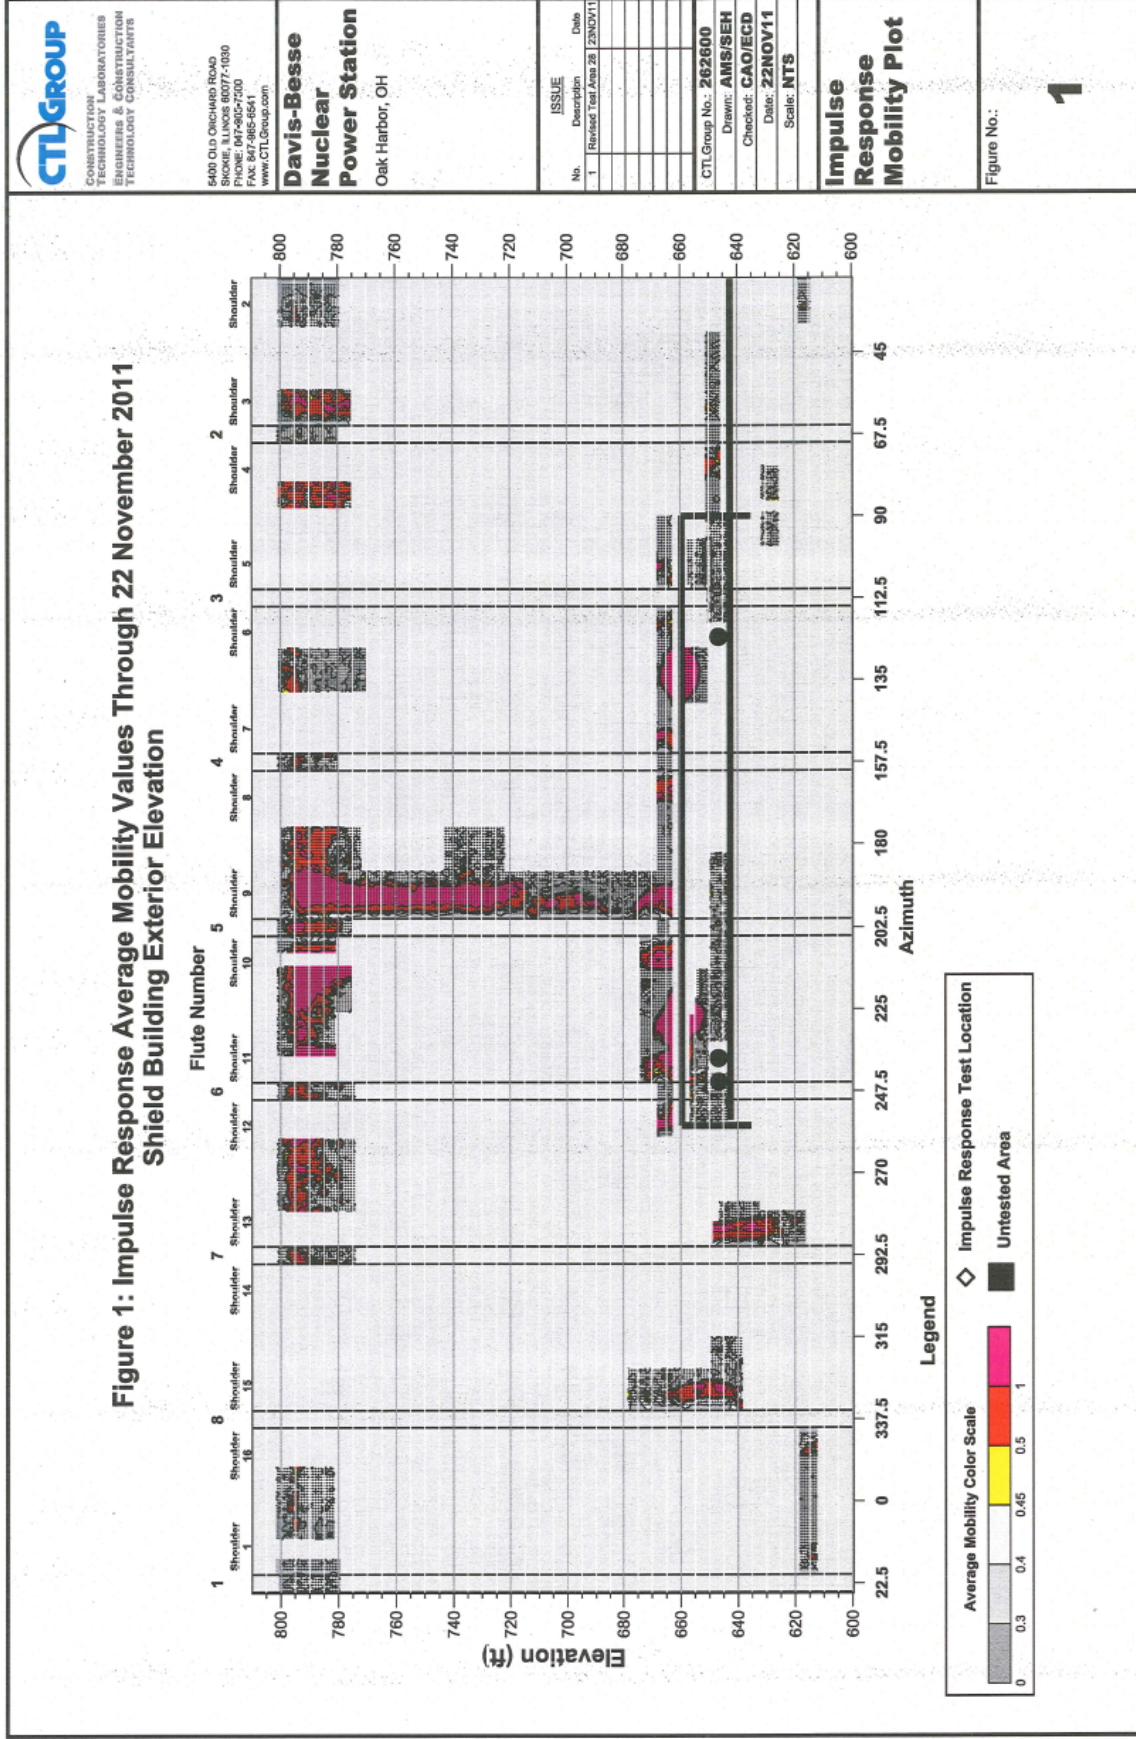
# Attachment 2, Shield Building Impulse Response Average Mobility Values

Acoustic sounding of the shield building exterior wall was performed using the Impulse Response testing method to locate areas with concrete laminar cracking. Confirmation of the Impulse Response testing results was achieved by visual inspection of 70 core bores, including crack characterization. The initial condition assessment determined that the shield building concrete wall contained tight width laminar cracking near the outer face of structural reinforcing steel. The majority of the shield building laminar cracking occurred in the concrete at the outer face of structural reinforcing steel located behind the architectural flute shoulder region. Some laminar cracking occurred beyond the architectural flute shoulder region as evident across the top 20 feet of the shield building and in localized areas adjacent to one side of each main steam line penetration blockout. The southwestern exposure of the shield building wall was observed with the most extensive concrete cracking. The initial condition assessment determined that the shield building was functional, but non-conforming with the concrete laminar cracking.

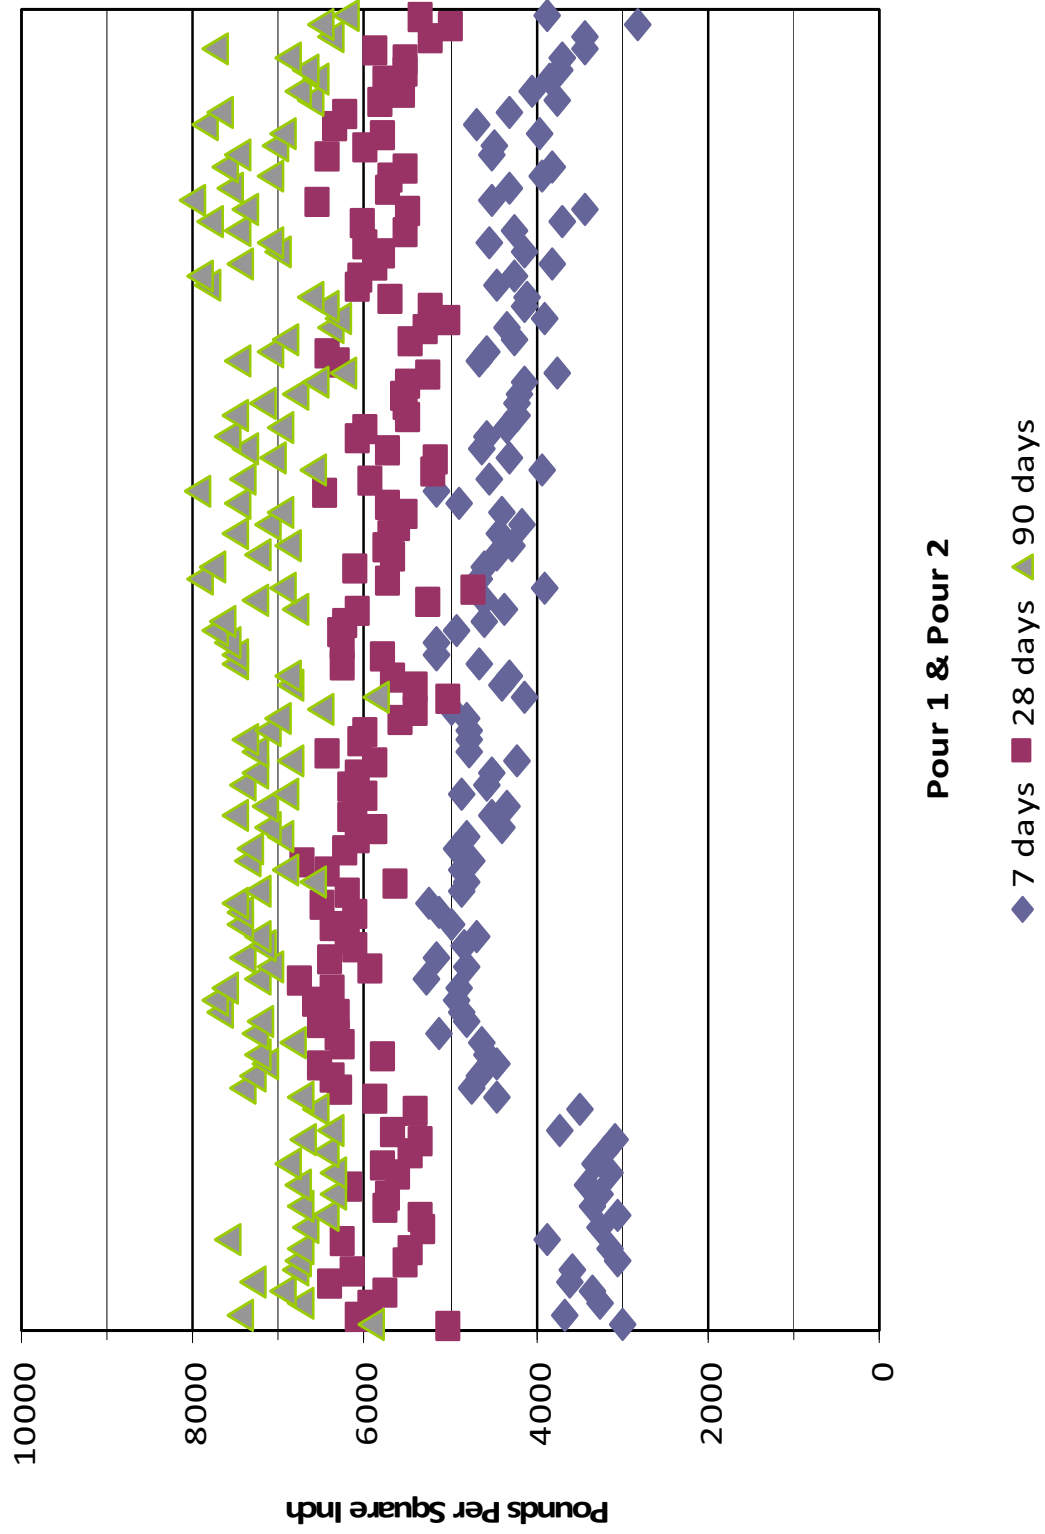
# Attachment 8, Shield Building Concrete Compression Test Results

The external laboratory examination of the shield building concrete cores determined that the concrete was in good condition, consistent with the mix design, and revealed no unacceptable or degraded material properties. There was no evidence of typical concrete time-dependent aging failure modes. The examination found the outer surface of the cores was not water-repellant, and the air voids were lined with secondary deposits of ettringite (crystal formation from sulfate reaction with calcium aluminates) and calcium hydroxide suggesting long-term exposure to moisture migrating through the concrete. The integrity of the concrete narrowed the failure mechanism to those related to design or environmental issues versus construction.
