## **CENTER FOR NUCLEAR WASTE REGULATORY ANALYSES**

### **TRIP REPORT**

**SUBJECT:** Trip Report for Busted Butte Rock Sampling and Observations of PTn on West Flank of Yucca Mountain (20.01402.861)

**DATE/PLACE:** May 22–23, 2000  
Yucca Mountain, Nevada

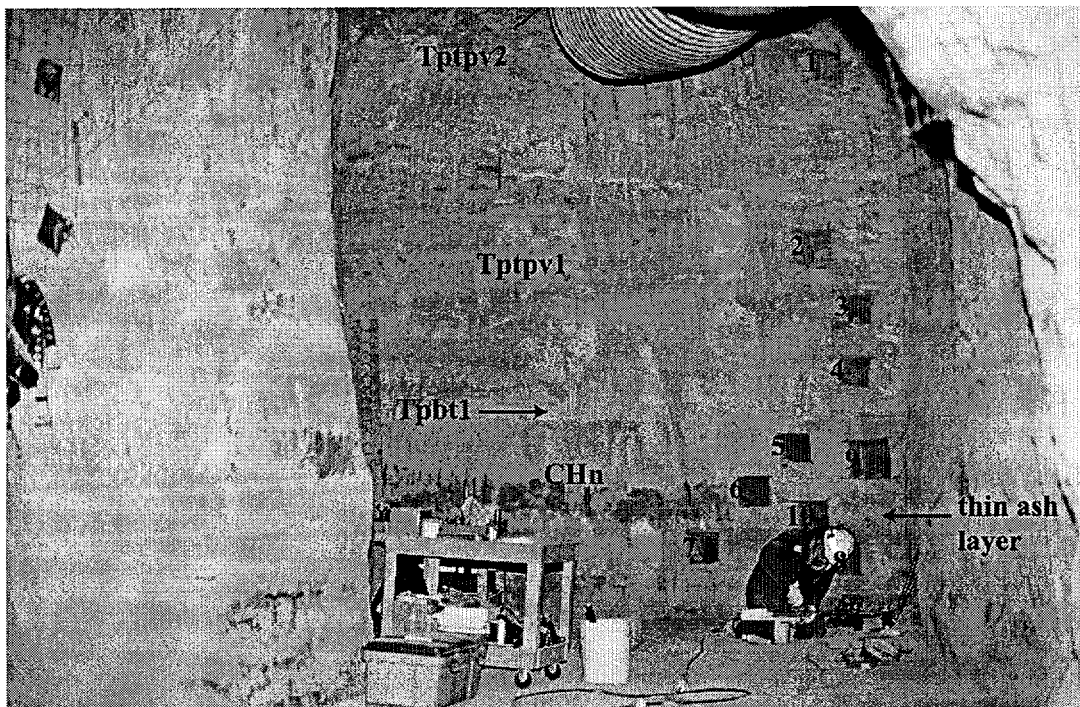
Four sample blocks (#1–4 of figure 3) were obtained from the basal Topopah Spring vitric tuff (Tptpv2, Tptpv1), which grades from partially welded to nonwelded as the CHn contact is approached. A thin (12–15 cm) horizon of bedded tuff separates the Tptpv1 from the CHn. Four sample blocks (#5–8 of figure 3) were obtained from the CHn, both above and below a thin (10–12 cm) indurated ash layer. Plugs will be cut from the blocks for geochemical and hydrological characterization before and after experiments to alter the vitric material to zeolites. Two blocks (#9–10 of figure 3) were obtained for thin section observation of fault features, such as solution features or mechanical grain deformation, by James Evans of USU. Block 10 includes the indurated ash layer within the CHn.

Figure 3. Sample locations 1-10 from Busted Butte mineback wall (see figure 1). The labeled units are the basal nonwelded Topopah Springs vitric (Tptpv2 and Tptpv1) and bedded (Tpbtl) tuffs and the Calico Hills tuff (CHn).

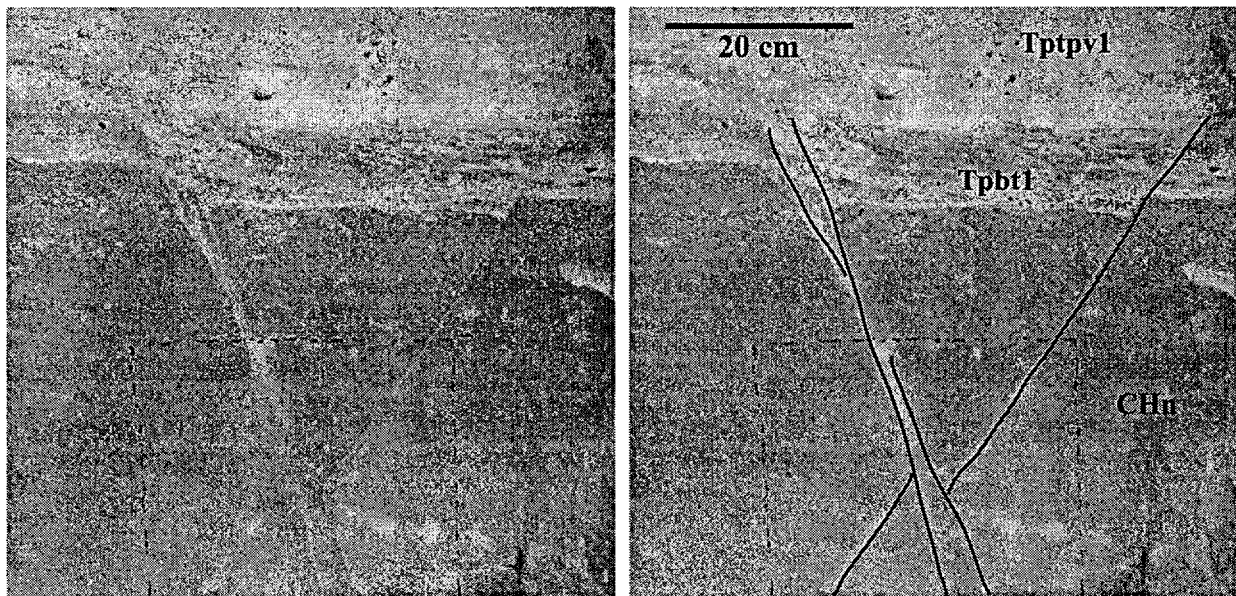
Mined-out walls enabled observation of several small faults on an east-west striking face (figure 4) and a north-south access wall. The small faults in the excavation are normal faults with several centimeters of slip. They are marked by a distinct lighter color that appears as thin, white planar zones. The whiter color may be caused by leaching along preferential flowpaths along the discontinuities. The faults appear to have mutually cross-cutting relationships and have several centimeters of slip where they cross the primary layering of bedded tuff and ash layers. Block samples collected from the wall appear to dry out quickly, leaving a moist trace along the fault surfaces. This suggests the small faults are able to retain moisture more readily than the matrix, likely due to the finer grain size associated with grain crushing on the fault plane. Because of the physics of UZ flow, the finer grain size along the fault would be associated with enhanced flux at the low percolation rates estimated for YM.

Figure 4. Cross-cutting faults near the contact between the basal nonwelded Topopah Springs vitric (Tptpv1) and bedded (Tpbtl) tuff and the Calico Hills tuff (CHn). Faults are highlighted on righthand side photograph. Part of sample block 9 outline (see figure 3) is shown in photograph.

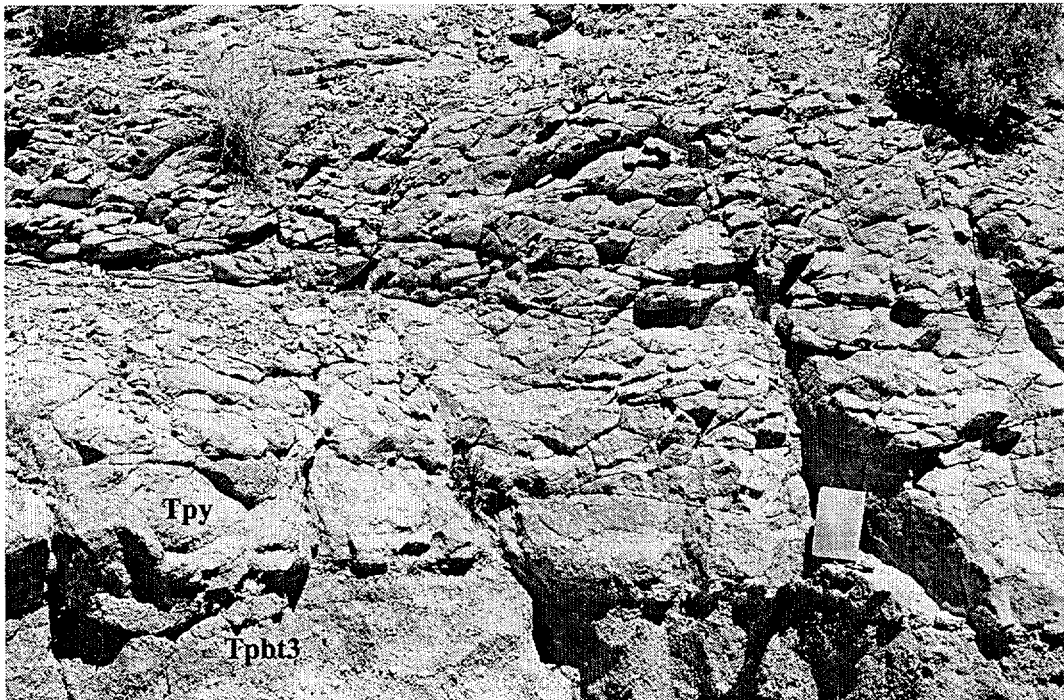
Fracture characteristics of the units are highly variable vertically in the sequence. As noted by Sweetkind et al. (1995, 1996), the more densely welded units exhibit the highest density of fractures. Uppermost in the sequence of exposures, the vitrophyre at the base of the Tiva Canyon and the Yucca Tuff vary in degree of welding from moderate to partial. The term "partially welded" is used by Moyer et al. (1995) and is intended to describe a degree of welding between nonwelded and moderately welded. Abundant vertical fractures are present in the Tpcpv2, Tpcpv1, and Tpy units. A small outcrop of the nonwelded bedded Tpbt4, which fits the light-colored, pumice-supported fallout description in Moyer et al. (1995) was only noted at the second site. The Tpy unit is massive with near-vertical fracture density variable in the range of 3-10 fractures/m (figure 5). There is a sharp contact with the Tpbt3 underlying the Tpy.

**Figure 5. Yucca Tuff (Tpy) contact with Pre-Yucca bedded tuff (Tpbt3). Note the extent of fracturing in the partially welded Tpy. The field notebook is 19 cm tall.**

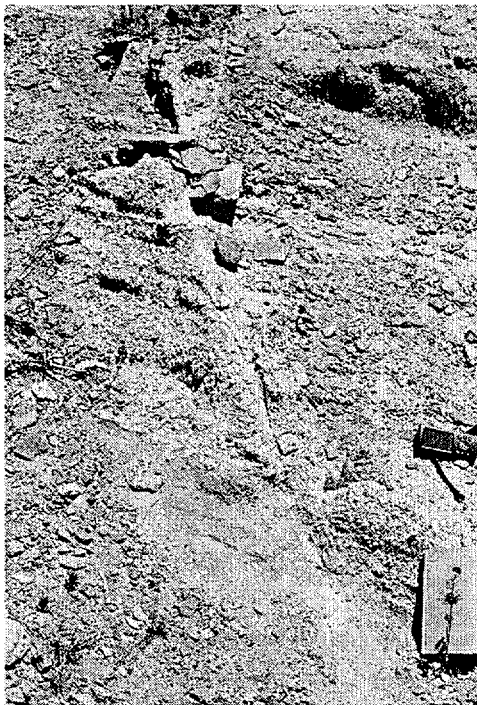
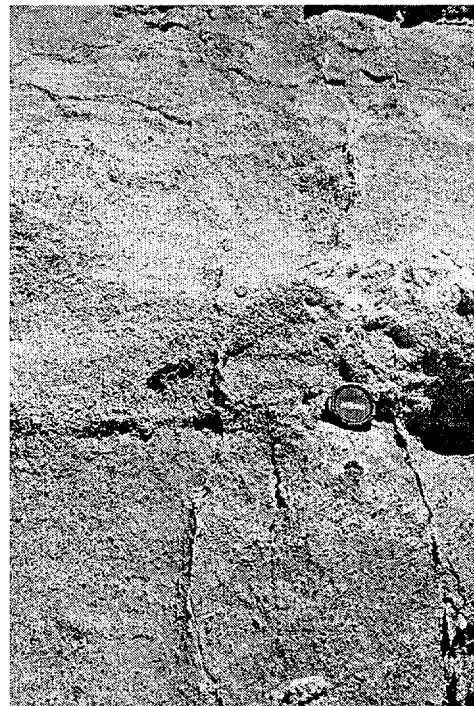
**Figure 6. Discontinuities in the nonwelded Pre-Yucca bedded tuff (Tpbt3): a) fault with leached, fined grained core, and b) fractures with caliche. The field notebook is 19 cm tall.**
