SSINS No.: 6835 IN 86-05

## January 31, 1986

# IE INFORMATION NOTICE NO. 86-05: MAIN STEAM SAFETY VALVE TEST FAILURES AND RING SETTING ADJUSTMENTS

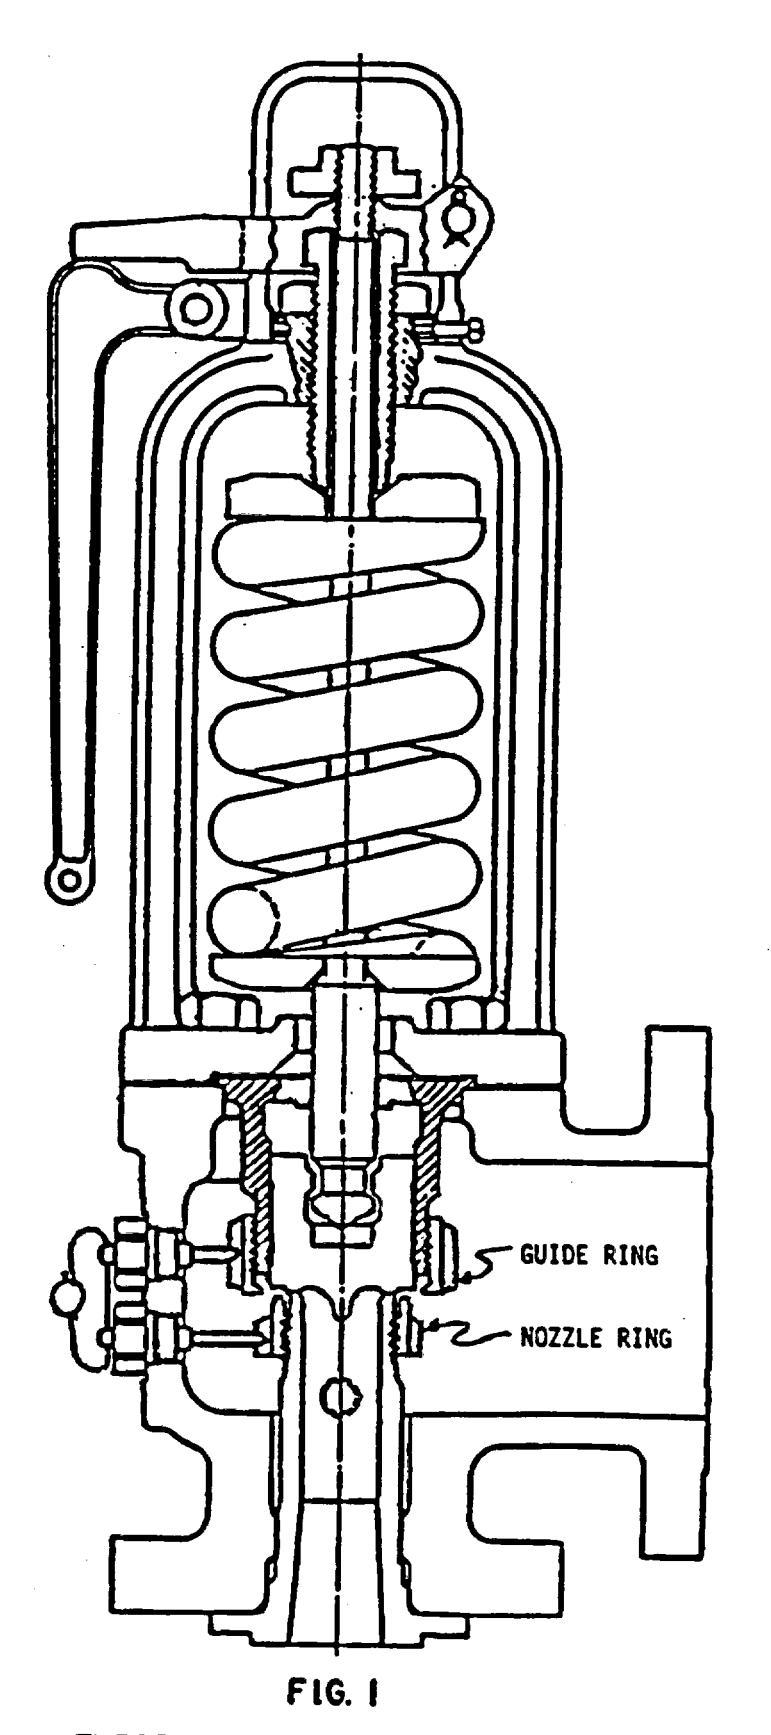
TYPICAL MAIN STEAM SAFETY VALVE

Additional tests were done in July 1985 to determine the appropriateness of the ring settings. Specifically, the tests were to determine if the "as-shipped" ring settings of the valves would allow the required disc travel with minimum tailpipe backpressure and to determine the effects on valve disc travel for a range of backpressures between 180 and 390 psig. During these tests, the upper (guide) ring setting was adjusted from +155 to 0 and then to +25 to achieve the required disc travel. This is a substantial adjustment. Subsequently, the

licensee consulted with the valve manufacturer and agreed on ring settings of +25 for the guide ring and -25 (the original setting) for the lower (nozzle) ring (see figure 1).
