Oyster Creek Generating Station
Facility Operating License No. DPR-16
NRC Docket No. 50-219

Subject: Response to Request for Additional Information Concerning the Fourth Ten-Year Interval Inservice Inspection Program

Damage Mechanism Assessment for Class 1 and 2 Piping Systems at Oyster Creek

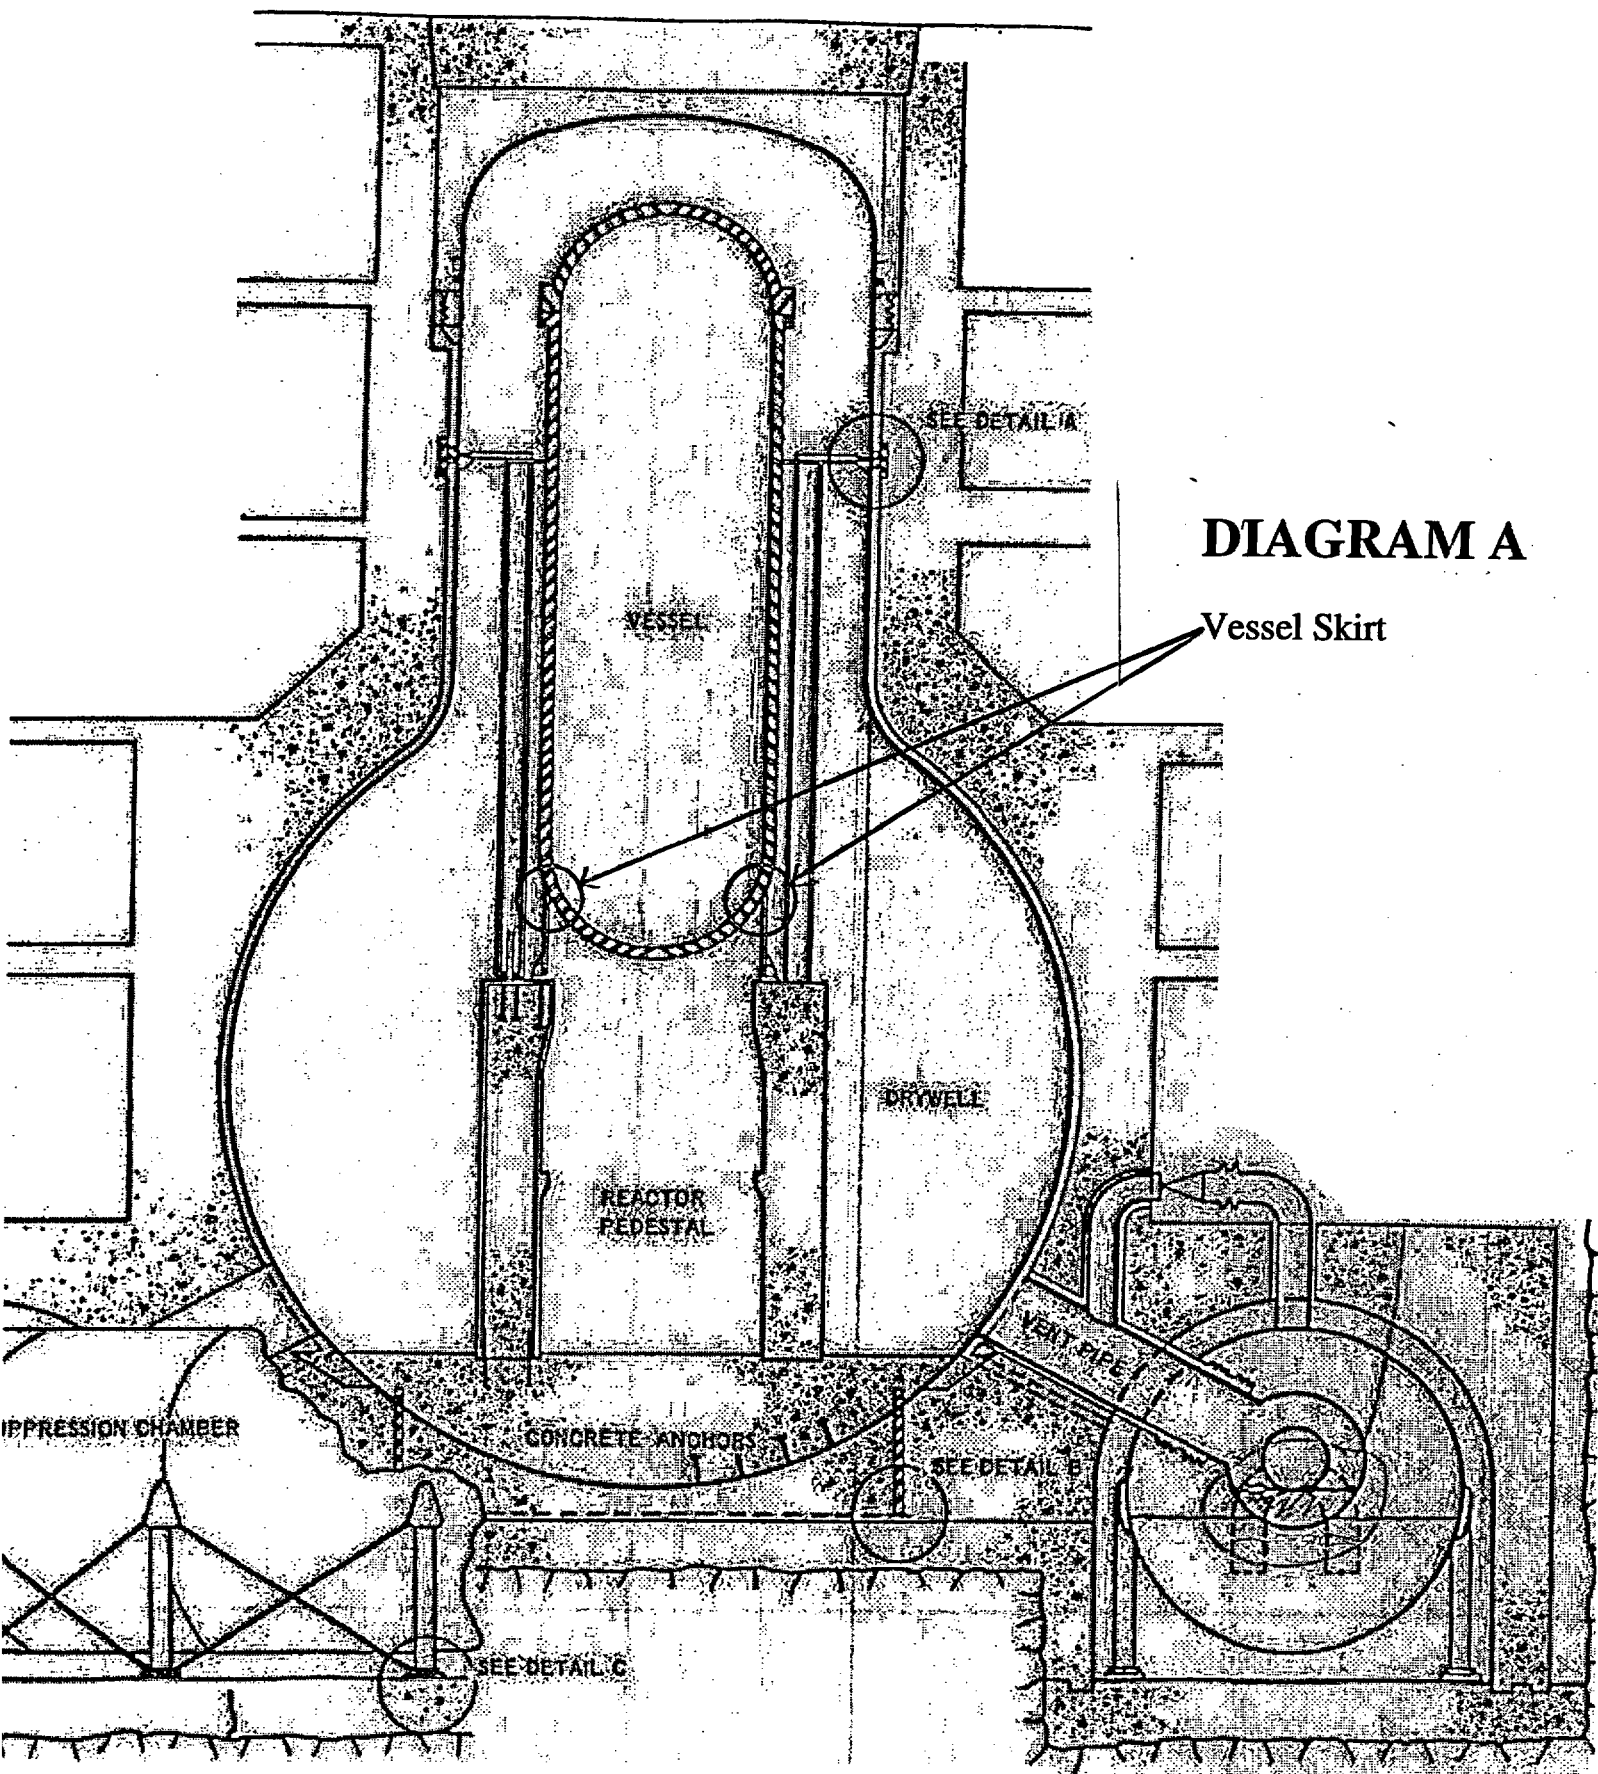
DIAGRAM A

The support skirt does not contain personnel access holes or inspection ports that would allow examination of the C-D surface area to the extent required by the Code. Attached Diagram A provides a view of the Oyster Creek vessel and the location of the vessel skirt. As discussed in our relief request, control rod drive housings and incore housings restrict access for examination of area C-D. Diagram B shows the location of the skirt, and as shown on Diagram B, no access points are provided for examining area C-D. Diagram C provides a closer view of the skirt and refers to Detail "E" which is shown in Diagram D. As discussed in the relief request, an ultrasonic examination was considered as an alternative, but as shown on Diagram D, the 1 1/2 inch radius demonstrates the limited capability to perform this type of exam. As discussed in the relief request, as an alternative to the code requirements, AmerGen proposed to perform a surface examination of area A-B, and perform a VT-3 visual examination of the IWB boundary as shown in Figure IWB-2500-13 of the relief request. This examination would inspect for support member degradation, which includes surface indications or defects.
