NAVAJO NATION ENVIRONMENTAL PROTECTION AGENCY
Water Quality/NNPDES Program
P.O. Box 1999
Shiprock, New Mexico 87420
Phone: (505) 368-1037
FAX: (505) 368-1416

January 16, 2004

RE: Navajo EPA Water Quality Program Concerns at the Shiprock Uranium Mill Tailings Site

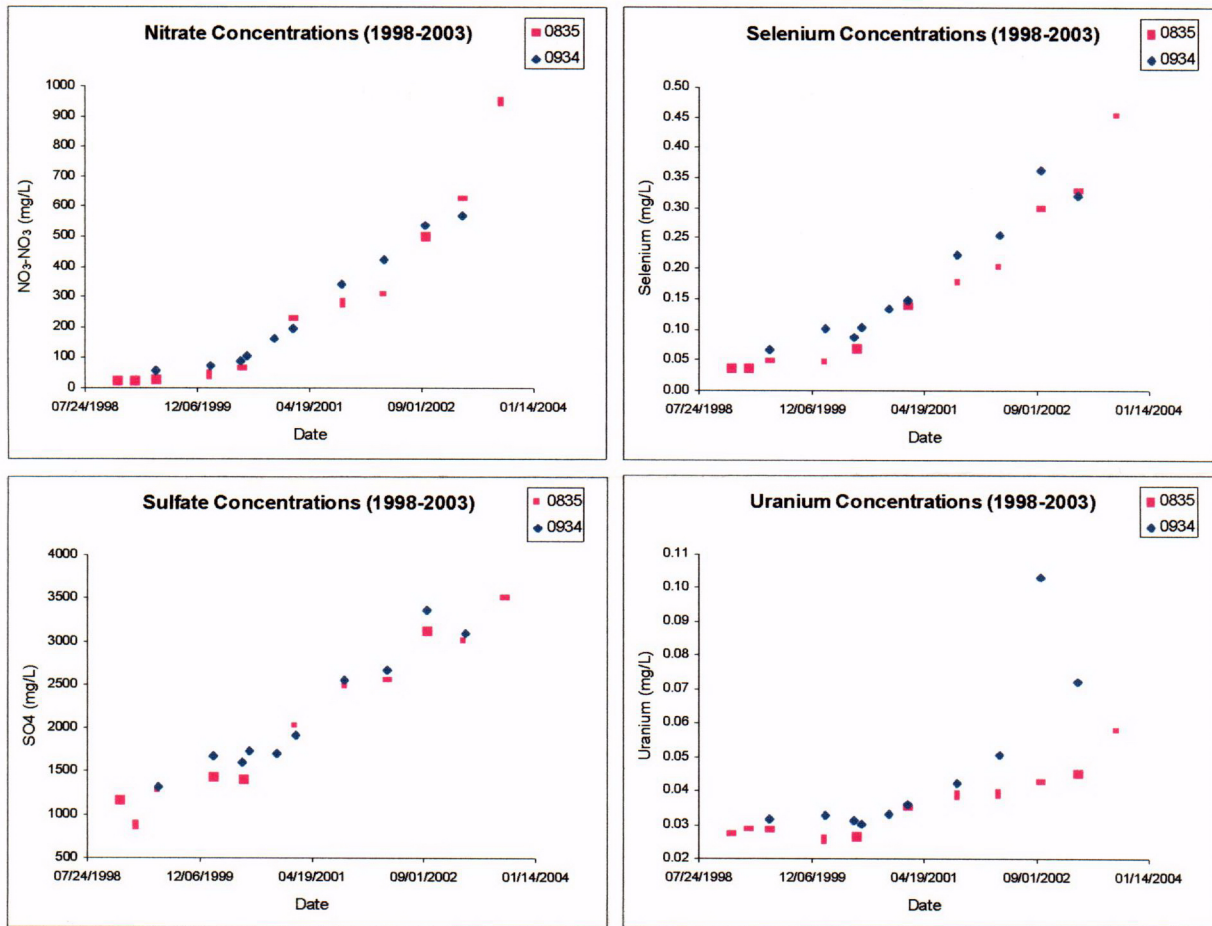
The past six years of data indicate that the terrace plume is migrating to the northwest along the area between Shiprock High and 2nd Wash. This is most apparent in wells 0835, 0838, and 0847/1079 and surface location 0934. Well 0835 and surface location 0934 are located near and in 2nd Wash, respectively. This area has seen concentrations of nitrate, selenium, sulfate, and uranium steadily increase since 1998 (Figure 1). The concentrations for each of these parameters now exceed the MCLs, benchmarks, and cleanup goals.

Figure 1. Contaminant concentrations in well 0835 and surface water site 0934 between 1998 and 2003.

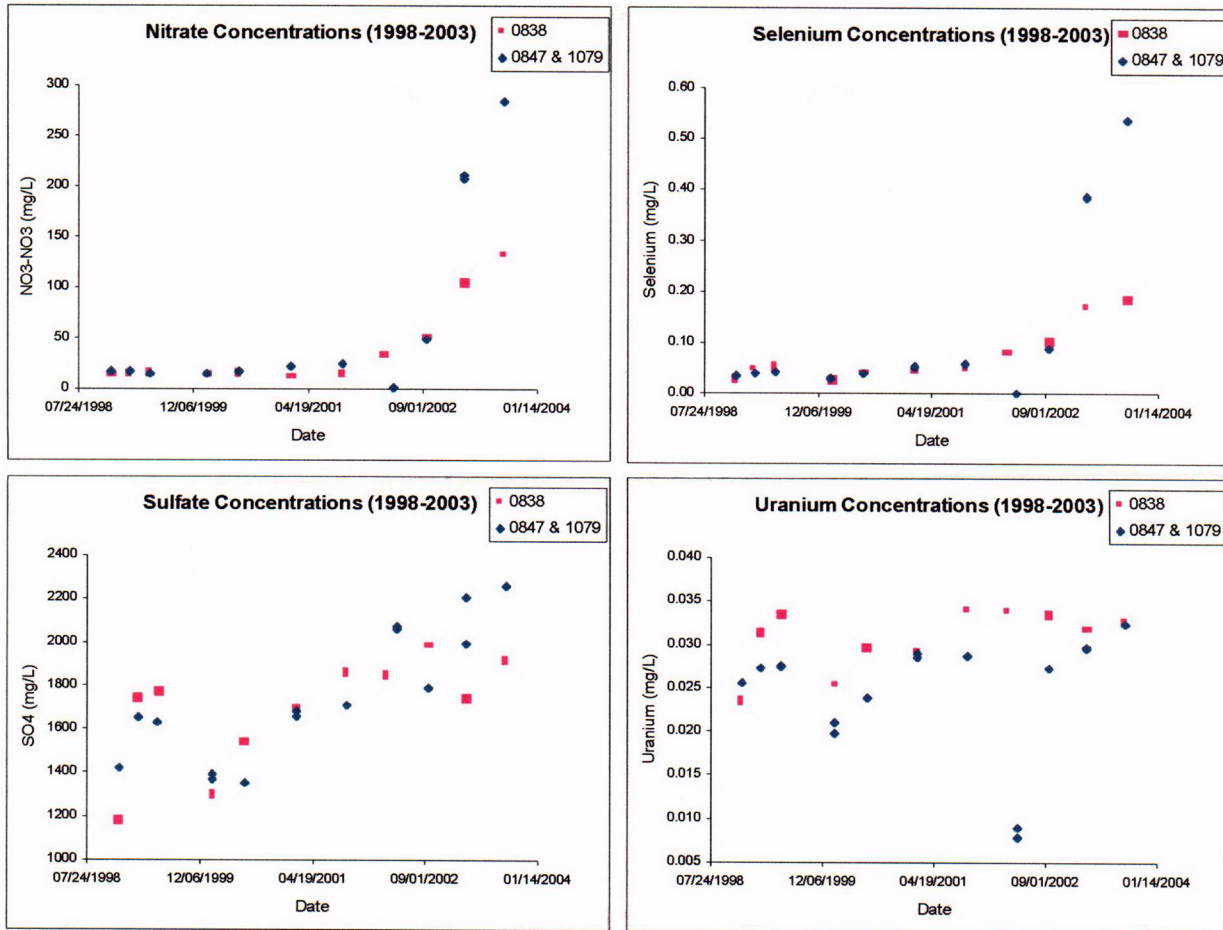
Although not as dramatically, wells 0838 and 0847/1079 near the high school have also been increasing over time (Figure 2). In these wells, sulfate concentrations have varied over the past six years, but the general trend is upward. Concentrations for sulfate are currently near the benchmark of 2000 mg/L. Nitrate and selenium were relatively stable until about three years ago, but they have both sharply increased since 2001. This change appears to coincide with the cessation of farming in the area where the new Dine College campus is being built. Both nitrate and selenium are now significantly greater than the MCLs. Uranium concentrations have slightly increased over the past six years, but they have not exceeded the MCL in either well to date.

Figure 2. Contaminant concentrations in wells 0838 and 0847/1079 between 1998 and 2003.
