Appendix D2

ESEM and SEM/EDS Data for Test-2 Day-30 Fiberglass in High- and Low-Flow Zones

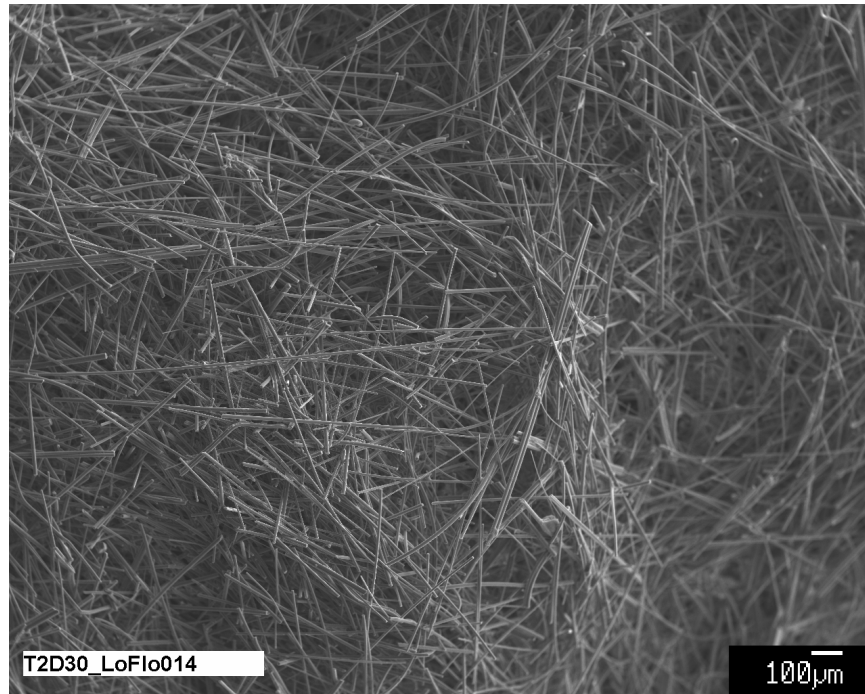
Figure D2-1. SEM image for a Test-2 Day-30 low-flow exterior fiberglass sample (T2D30_LoFlo014).

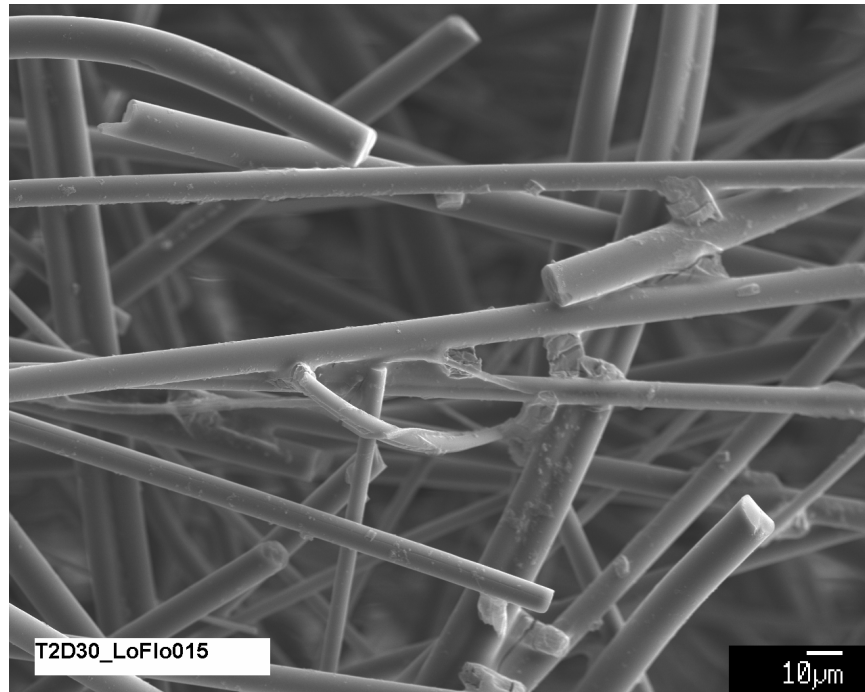
Figure D2-2. SEM image of a higher magnification for a Test-2 Day-30 low-flow exterior fiberglass sample (T2D30_LoFlo015).

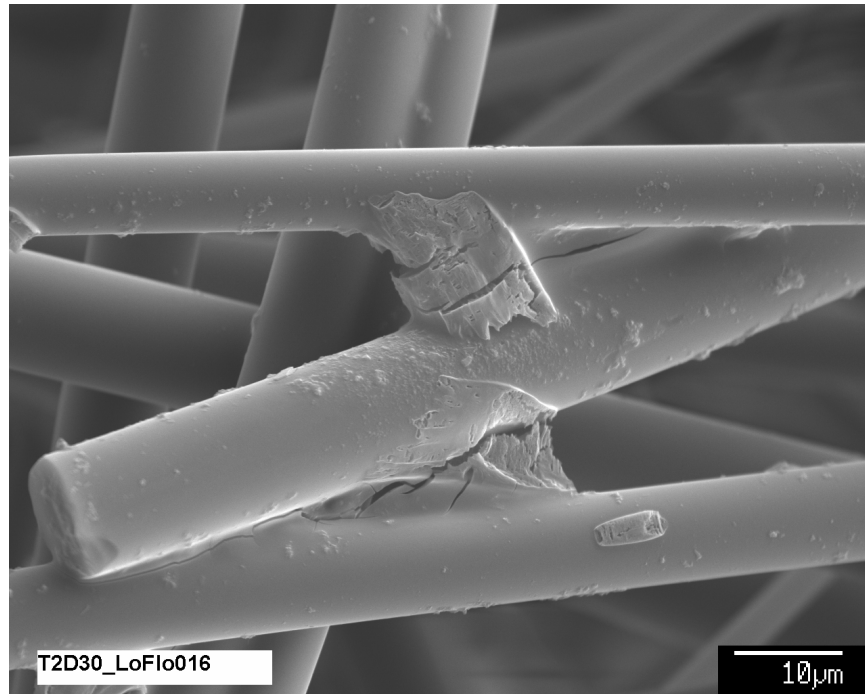
Figure D2-3. SEM image of a higher magnification for a Test-2 Day-30 low-flow exterior fiberglass sample (T2D30_LoFlo016).

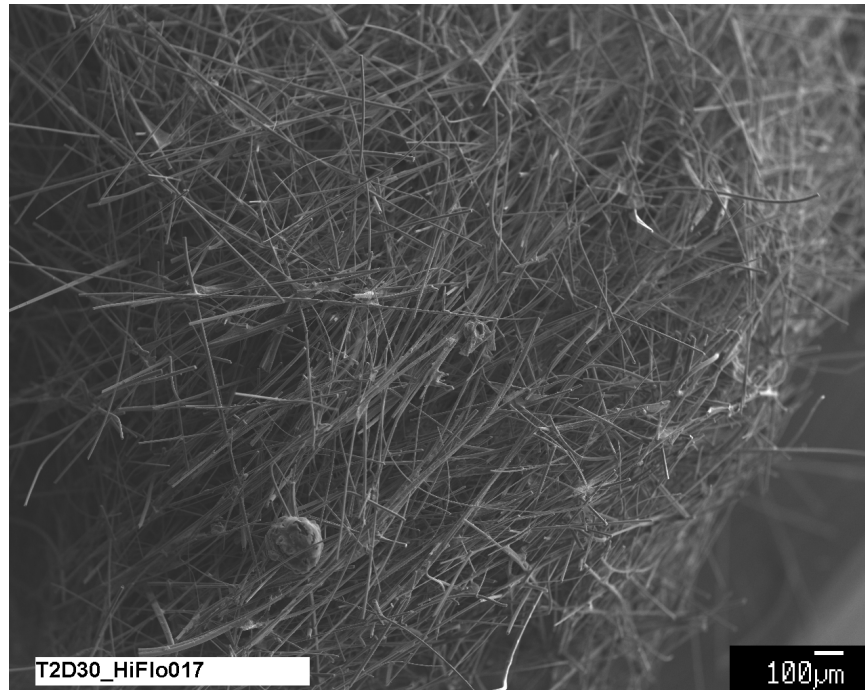
Figure D2-4. SEM image for a Test-2 Day-30 high-flow exterior fiberglass sample (T2D30_HiFlo017).

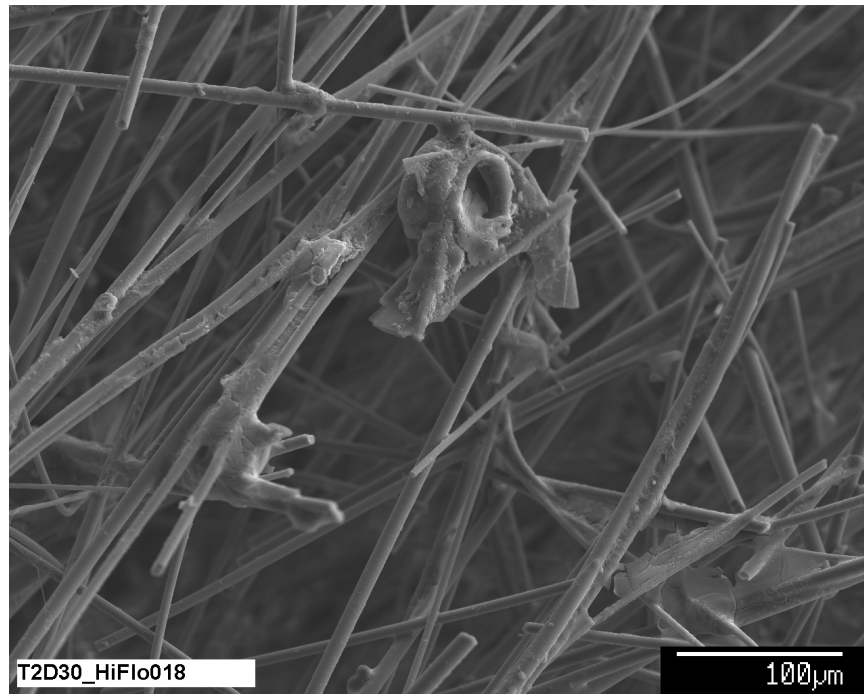
Figure D2-5. SEM image for a Test-2 Day-30 high-flow exterior fiberglass sample (T2D30_HiFlo018).

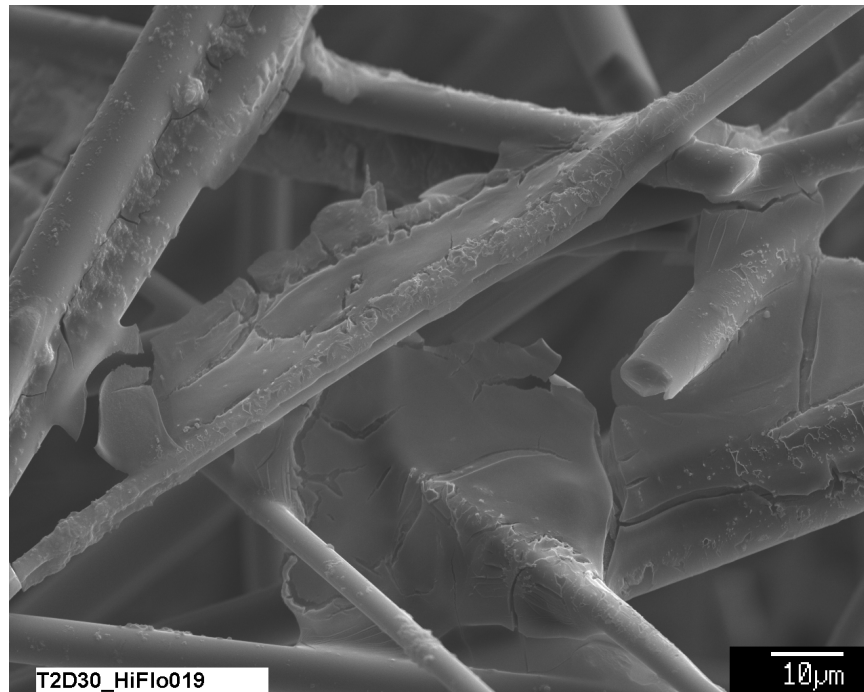
Figure D2-6. SEM image of a higher magnification for a Test-2 Day-30 high-flow exterior fiberglass sample (T2D30_HiFlo019).

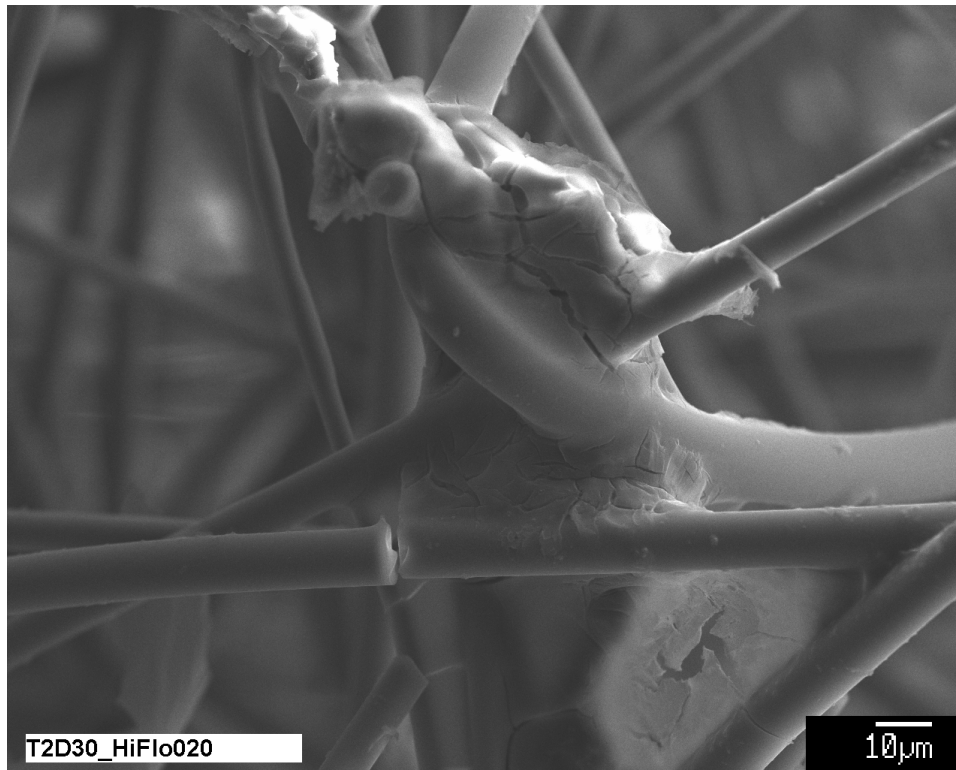
Figure D2-7. SEM image of a higher magnification for a Test-2 Day-30 high-flow exterior fiberglass sample (T2D30_HiFlo020).

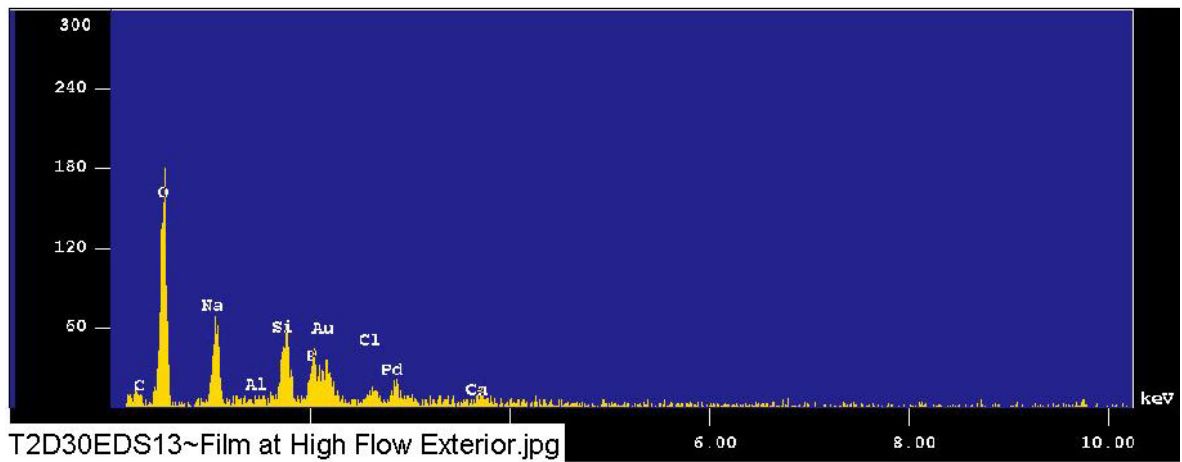
Figure D2-8. EDS counting spectrum for the film deposits or growth on fiberglass as shown in Figure D2-7 (T2D30EDS13~Film at High Flow Exterior)..

The results from the chemical composition analysis for T2D30EDS13 are given in Table D2-1.

Element	Mass%	Atomic%	ZAF	Z	A	F
C	0.000	0.0000	6.0057	1.0404	5.7730	0.9999
O	68.212	77.9670	0.7076	0.9928	0.7128	1.0000
Na	15.750	12.5283	1.5604	1.0448	1.4934	1.0001
Si	7.284	4.7427	1.3779	0.9953	1.3873	0.9980
P	4.750	2.8046	0.8298	1.1782	0.7048	0.9993
Cl	2.197	1.1335	1.1025	1.0478	1.0529	0.9993
Ca	1.806	0.8239	1.0120	1.0156	0.9965	1.0000

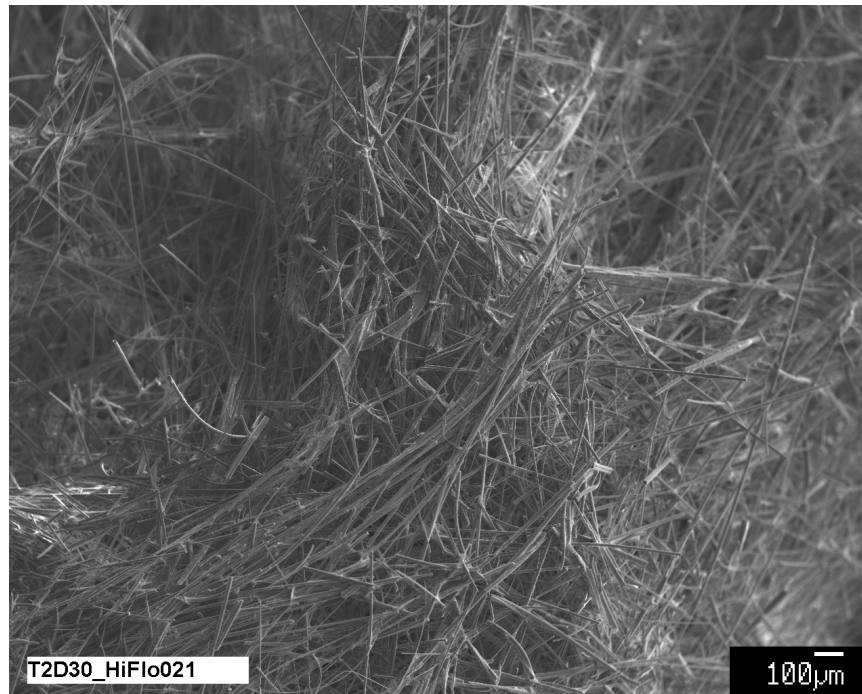
Figure D2-9. SEM image for a Test-2 Day-30 high-flow interior fiberglass sample (T2D30_HiFlo021).

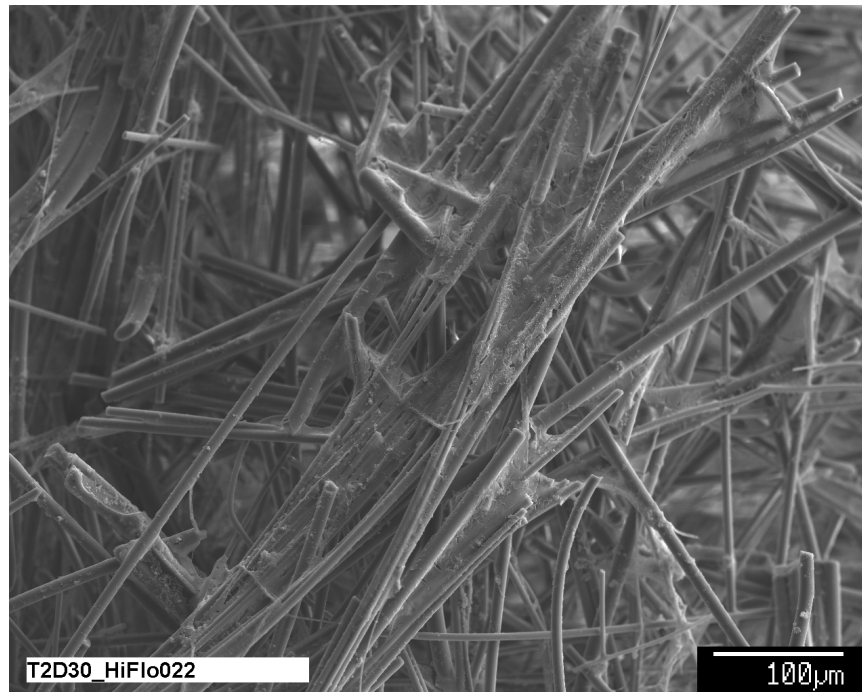
Figure D2-10. SEM image for a Test-2 Day-30 high-flow interior fiberglass sample (T2D30_HiFlo022).

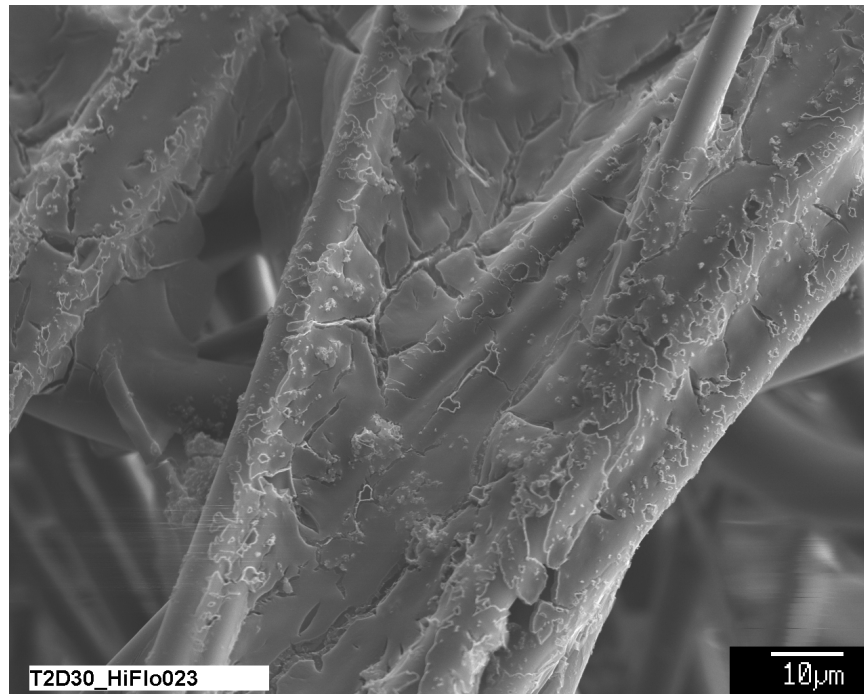
Figure D2-11. SEM image at 1000× magnification for a Test-2 Day-30 high-flow interior fiberglass sample (T2D30_HiFlo023).

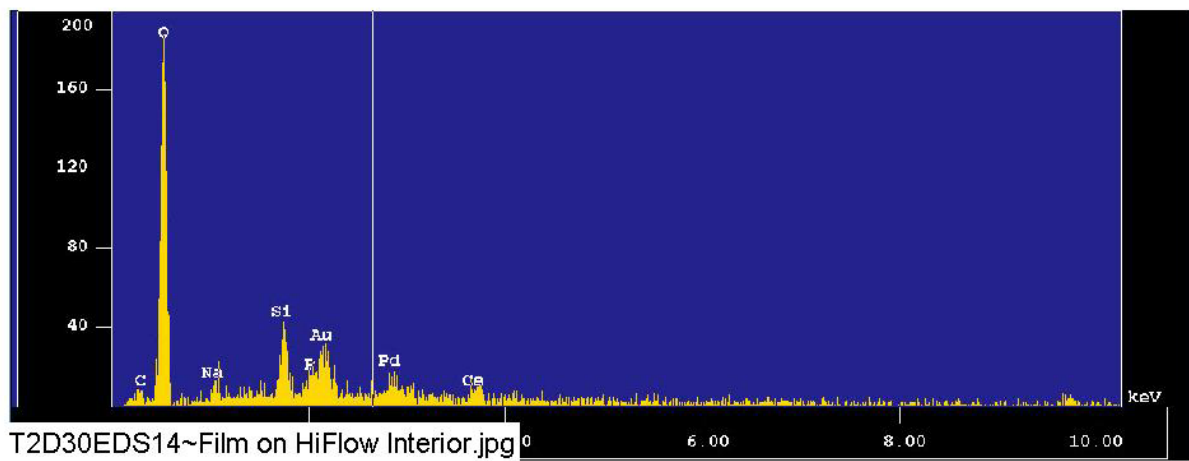
Figure D2-12. EDS counting spectrum for the film deposits or growth on fiberglass as shown in Figure D2-11 (T2D30EDS14~Film on HiFlow Interior).

The results from the chemical composition analysis for T2D30EDS14 are given in Table D2-2.

Element	Mass%	Atomic%	ZAF	Z	A	F
C	0.000	0.0000	3.8510	1.0451	3.6851	0.9999
O	85.150	90.8939	0.5770	0.9974	0.5785	1.0000
Na	4.620	3.4320	1.8017	1.0498	1.7160	1.0002
Si	6.368	3.8722	1.3235	1.0003	1.3239	0.9994
P	1.246	0.6870	0.7999	1.1842	0.6756	0.9999
Ca	2.616	1.1148	0.9886	1.0213	0.9680	1.0000

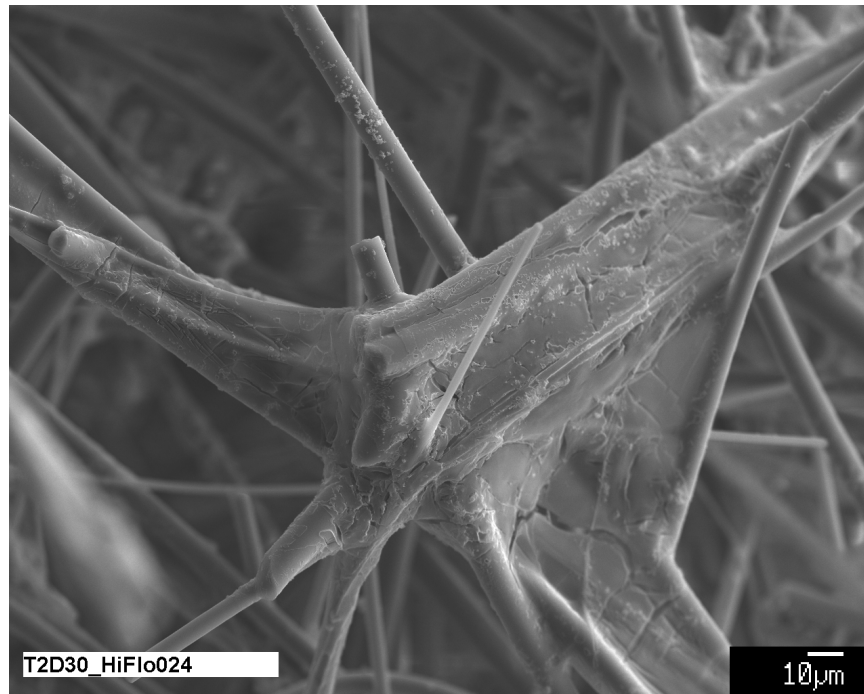
Figure D2-13. SEM image of a higher magnification for a Test-2 Day-30 high-flow interior fiberglass sample (T2D30_HiFlo024).

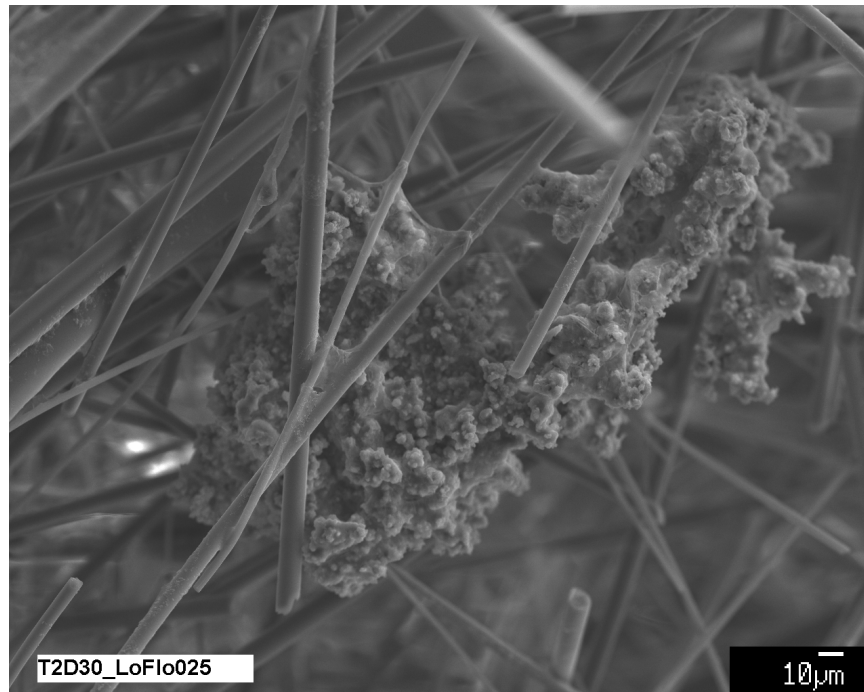
Image: T2D30_LoFlo025 350 × On possible bacteria or Ca Phosphate
EDS: T2D30EDS15 Globular cluster from image 025
Image: T2D30_LoFlo026 800 × Different area

Figure D2-14. SEM image for a Test-2 Day-30 low-flow interior fiberglass sample (T2D30_LoFlo025).

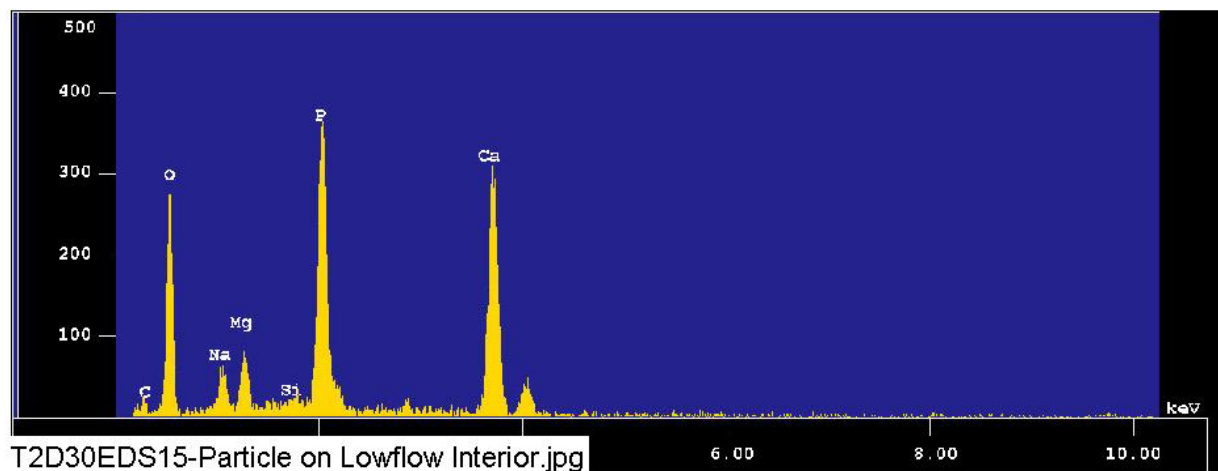
Figure D2-15. EDS counting spectrum for the particulate deposits or growth on fiberglass as shown in Figure D2-14 (T2D30EDS15-Particle on LowFlow Interior).

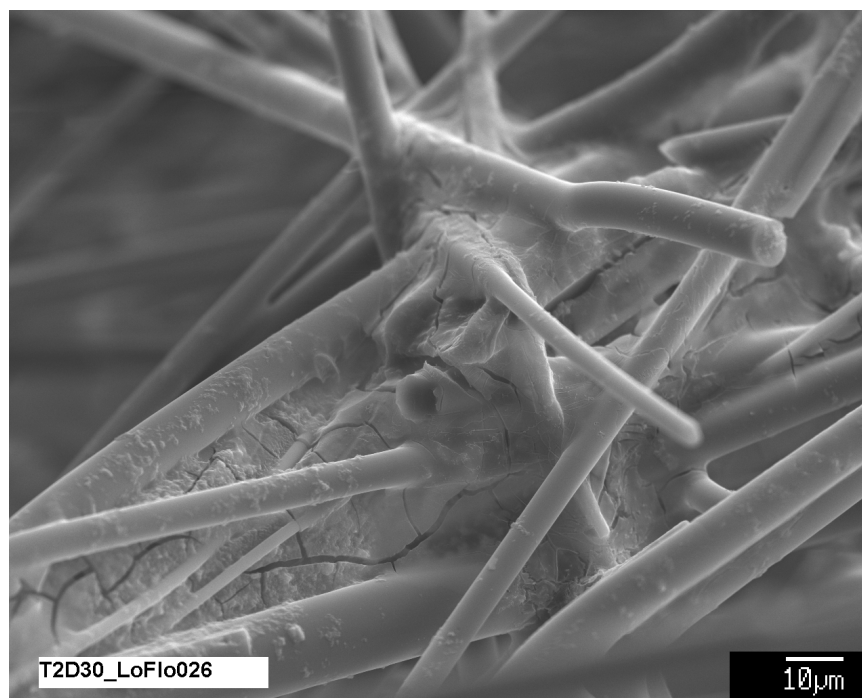
Figure D2-16. SEM image of a higher magnification for a Test-2 Day-30 low-flow interior fiberglass sample (T2D30_LoFlo026).

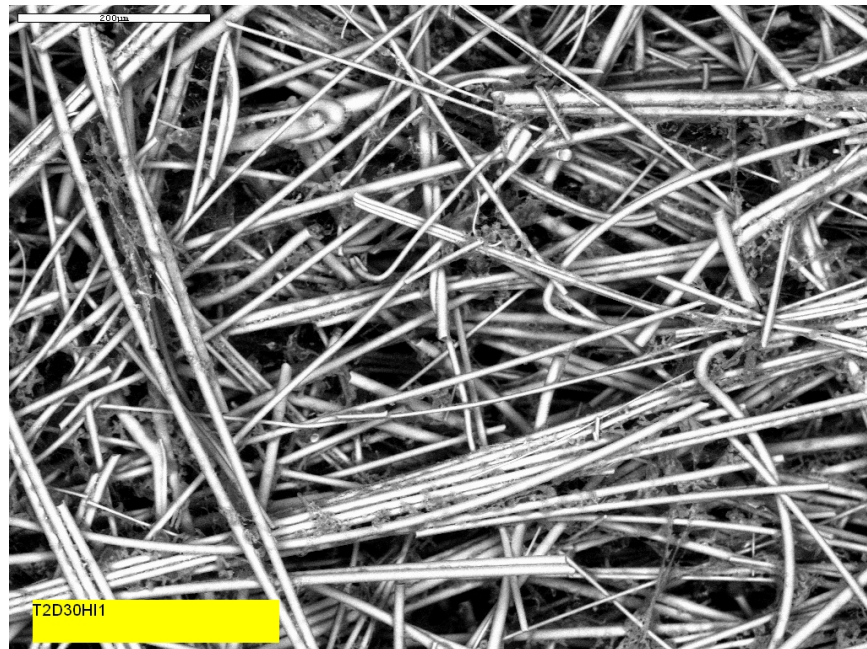
Figure D2-17. ESEM image for a Test-2 Day-30 high-flow interior fiberglass sample. It seems the interior fiberglass is cleaner than exterior fiberglass (T2D30HI1).

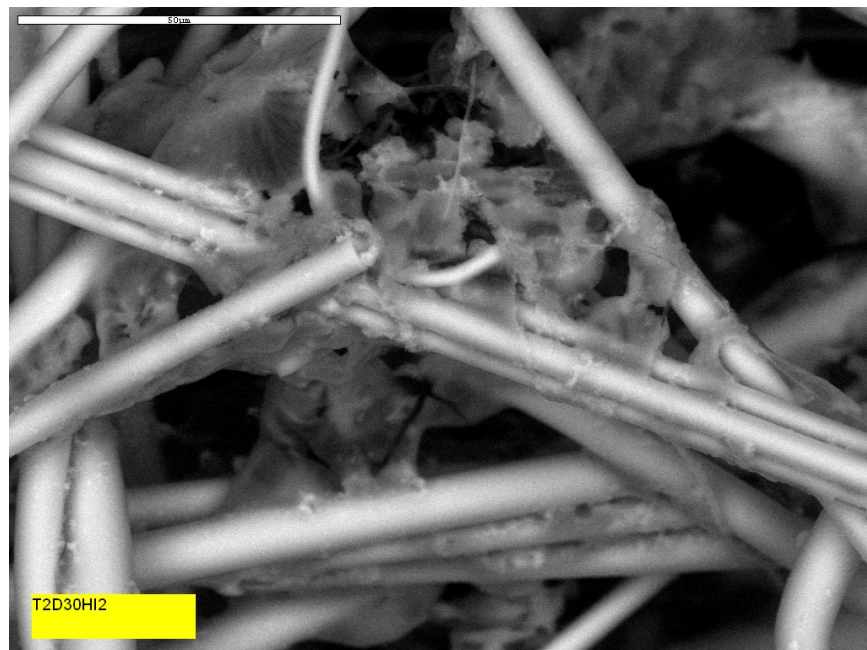
Figure D2-18. ESEM image of a higher magnification for a Test-2 Day-30 high flow interior fiberglass sample (T2D30HI2).

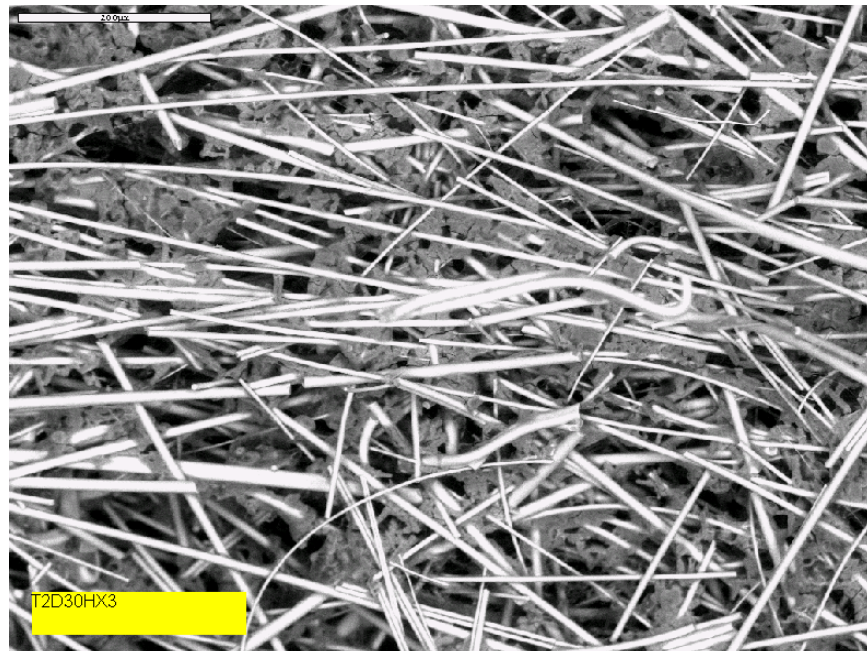
Figure D2-19. ESEM image for a Test-2 Day-30 high flow exterior fiberglass sample (T2D30HX3).

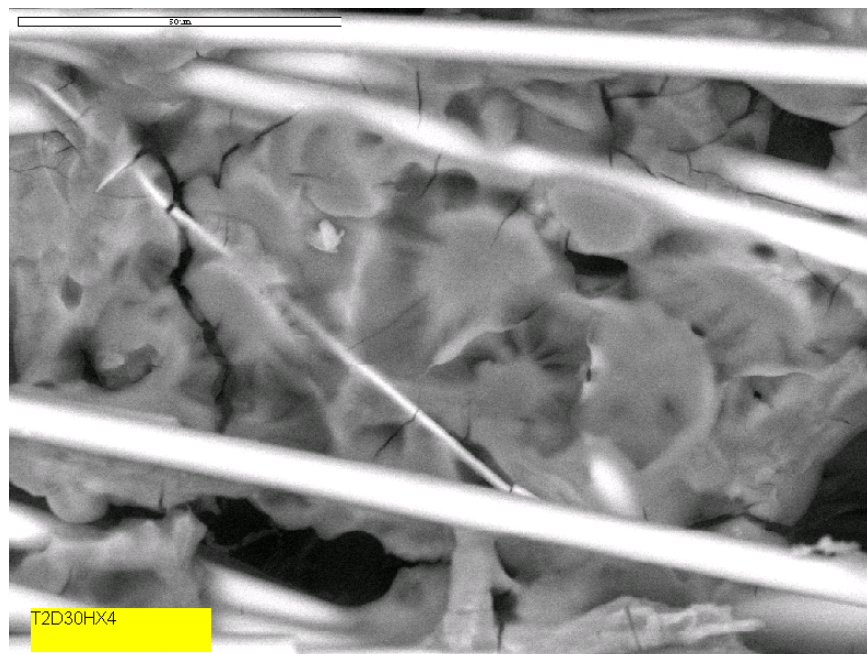
Figure D2-20. ESEM image of a higher magnification for a Test-2 Day-30 high-flow exterior fiberglass sample (T2D30HX4).

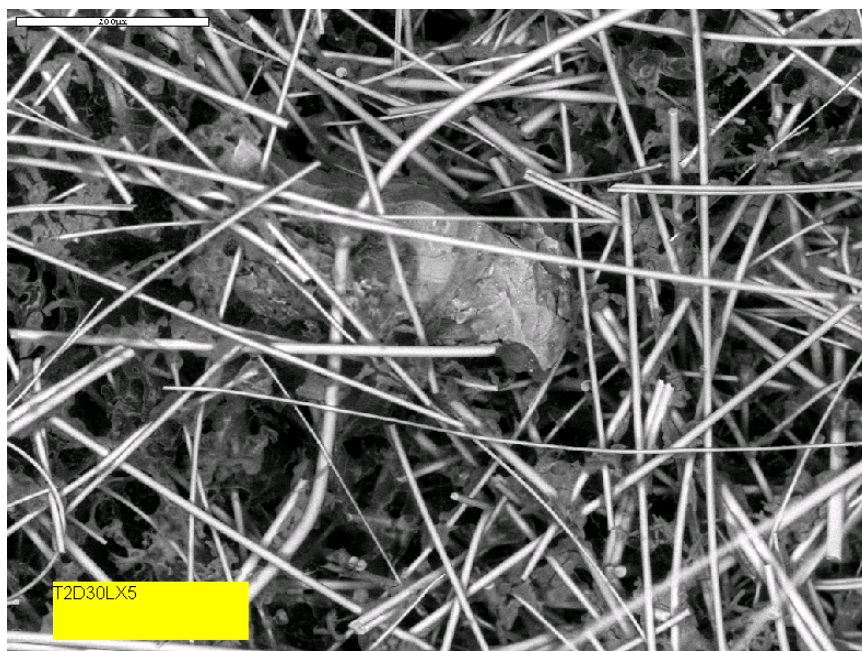
Figure D2-21. ESEM image for a Test-2 Day-30 low-flow exterior fiberglass sample (T2D30LX5).

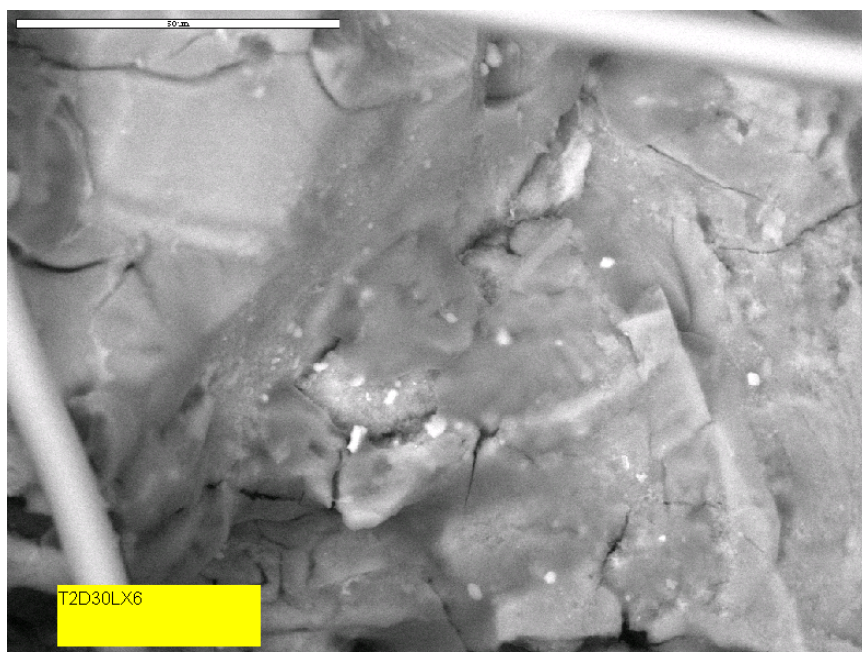
Figure D2-22. ESEM image of a higher magnification for a Test-2 Day-30 low-flow exterior fiberglass sample (T2D30LX6).

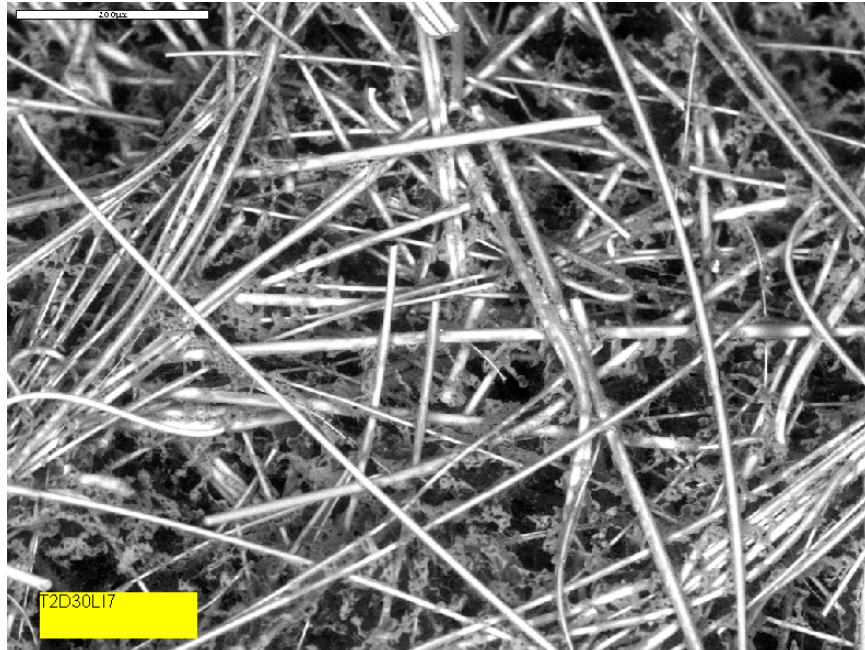
Figure D2-23. ESEM image for a Test-2 Day-30 low-flow interior fiberglass sample (T2D30LI7).

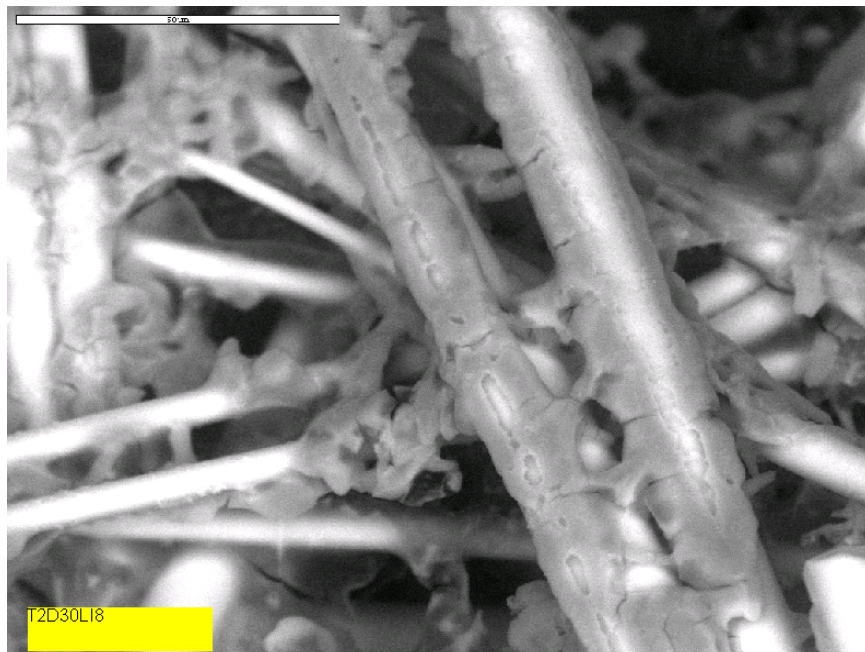
Figure D2-24. ESEM image of a higher magnification for a Test-2 Day-30 low-flow interior fiberglass sample (T2D30LI8).
