Appendix B1

ESEM/EDS and SEM/EDS Data for Test #3 Day-15 Fiberglass in High-Flow Zones

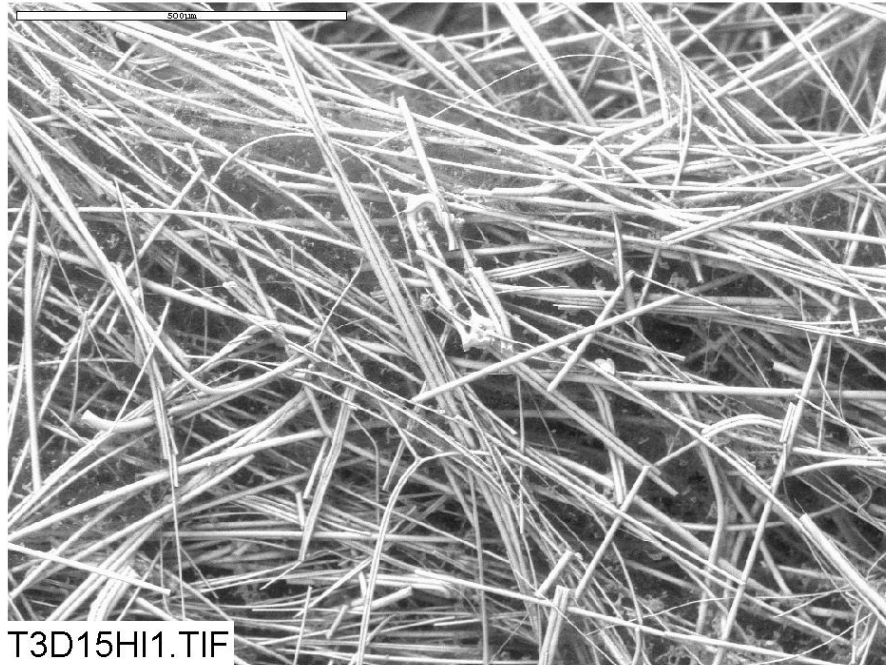
Figure B1-1: Environmental SEM image magnified 100 times for a Test #3 Day-15 high-flow interior fiberglass sample. (T3D15HI1)

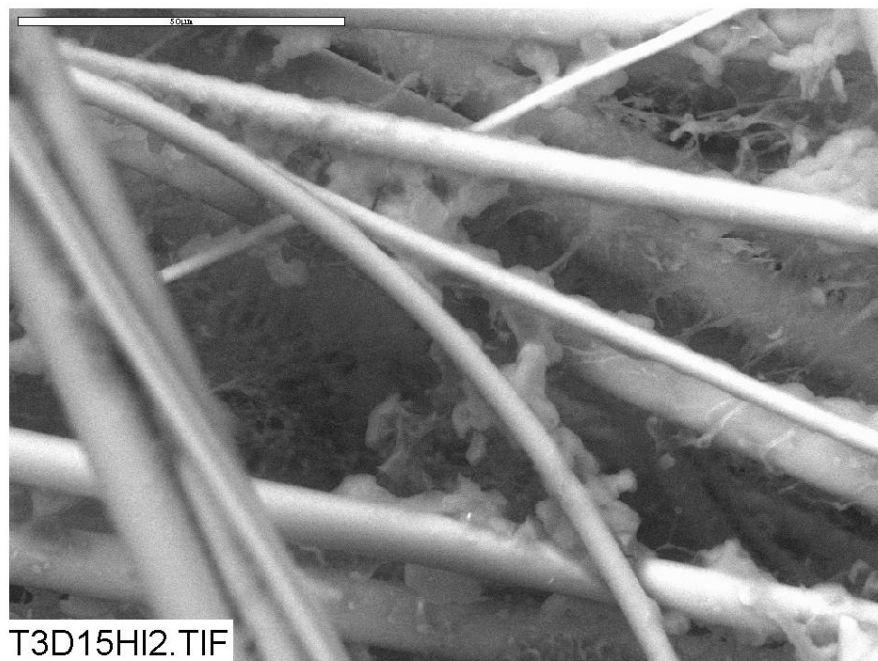
Figure B1-2: Environmental SEM image magnified 1000 times for a Test #3 Day-15 high-flow interior fiberglass sample. (T3D15HI2)

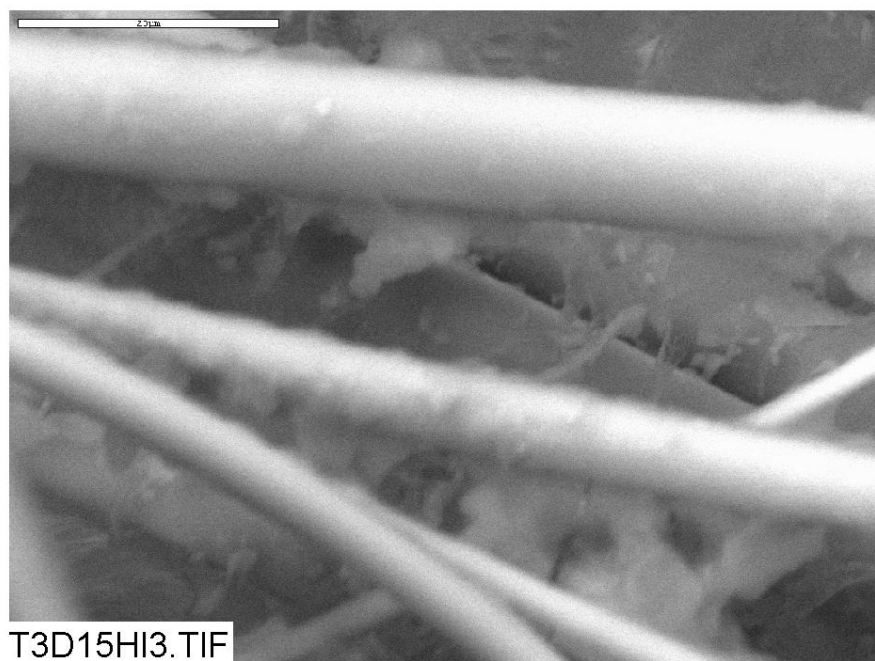
Figure B1-3: Environmental SEM image magnified 2000 times for a Test #3 Day-15 high-flow interior fiberglass sample. (T3D15HI3)

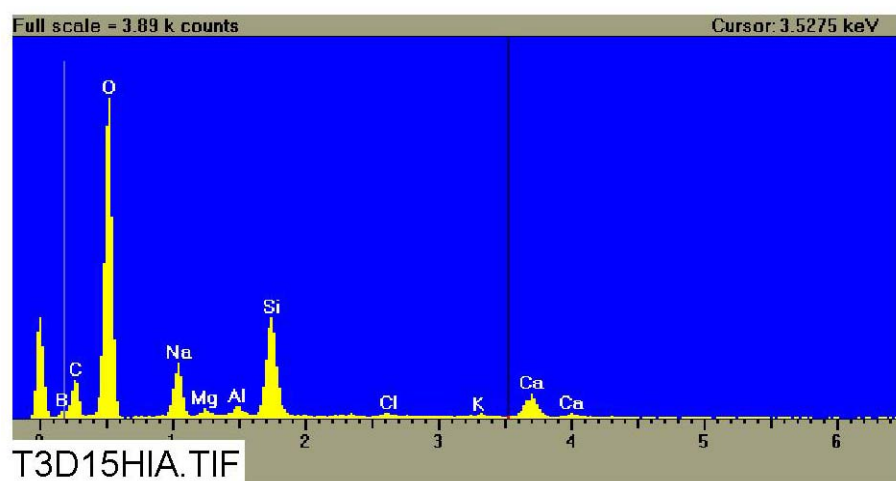
Figure B1-4: EDS counting spectrum for the flocculence deposits between the fibers on ESEM image shown in Figure B1-3. (T3D15HIA)

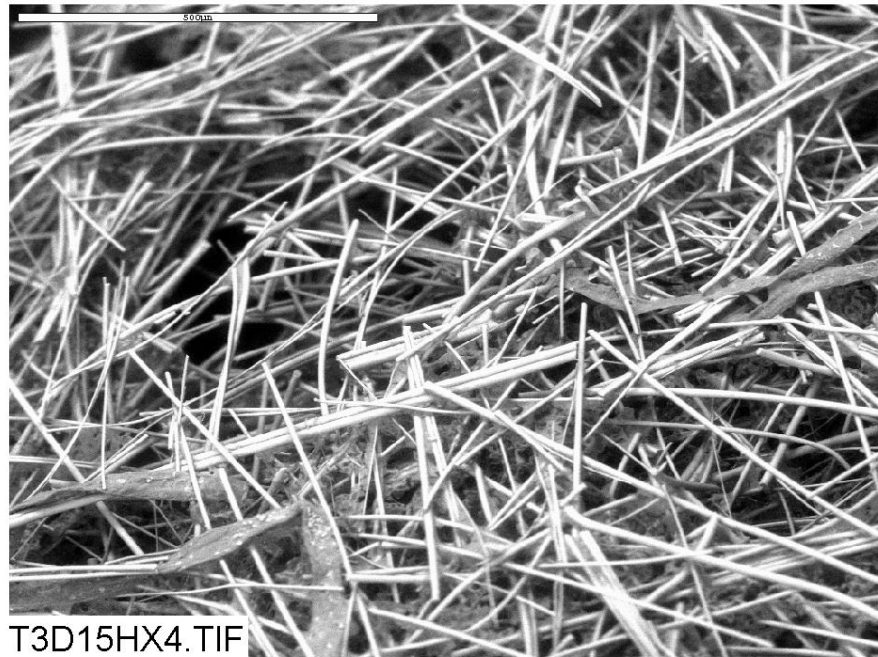
Figure B1-5: Environmental SEM image magnified 110 times for a Test #3 Day-15 high-flow exterior fiberglass sample. (T3D15HX4)

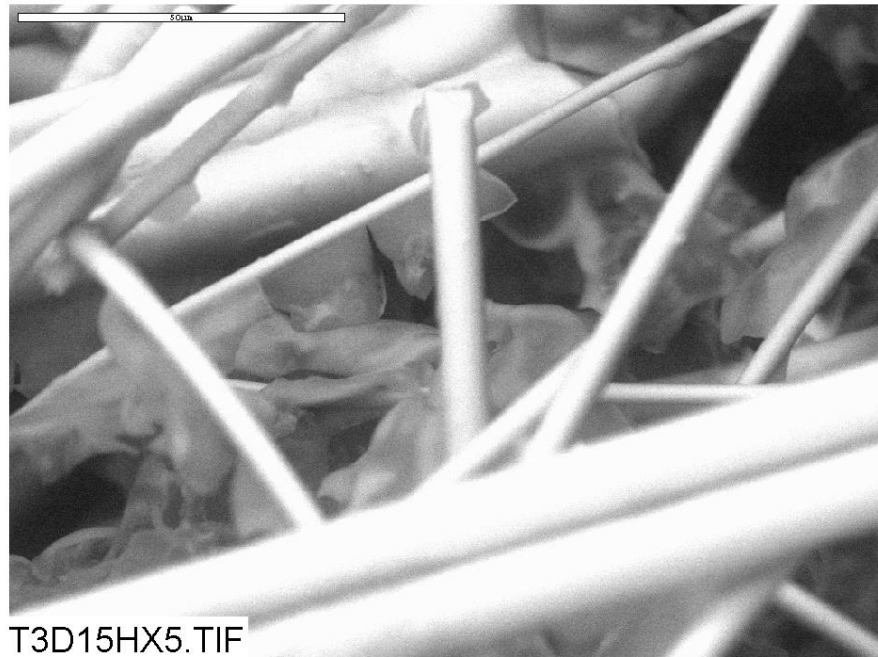
Figure B1-6: Environmental SEM image magnified 1000 times for a Test #3 Day-15 high-flow exterior fiberglass sample. (T3D15HX5)

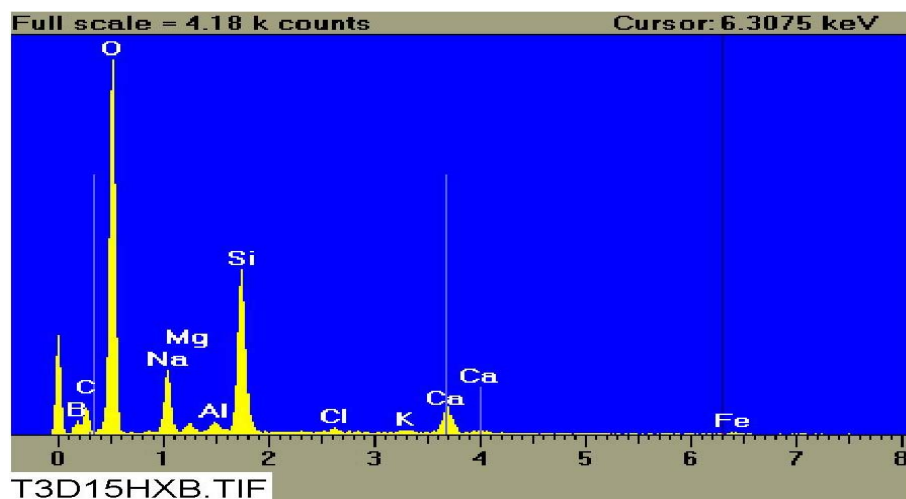
Figure B1-7: EDS counting spectrum for the deposits between the fibers on ESEM image shown in Figure B1-6. (T3D15HXB)

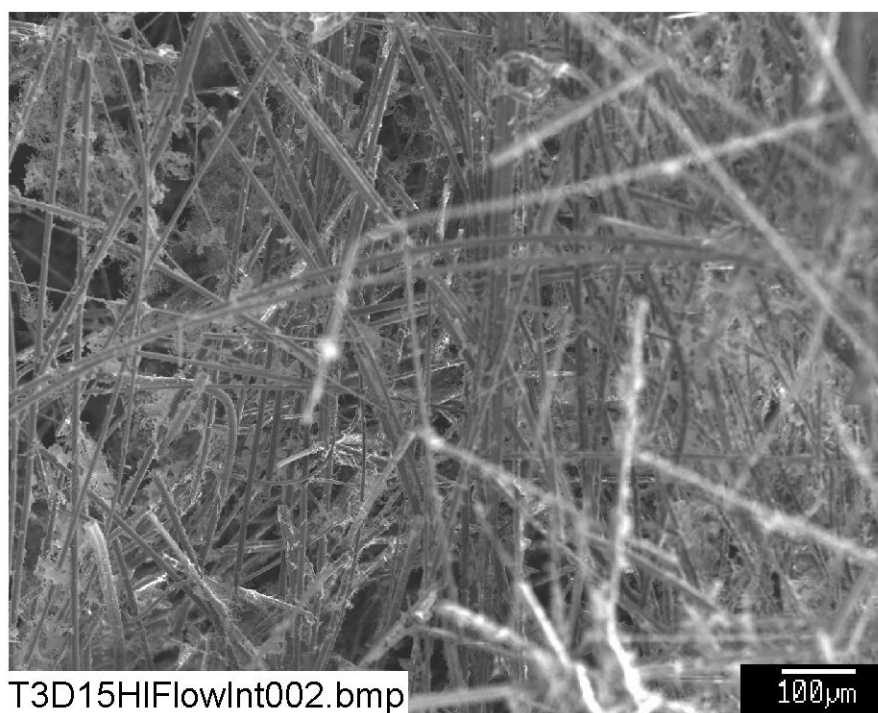
Figure B1-8: SEM image magnified 100 times for a Test #3 Day-15 high-flow interior fiberglass sample. (T3D15HIFlowInt002)

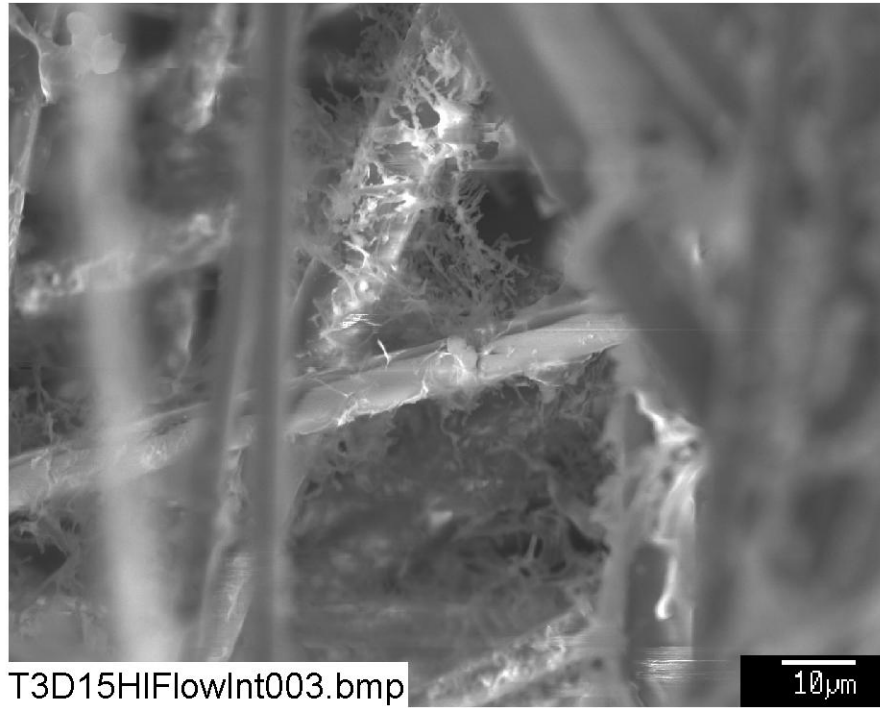
Figure B1-9: SEM image magnified 1000 times for a Test #3 Day-15 high-flow interior fiberglass sample. (T3D15HIFlowInt003)

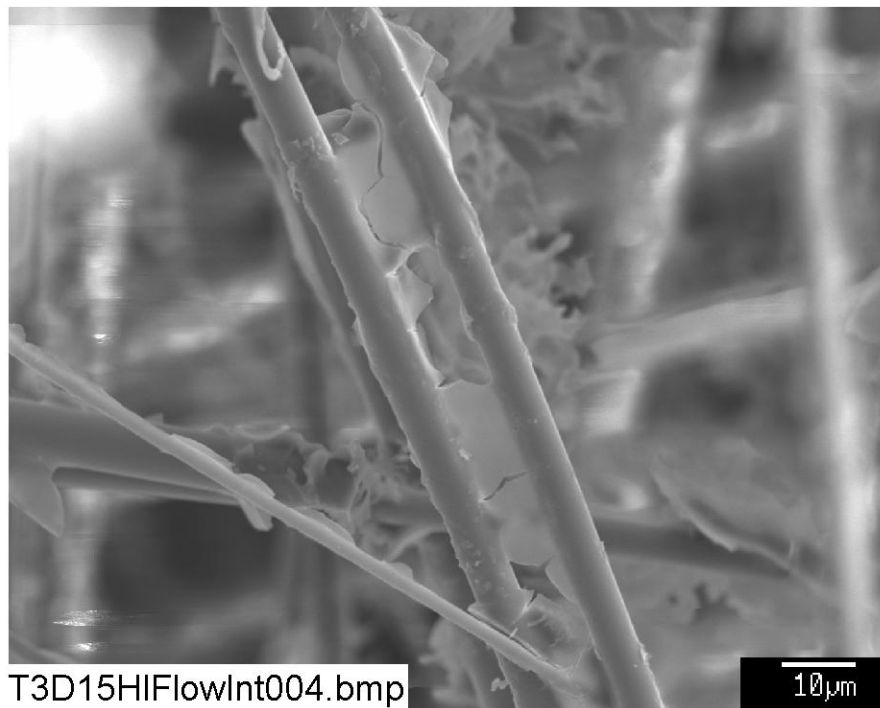
Figure B1-10: SEM image magnified 1000 times for a Test #3 Day-15 high-flow interior fiberglass sample. (T3D15HIFlowInt004)

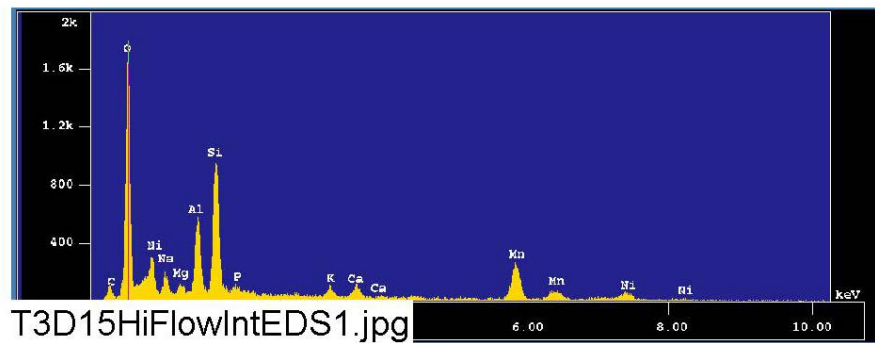
Figure B1-11: EDS counting spectrum for the flocculence deposits between the fibers on SEM image shown in Figure B1-10. (T3D15HiFlowIntEDS1)

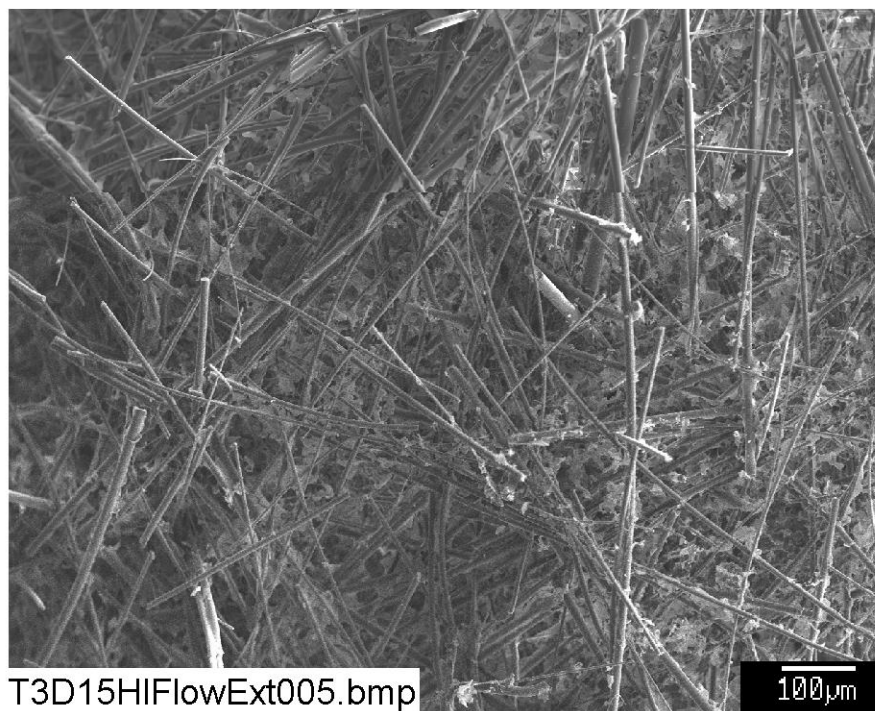
Figure B1-12: SEM image magnified 100 times for a Test #3 Day-15 high-flow exterior fiberglass sample. (T3D15HiFlowExt005)

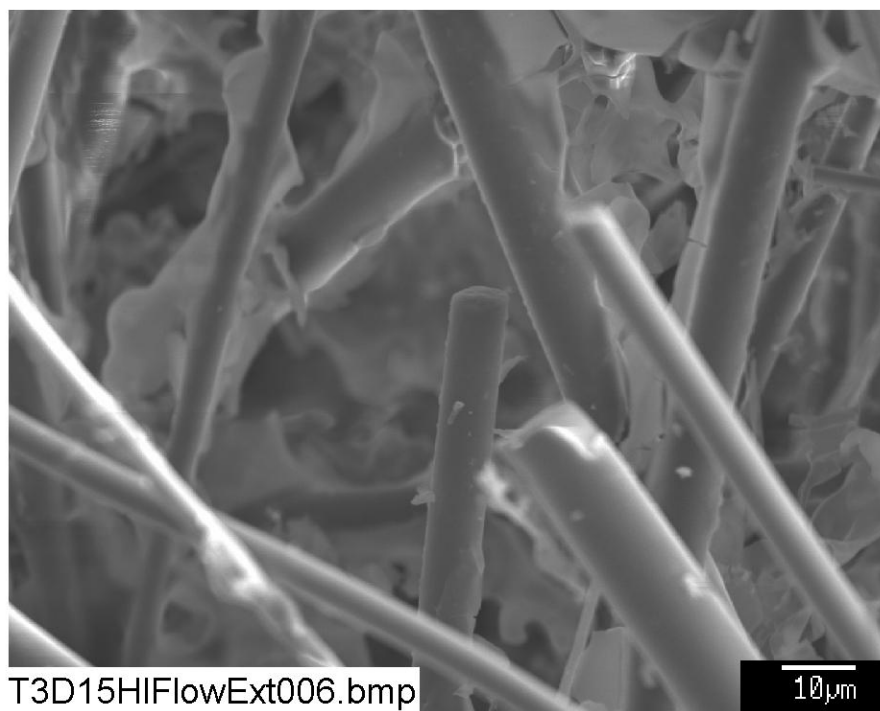
Figure B1-13: SEM image magnified 1000 times for a Test #3 Day-15 high-flow exterior fiberglass sample. (T3D15HIFlowExt006)

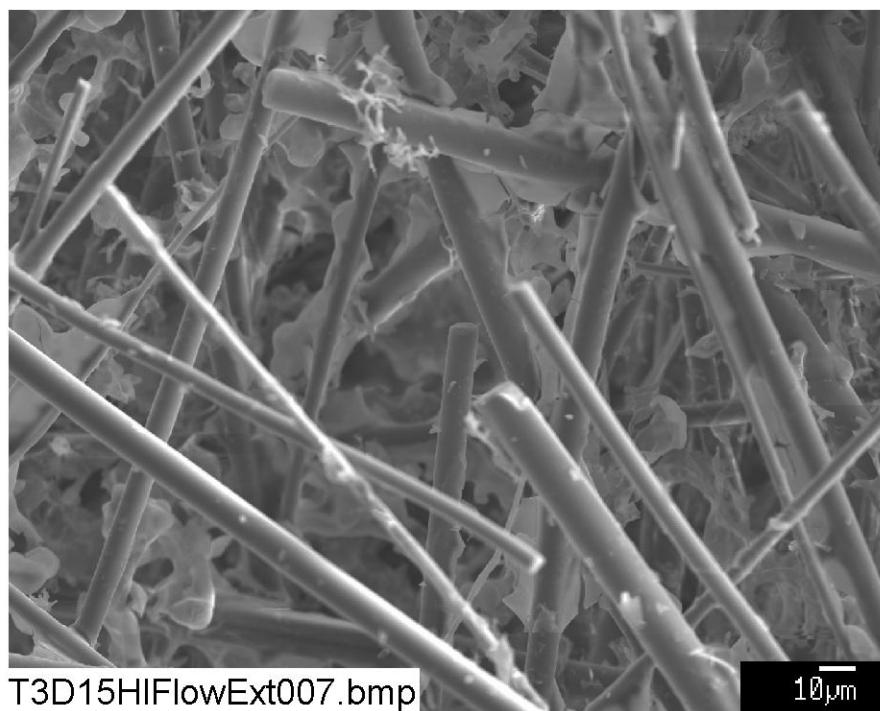
Figure B1-14: SEM image magnified 500 times for a Test #3 Day-15 high-flow exterior fiberglass sample. (T3D15HIFlowExt007)

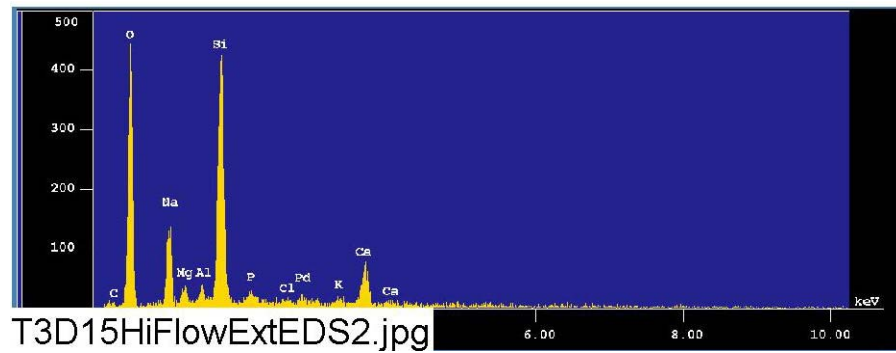
Figure B1-15: EDS counting spectrum for the flocculence deposits between the fibers on SEM image shown in Figure B1-14. (T3D15HiFlowExtEDS2)
