## Appendix C1

### ESEM/EDS Data for Test #3 Day-30 Fiberglass in High-Flow Zones

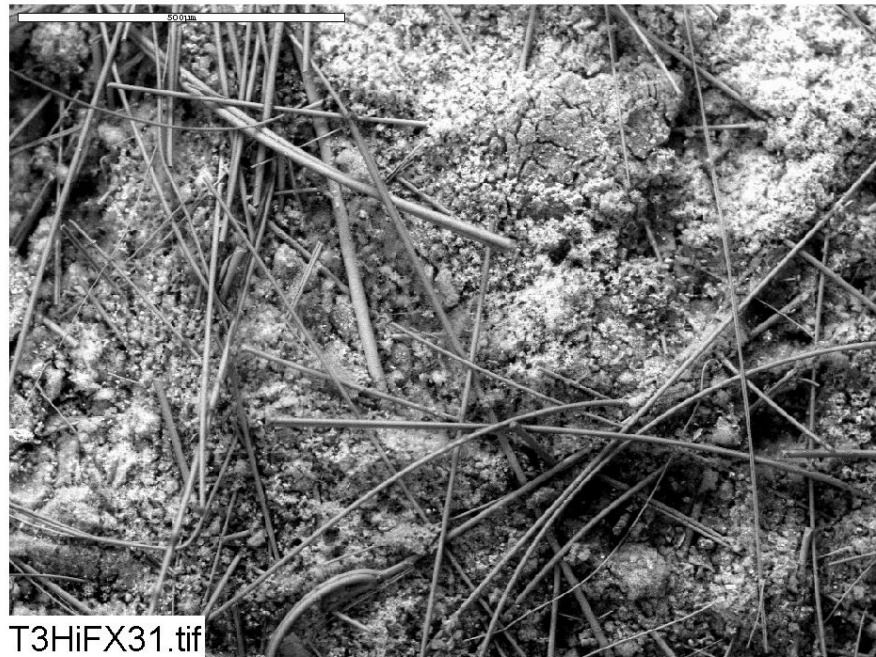
**Figure C1-1: ESEM image magnified 100 times for a Test #3 Day-30 exterior high-flow fiberglass sample. (T3HiFX31)**

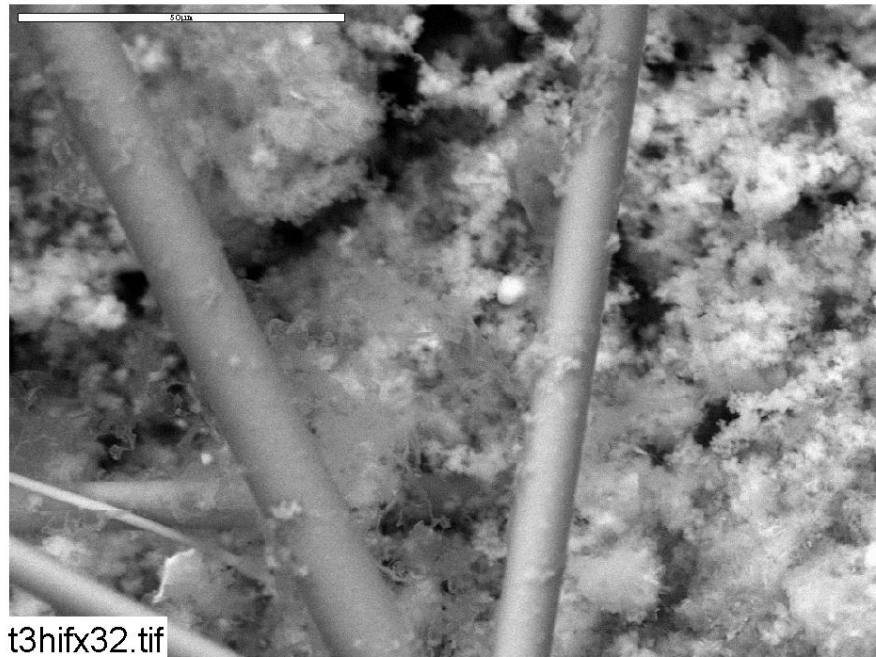
**Figure C1-2: ESEM image magnified 1000 times for a Test #3 Day-30 exterior high-flow fiberglass sample. (t3hifx32)**

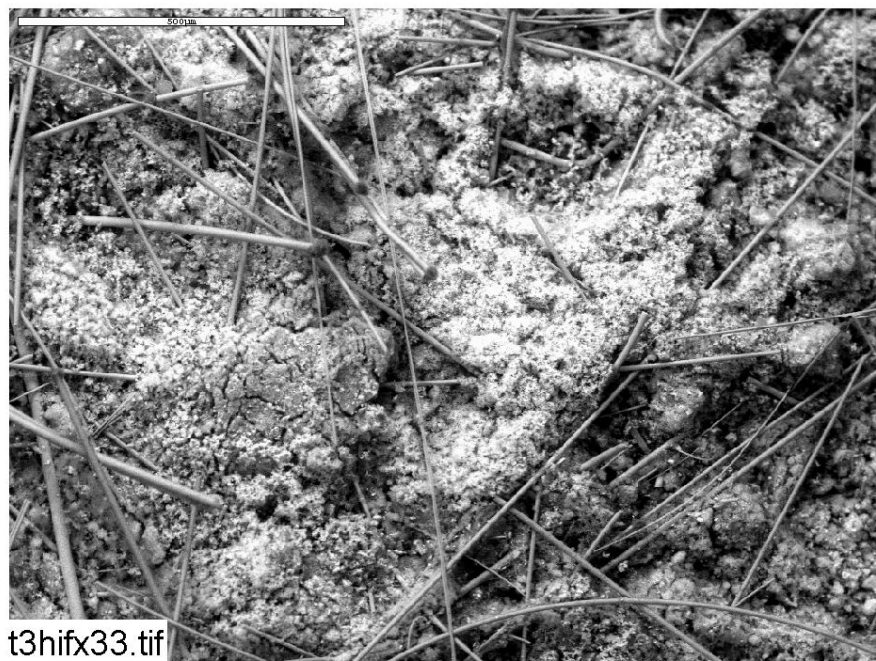
**Figure C1-3: ESEM image magnified 100 times for a Test #3 Day-30 exterior high-flow fiberglass sample. (t3hifx33)**

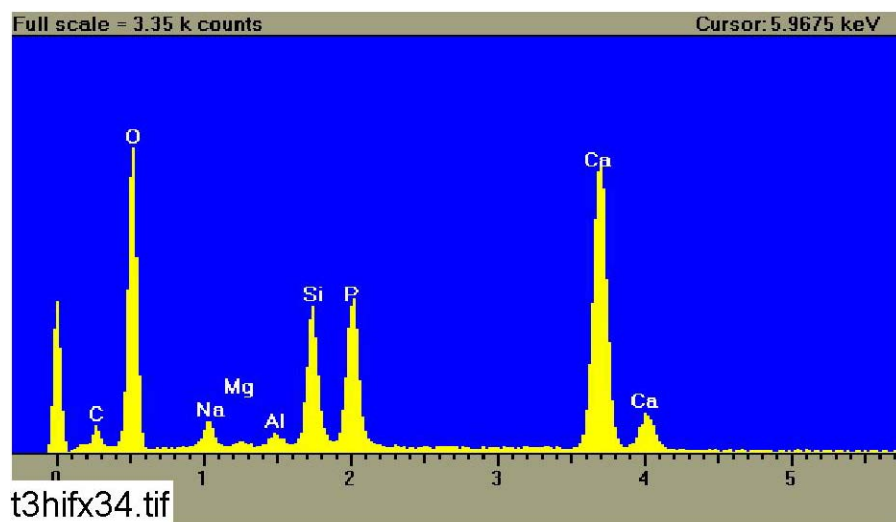
**Figure C1-4: EDS counting spectrum for the large masses of particulate deposits shown in Figure C1-3. (t3hifx34)**

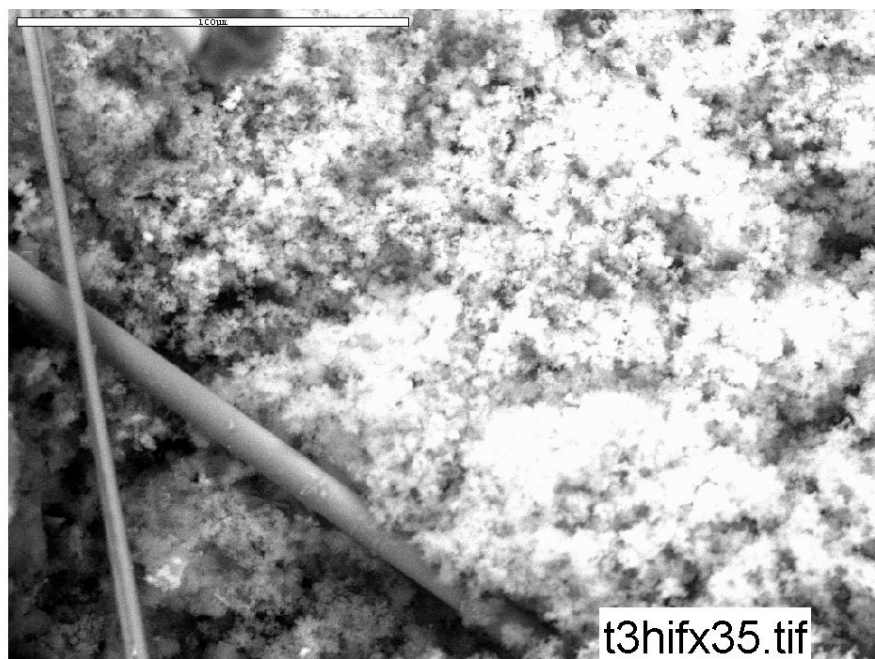
**Figure C1-5: ESEM image magnified 600 times for a Test #3 Day-30 exterior high-flow fiberglass sample. (t3hifx35)**

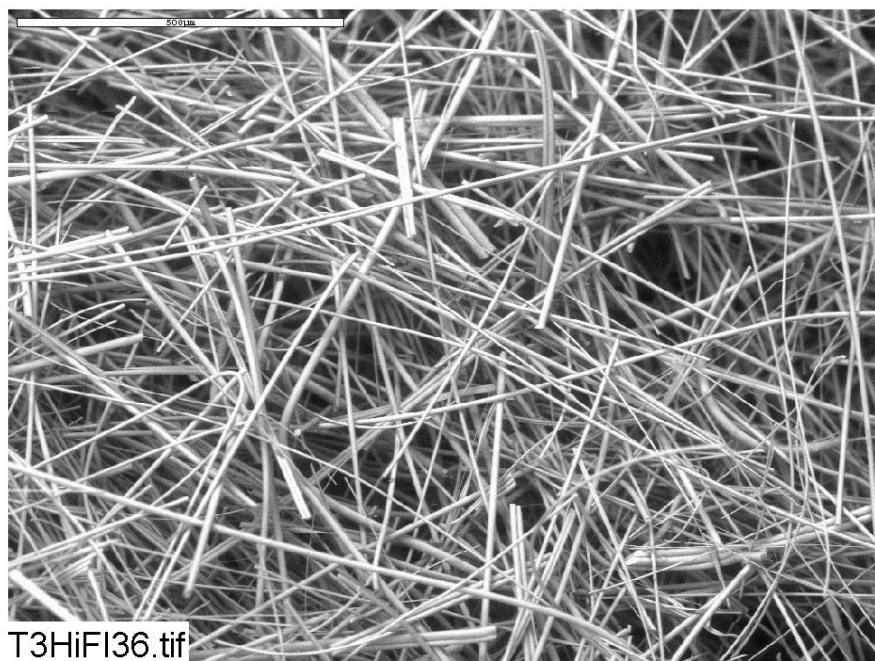
**Figure C1-6: ESEM image magnified 100 times for a Test #3 Day-30 interior high-flow fiberglass sample. (T3HiFI36)**

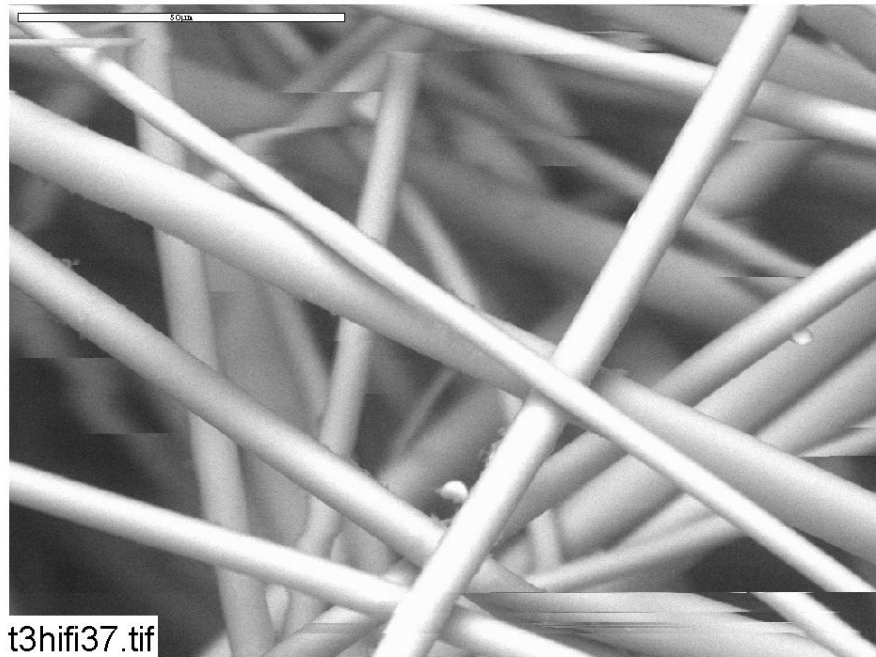
**Figure C1-7: ESEM image magnified 1000 times for a Test #3 Day-30 interior high-flow fiberglass sample. (t3hifi37)**

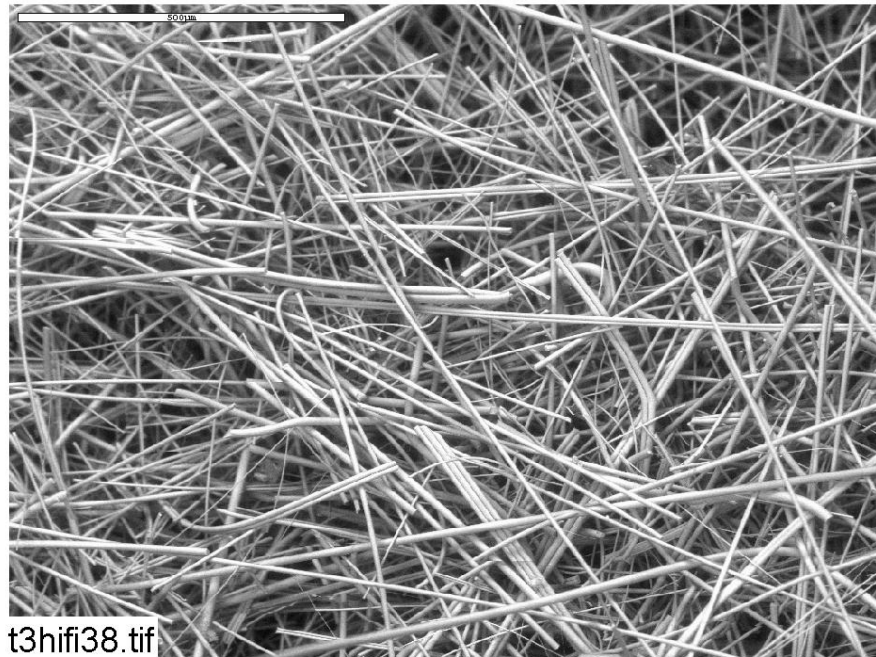
**Figure C1-8: ESEM image magnified 100 times for a Test #3 Day-30 interior high-flow fiberglass sample. (t3hifi38)**
