Appendix C6

ESEM/EDS Data for Test #4 Day-30 Drain Collar Fiberglass

Test #4 Day-30 Drain Collar Fiberglass.

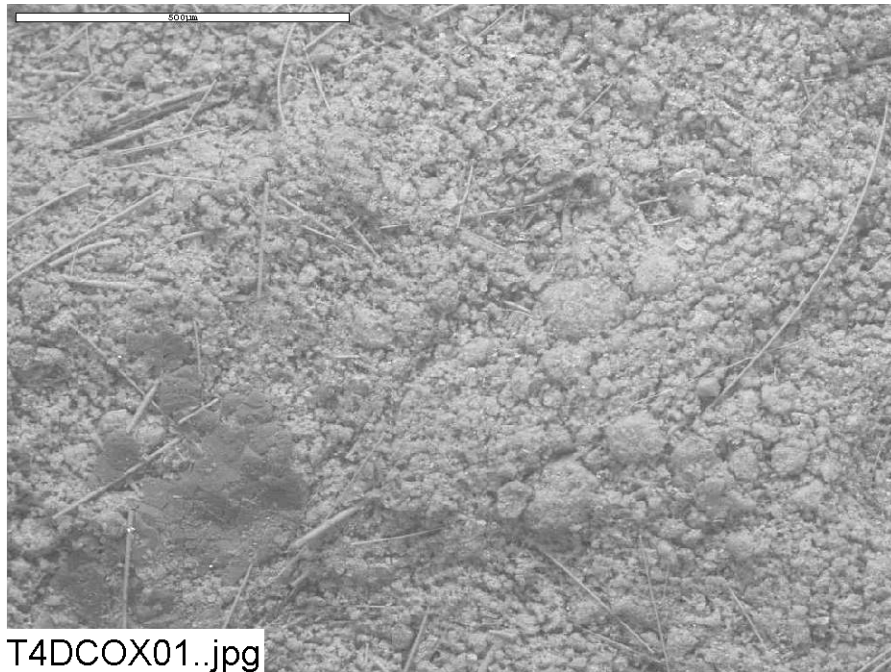
Figure C6-1: Environmental SEM image magnified 100 times for a Test #4 Day-30 exterior fiberglass sample on the drain collar (away from the drain screen). (T4DCOX01.jpg)

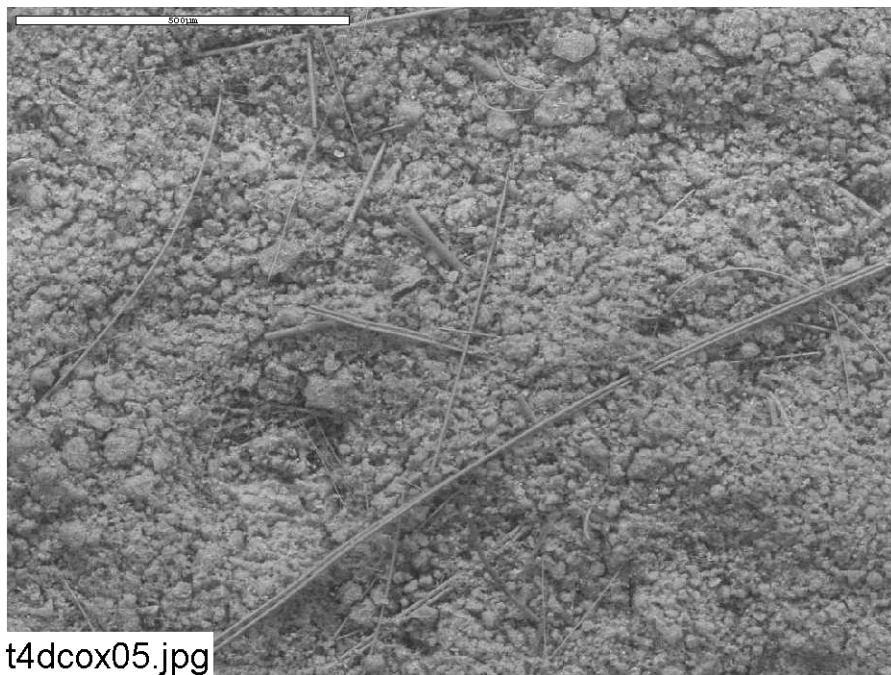
Figure C6-2: Environmental SEM image magnified 100 times for a Test #4 Day-30 exterior fiberglass sample on the drain collar (away from the drain screen). (t4dcox05.jpg)

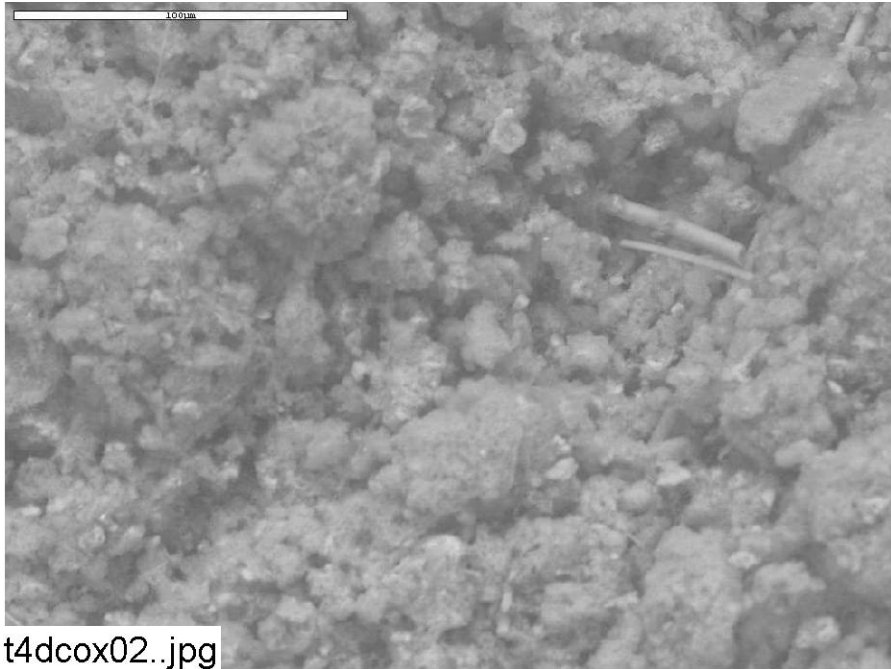
Figure C6-3: Environmental SEM image magnified 500 times for a Test #4 Day-30 exterior fiberglass sample on the drain collar (away from the drain screen). (t4dcox02.jpg)

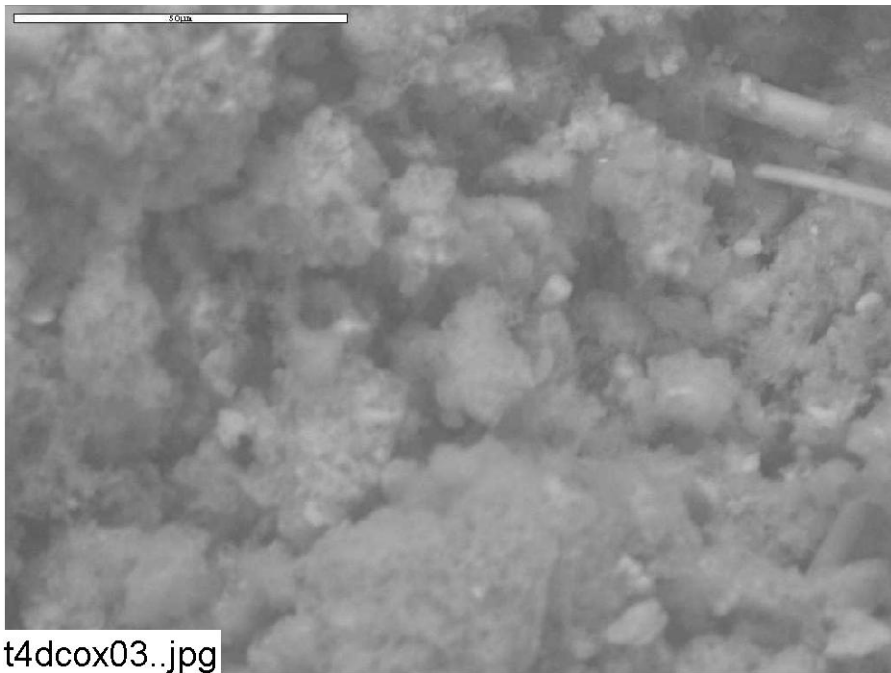
Figure C6-4: Environmental SEM image magnified 1000 times for a Test #4 Day-30 exterior fiberglass sample on the drain collar (away from the drain screen). (t4dcox03.jpg)

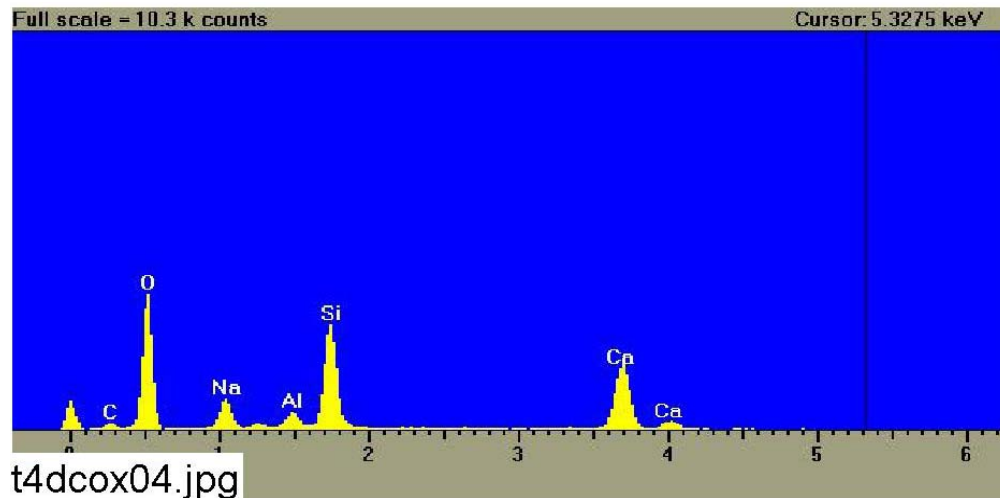
Figure C6-5: EDS counting spectrum for the large mass of particulate deposits on fiberglass shown in Figure C6-4. (t4dcox04.jpg)

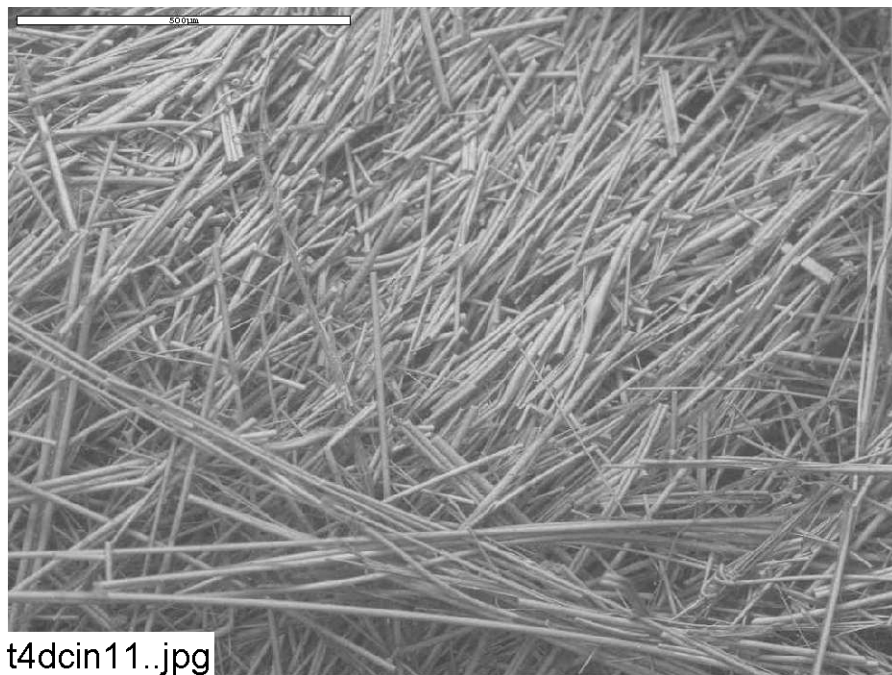
Figure C6-6: Environmental SEM image magnified 100 times for a Test #4 Day-30 interior fiberglass sample on the drain collar. (t4dcin11.jpg)

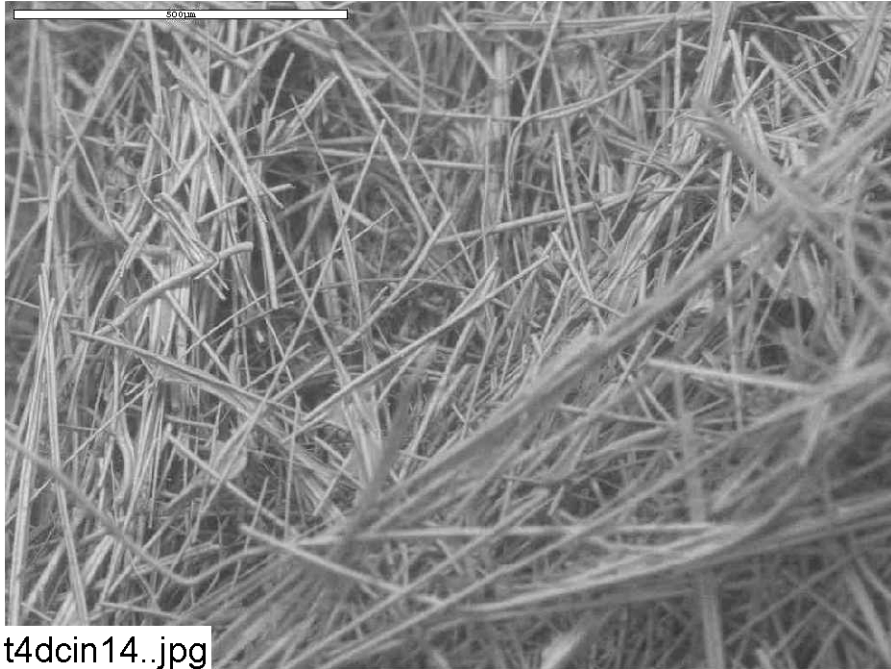
t4dcin14.jpg

Figure C6-7: Environmental SEM image magnified 100 times for a Test #4 Day-30 interior fiberglass sample on the drain collar. (t4dcin14.jpg)

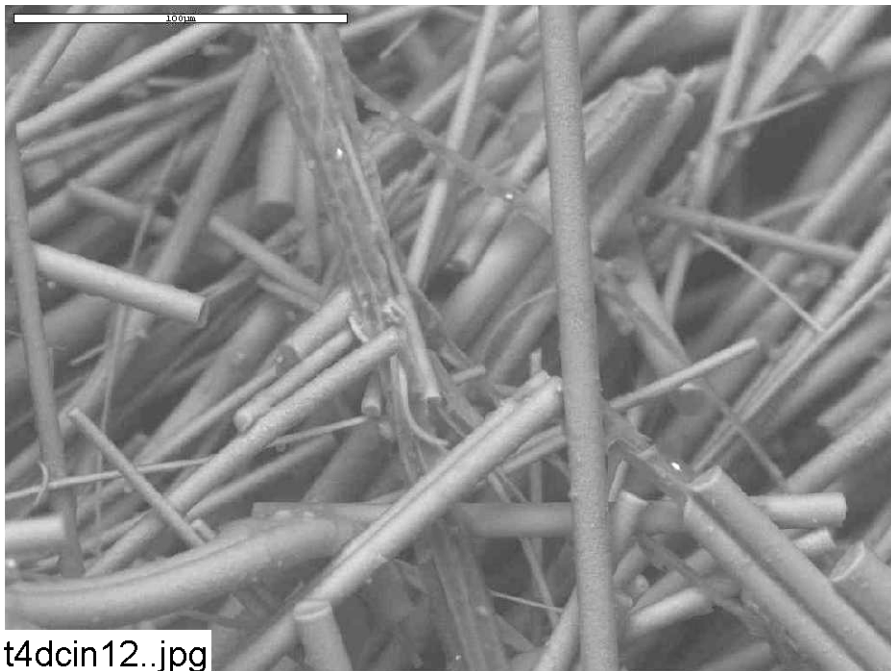
t4dcin12.jpg

Figure C6-8: Environmental SEM image magnified 500 times for a Test #4 Day-30 interior fiberglass sample on the drain collar. (t4dcin12.jpg)

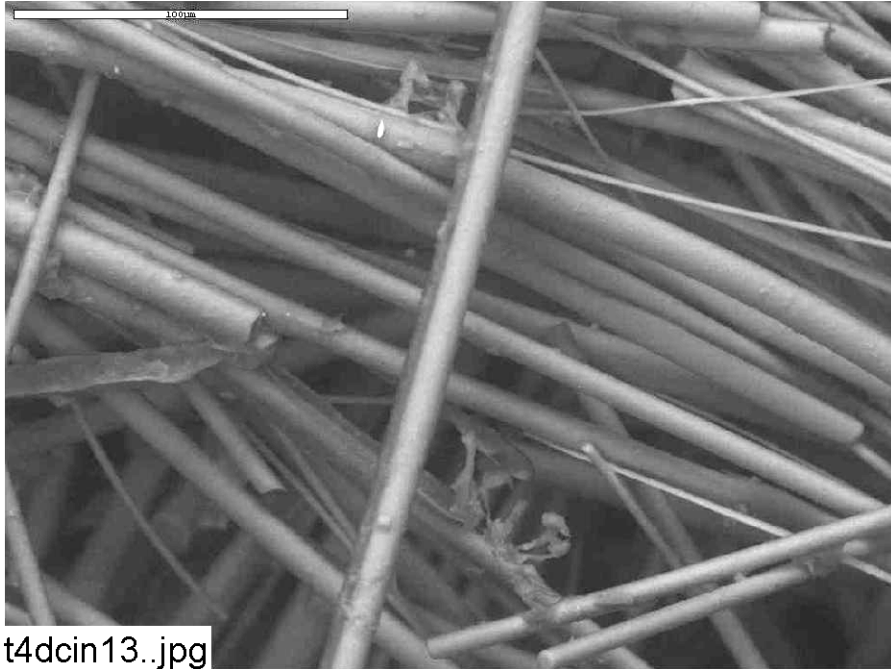
Figure C6-9: Environmental SEM image magnified 500 times for a Test #4 Day-30 interior fiberglass sample on the drain collar. (t4dcin13.jpg)

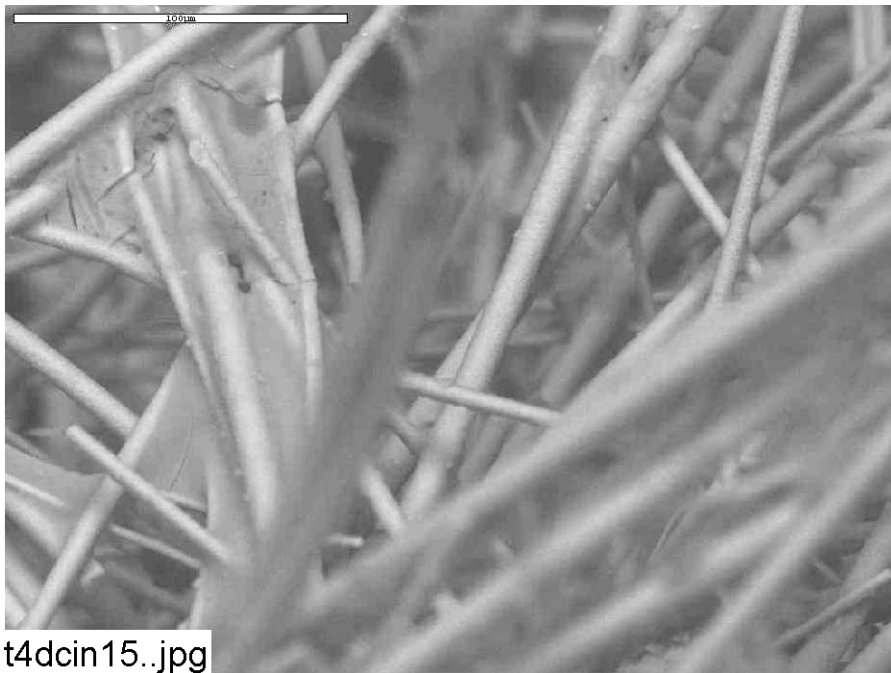
Figure C6-10: Environmental SEM image magnified 500 times for a Test #4 Day-30 interior fiberglass sample on the drain collar. (t4dcin15.jpg)

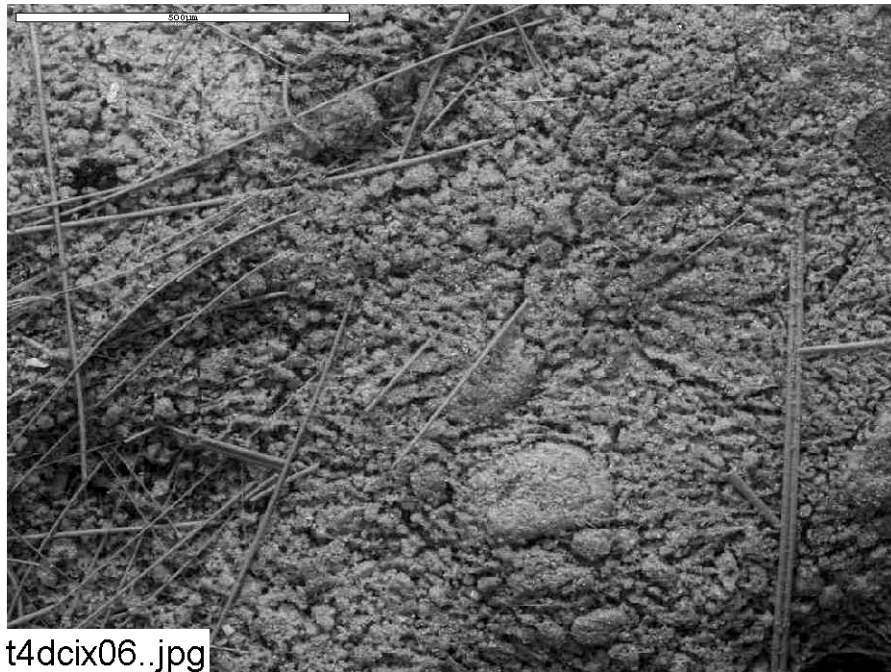
Figure C6-11: Environmental SEM image magnified 100 times for a Test #4 Day-30 exterior fiberglass sample on the drain collar (next to the drain screen). (t4dcix06.jpg)

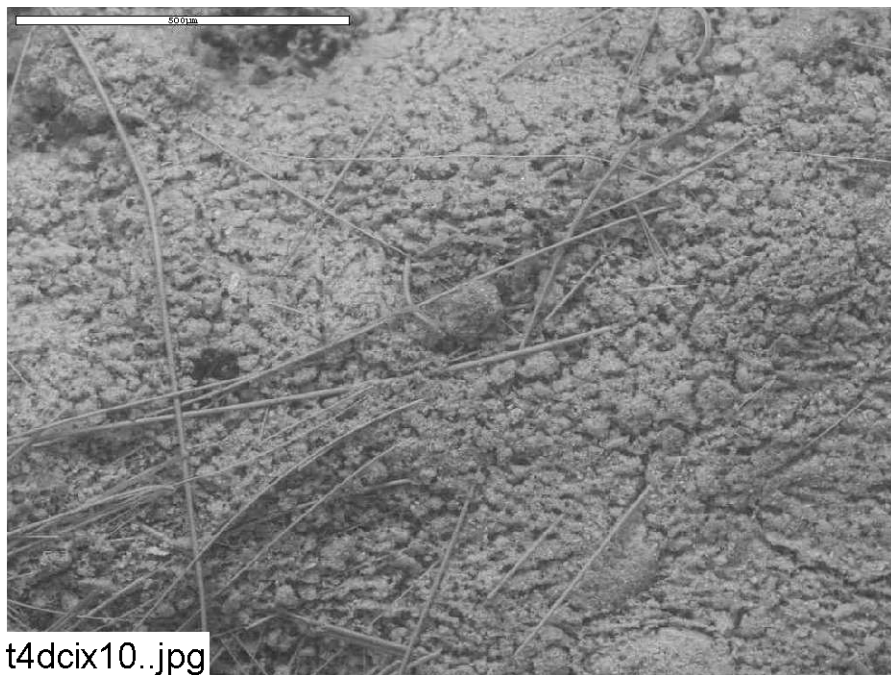
Figure C6-12: Environmental SEM image magnified 100 times for a Test #4 Day-30 exterior fiberglass sample on the drain collar (next to the drain screen). (t4dcix10.jpg)

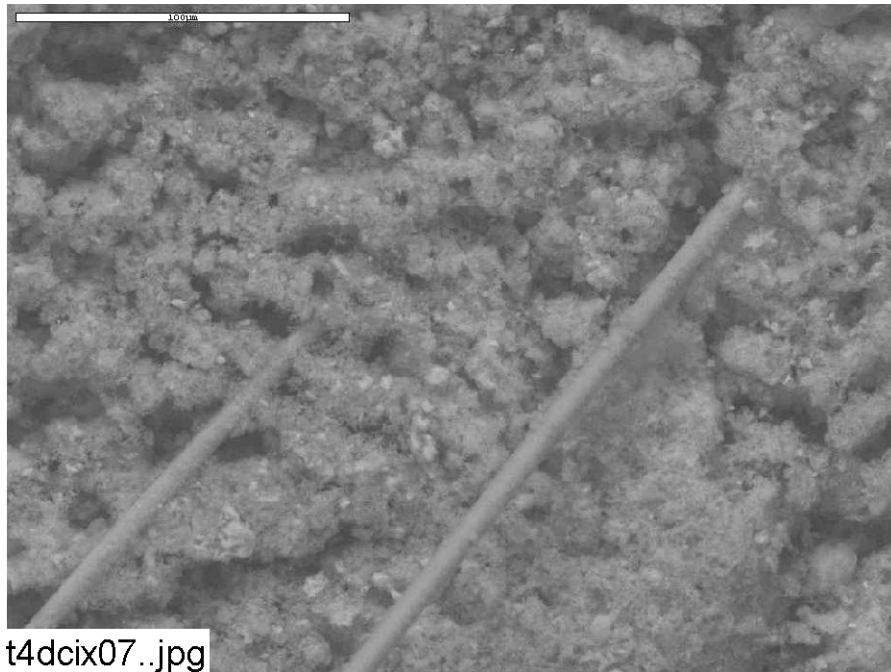
Figure C6-13: Environmental SEM image magnified 500 times for a Test #4 Day-30 exterior fiberglass sample on the drain collar (next to the drain screen). (t4dcix07.jpg)

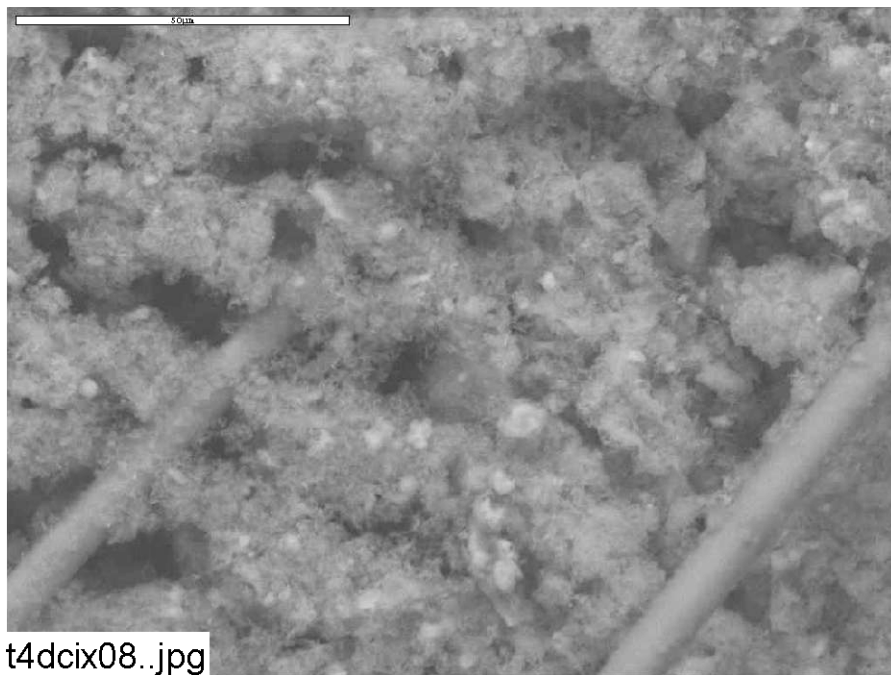
Figure C6-14: Environmental SEM image magnified 1000 times for a Test #4 Day-30 exterior fiberglass sample on the drain collar (next to the drain screen). (t4dcix08.jpg)

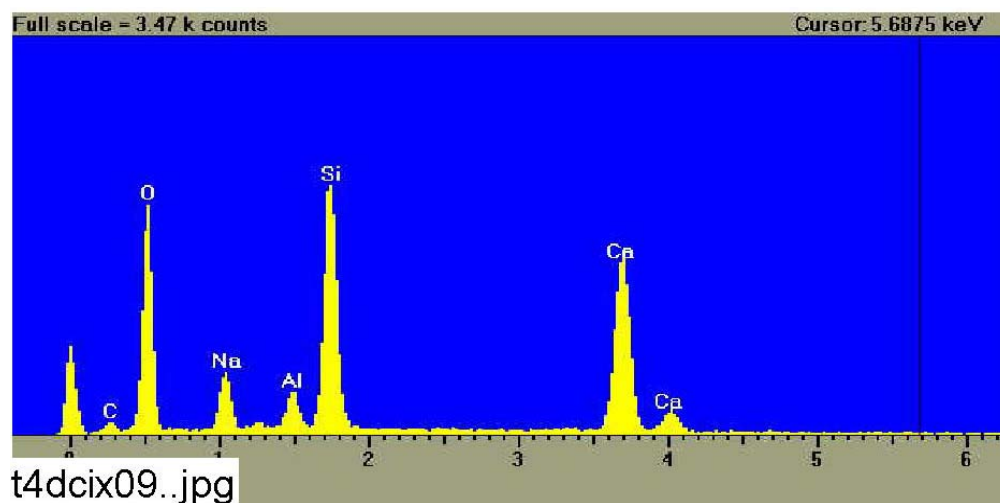
Figure C6-15: EDS counting spectrum for the large mass of particulate deposits on fiberglass shown in Figure C6-14. (t4dcix09.jpg)
