UNITED STATES OF AMERICA
NUCLEAR REGULATORY COMMISSION

(License Renewal for the Oyster Creek
Nuclear Generating Station))

Docket No. 50-0219-LR

**CITIZENS' INITIAL STATEMENT REGARDING RELICENSING OF OYSTER
CREEK NUCLEAR GENERATING STATION**

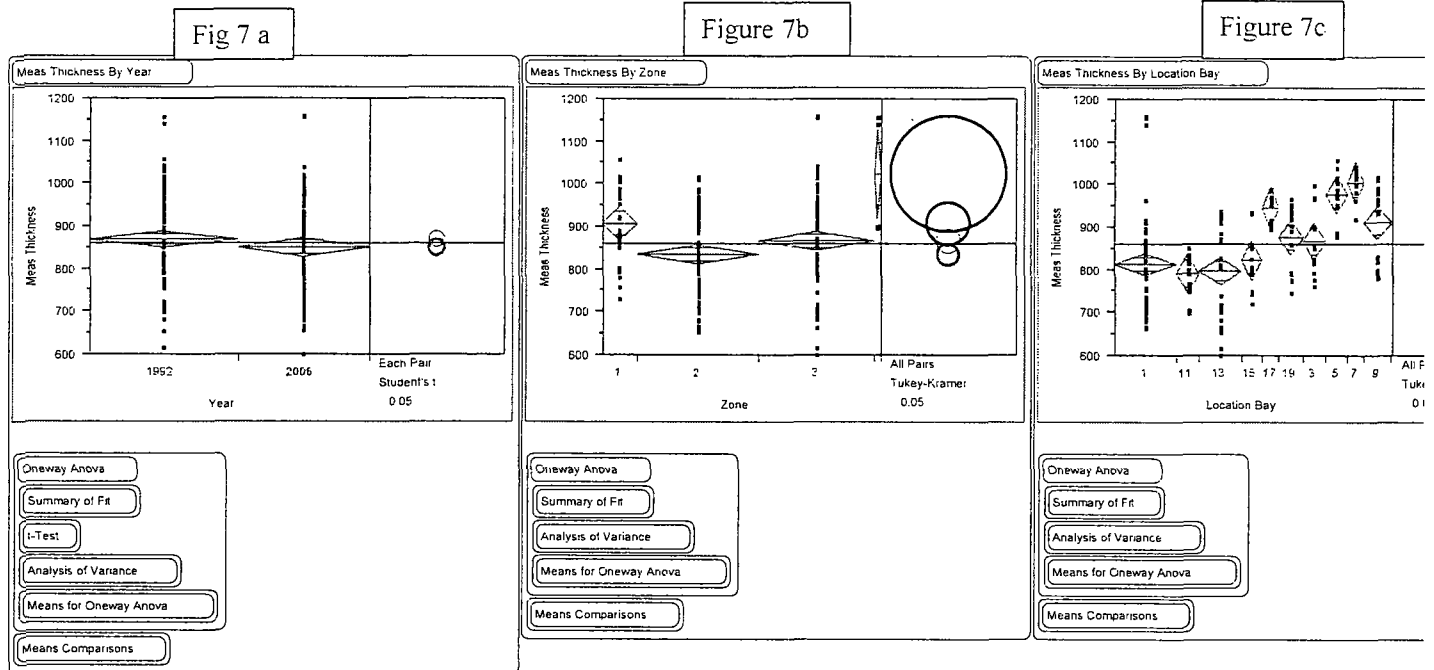
Figure 7

Figure 7a: Comparison between measurements I 1992 and 2006 show no significant difference. The mea 1992 and 2006 show a bias of 0.018 inches, but the bias is statistically not significant despite of the many points. Fig. 7b: The comparison between the "zones" (elevations) is significant. Zones 1 is significantly different from zones 2 and 3. For zone 4 there are not enough data for statistical significance. Fig. 7c: So bays, red ones, are significantly different from the black ones.

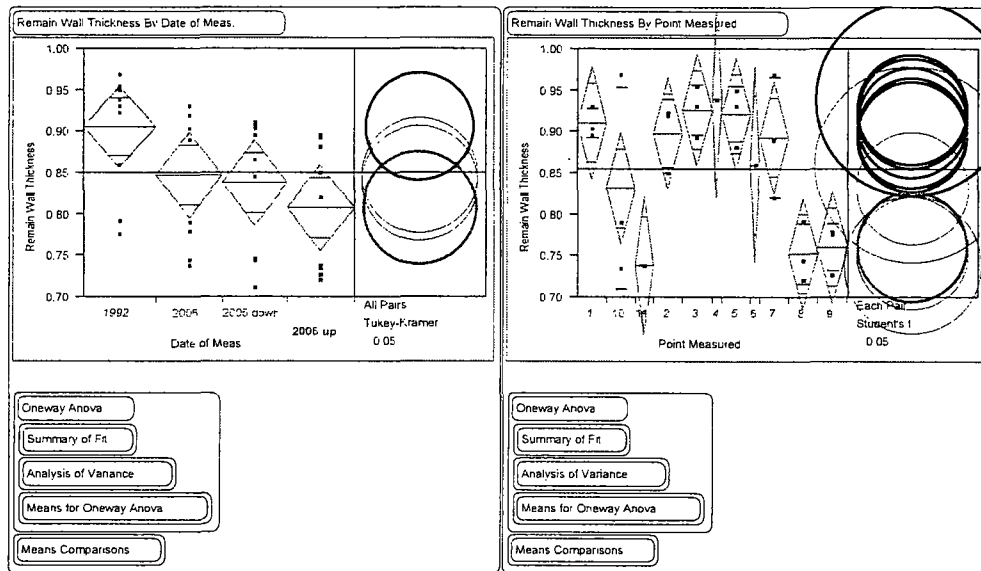
Figure 10: External UT measurements in Bay 19

Again one finds that the “up” measurements are significantly lower from the 1992 measurements.

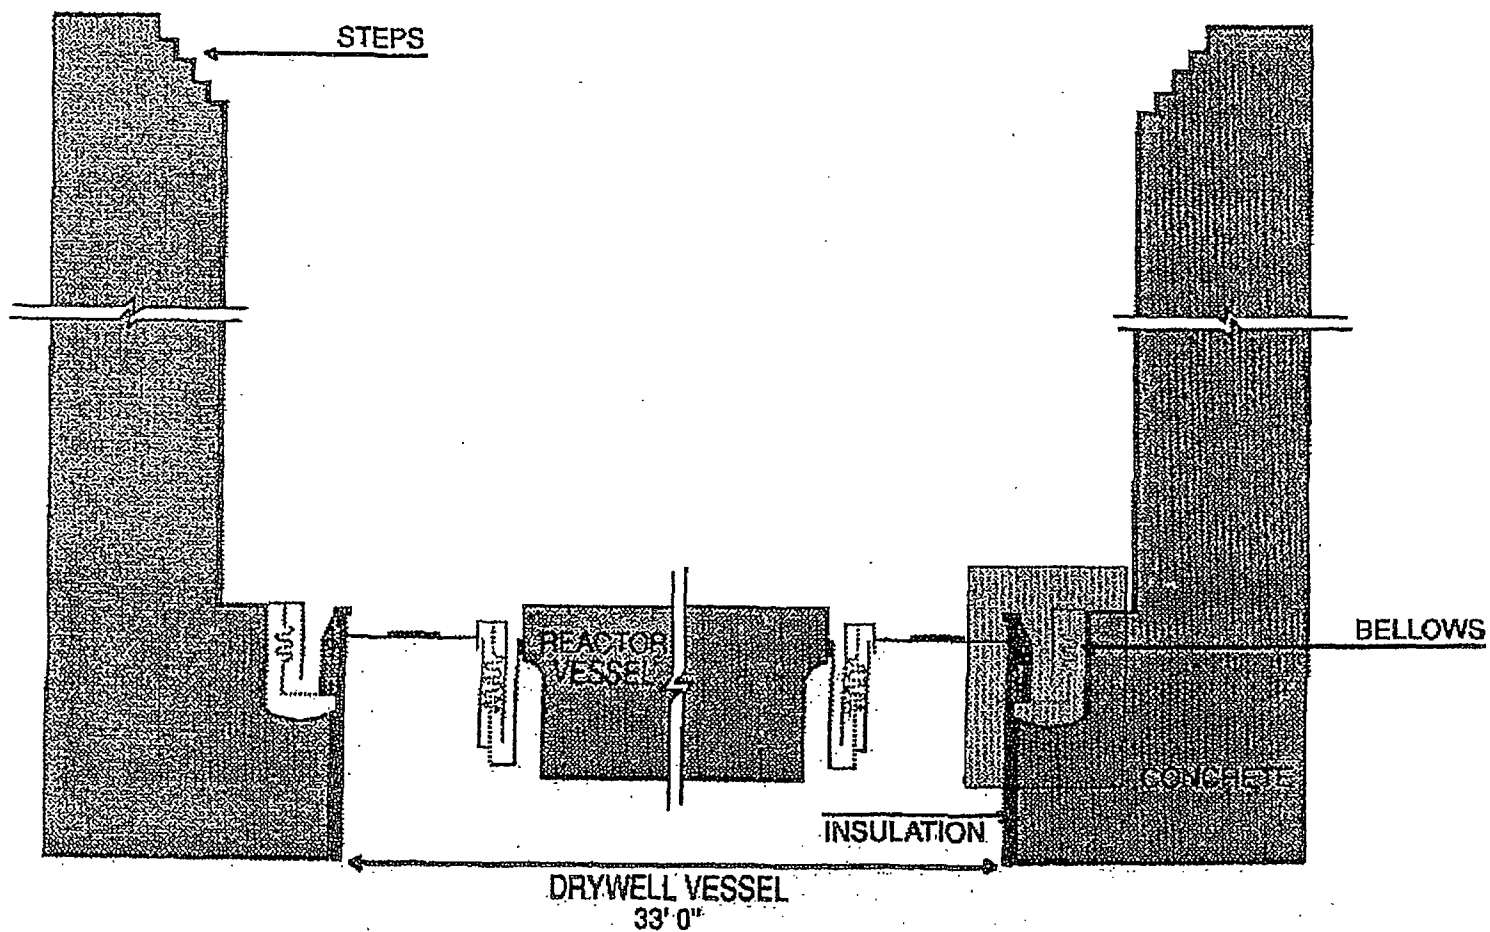
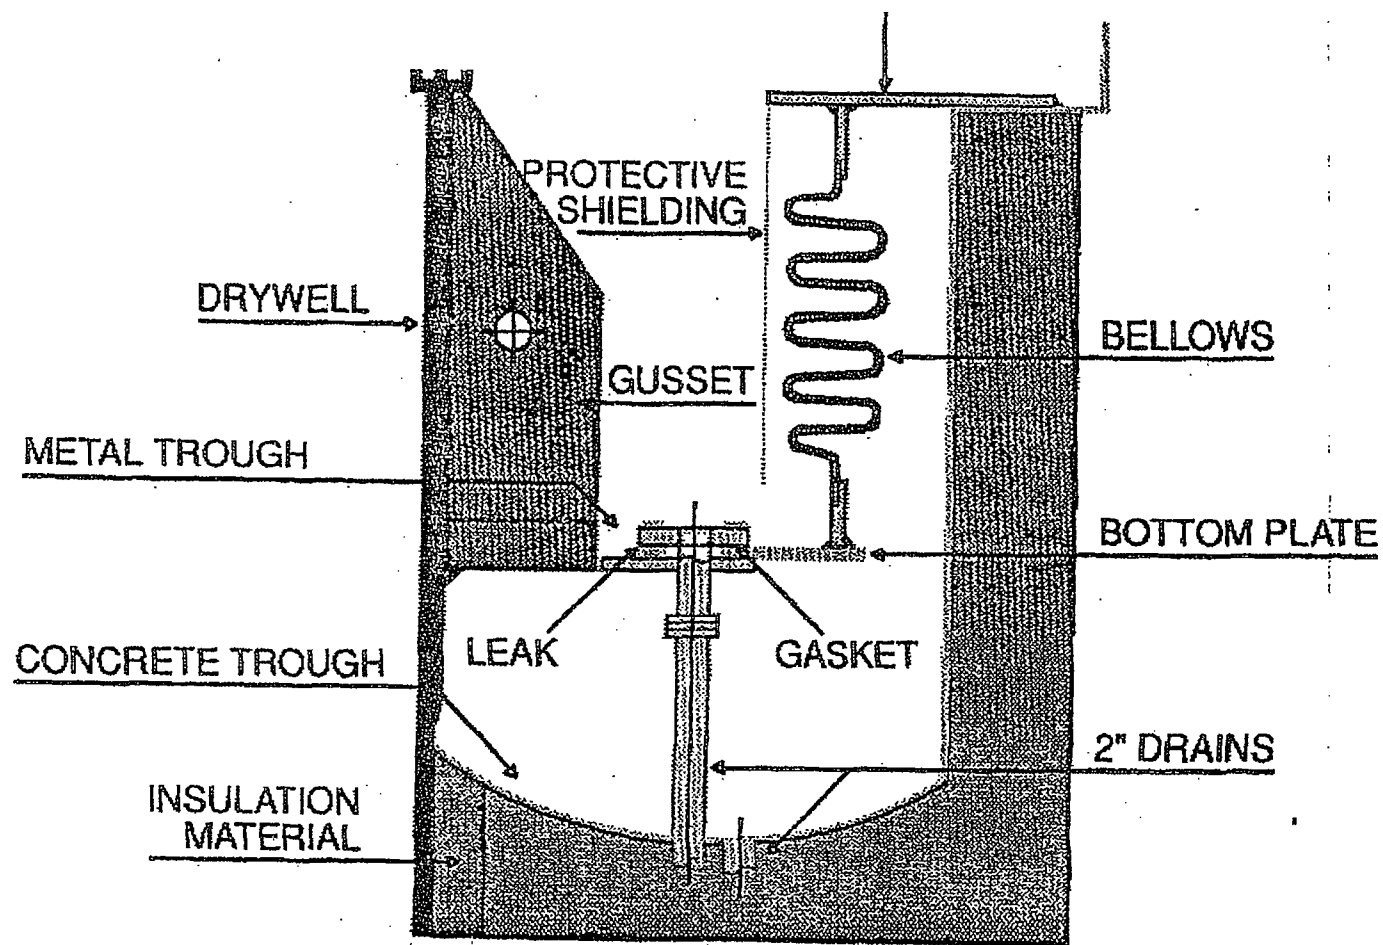
Stains on the equipment pool and reactor cavity walls above elevation 95'-0" do indicate slight corrosion of the reinforcing bar. To determine the potential effect of this corrosion, a compositional analysis of a representative concrete core sample was performed in October, 1988. This analysis indicates that the diameter of a typical reinforcing bar could be expected to be reduced by 0.002 inch/year. The walls in question are reinforced with #8 and #11 reinforcing bar. Therefore, if the corrosion continues, the diameter of the reinforcing bar would be reduced by 8% and 6% respectively over a 40-year period. Since the corrosion is localized, this reduction has no impact on concrete integrity.
