Appendix D2

ESEM and SEM/EDS Data for Test #2, Day-30 Fiberglass in High- and Low-Flow Zones

Appendix D3

ESEM and SEM/EDS Data for Test #2, Day-30 Drain Collar Fiberglass

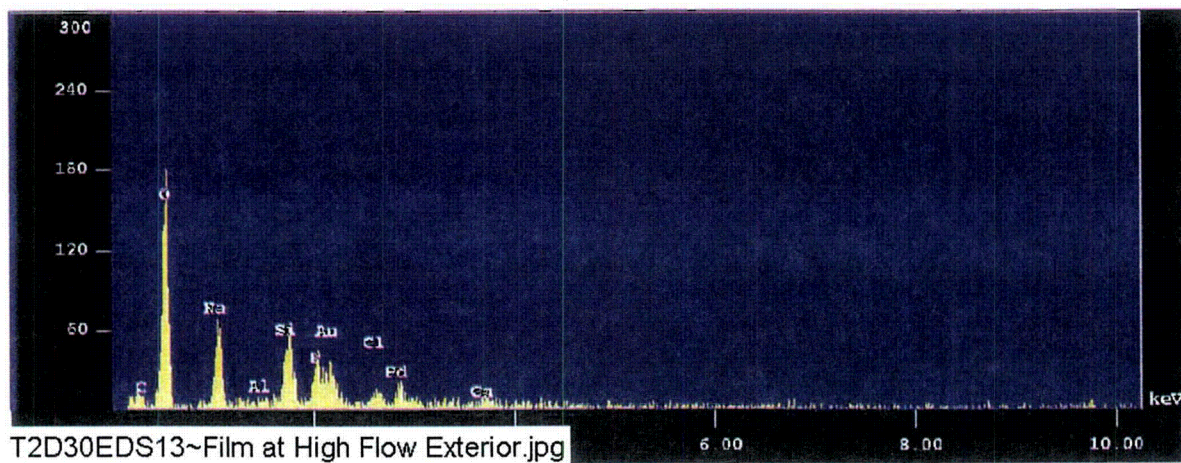
Figure D2-8. EDS counting spectrum for the film deposits or growth on fiberglass, as shown in Figure D2-7. (T2D30EDS13~Film at High Flow Exterior)

The results from the chemical composition analysis for T2D30EDS13 are given in Table D2-1.

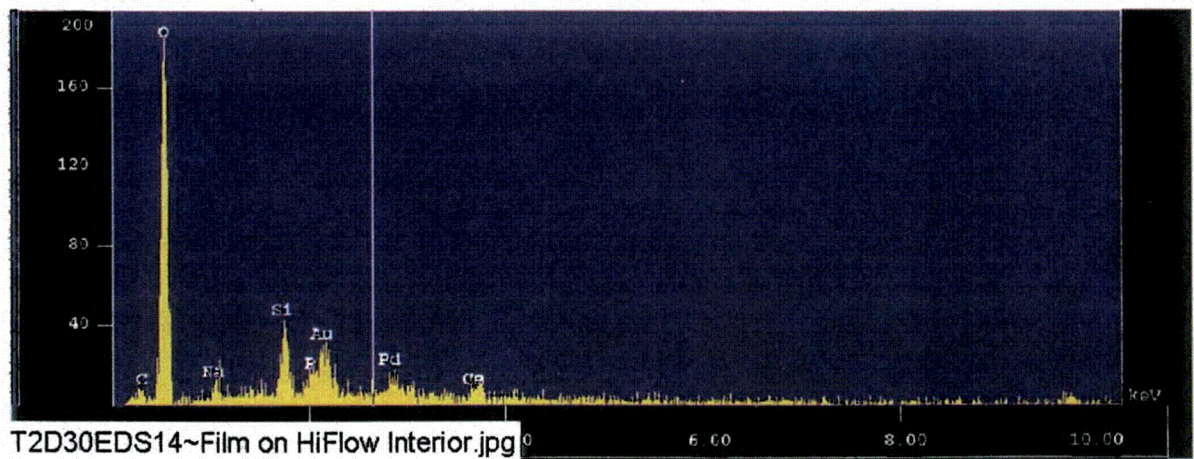
Figure D2-12. EDS counting spectrum for the film deposits or growth on fiberglass, as shown in Figure D2-11. (T2D30EDS14~Film on HiFlow Interior)

The results from the chemical composition analysis for T2D30EDS14 are given in Table D2-2.

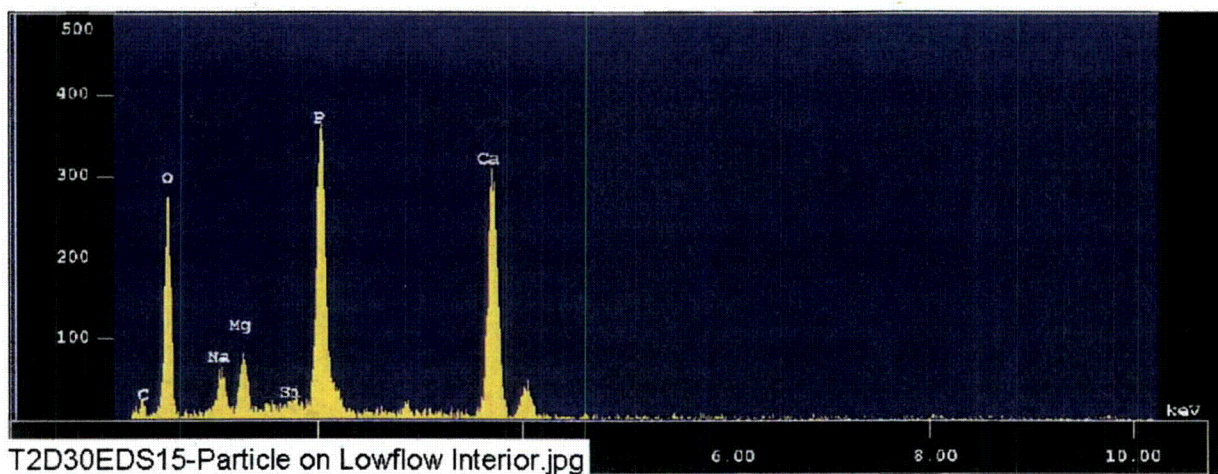
Figure D2-15. EDS counting spectrum for the particulate deposits or growth on fiberglass, as shown in Figure D2-14. (T2D30EDS15-Particle on Lowflow Interior)

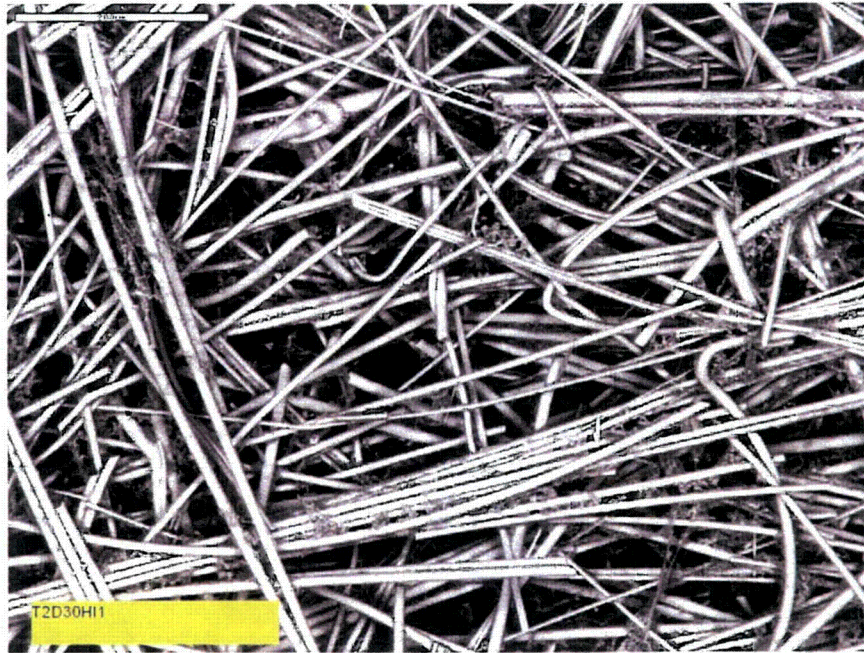
Figure D2-17. ESEM image for a Test #2, Day-30 high-flow interior fiberglass sample. It seems the interior fiberglass is cleaner than exterior fiberglass. (T2D30HI1)

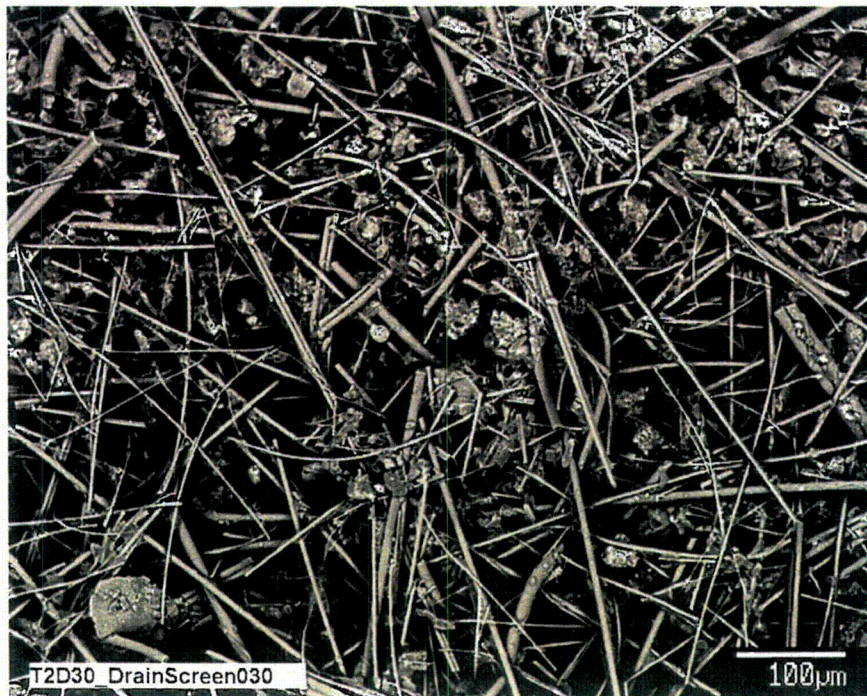
Figure D3-2. Backscattered SEM image for a Test #2, Day-30 fiberglass sample on the drain collar next to the drain screen, illustrating that deposits have a similar atomic number to fiberglass. (T2D30_DrainScreen030)

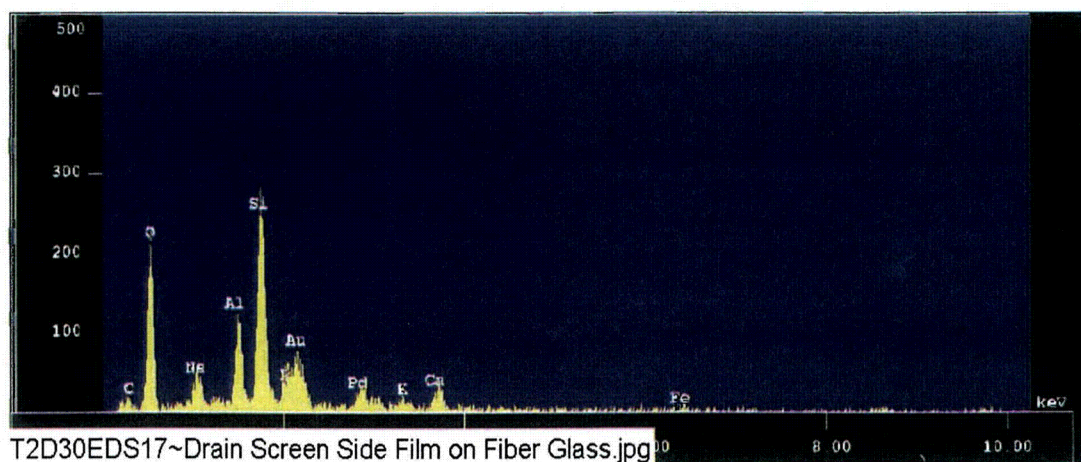
Figure D3-6. EDS counting spectrum for the film between fibers shown in Figure D3-4. The film is rich in silicon, oxygen, aluminum, sodium, and calcium. (T2D30EDS17~Drain Screen Side Film on Fiber Glass)

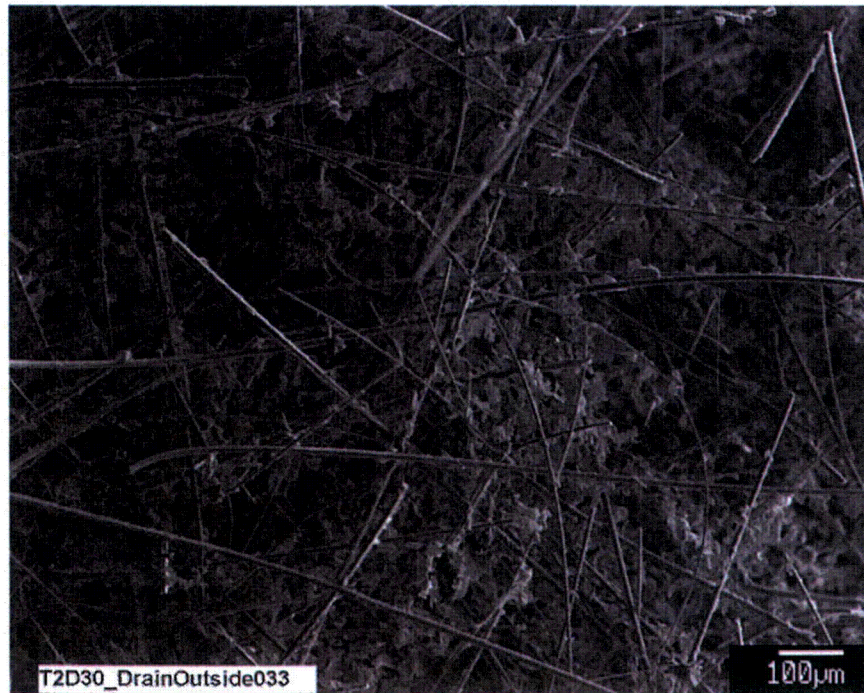
Figure D3-7. SEM image for a Test #2, Day-30 exterior fiberglass sample on the drain collar (away from the drain screen) showing deposits or growth on fiberglass. (T2D30_DrainOutside033)

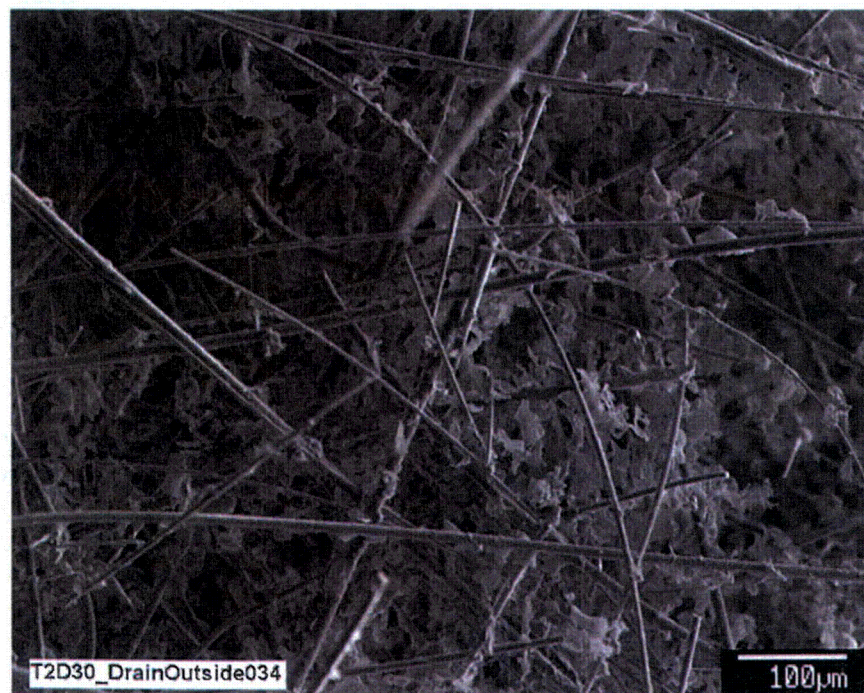
Figure D3-8. SEM image for a Test #2, Day-30 exterior fiberglass sample on the drain collar showing deposits or growth on fiberglass. (T2D30_DrainOutside034)

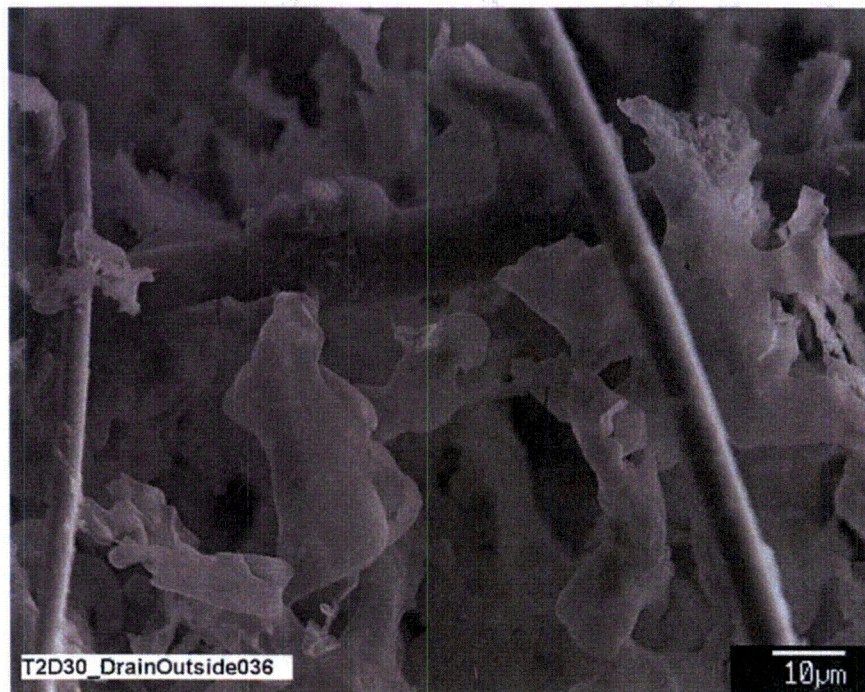
Figure D3-10. SEM image at a higher magnification for a Test #2, Day-30 exterior fiberglass sample on the drain collar showing deposits or growth on fiberglass. (T2D30_DrainOutside 036)

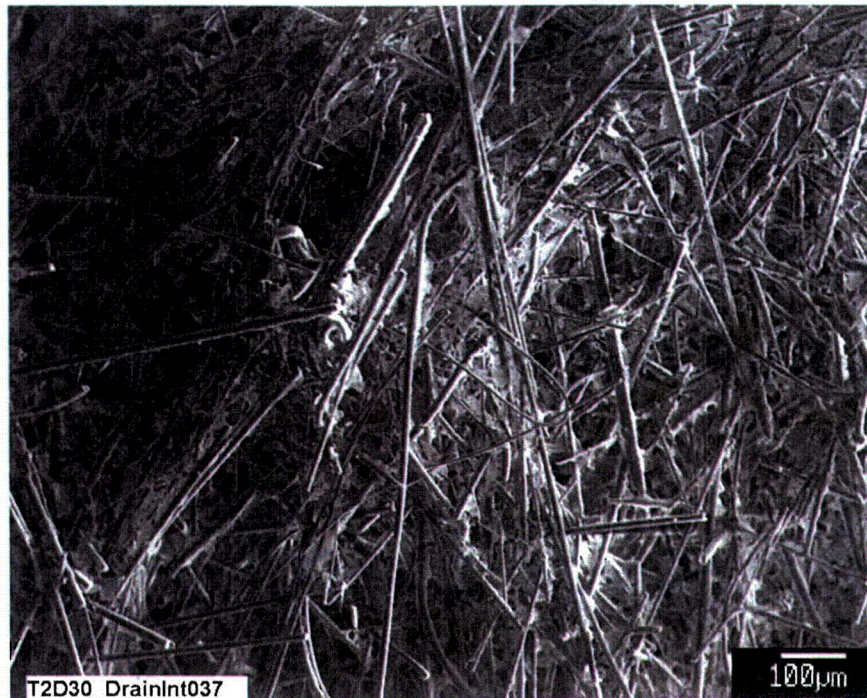
Figure D3-13. SEM image for a Test #2, Day-30 interior fiberglass sample on the drain collar. Image shows deposits or growth on fiberglass. (T2D30_DrainInt037)

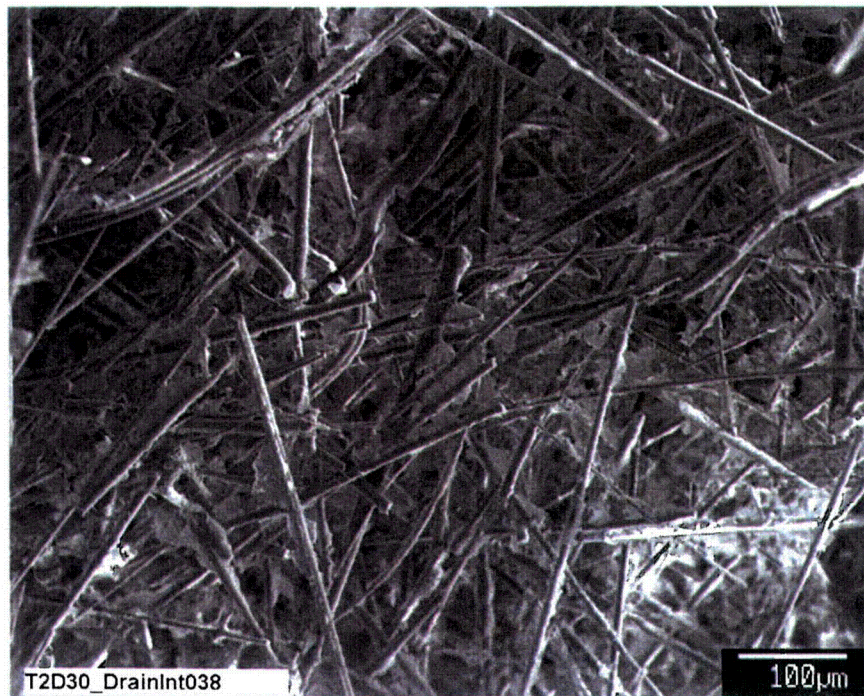
Figure D3-14. SEM image for a Test #2, Day-30 interior fiberglass sample on the drain collar. Image shows deposits or growth on fiberglass. (T2D30_DrainInt038)

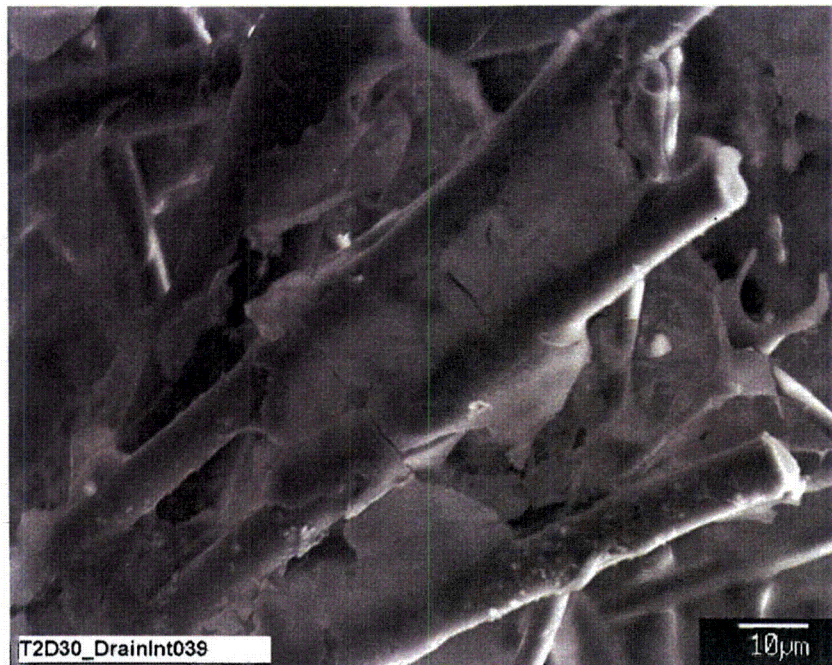
Figure D3-15. SEM image of a higher magnification for a Test #2, Day-30 interior fiberglass sample on the drain collar. The image shows deposits or growth on fiberglass. (T2D30_DrainInt039)

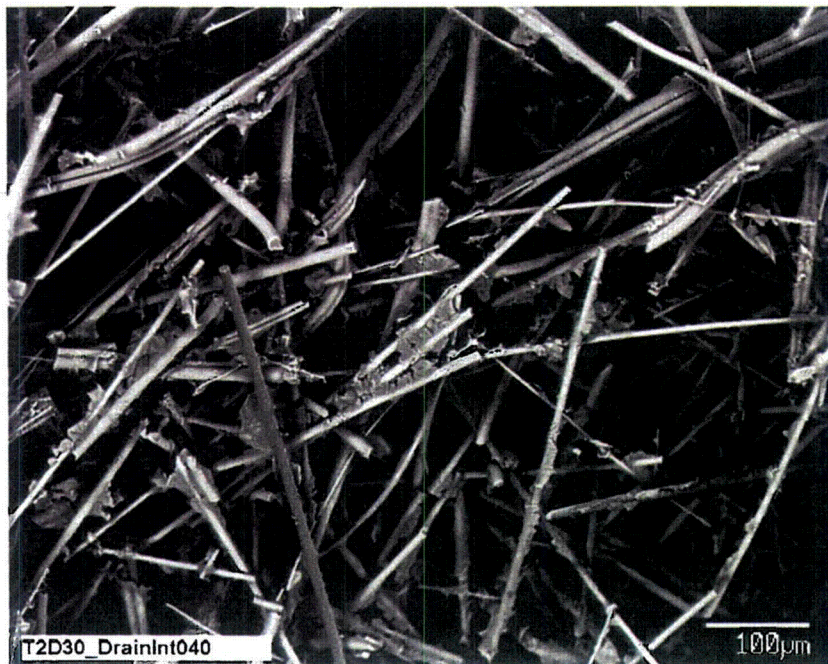
Figure D3-16. Backscattered SEM image for a Test #2, Day-30 interior fiberglass sample on the drain collar. Deposits appear to have a similar or lower atomic number as compared with fiberglass. (T2D30_DrainInt040)

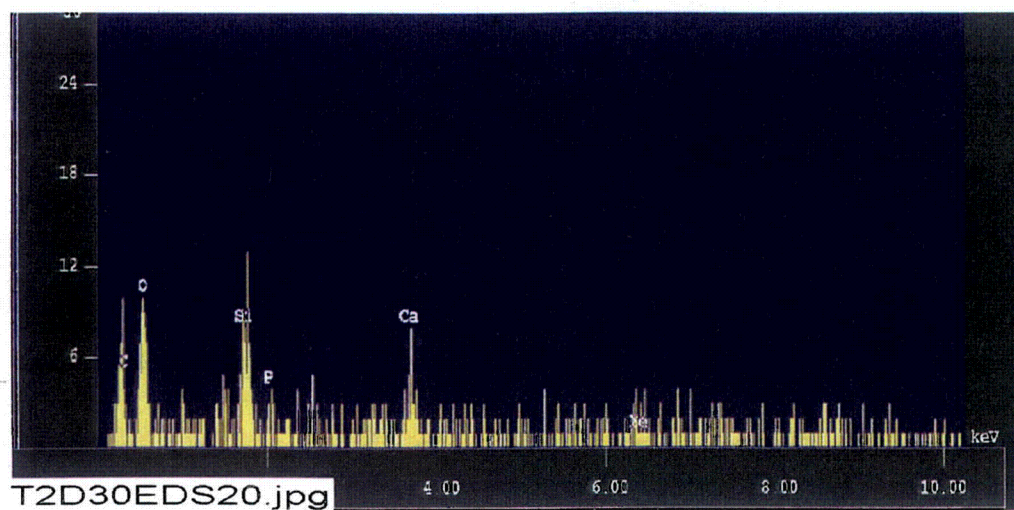
Figure D3-17. EDS counting spectrum for the deposits or growth on fiberglass. The deposits are rich in silicon, carbon, oxygen, and calcium. The deposits are very thin, and thus it was difficult to obtain high-quality EDS spectra. (T2D30EDS20)

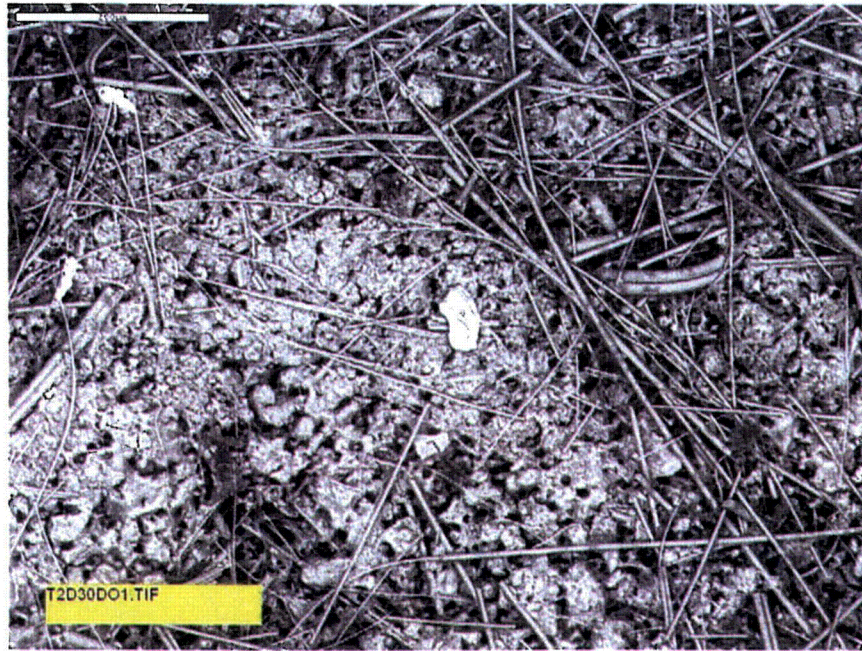
Figure D3-18. ESEM image for a Test #2, Day-30 exterior fiberglass sample on the drain collar. Image shows particulate deposits or growth on fiberglass. (T2D30DO1)

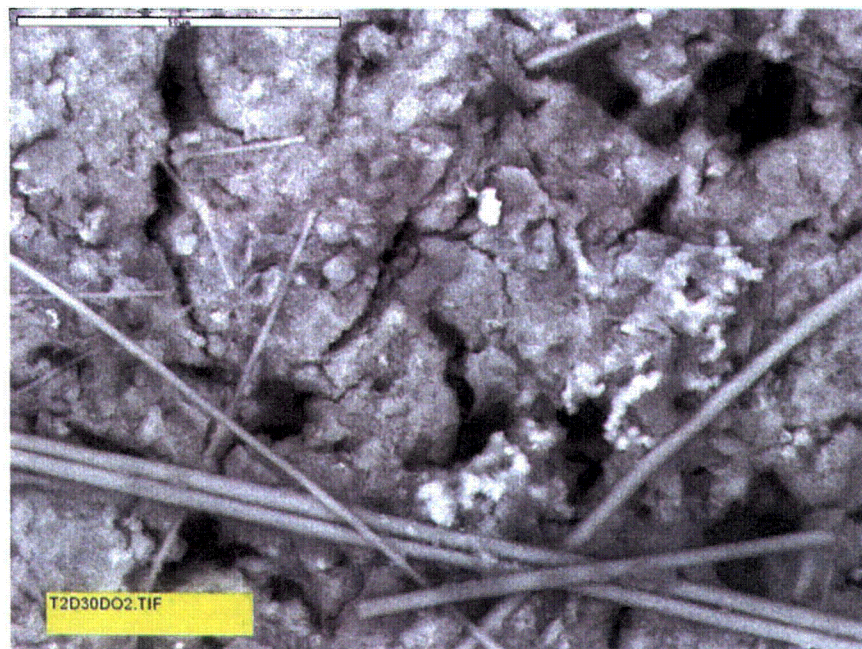
Figure D3-19. ESEM image of a higher magnification for a Test #2, Day-30 exterior fiberglass sample on the drain collar. The image shows particulate deposits or growth on fiberglass. (T2D30DO2)

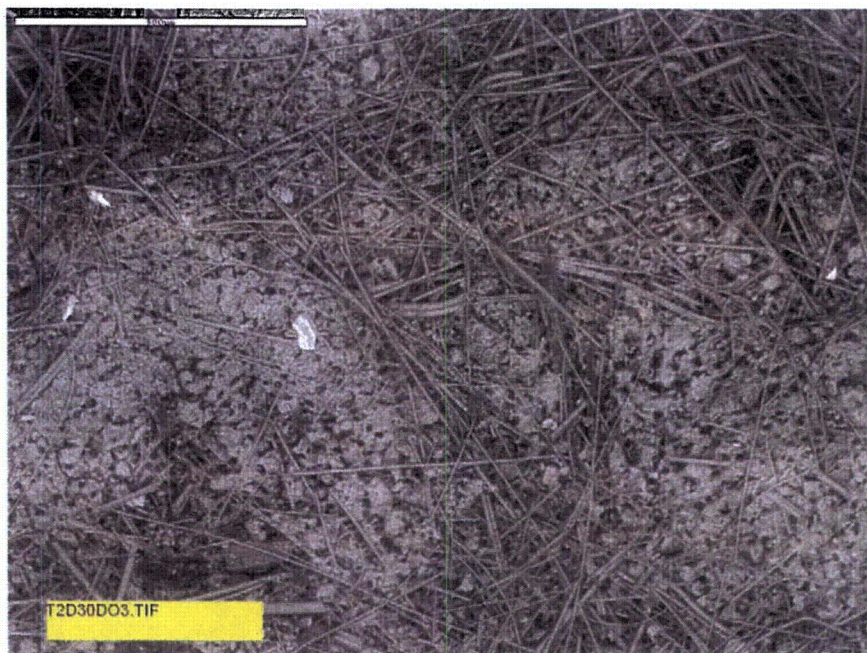
Figure D3-20. ESEM image for a Test #2, Day-30 exterior fiberglass sample on the drain collar. Image shows particulate deposits or growth on fiberglass. (T2D30DO3)

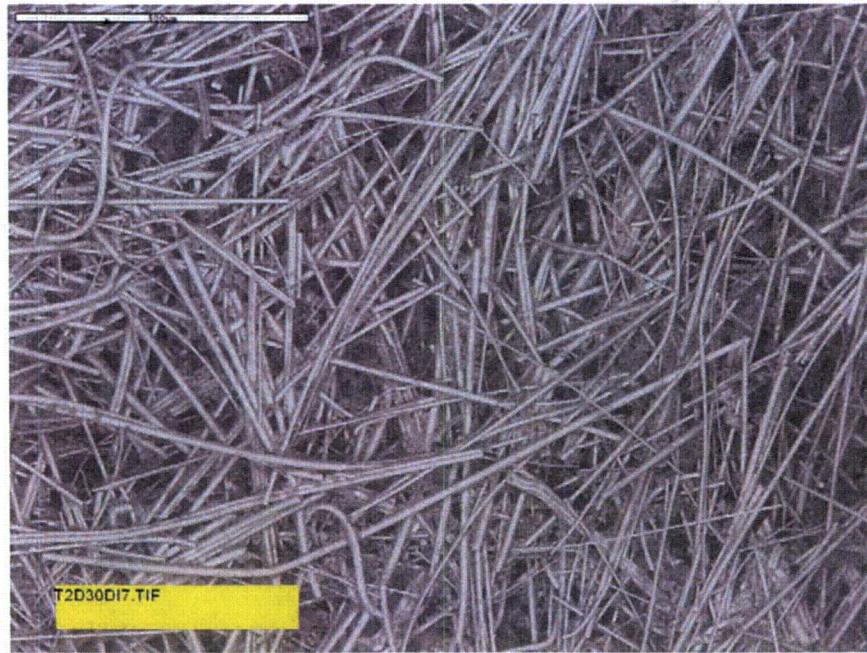
Figure D3-24. ESEM image for a Test #2, Day-30 interior fiberglass sample on the drain collar. Image suggests that interior fiberglass was relatively clean as compared with exterior. (T2D30DI7)

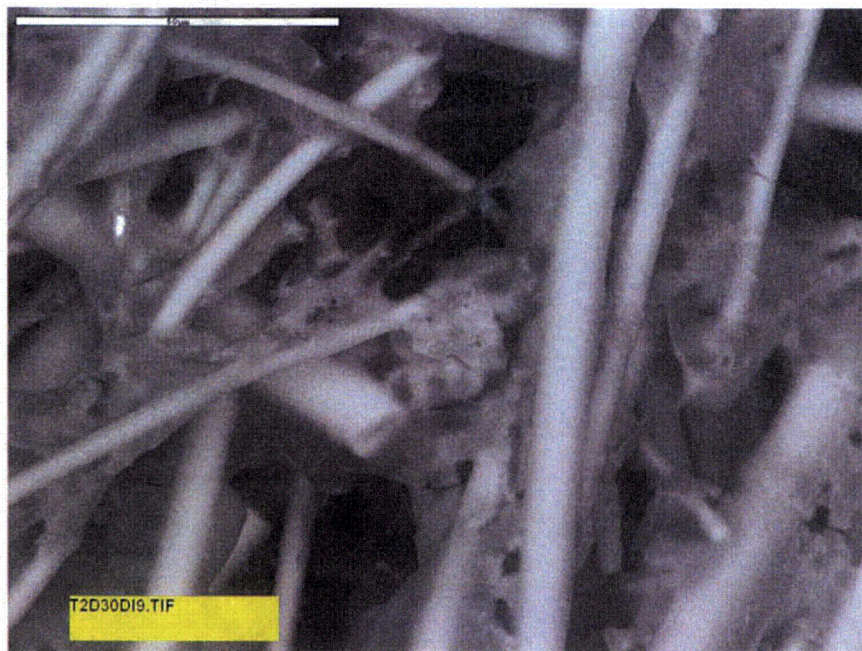
Figure D3-26. ESEM image of a higher magnification for a Test #2, Day-30 interior fiberglass sample on the drain collar. The image shows deposits or growth on the interior fiberglass, although the quantity was less than for exterior samples. (T2D30DI9)

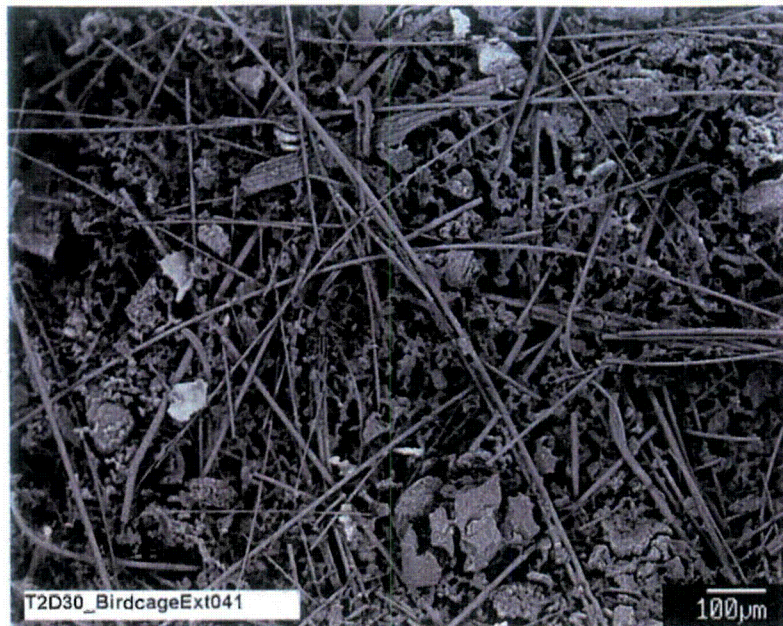
Figure D4-1. SEM image for a Test #2, Day-30 exterior fiberglass sample within the birdcage. The image shows particulate deposits or growth on fiberglass. (TD30_BirdcageExt041)

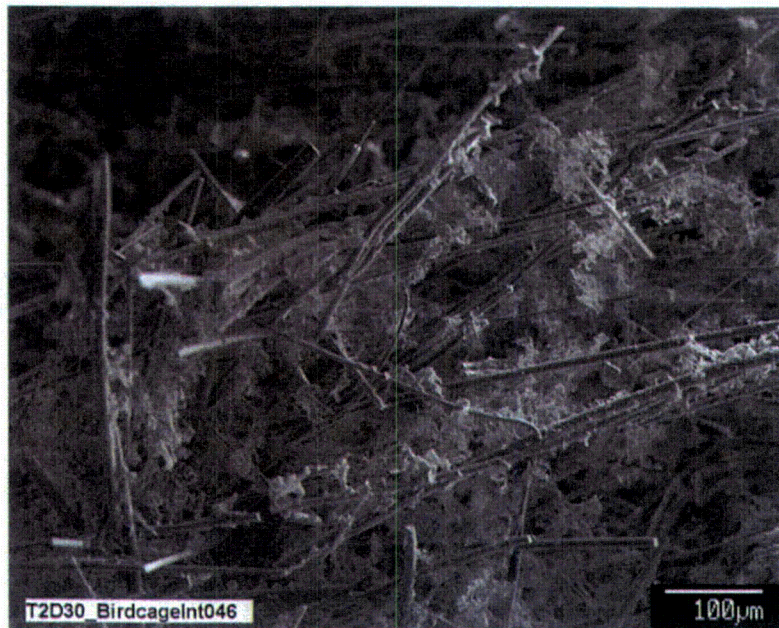
Figure D4-9. SEM image for a Test #2, Day-30 interior fiberglass sample within the birdcage. The image shows deposits or growth on the fiberglass. (T2D30_BirdcageInt046)

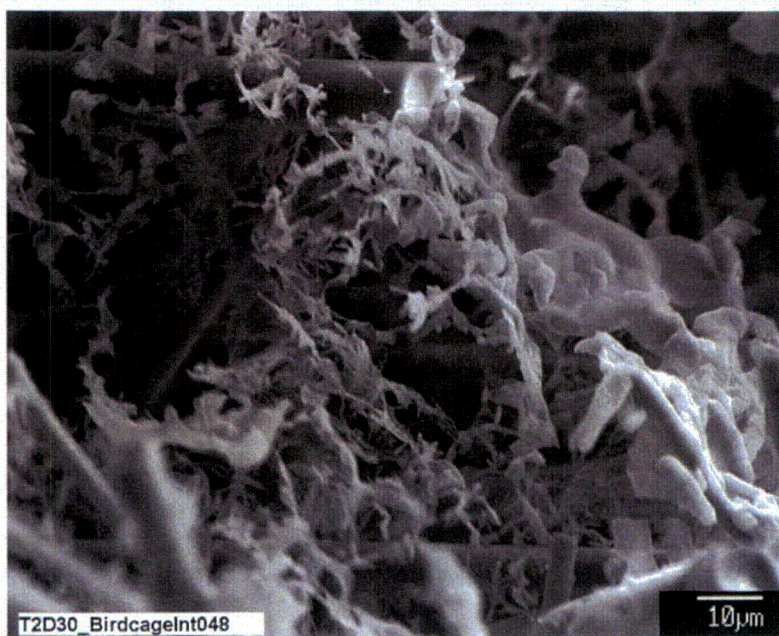
Figure D4-11. SEM image of a higher magnification for a Test #2, Day-30 interior fiberglass sample within the birdcage. The image shows deposits or growth on the fiberglass. (T2D30_BirdcageInt048)
