From: "Sanchez, Edward" <esanch1@entergy.com>
To: "Perry Buckberg" <PHB1@nrc.gov>
Date: 8/27/2007 10:48:03 AM
Subject: Copy of Pilgrim ACRS slides

Pilgrim Nuclear Power Station

License Renewal ACRS
September 6, 2007

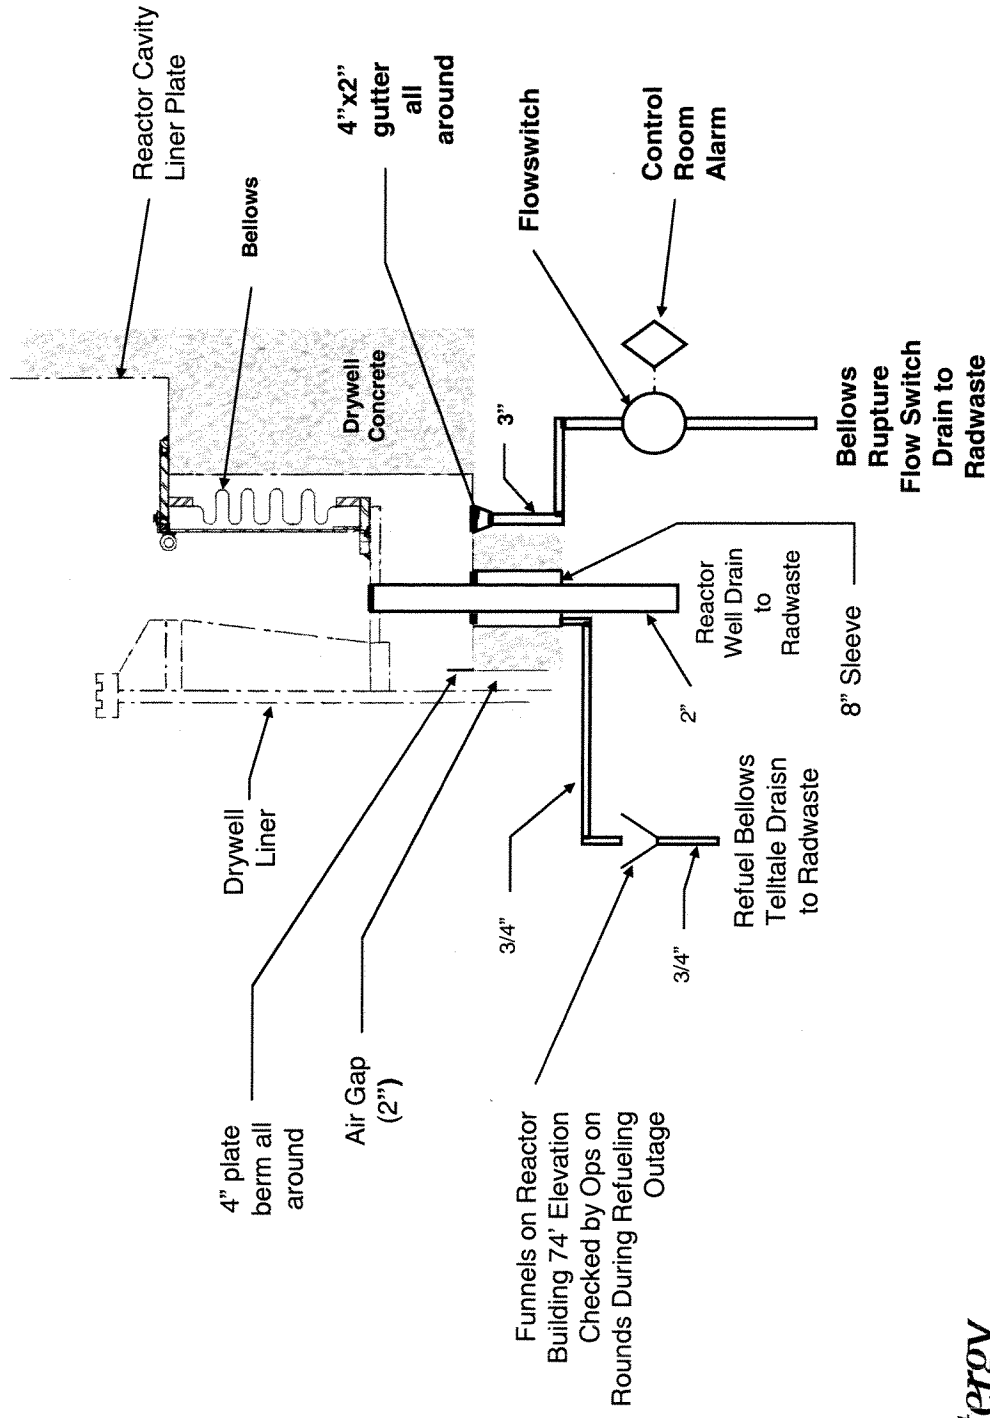
3" instrumented drain line alarms in control room

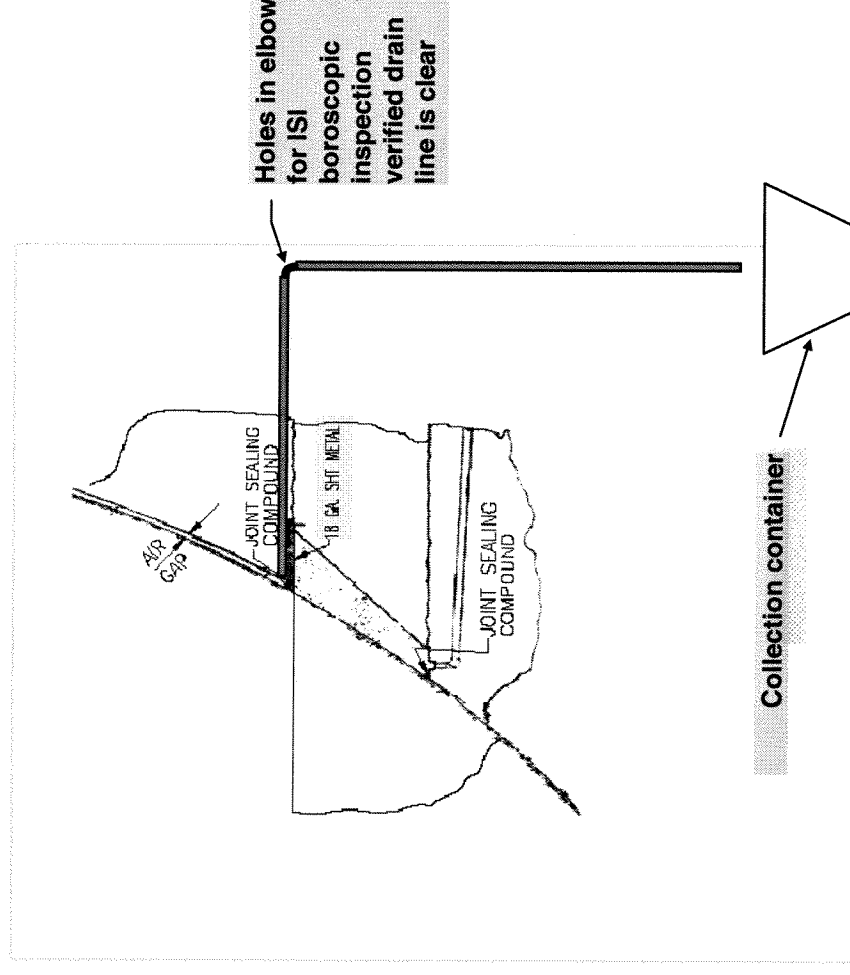
Four 4" upper sand cushion drains
drain into collection devices and are
monitored at beginning and end of each RFO

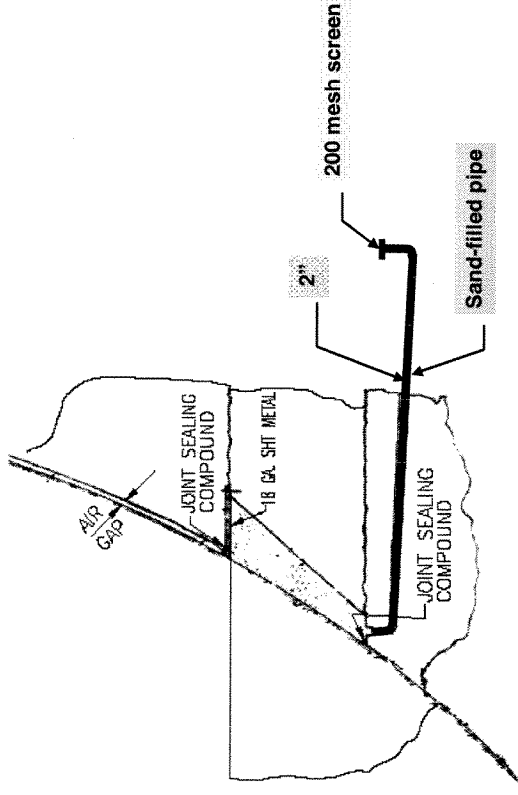
Four sand cushion drains provide further detection capabilities

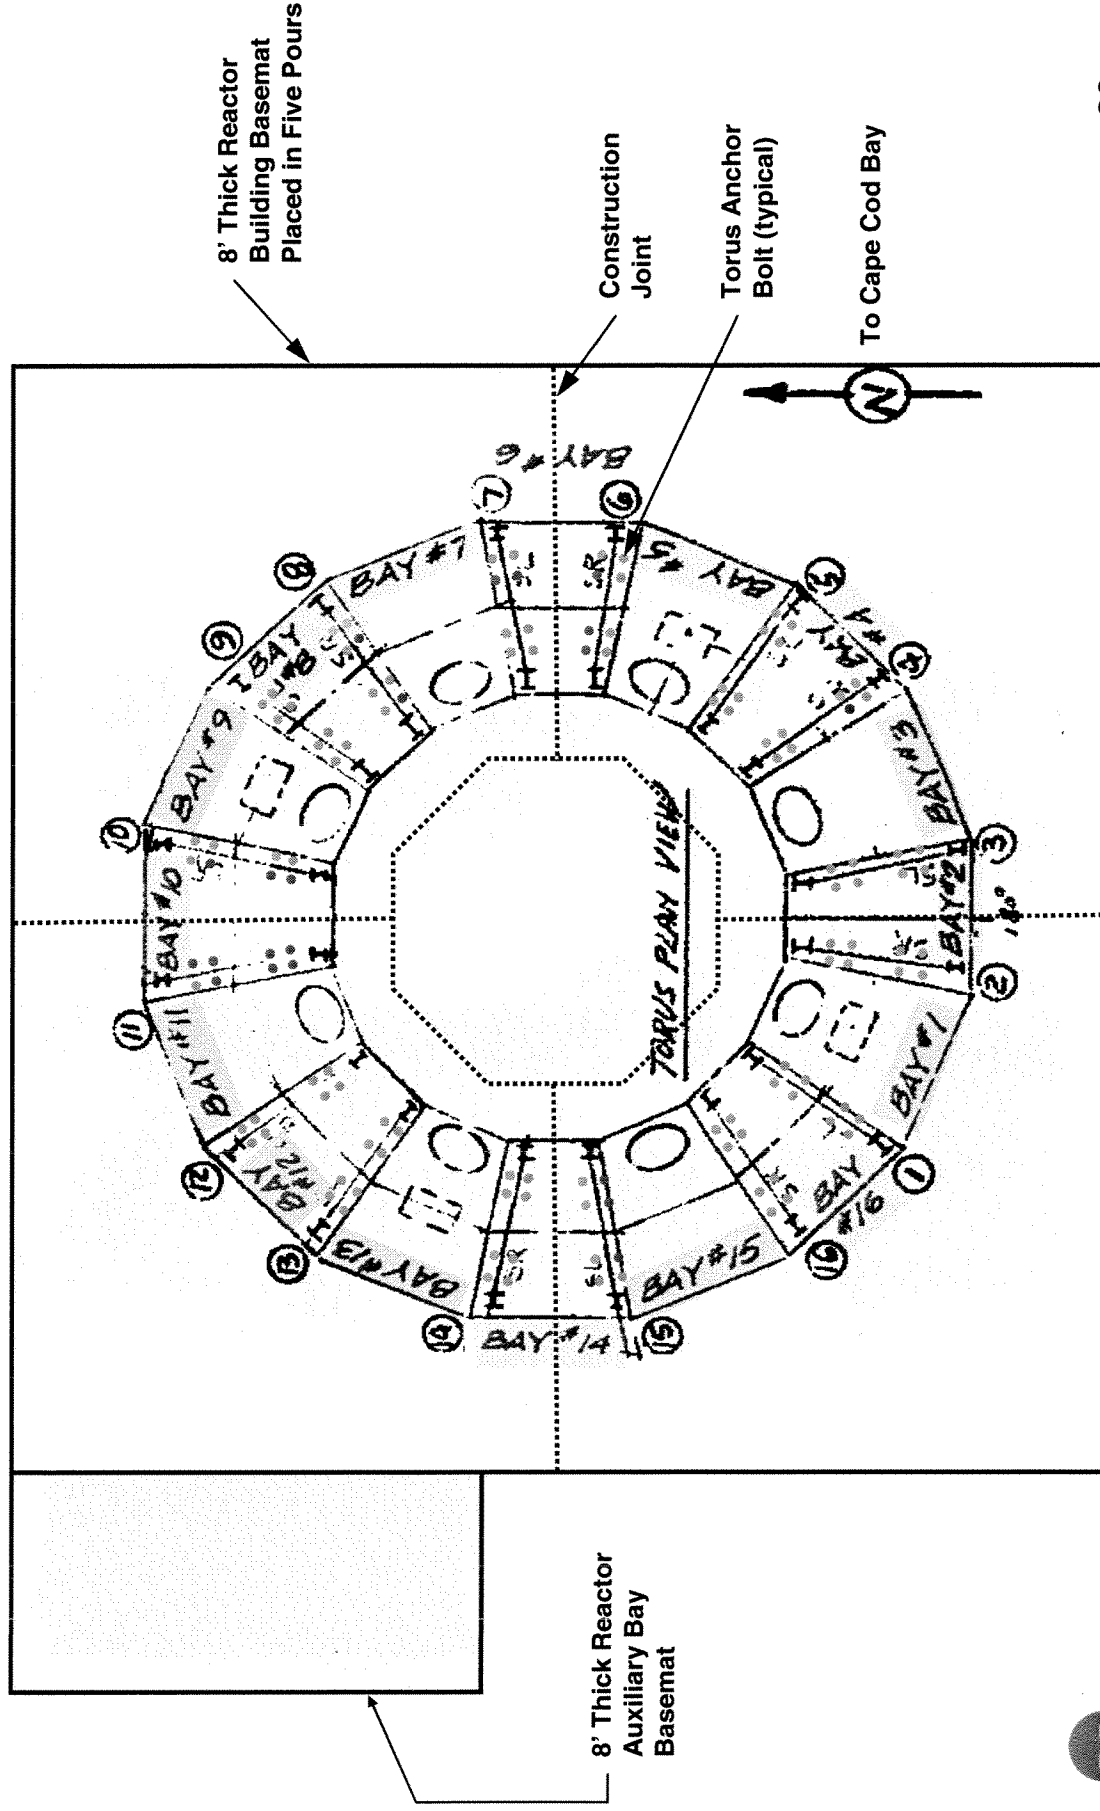
Torus Room Floor

- The source is ground water seepage under hydraulic pressure
- Path is through vertical joints and zones most likely weakened by tensions generated during setting and hydration following the construction (normal occurrence)
- Low seepage rate is counteracted by evaporation
- Non-aggressive, benign water chemistry

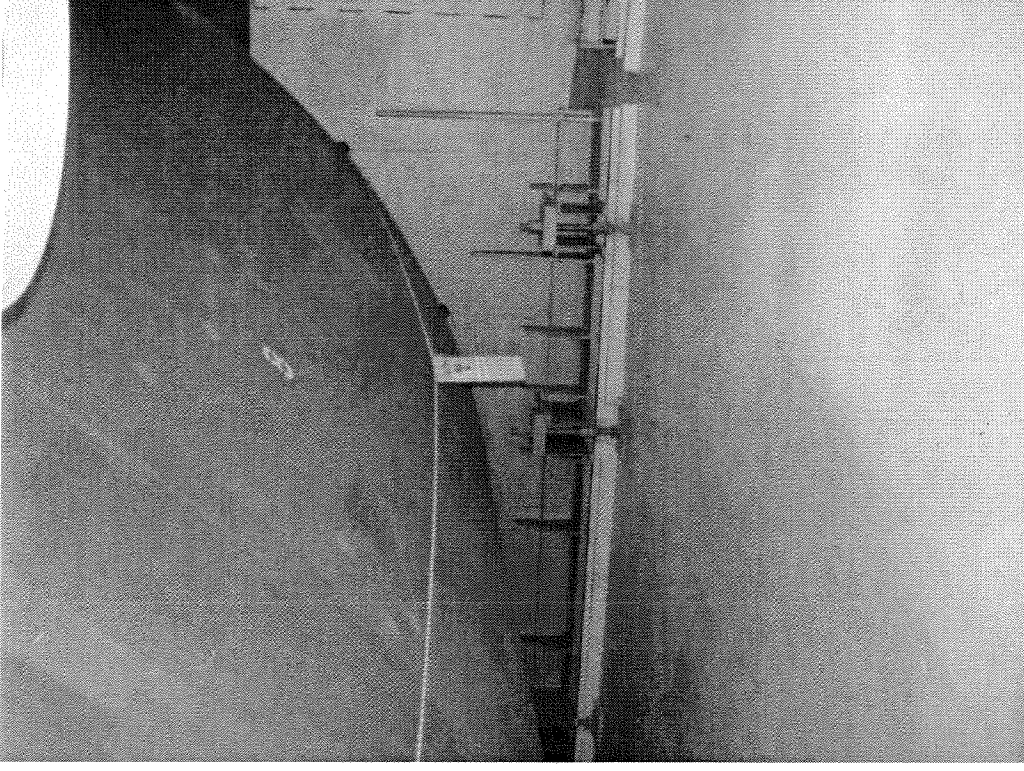
Bay 8

Bay 8: Typically dry (1 bolt inspected)

No degradation of bolt or grout

- Determine additional actions based on inspection of bolts and water analysis, prior to the period of extended operation
- Monitor chemistry of groundwater, every five years
- Monitor chemistry of water on floor
 - Prior to the period of extended operation, and
 - Once every five years during the period of extended operation
- Inspect Structure in accordance with Structures Monitoring Program, every five years

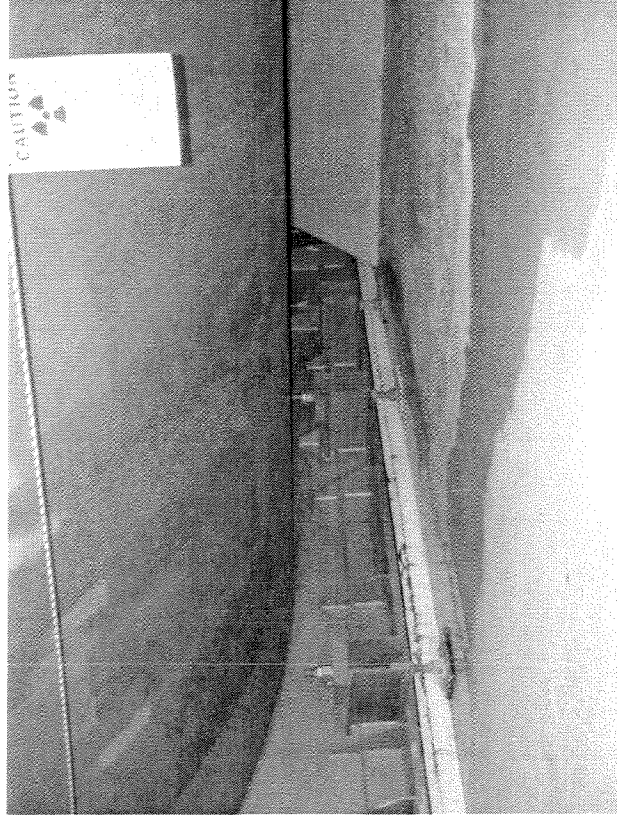
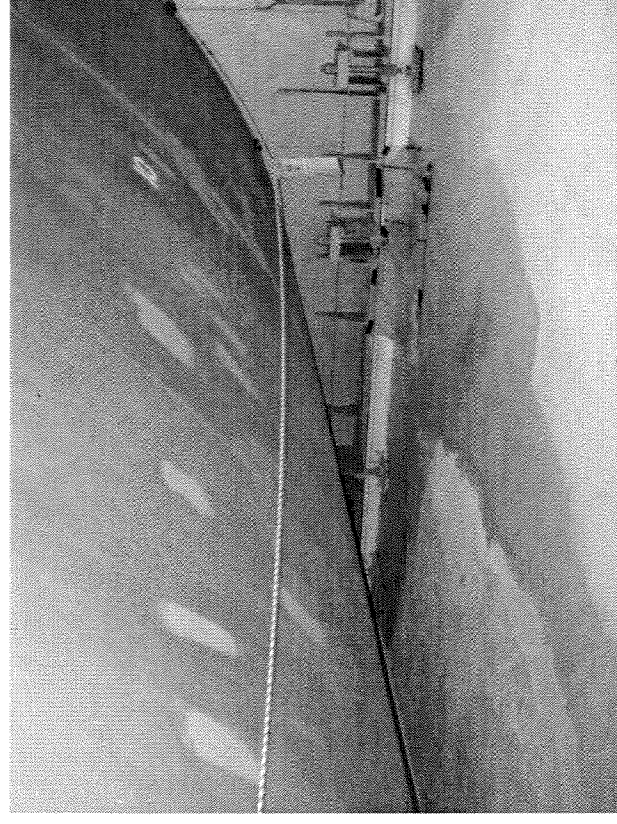
Bay 10

Bay 10: Typically wet (4 bolts inspected)
