**UNITED STATES
NUCLEAR REGULATORY COMMISSION**
REGION II
245 PEACHTREE CENTER AVENUE NE, SUITE 1200
ATLANTA, GEORGIA 30303-1257

October 12, 2010

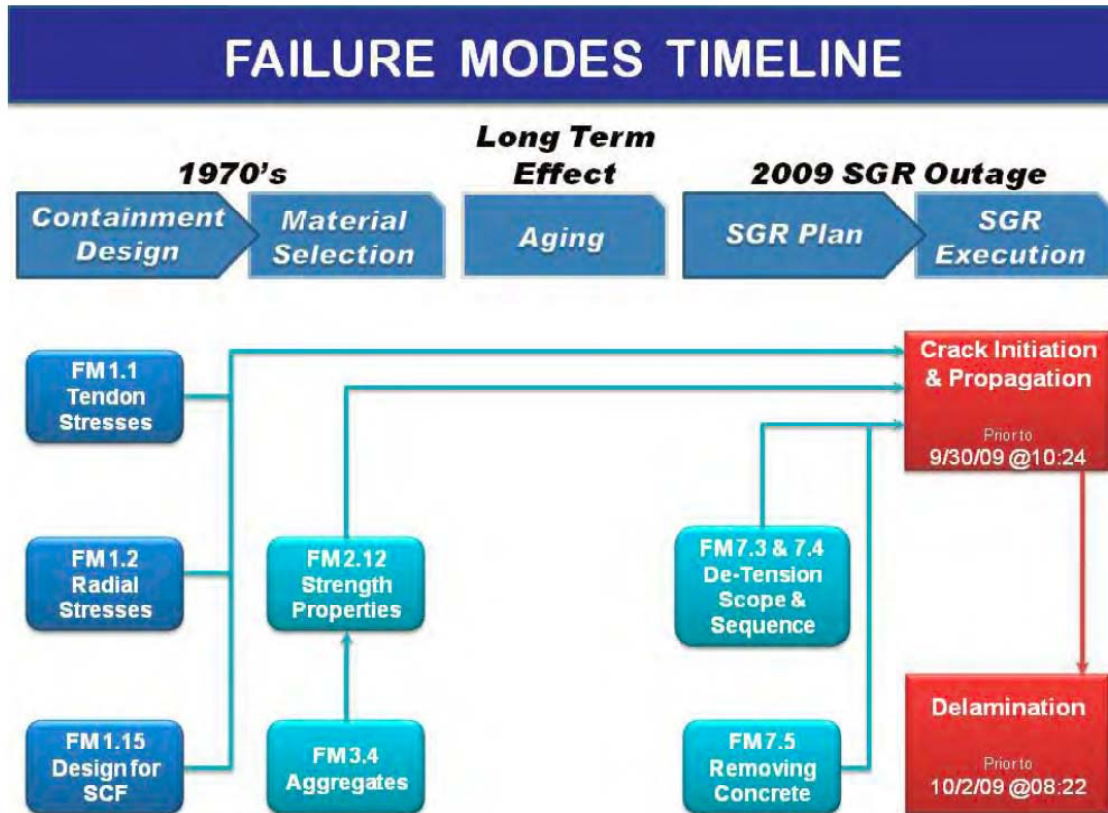
Figure 5.2.3 Failure Modes Timeline

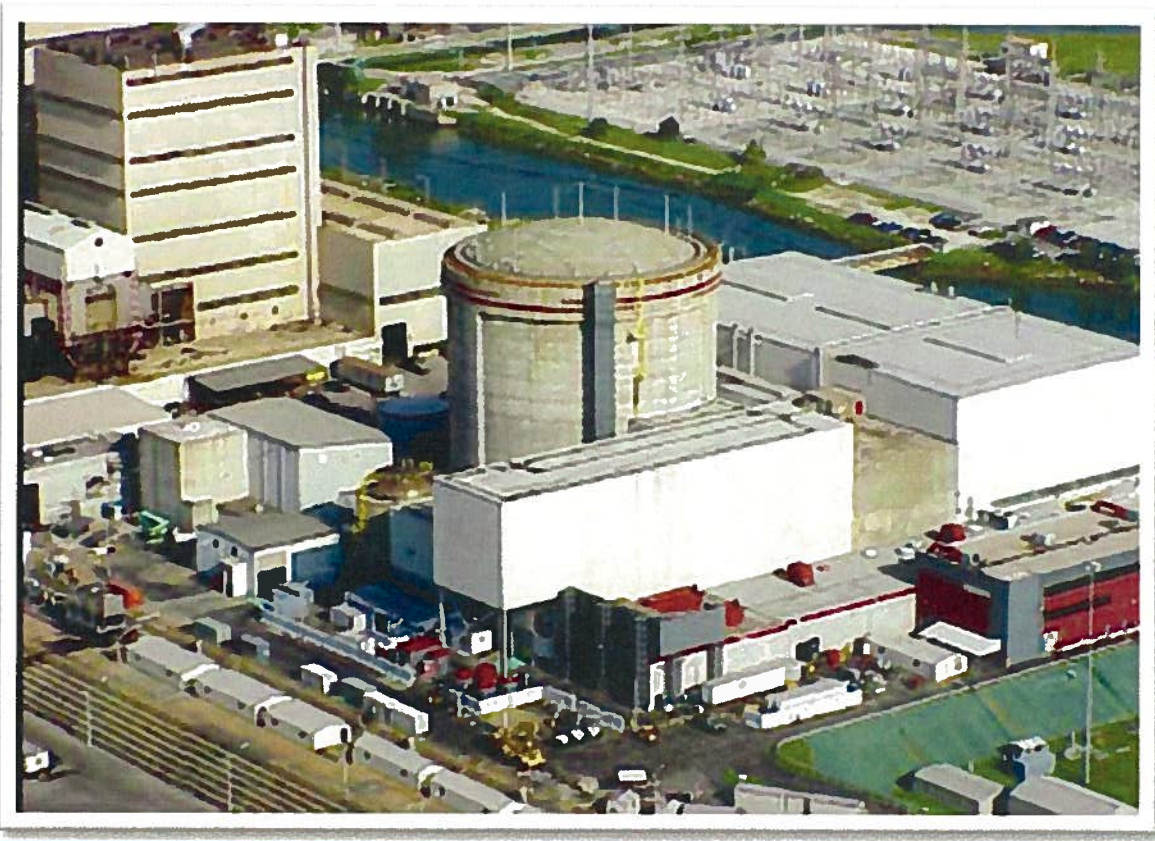
ROOT CAUSE ASSESSMENT CRYSTAL RIVER UNIT 3 CONTAINMENT CONCRETE DELAMINATION

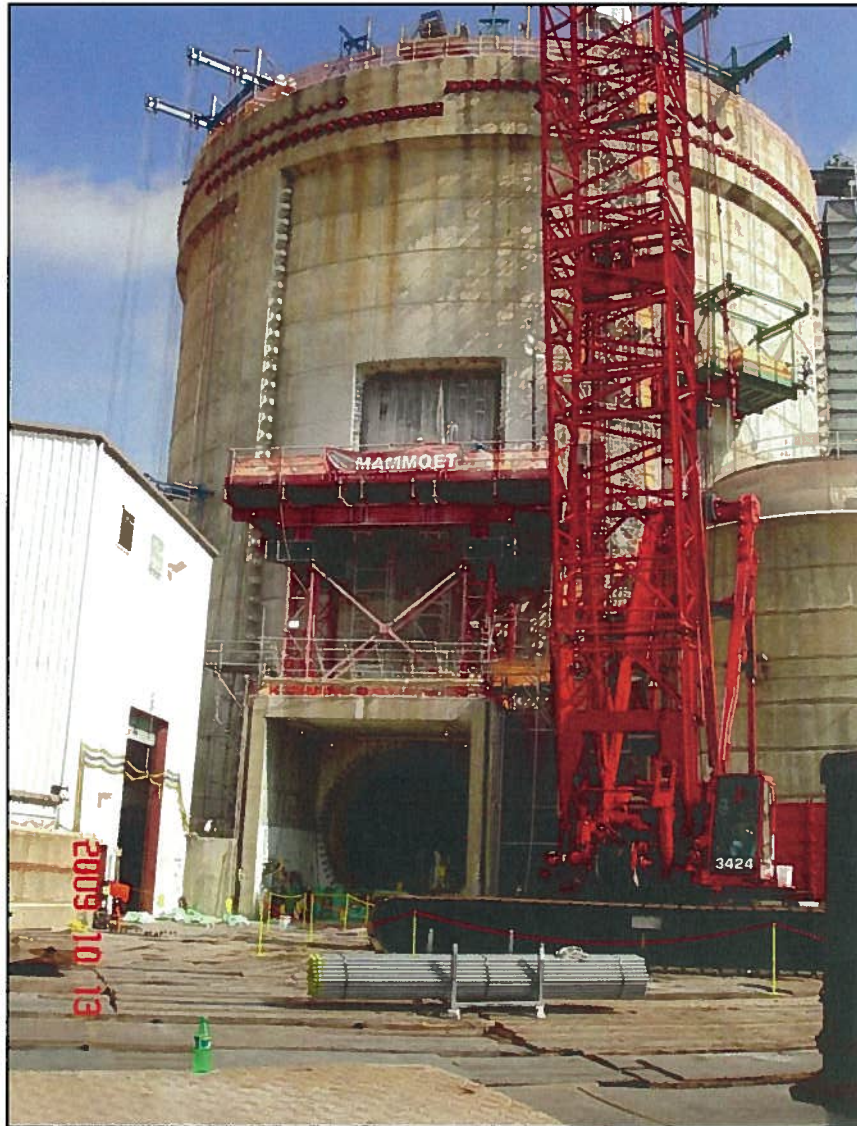
Figure 1.1 Photograph of the steam generator opening worksite.
Note the newly constructed rectangular opening above the existing circular equipment hatch.

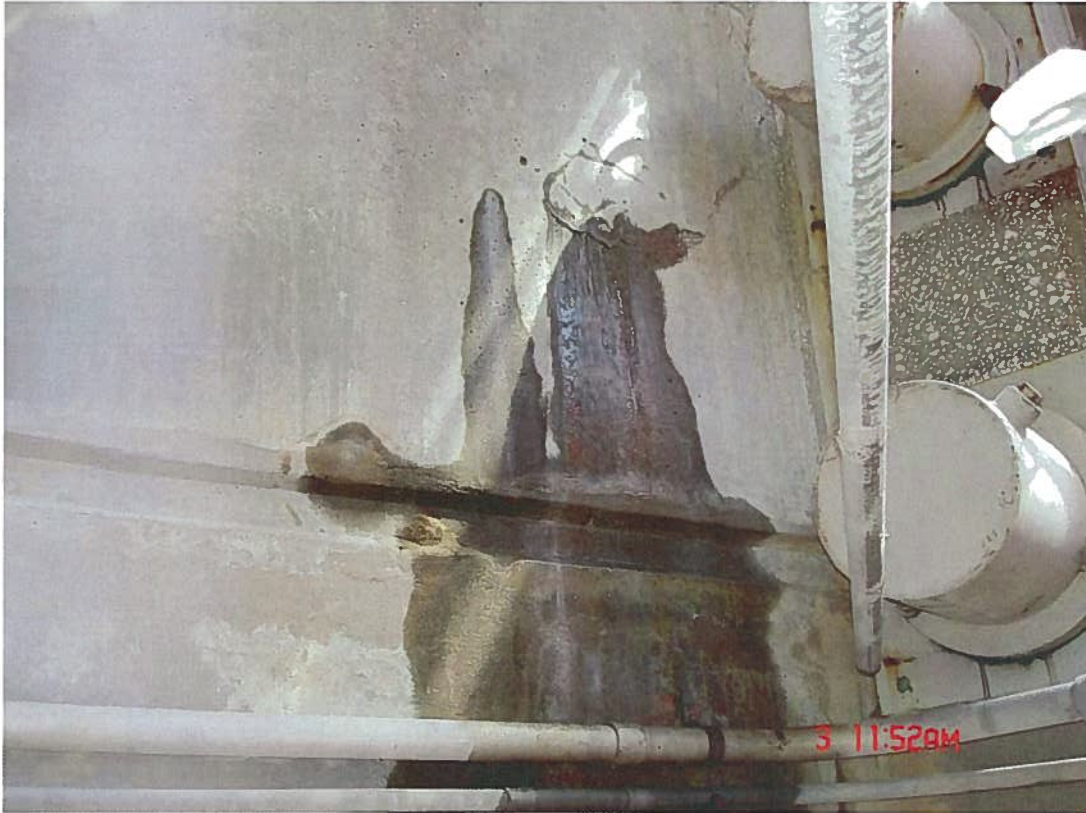
Figure 1.2 Photograph of water leakage from the containment wall (10/3/2009).

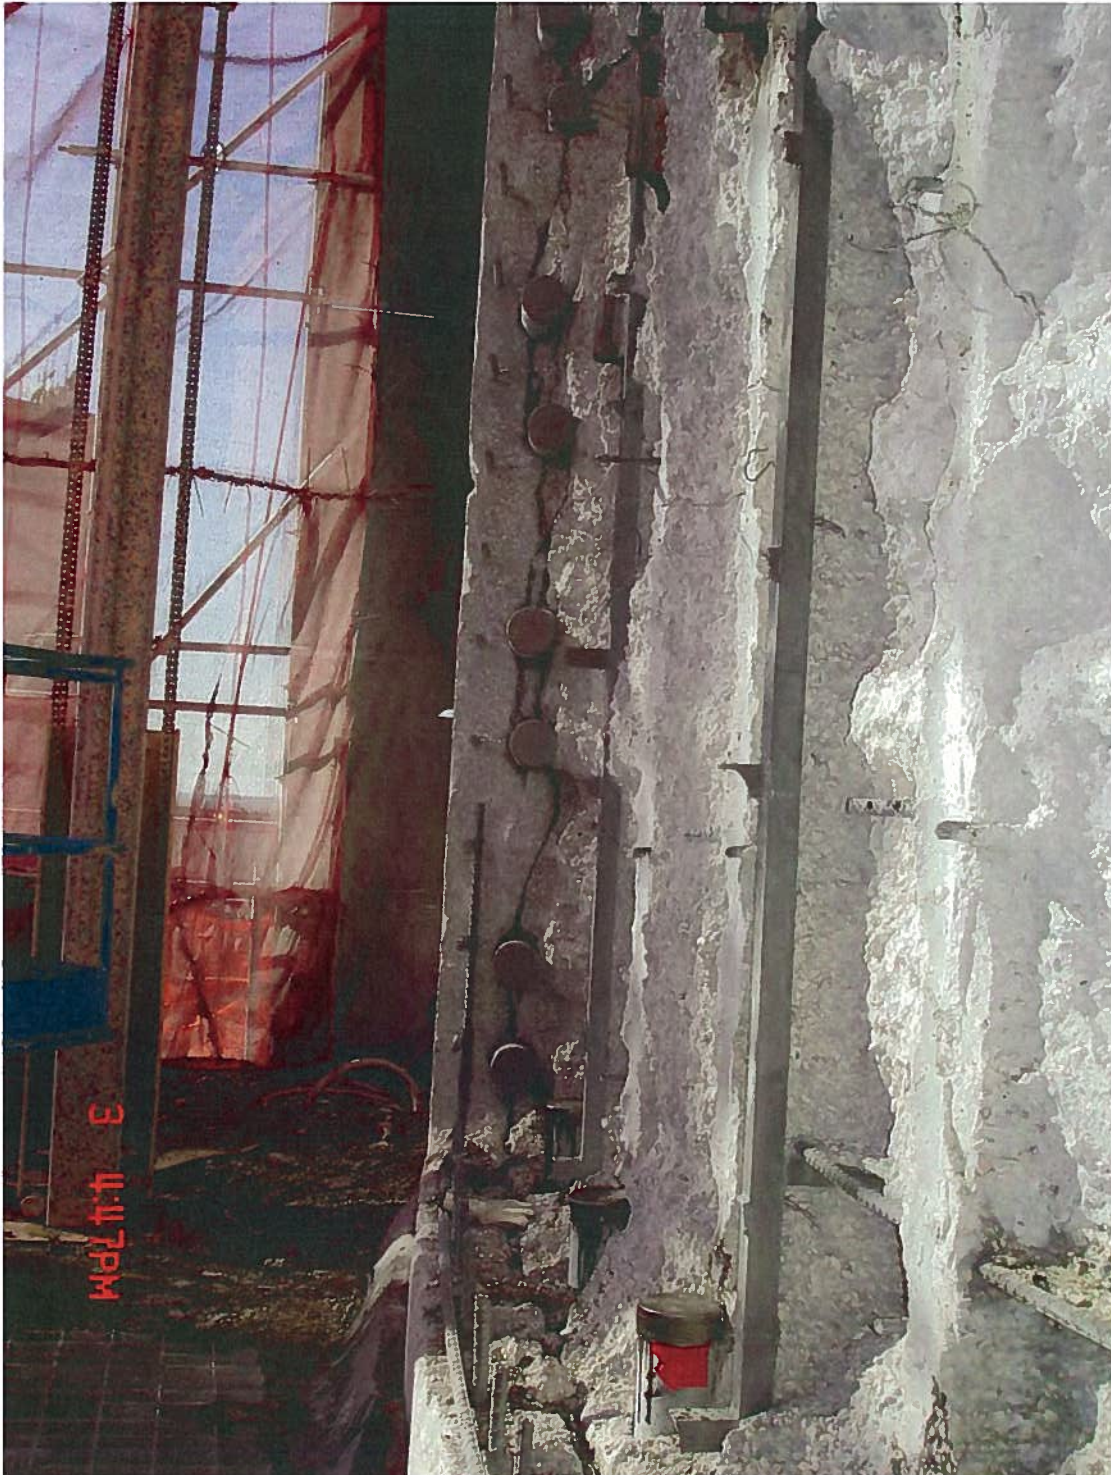
Figure 1.3 Photograph of delamination crack running from horizontal tendon to horizontal tendon, parallel to the wall surface, approximately 10 inches deep. (Photo taken after partial concrete demolition)

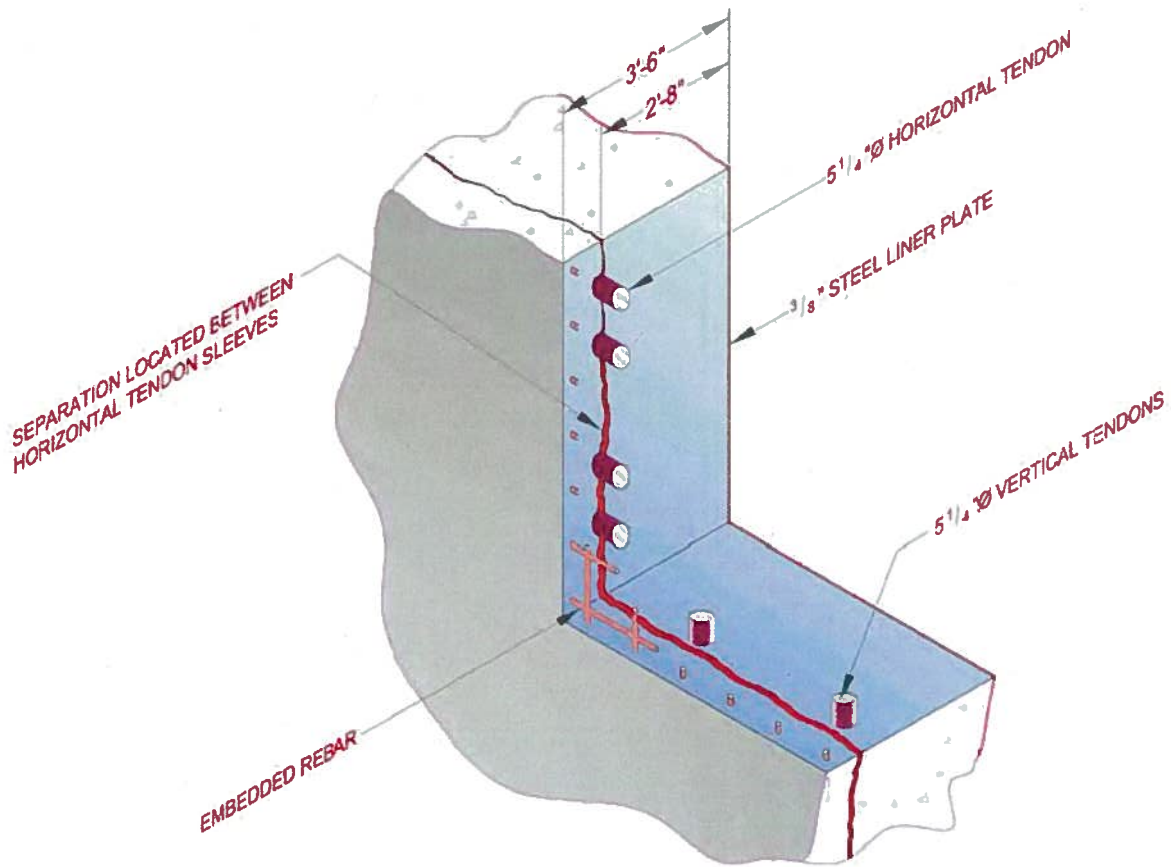
Figure 1.4 Sketch of the delamination cracking in the bay 34 wall.

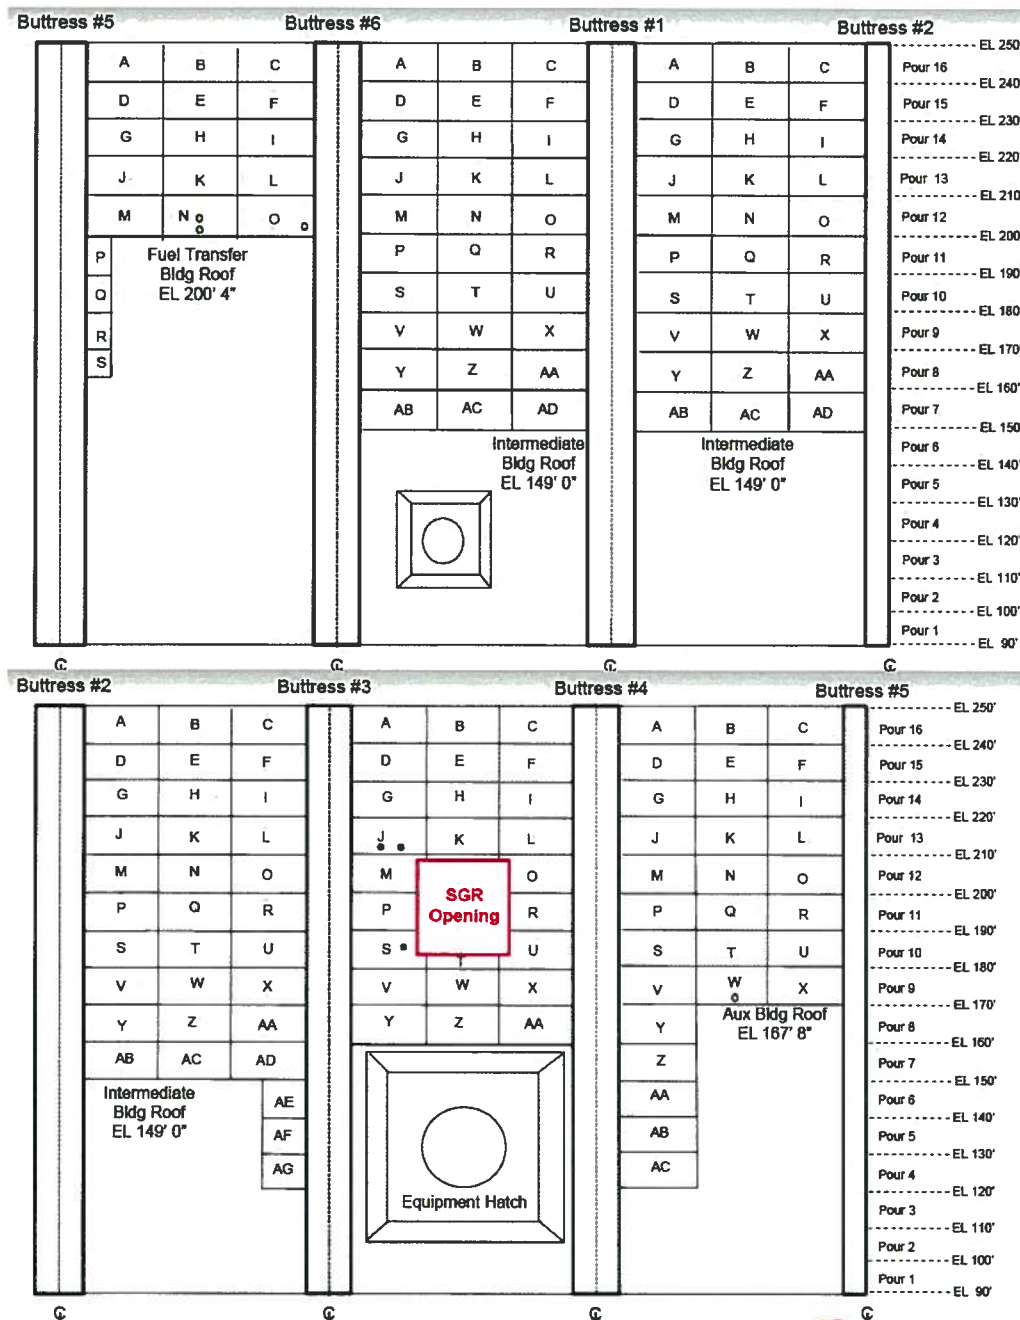
Figure 1.5 Sketch of the containment structure unfolded.

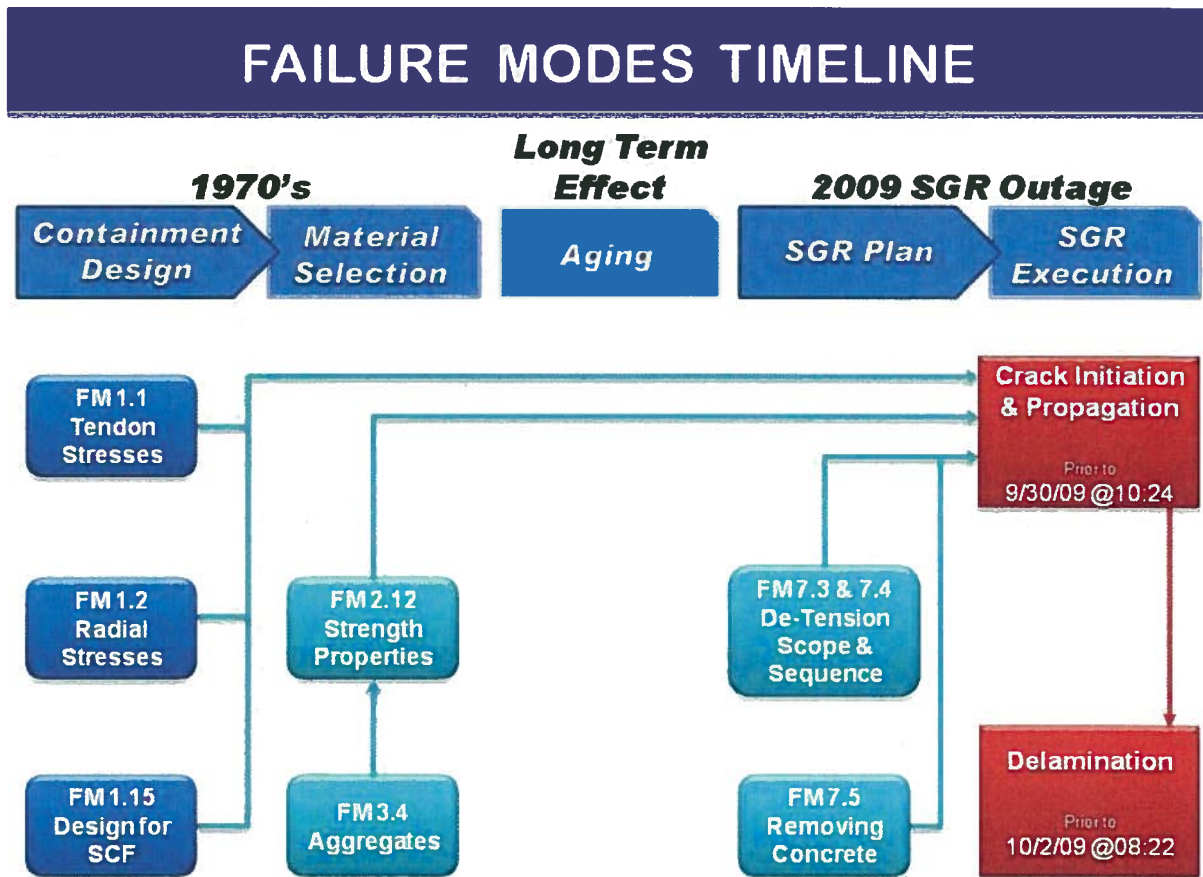
Figure 2.1 Failure Mode Timeline

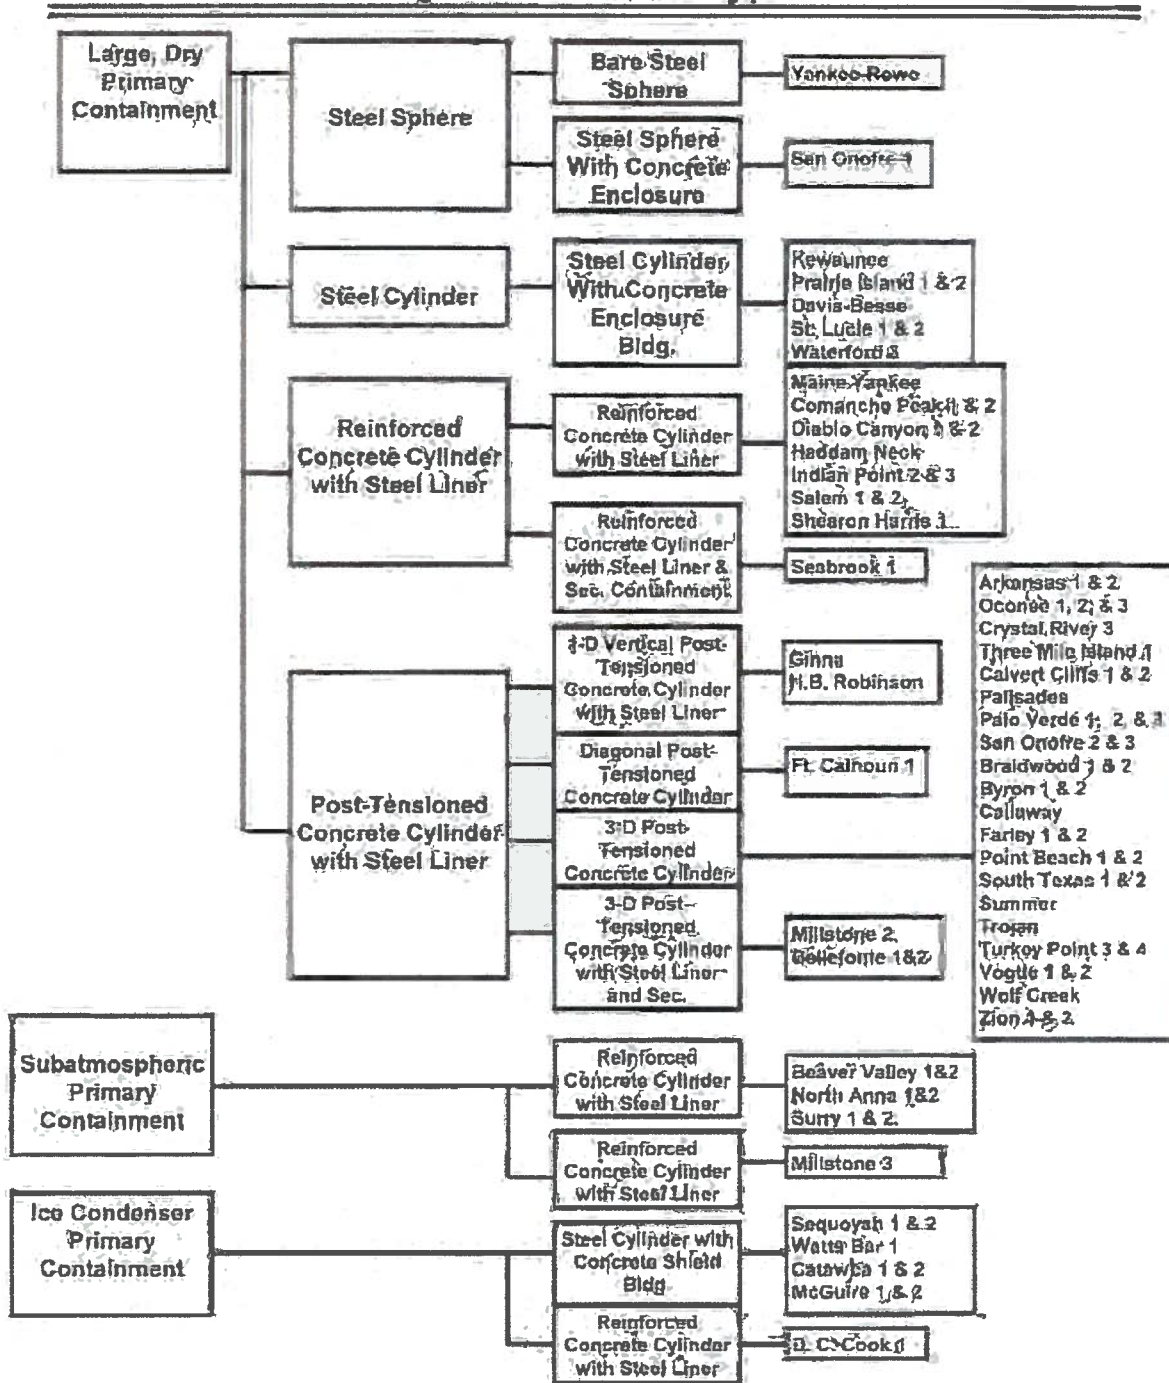
From US NRC PWR EAWL Real Riskmaking Package

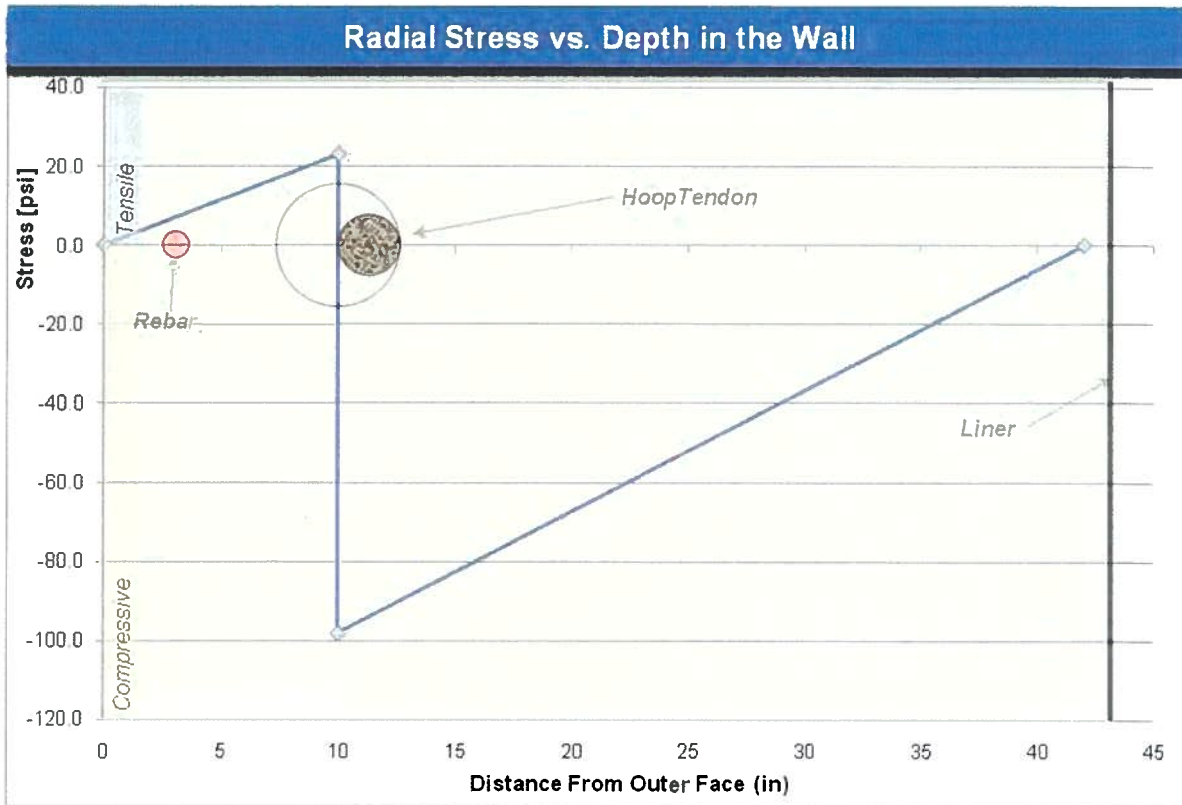
Figure 3.3 Tensile and compressive stresses in concrete wall cross-section due to horizontal tendons.

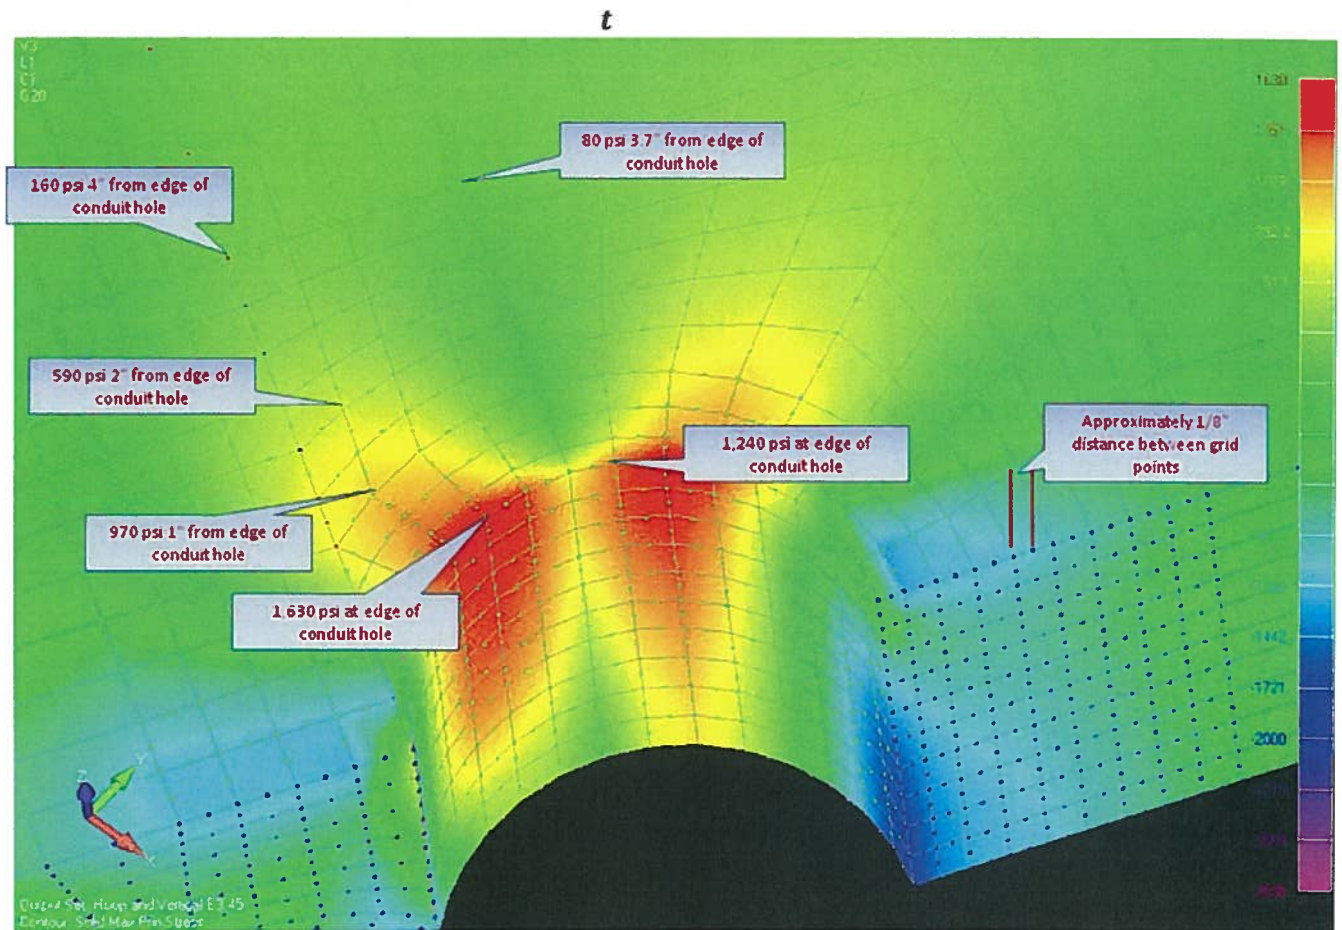
Detailed FEM at Conduit Intersections – Lockoff Hoop & Vertical Loading, $E_c=3.45 \times 10^6$ psi

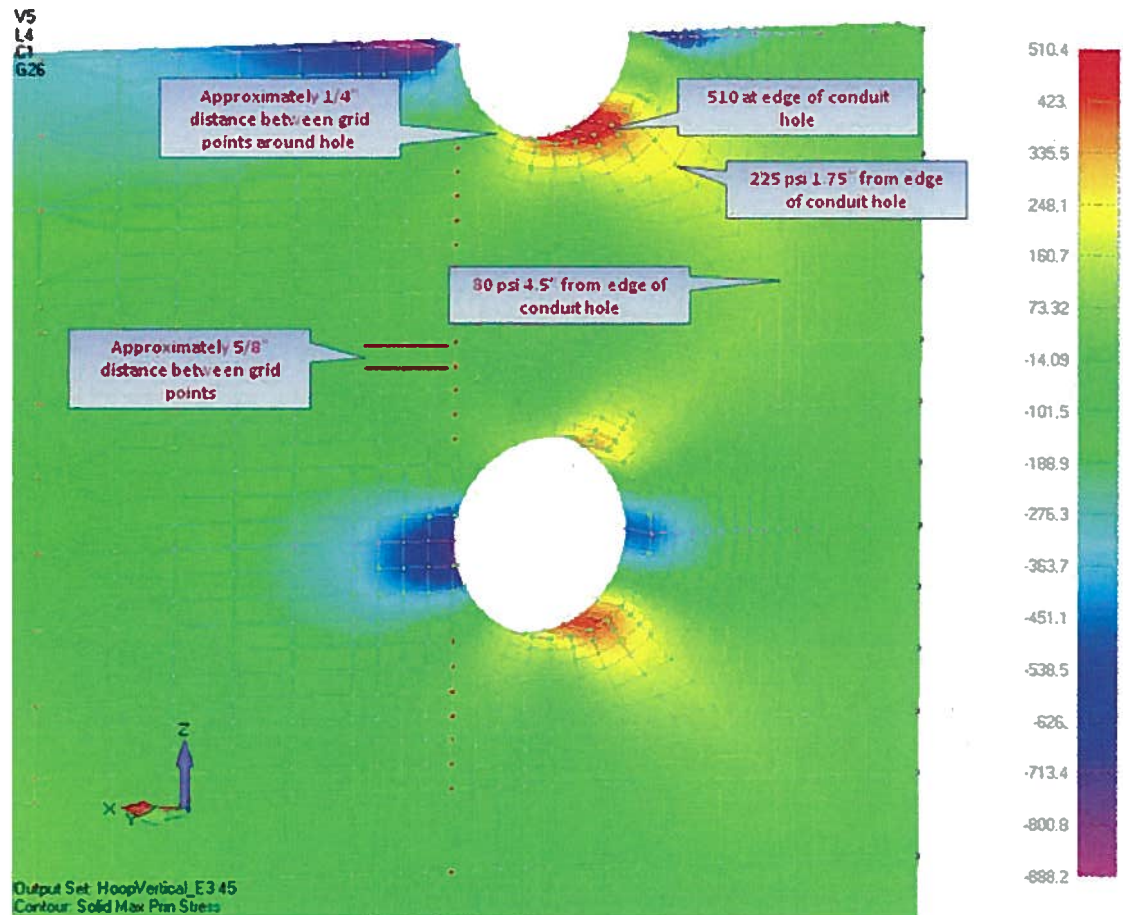
Expanded FEM *Between* Vertical Conduits – Lockoff Hoop & Vertical Loading, $E_c=3.45 \times 10^6$ psi

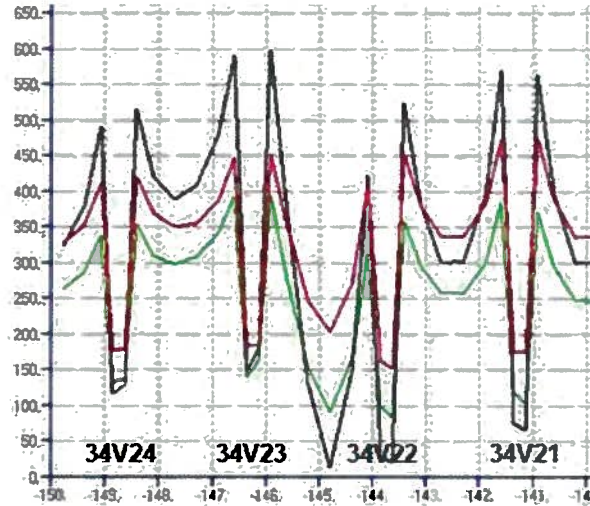
Circumferential Distance, feet and tendon number

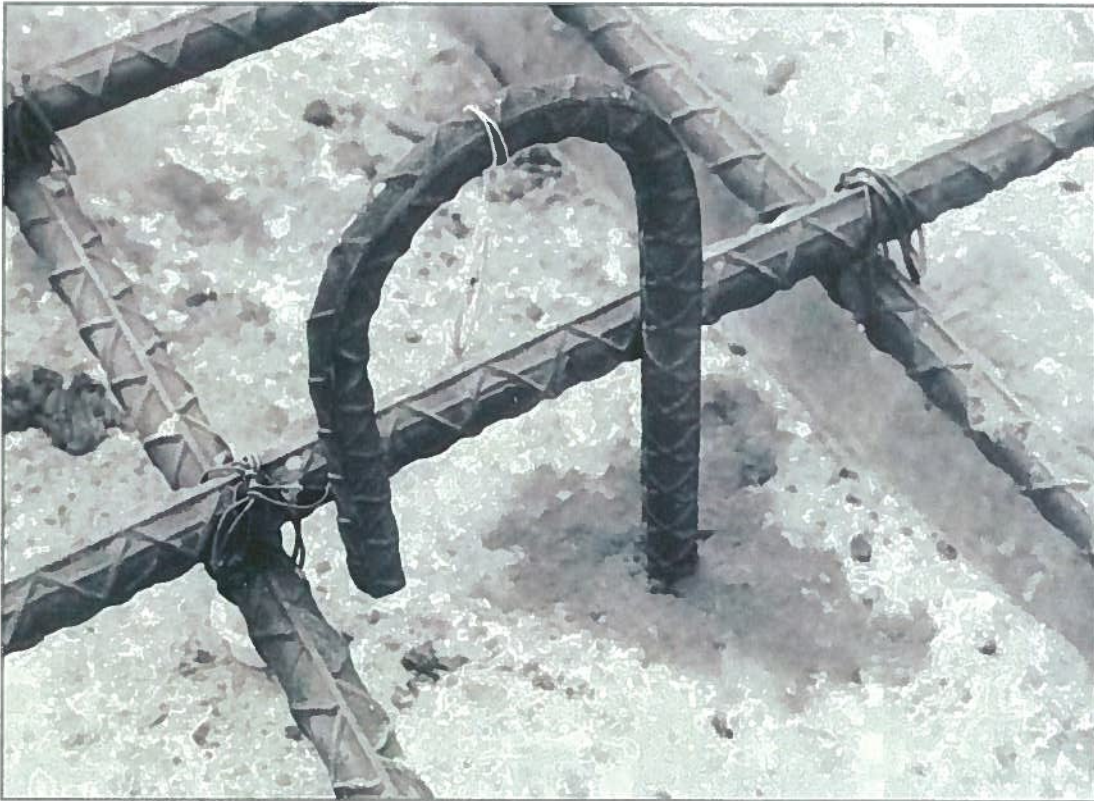
Figure 3.7 Photograph of a radial reinforcement installed as a corrective action to the CR3 Dome delamination

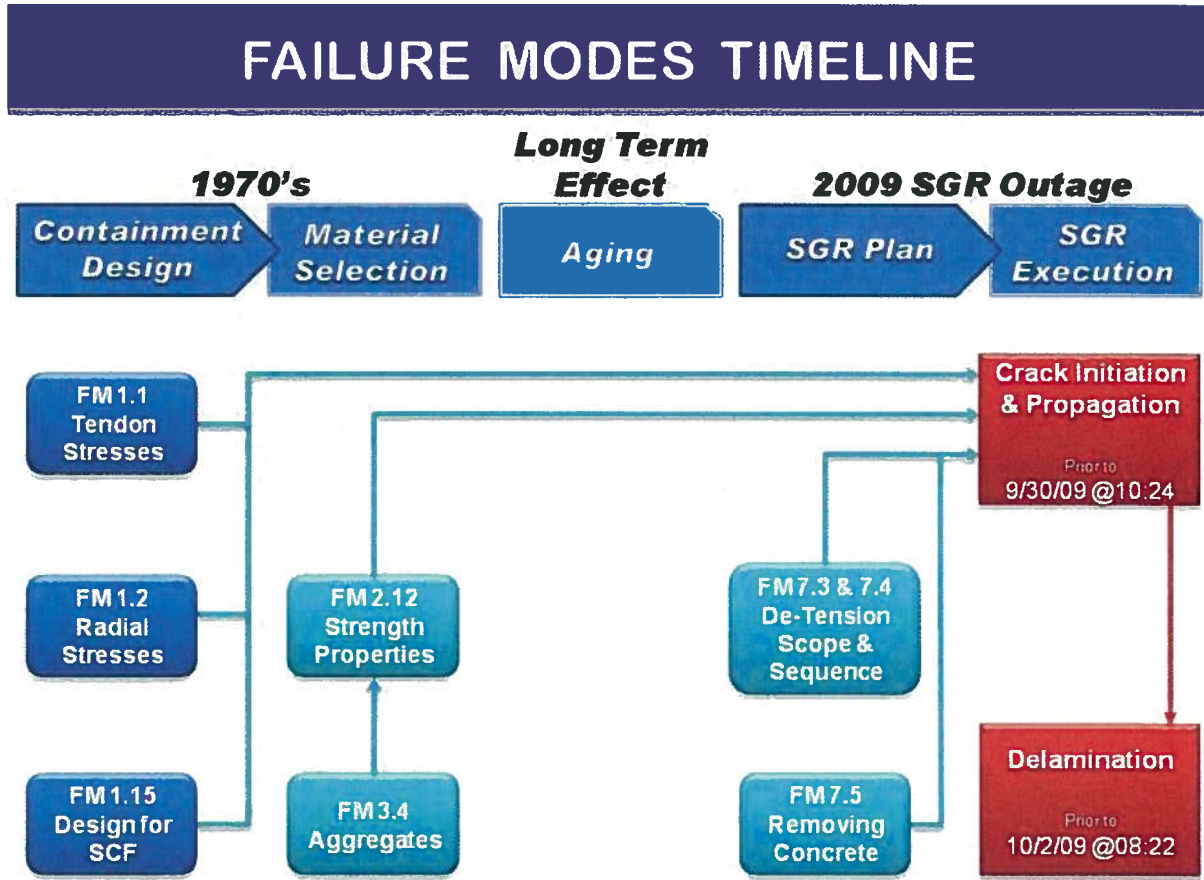
Figure 7.1 Failure Modes flow chart

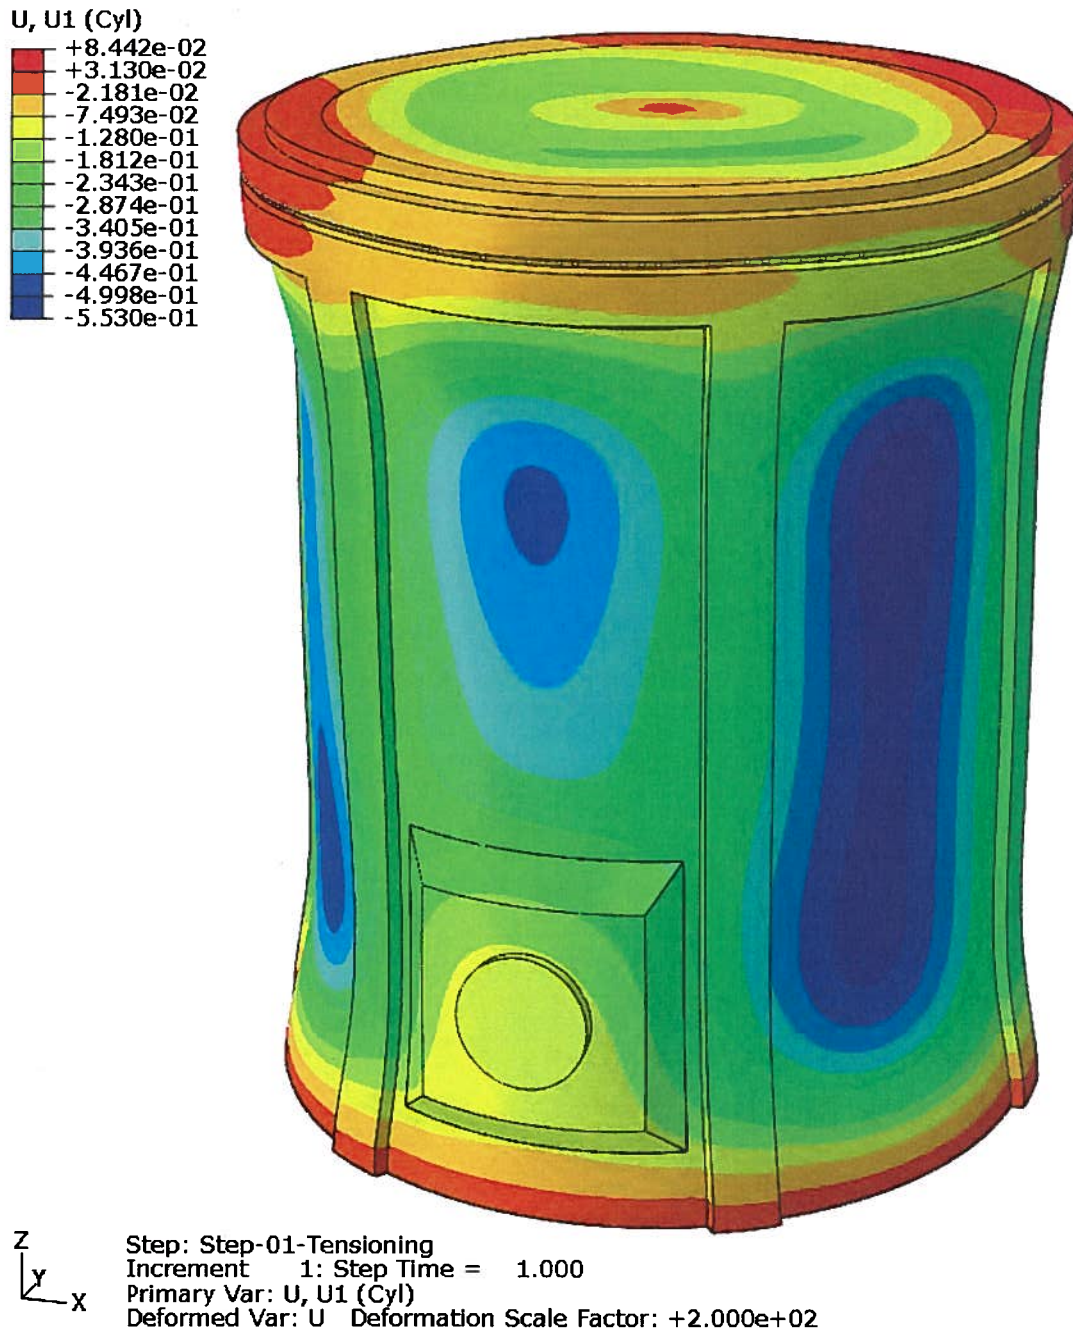
Figure 7.3 CR3 containment building fully tensioned.
The parameter being displayed (U) is radial displacement.

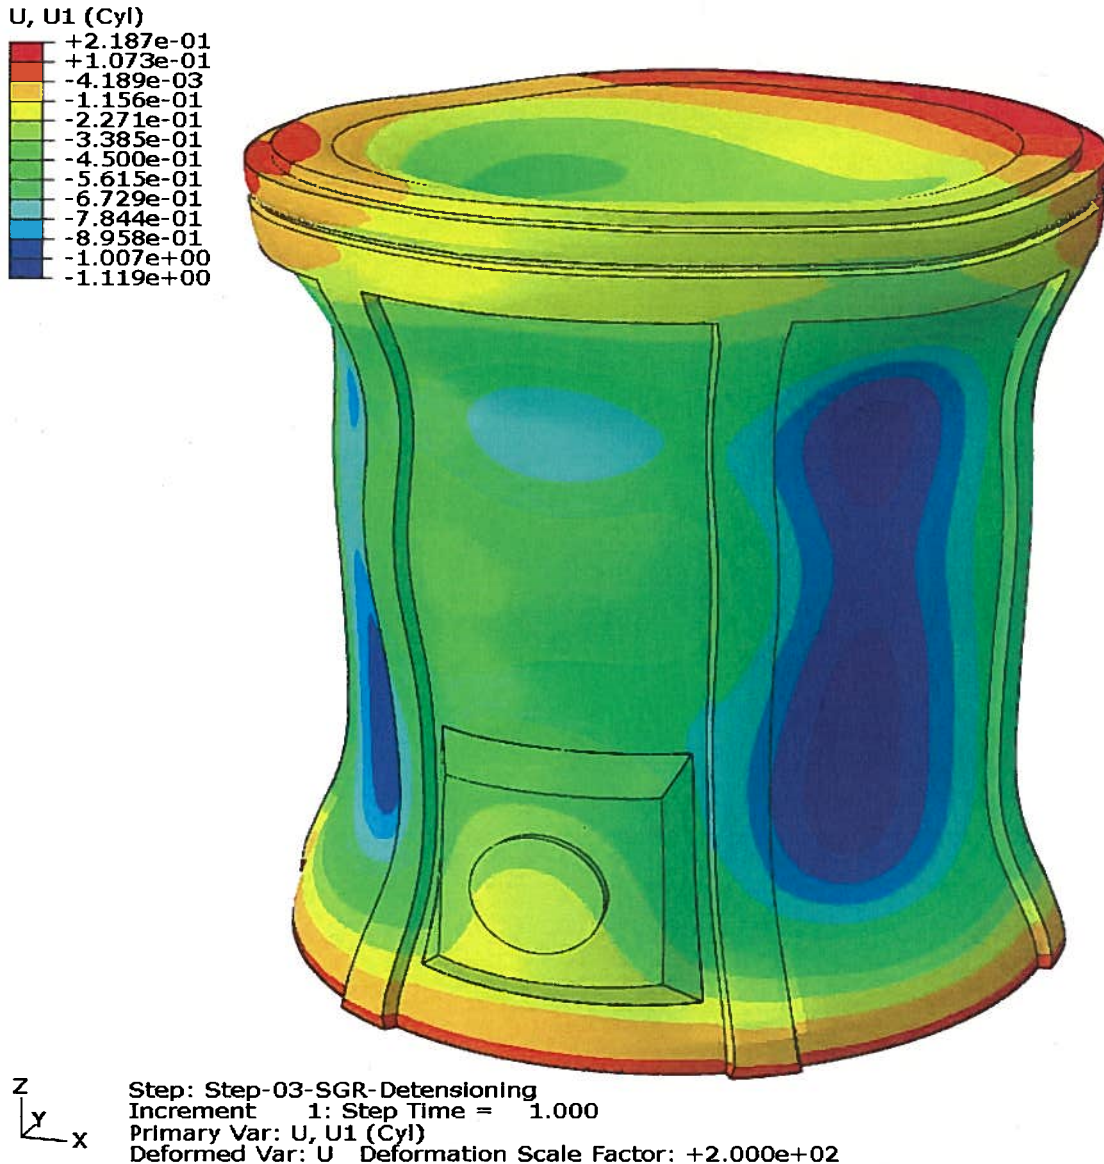
Figure 7.5 CR3 containment radial displacement post-SGR de-tensioning

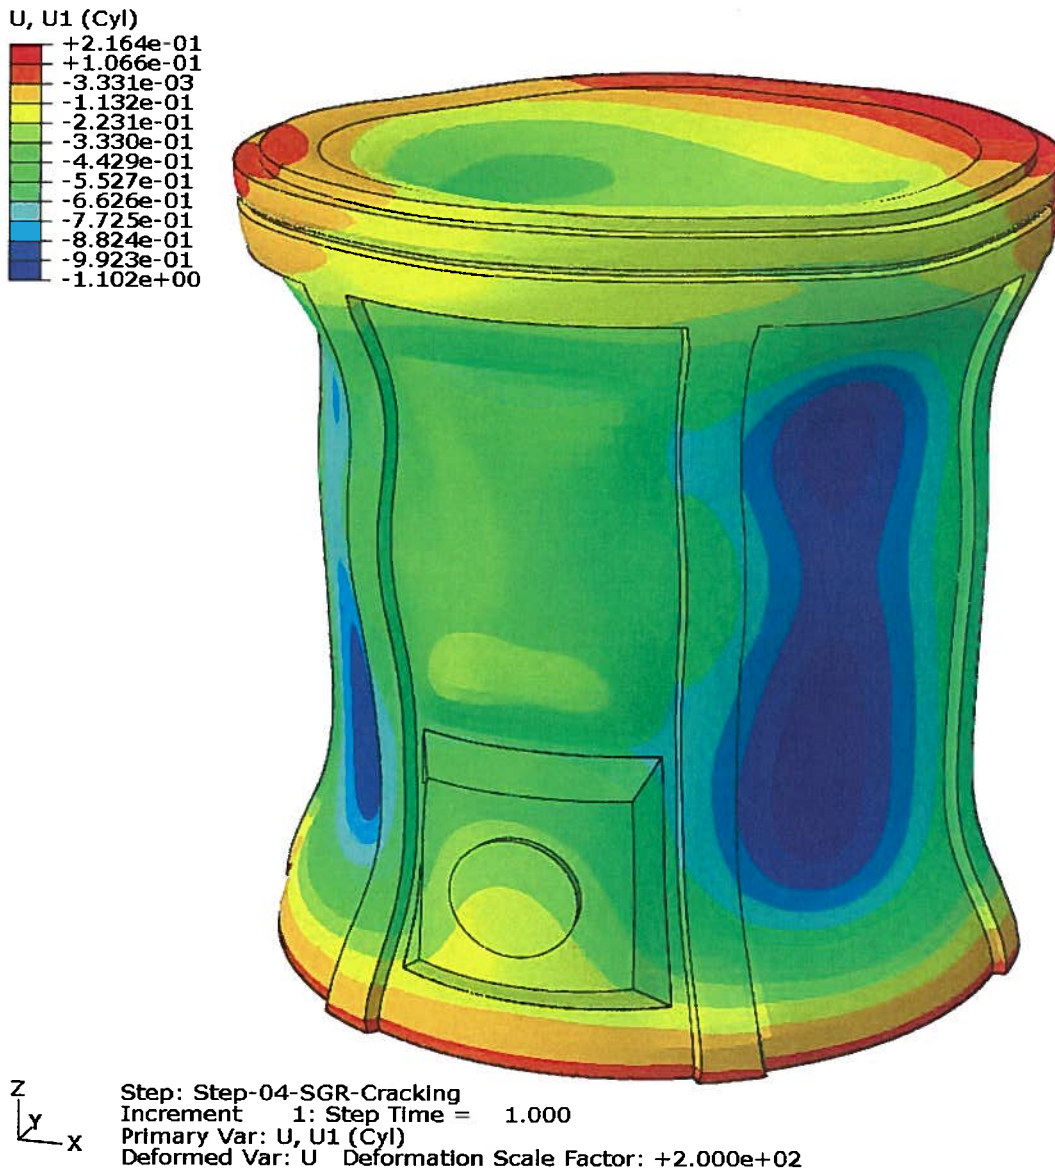
Figure 7.6 CR3 containment radial displacement post SGR de-tensioning

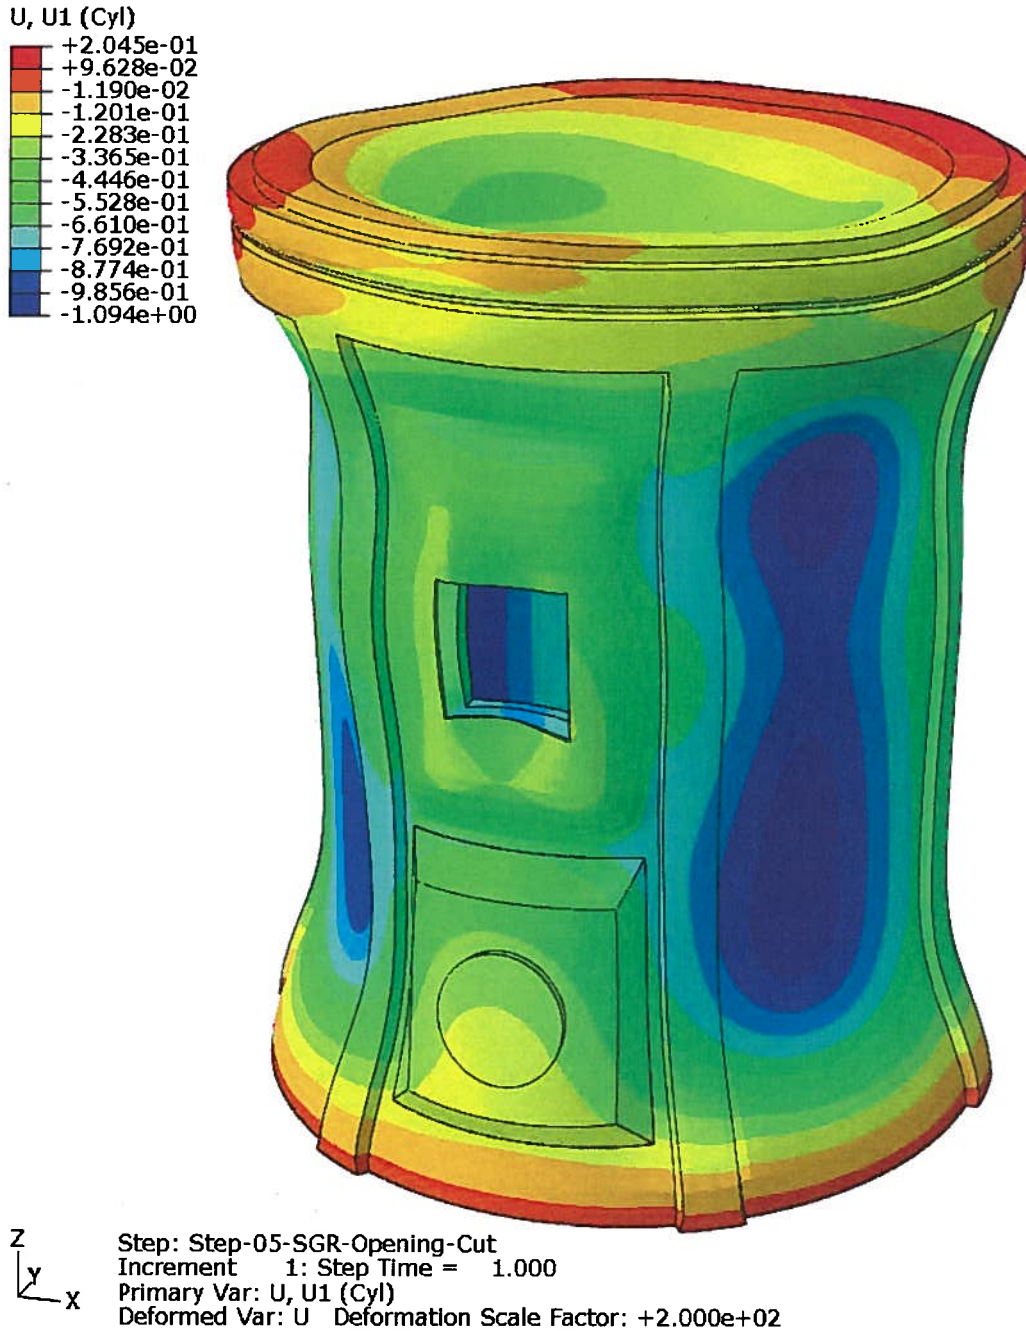
Figure 7.7 CR3 containment radial displacement after SGR opening completion.

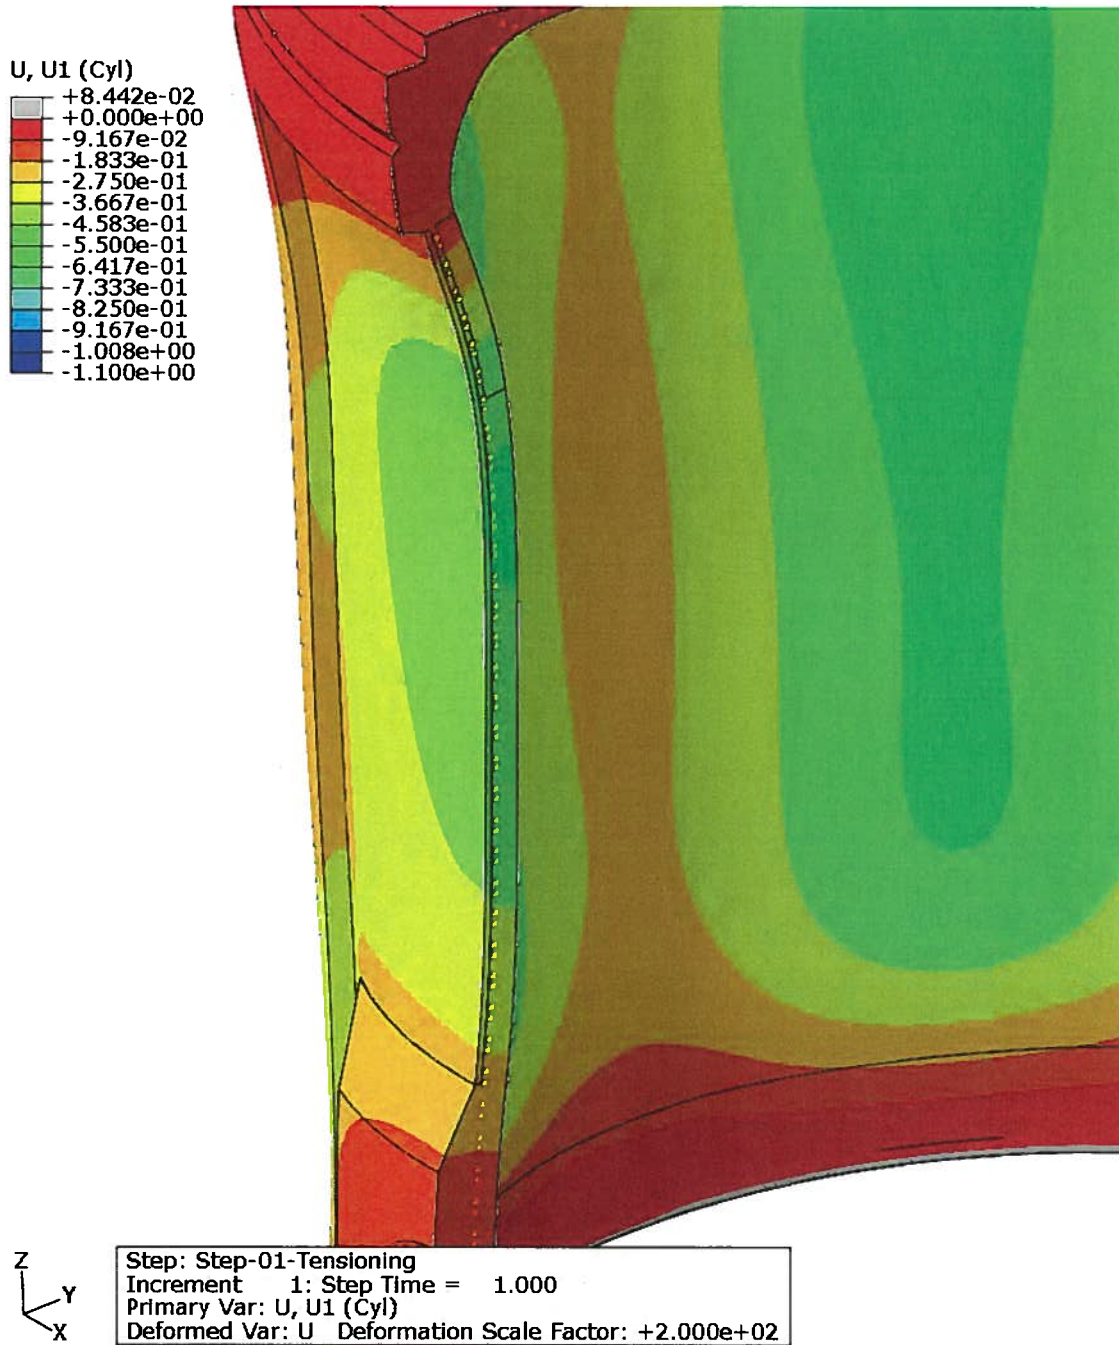
Figure 7.8 CR3 Bay 34 wall profile radial displacement post initial tensioning in 1975. The next milestone is in 2009 after 30 years of creep.
