**UNITED STATES
NUCLEAR REGULATORY COMMISSION**
REGION II
245 PEACHTREE CENTER AVENUE NE, SUITE 1200
ATLANTA, GEORGIA 30303-1257

October 12, 2010

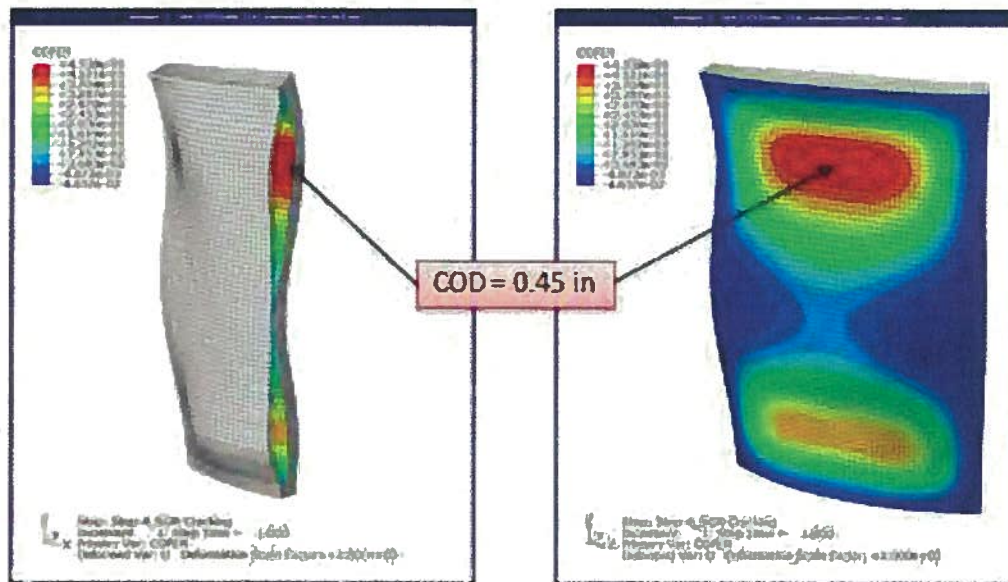
Figure 7.12 The Dimensional response to delamination – Step 4 SGR Cracking
Crack Opening Distance (COD) is the width of the crack that develops. Note the similarity of the pattern in this Figure to that in Figure 7.14.

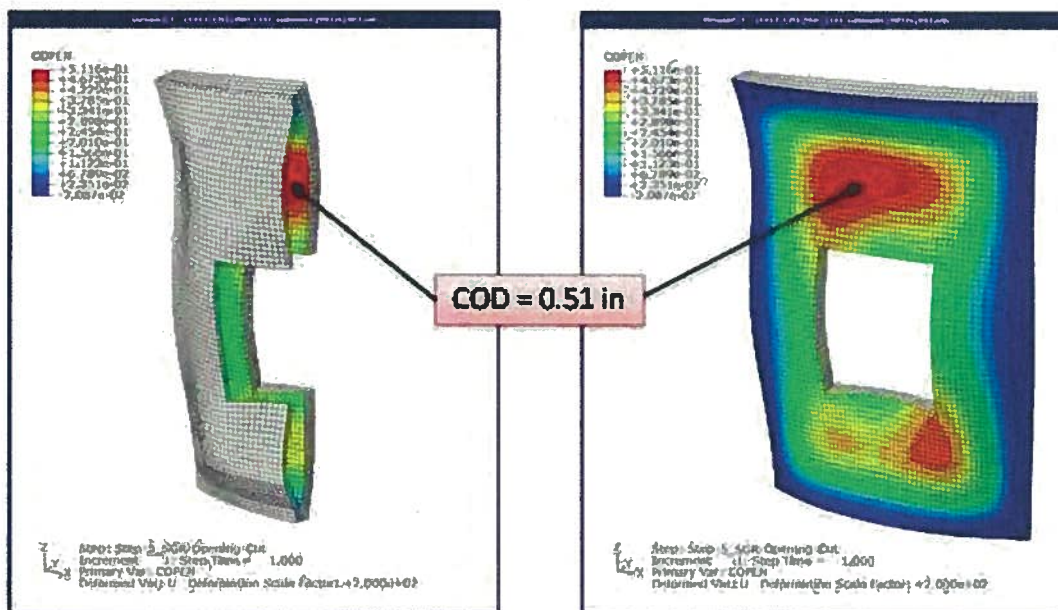
Figure 7.13 Crack Opening Distance (COD) after Concrete Removal – Step 5.
Note the width of the crack increased by about 10% due to concrete removal. Concrete removal does cause an increase but not a significant one.

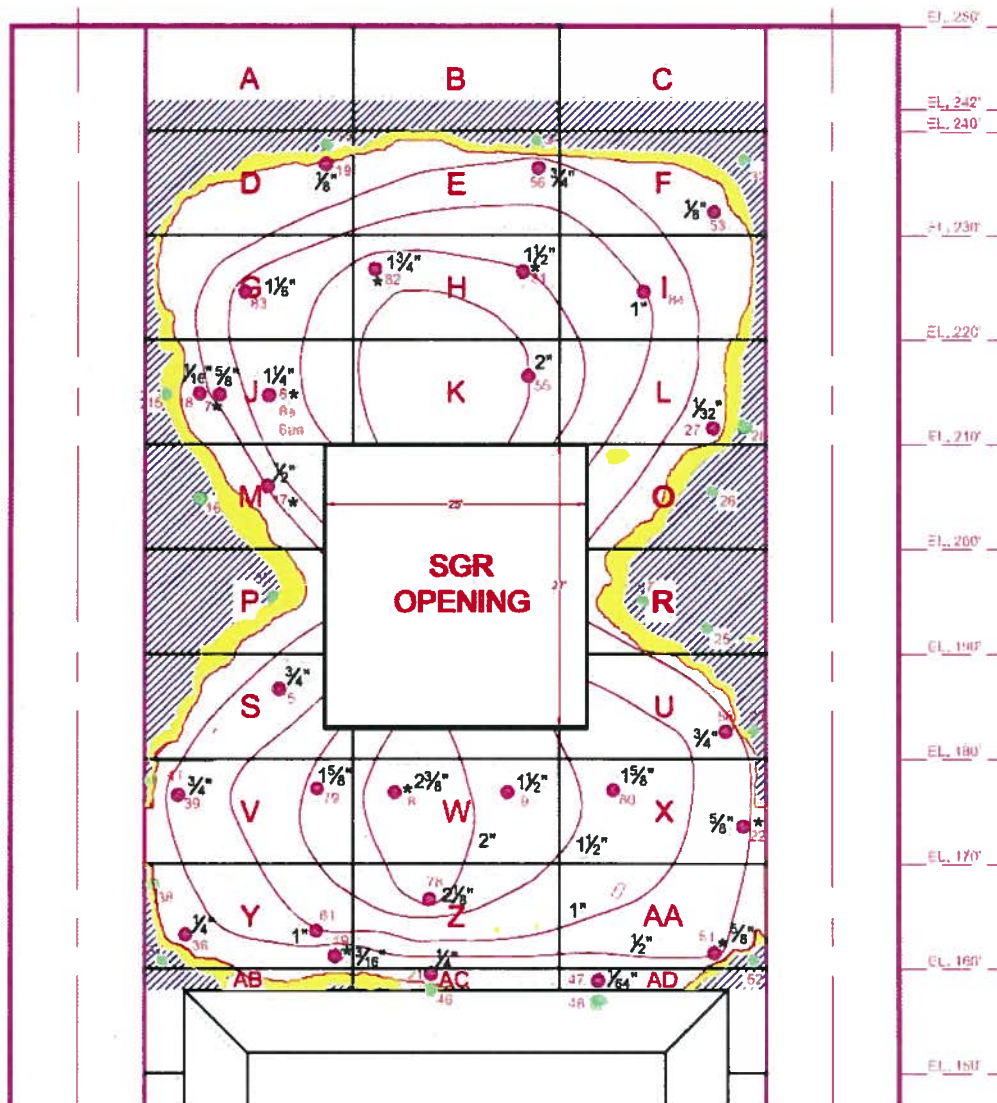
Figure 7.14 Plot of delamination damage in Bay 34. Shown are the measurements of the delamination gap both by impulse response test and by core bores.

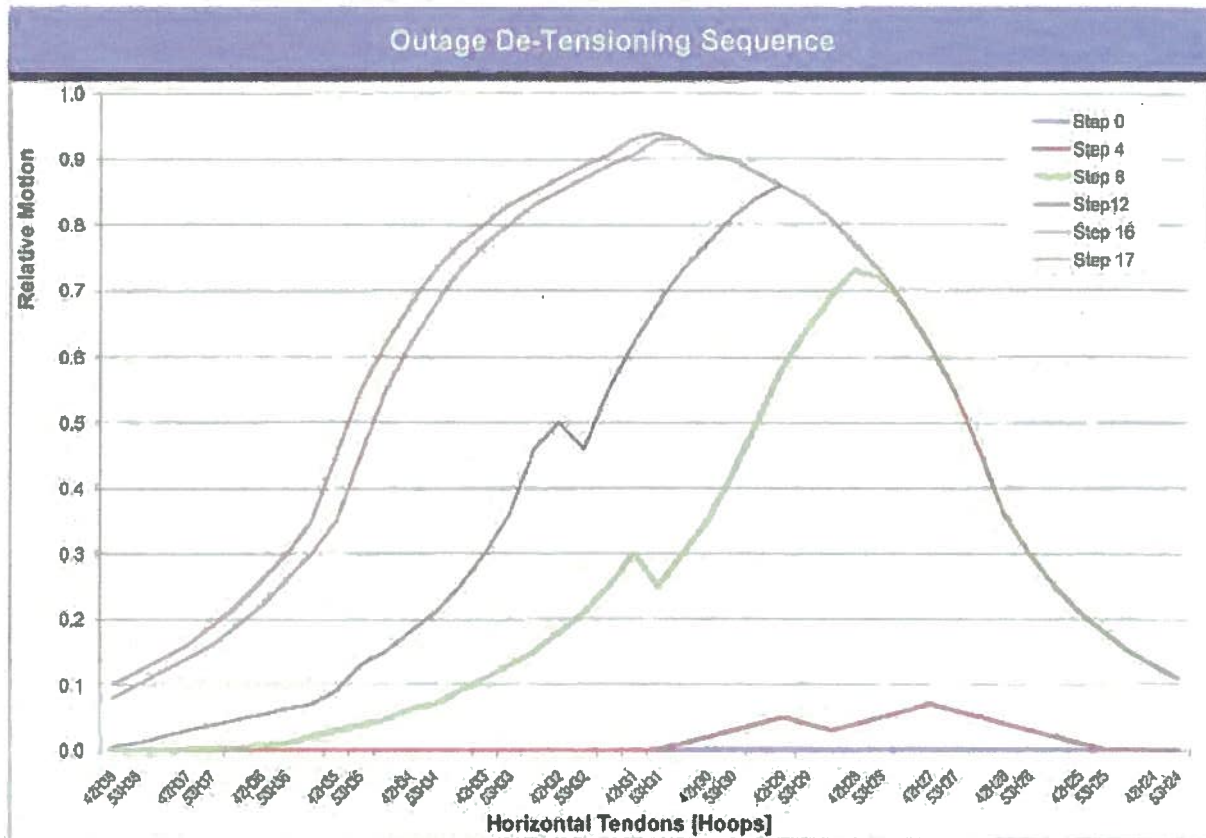
Figure 7.25 A Plot of the radial displacement in Bay 34 as SGR tendon de-tensioning progressed. The full displacement was 0.5”.

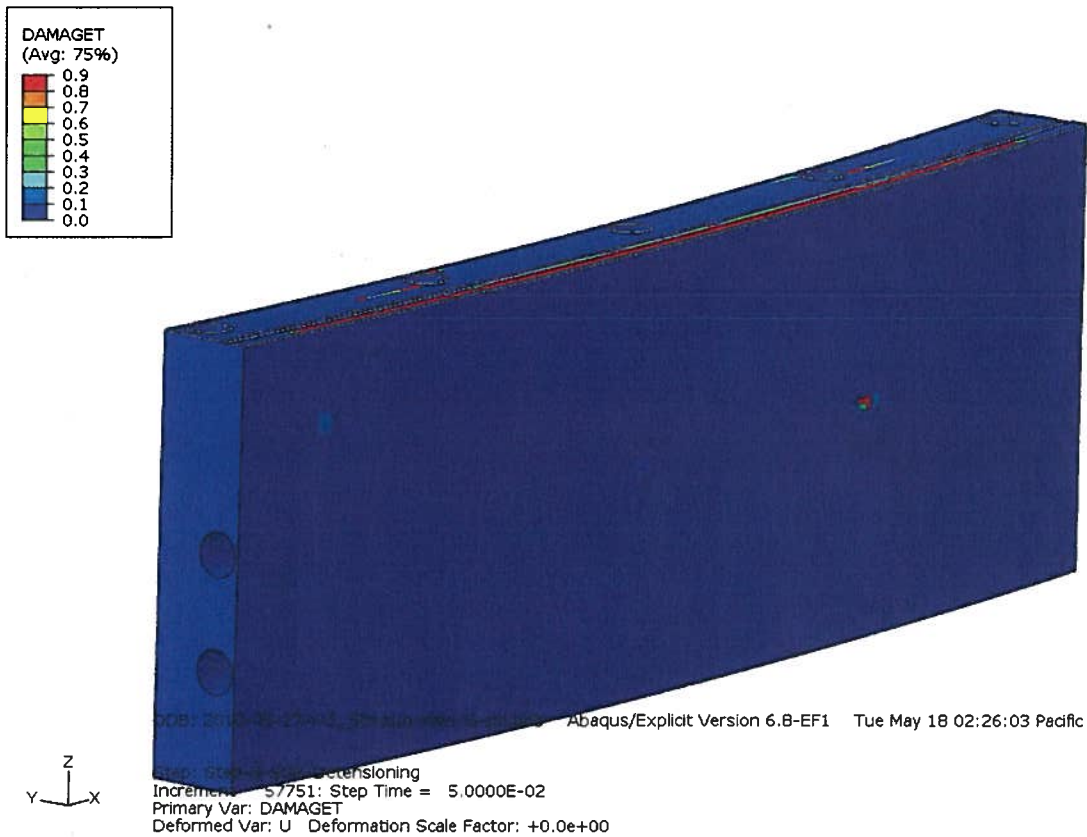
Figure 7.26 A Plot of a bay 34 wall segment approaching delamination.

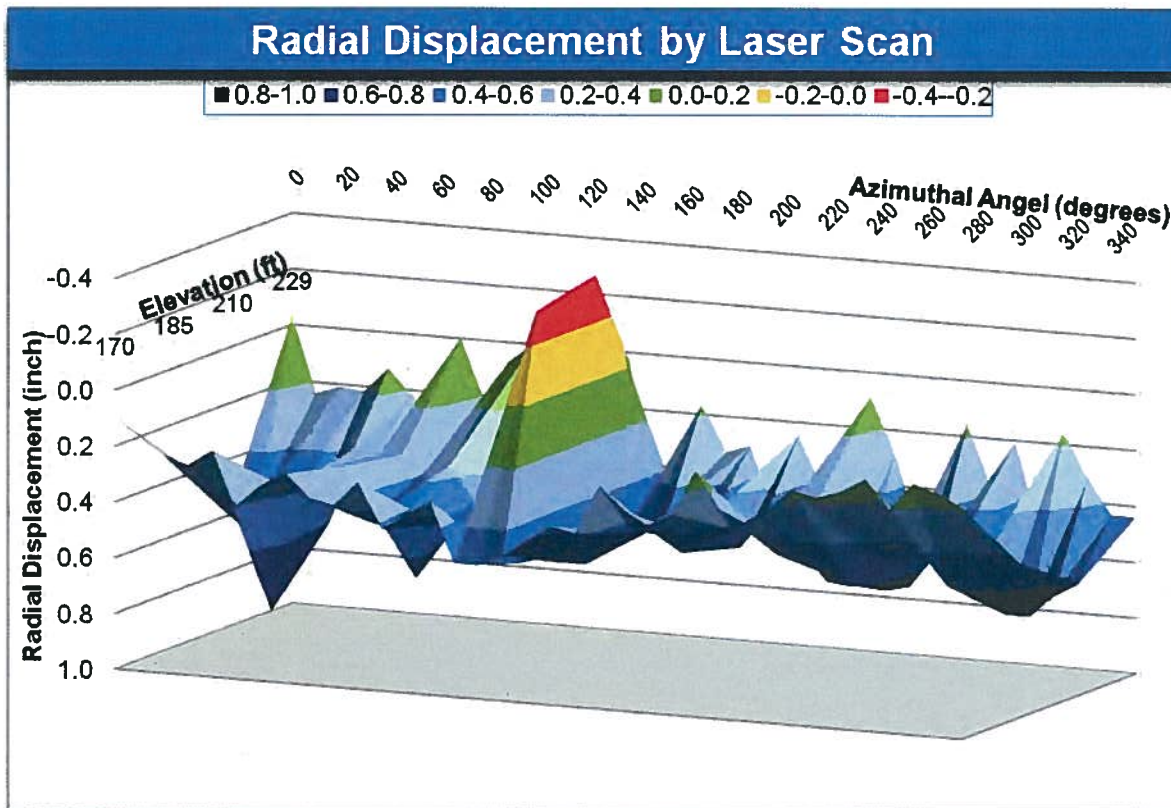
Figure 7.30 Three dimensional representation of radial displacement as a function of azimuthal angle and elevation.

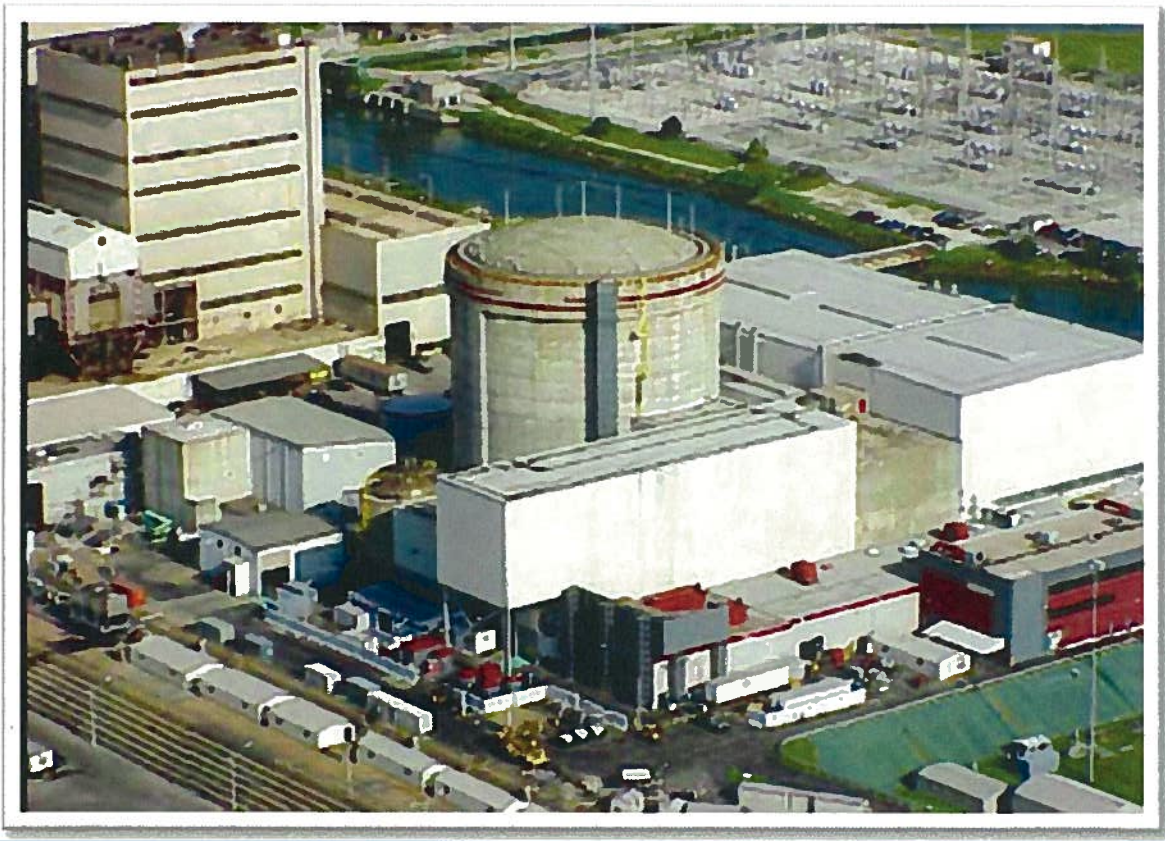
ROOT CAUSE ASSESSMENT CRYSTAL RIVER UNIT 3 CONTAINMENT CONCRETE DELAMINATION

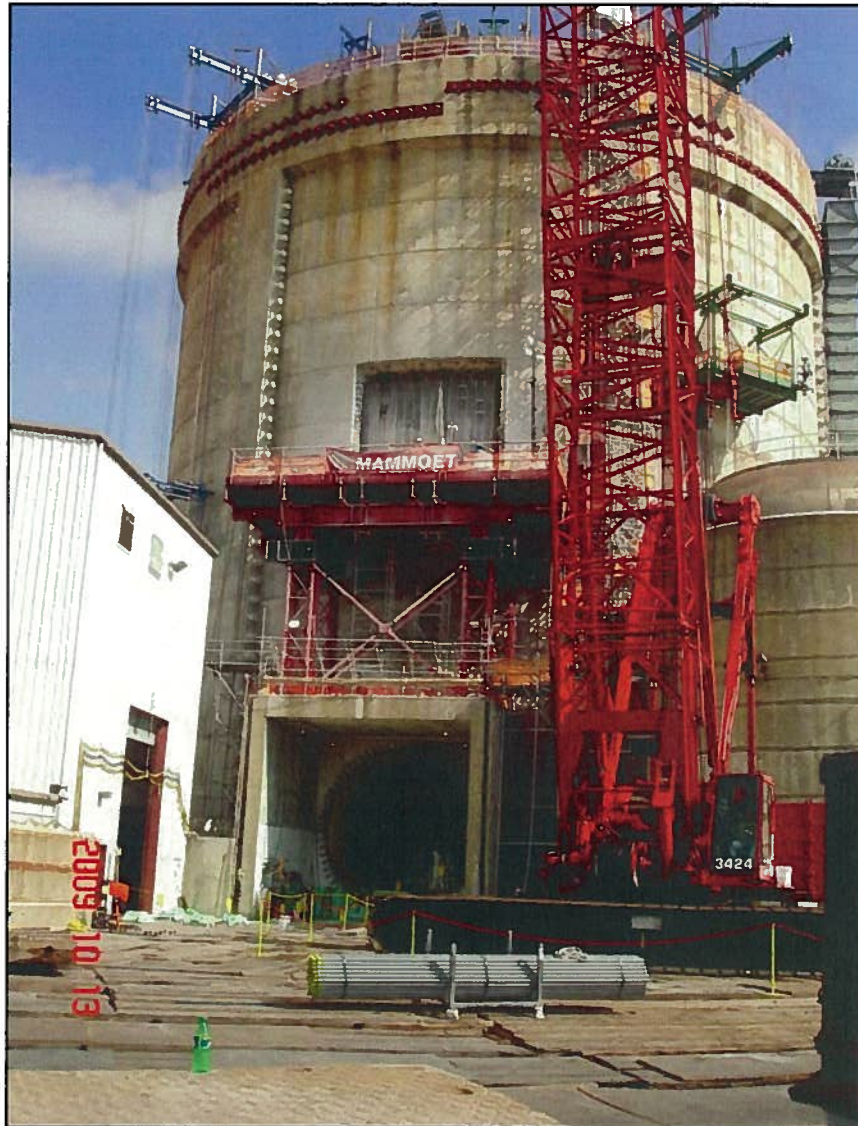
Figure 1.1 Photograph of the steam generator opening worksite.
Note the newly constructed rectangular opening above the existing circular equipment hatch.

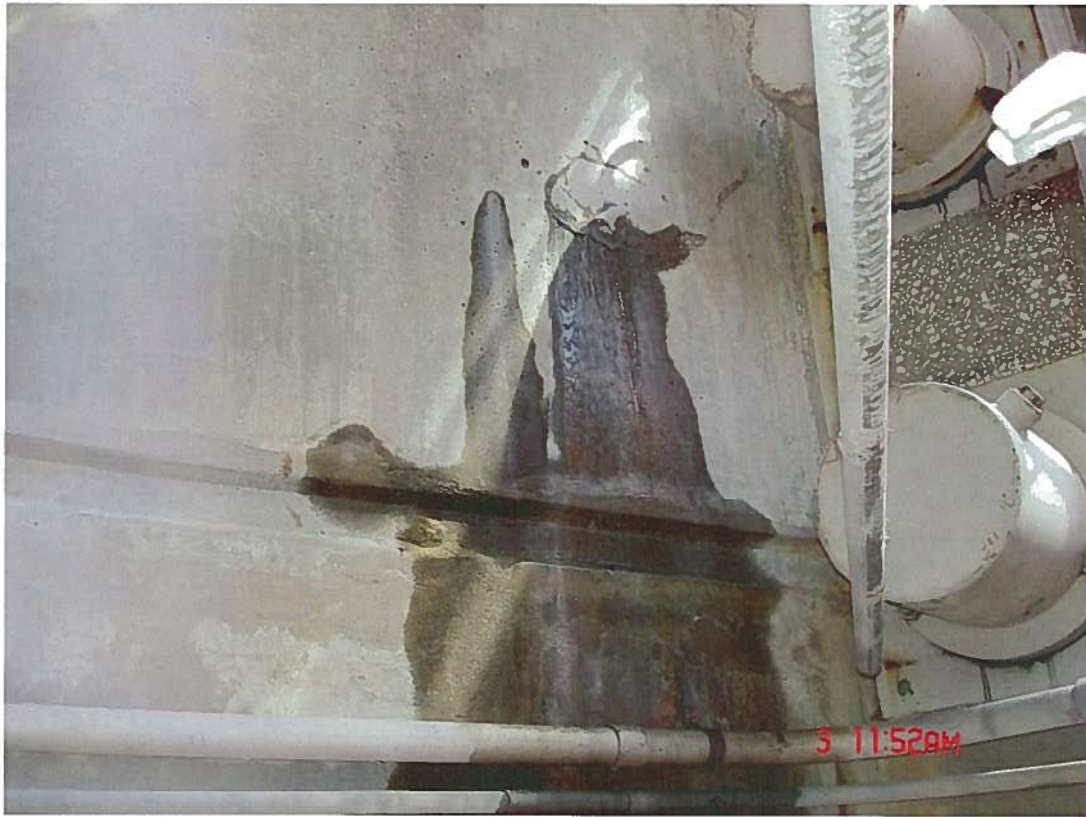
Figure 1.2 Photograph of water leakage from the containment wall (10/3/2009).

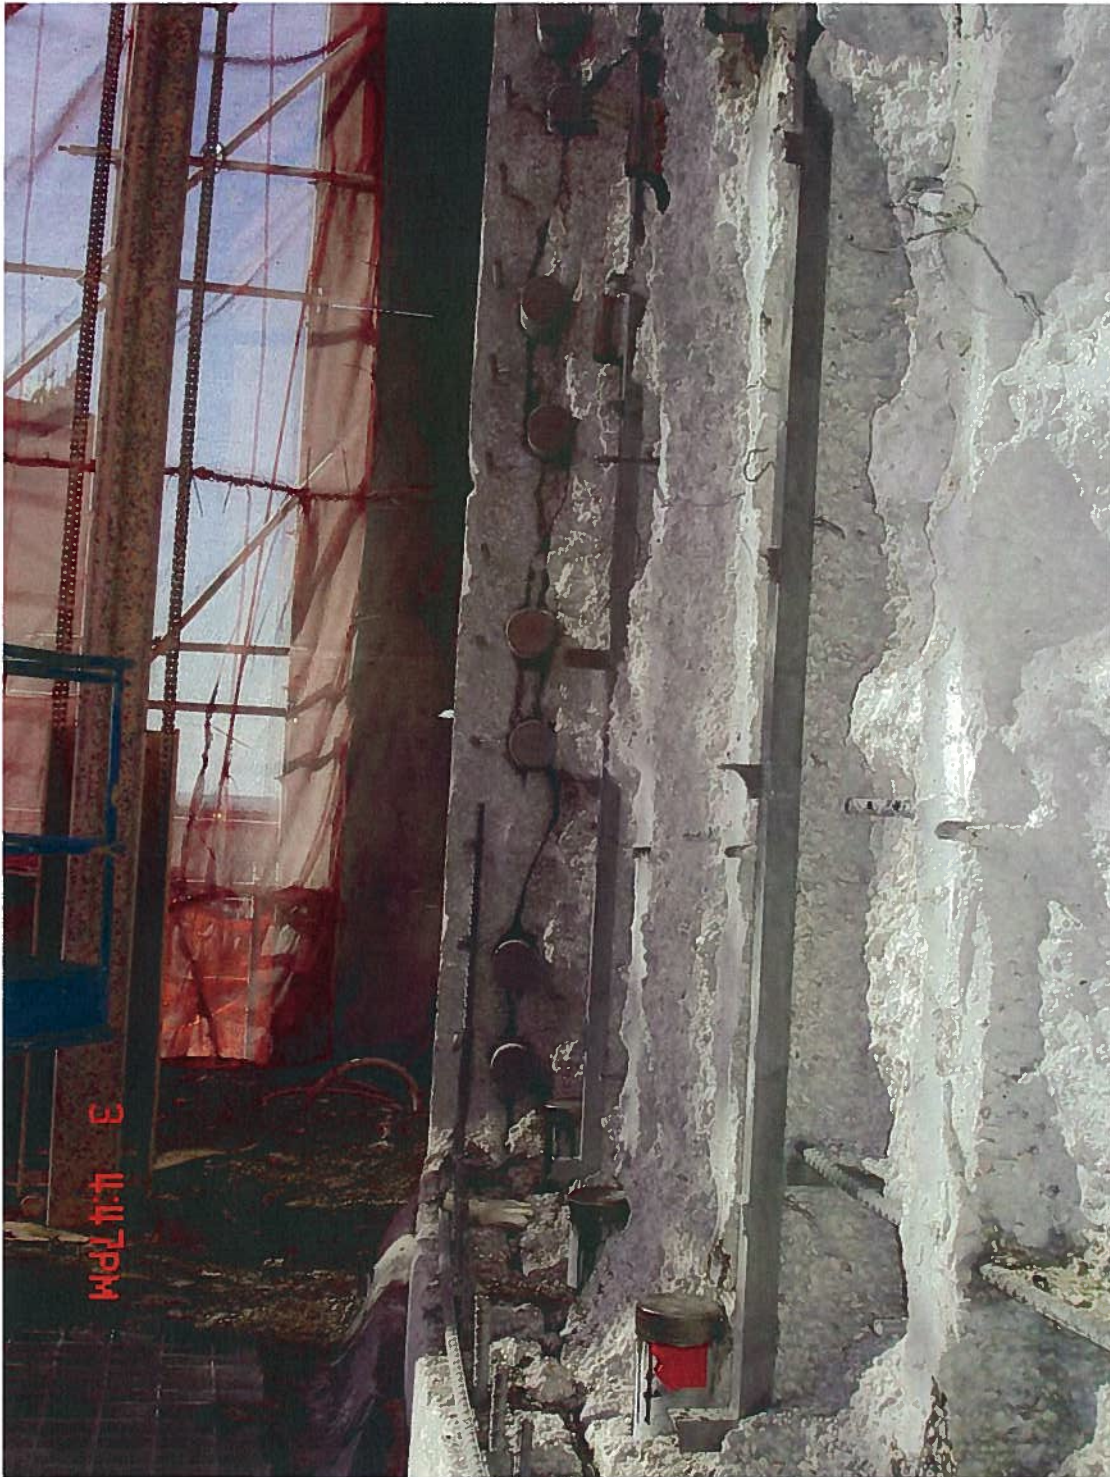
Figure 1.3 Photograph of delamination crack running from horizontal tendon to horizontal tendon, parallel to the wall surface, approximately 10 inches deep. (Photo taken after partial concrete demolition)

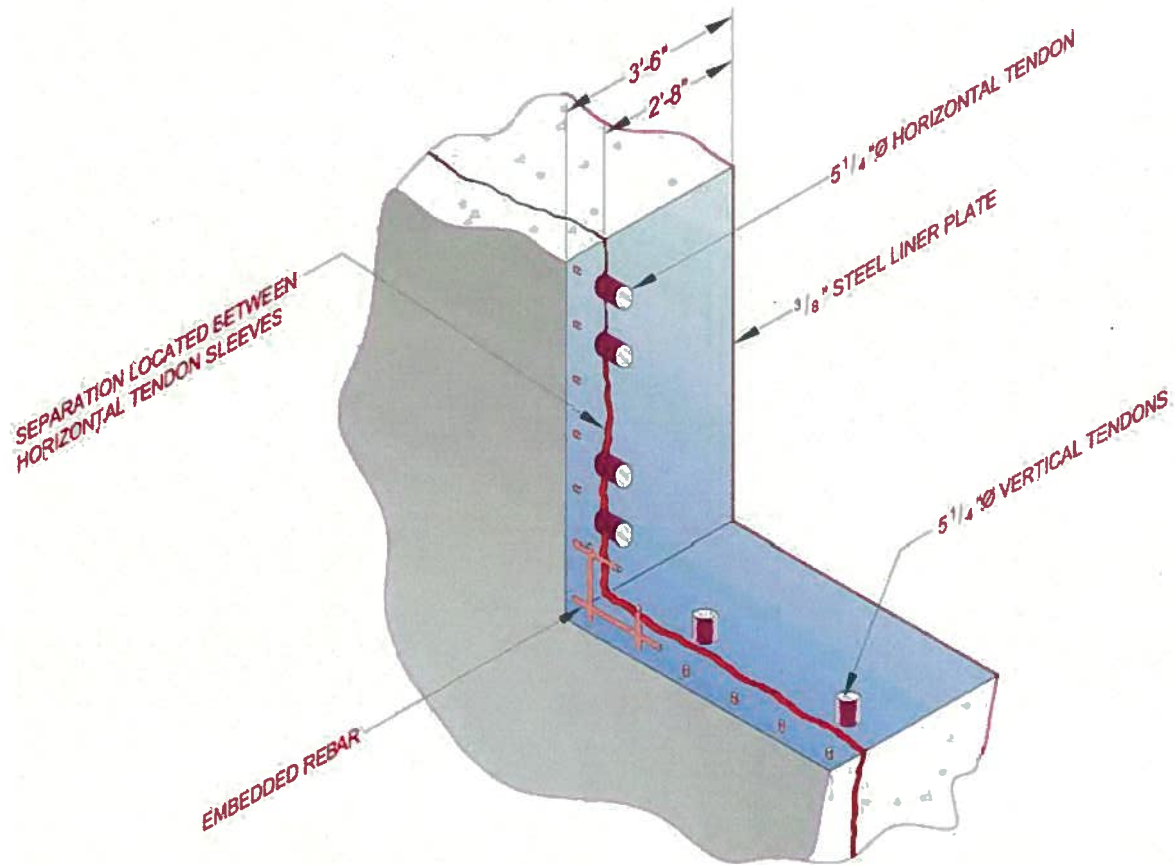
Figure 1.4 Sketch of the delamination cracking in the bay 34 wall.

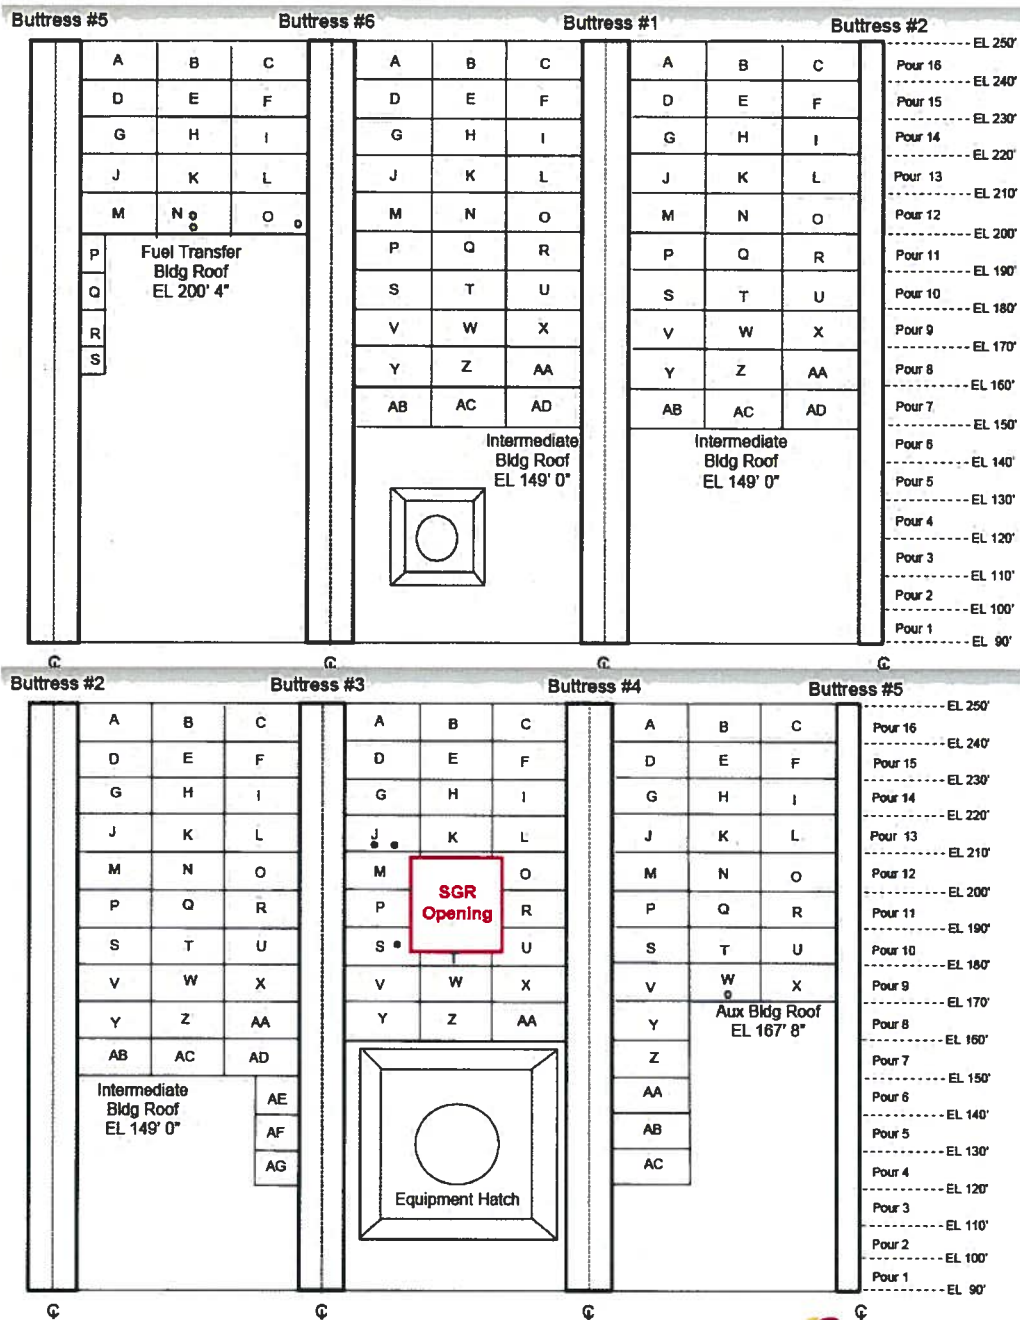
Figure 1.5 Sketch of the containment structure unfolded.

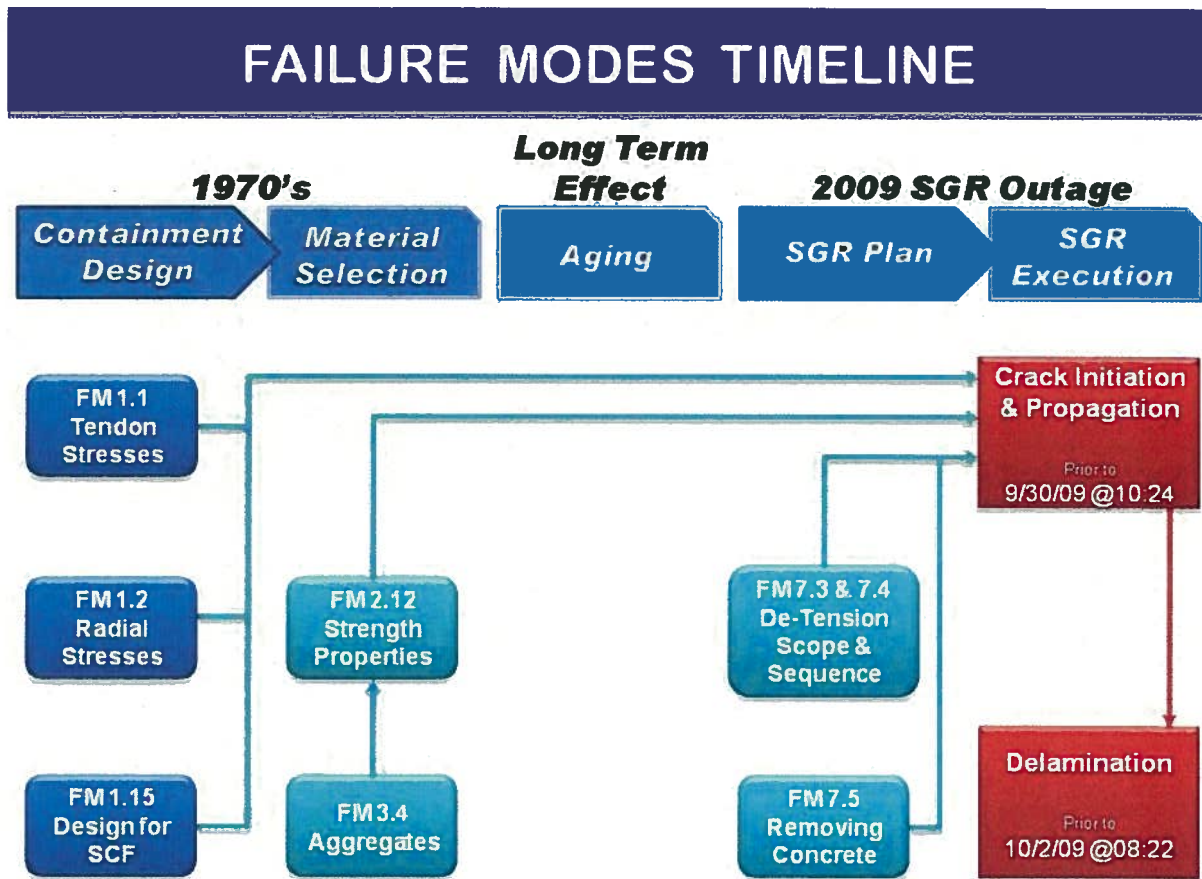
Figure 2.1 Failure Mode Timeline

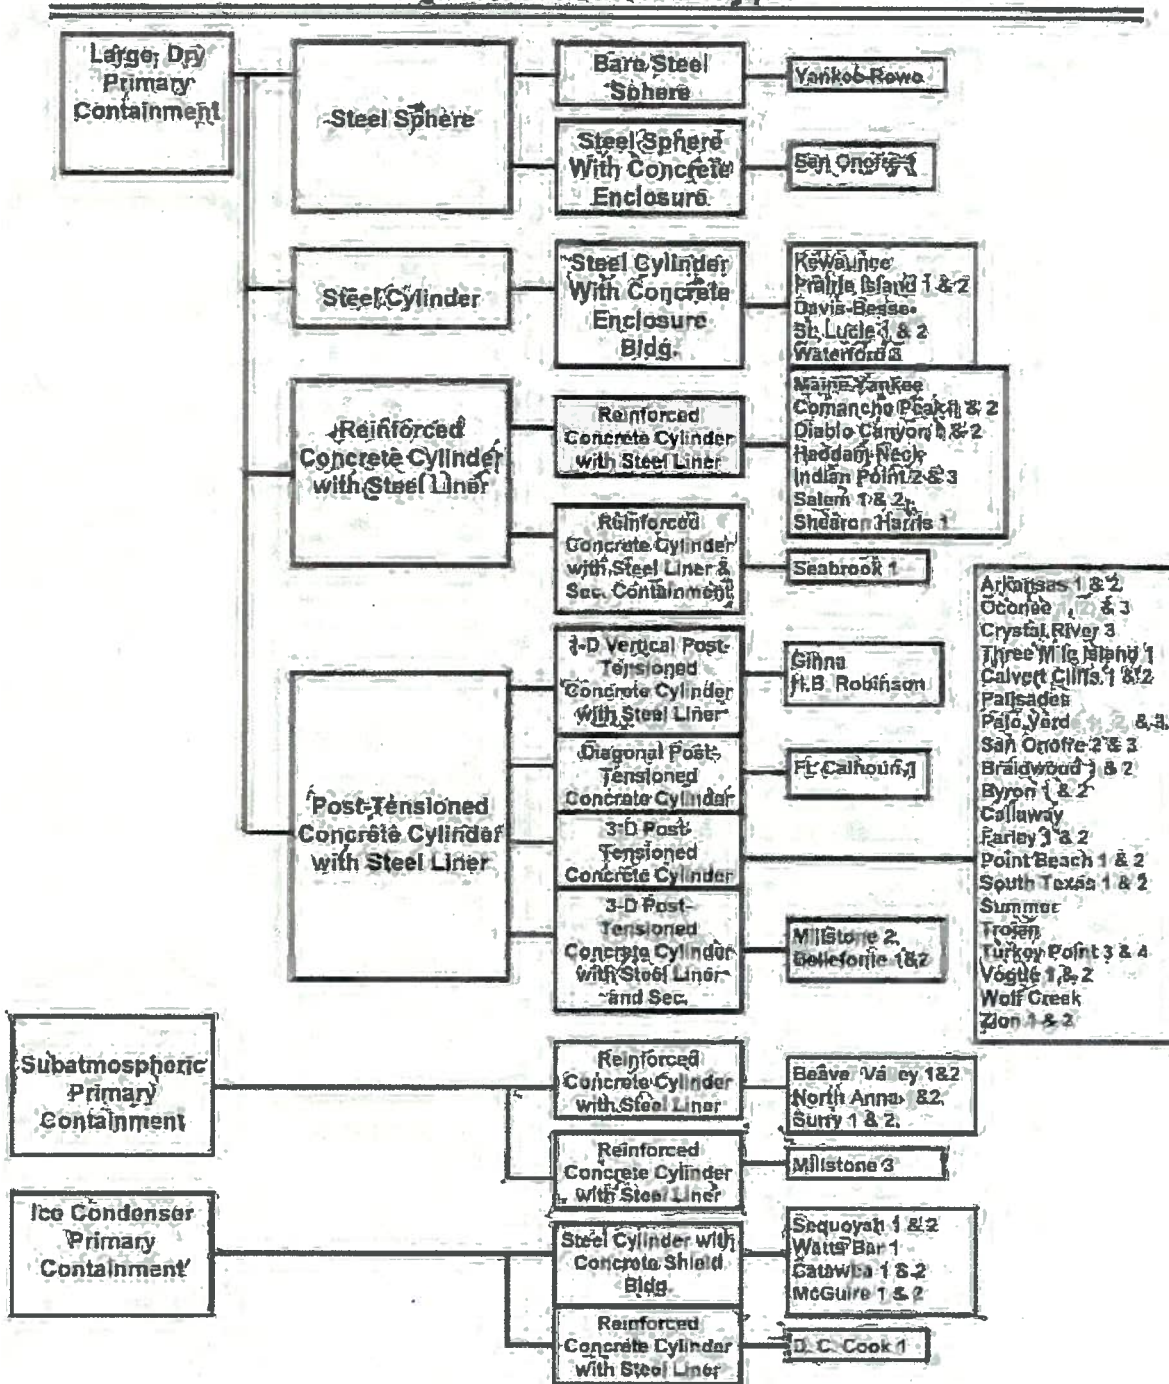
From USNRC: www.nrc.gov/reading_rm/reports/2002/02-010

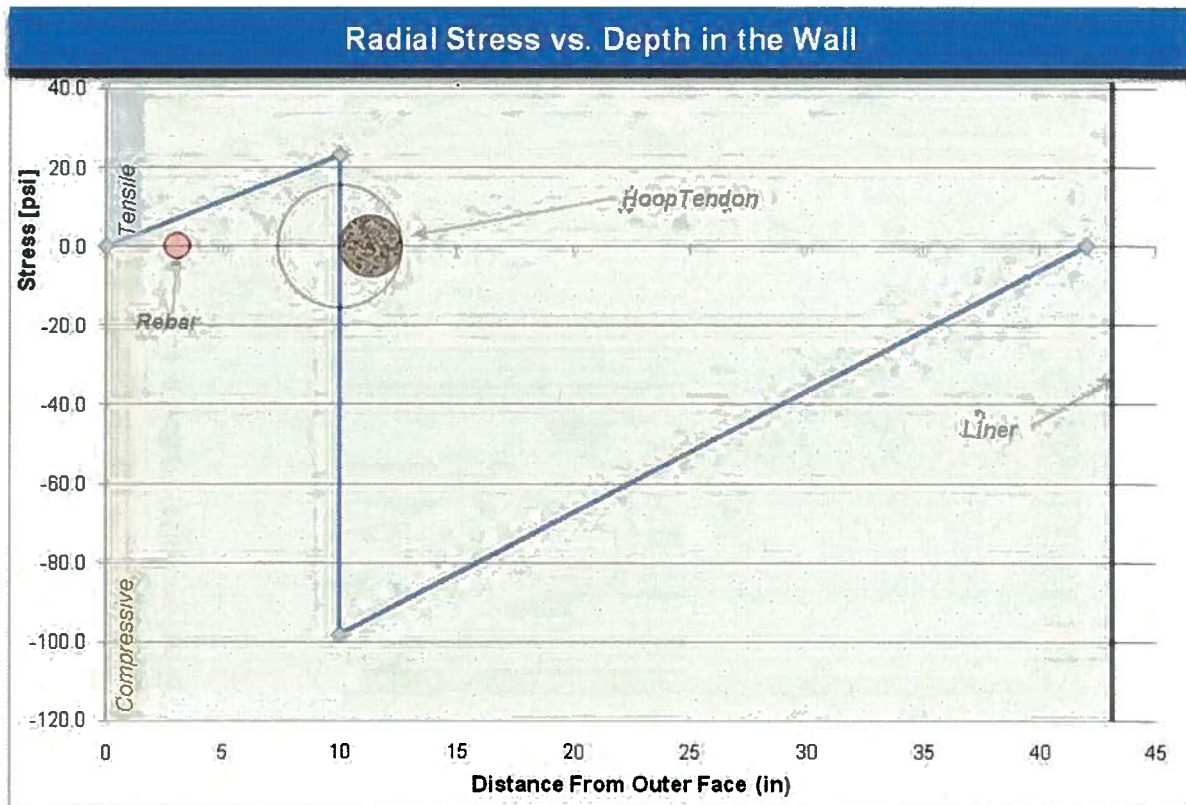
Figure 3.3 Tensile and compressive stresses in concrete wall cross-section due to horizontal tendons.

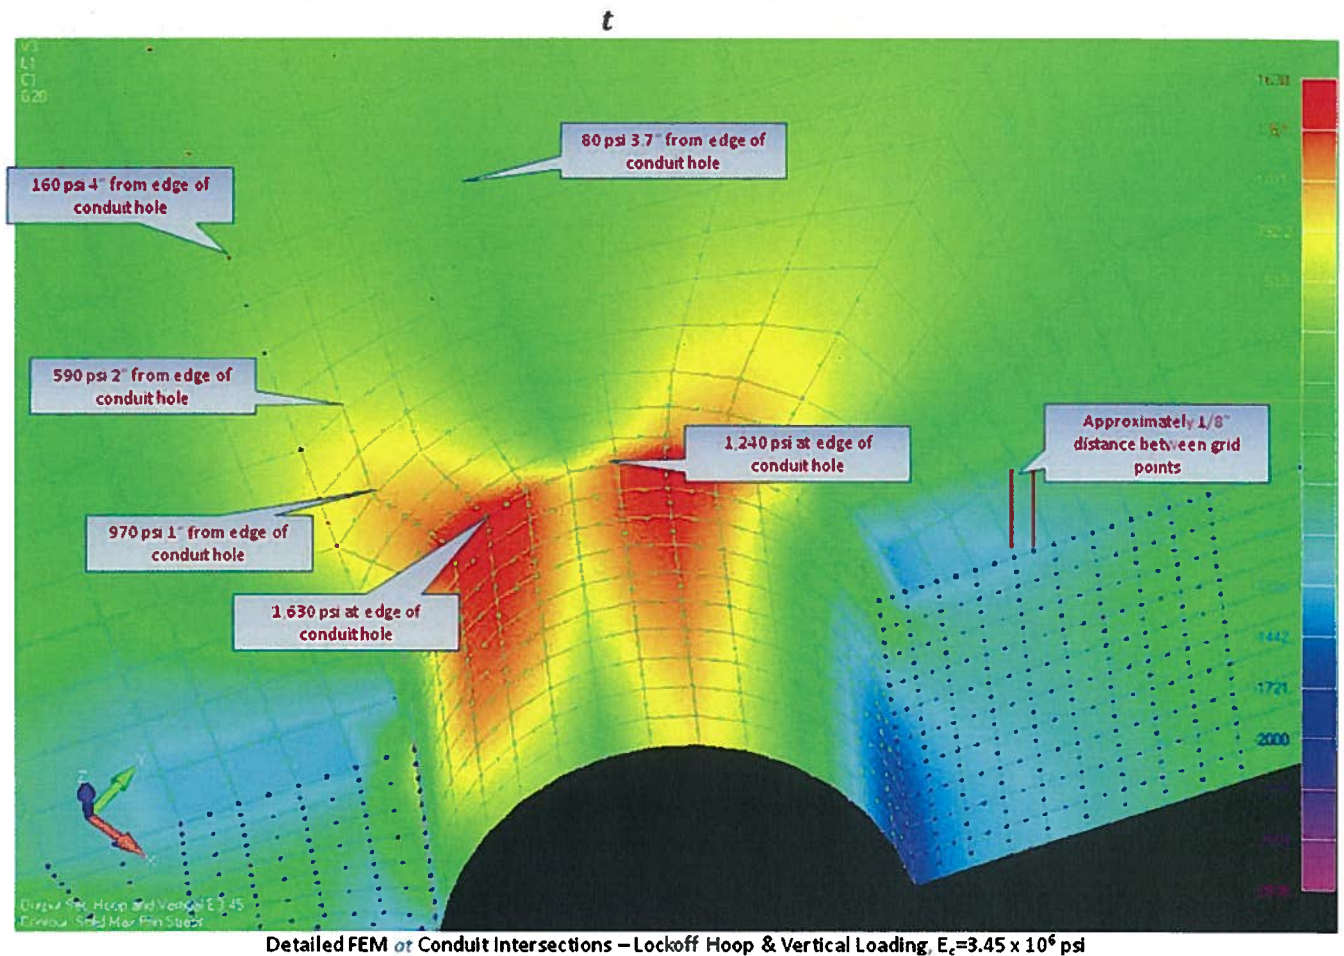
Figure 3.4 Stress contours for normally tensioned conditions at the intersection of a vertical and horizontal tendon.(3 Dimensional Effect Looking Through a Hoop Tendon Hole)

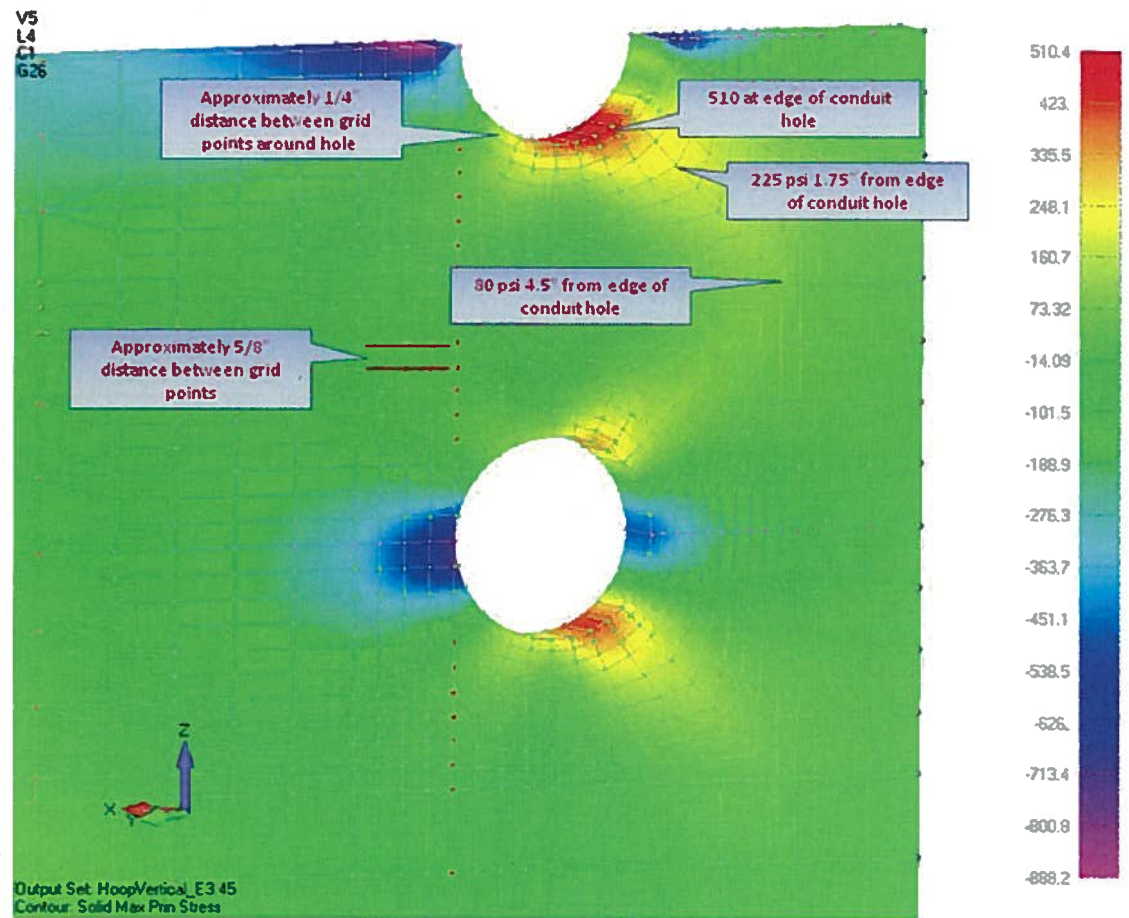
Expanded FEM *Between* Vertical Conduits – Lockoff Hoop & Vertical Loading, $E_c=3.45 \times 10^6$ psi

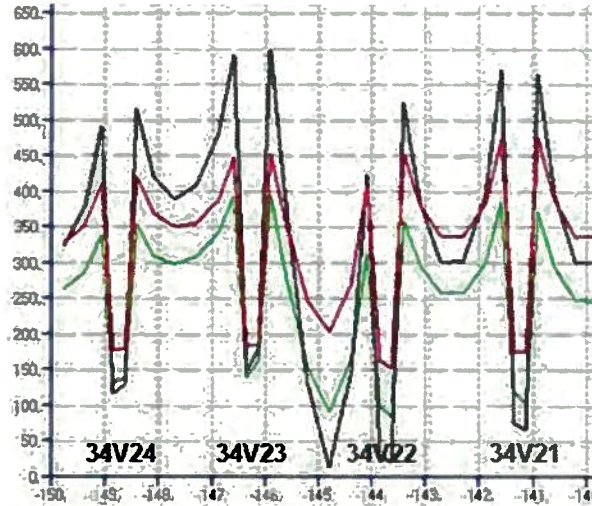
Circumferential Distance, feet and tendon number

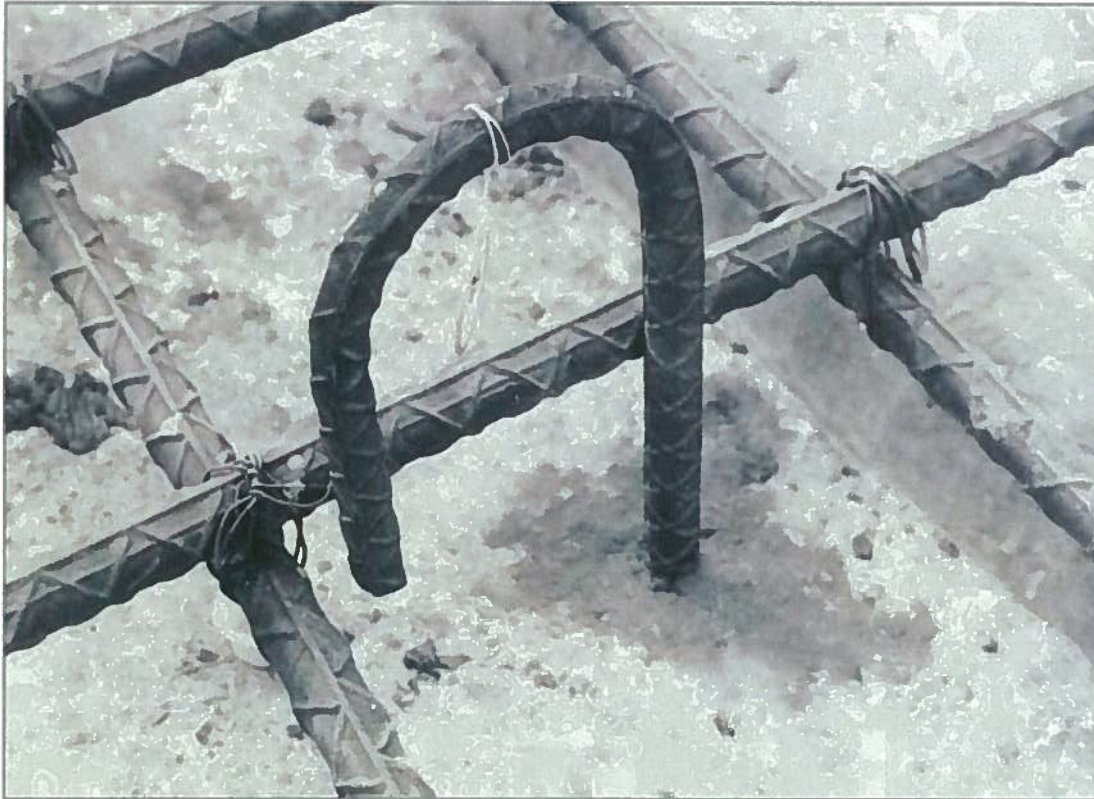
Figure 3.7 Photograph of a radial reinforcement installed as a corrective action to the CR3 Dome delamination

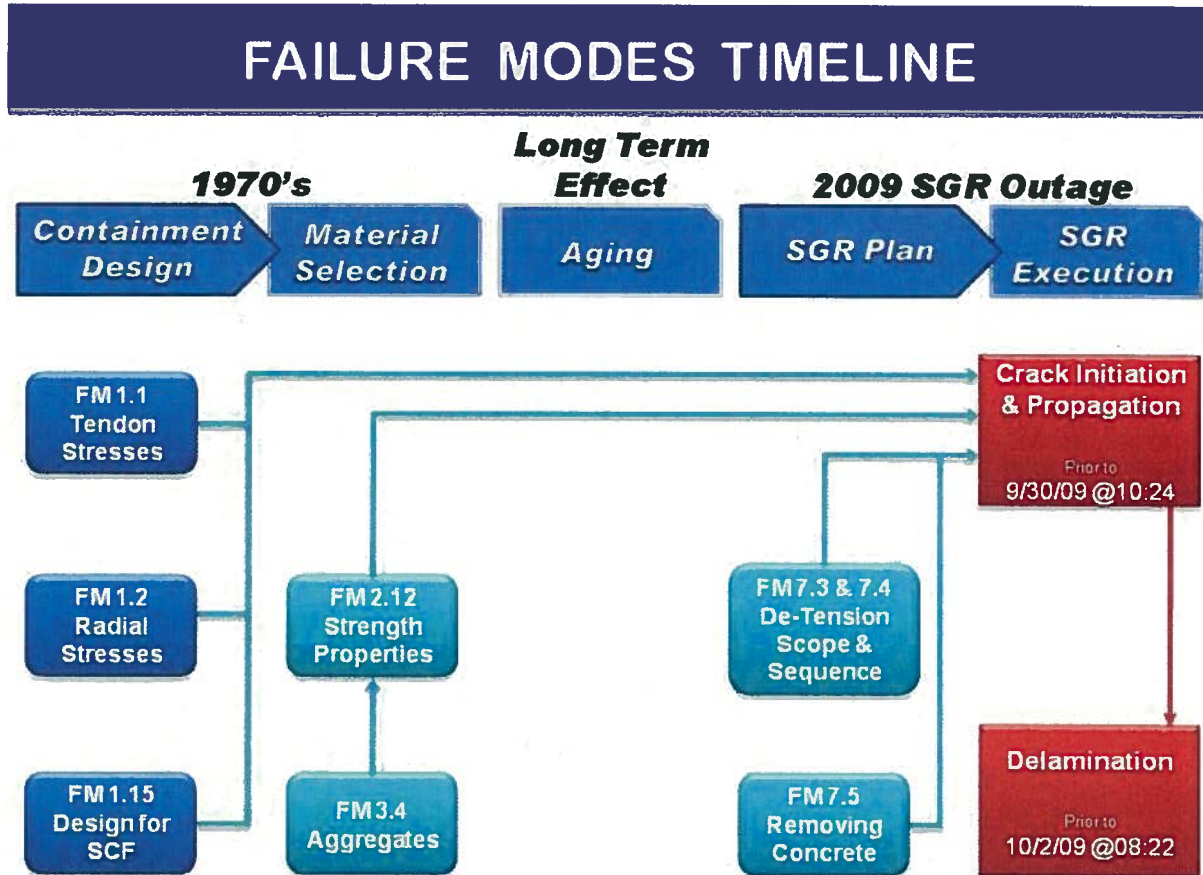
Figure 7.1 Failure Modes flow chart

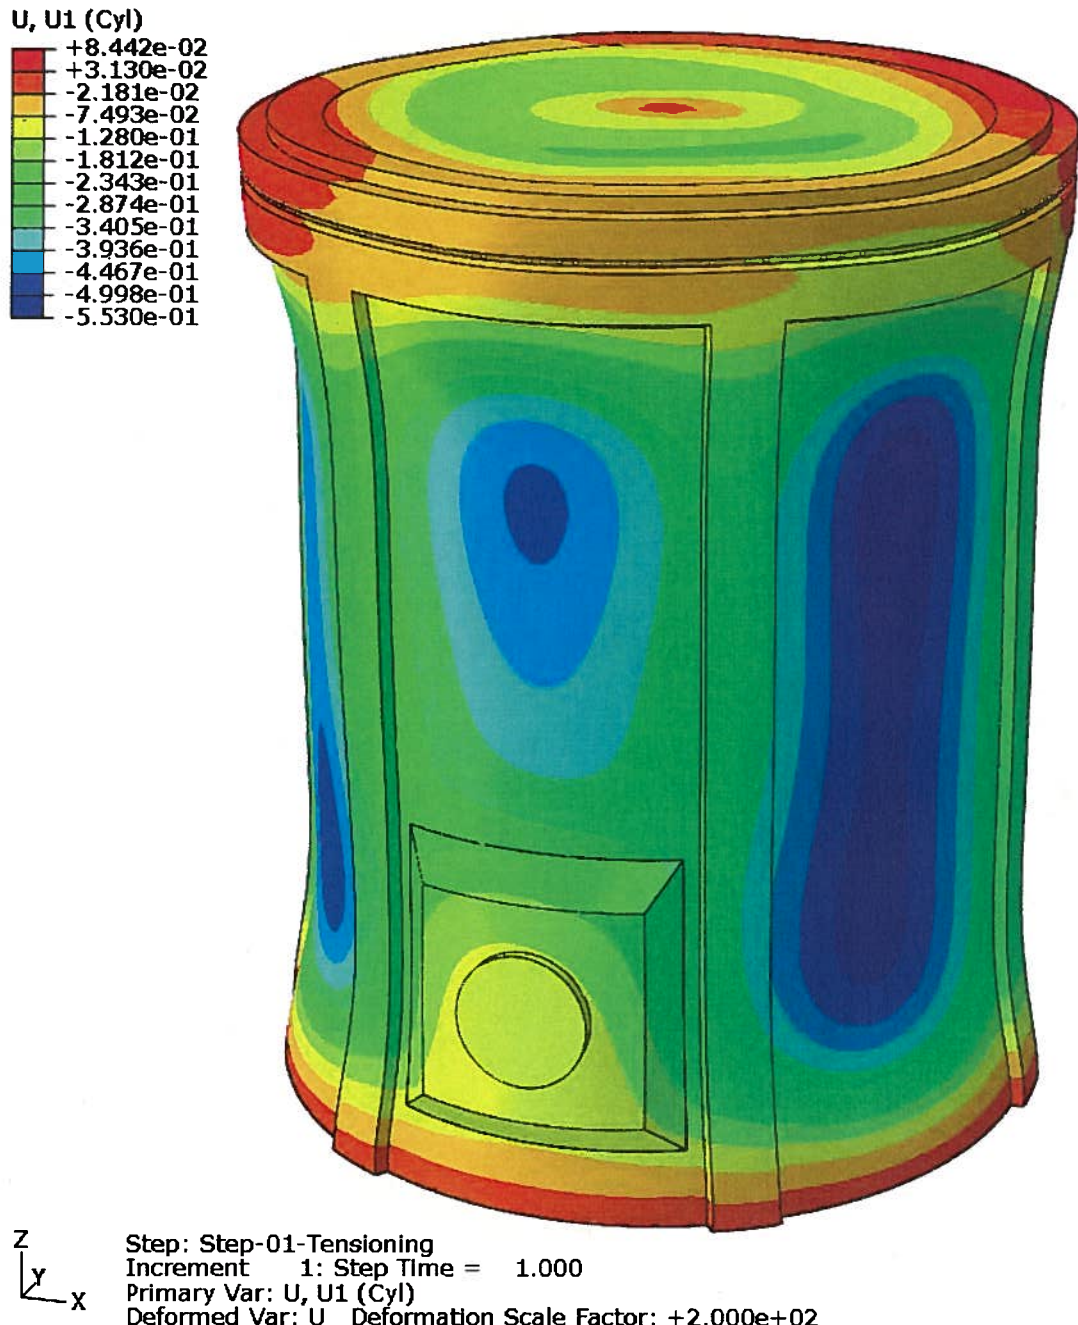
Figure 7.3 CR3 containment building fully tensioned.
The parameter being displayed (U) is radial displacement.
