**UNITED STATES
NUCLEAR REGULATORY COMMISSION**
REGION II
245 PEACHTREE CENTER AVENUE NE, SUITE 1200
ATLANTA, GEORGIA 30303-1257

October 12, 2010

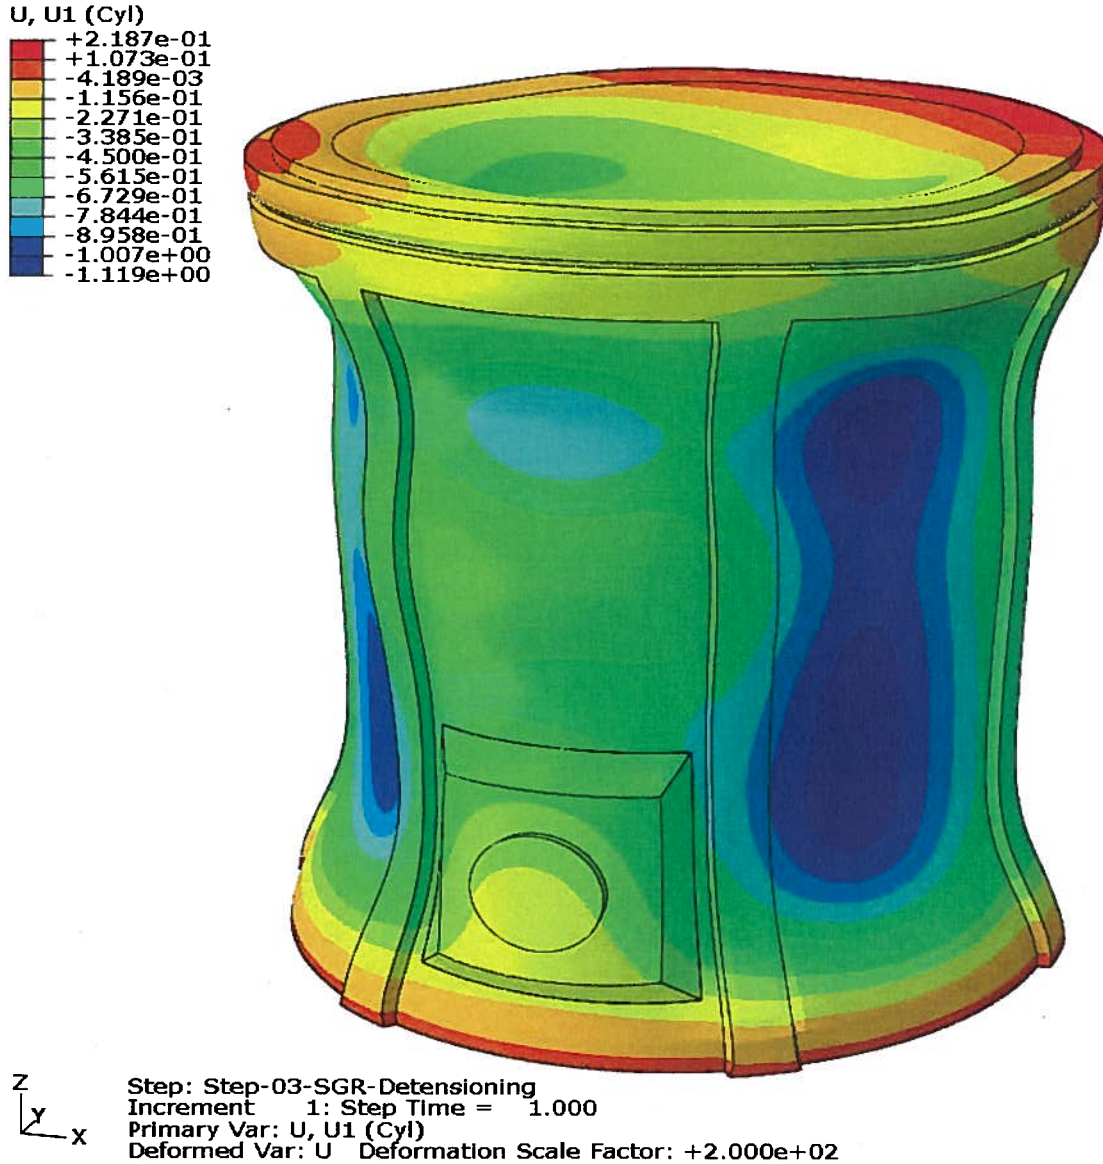
Figure 7.5 CR3 containment radial displacement post-SGR de-tensioning

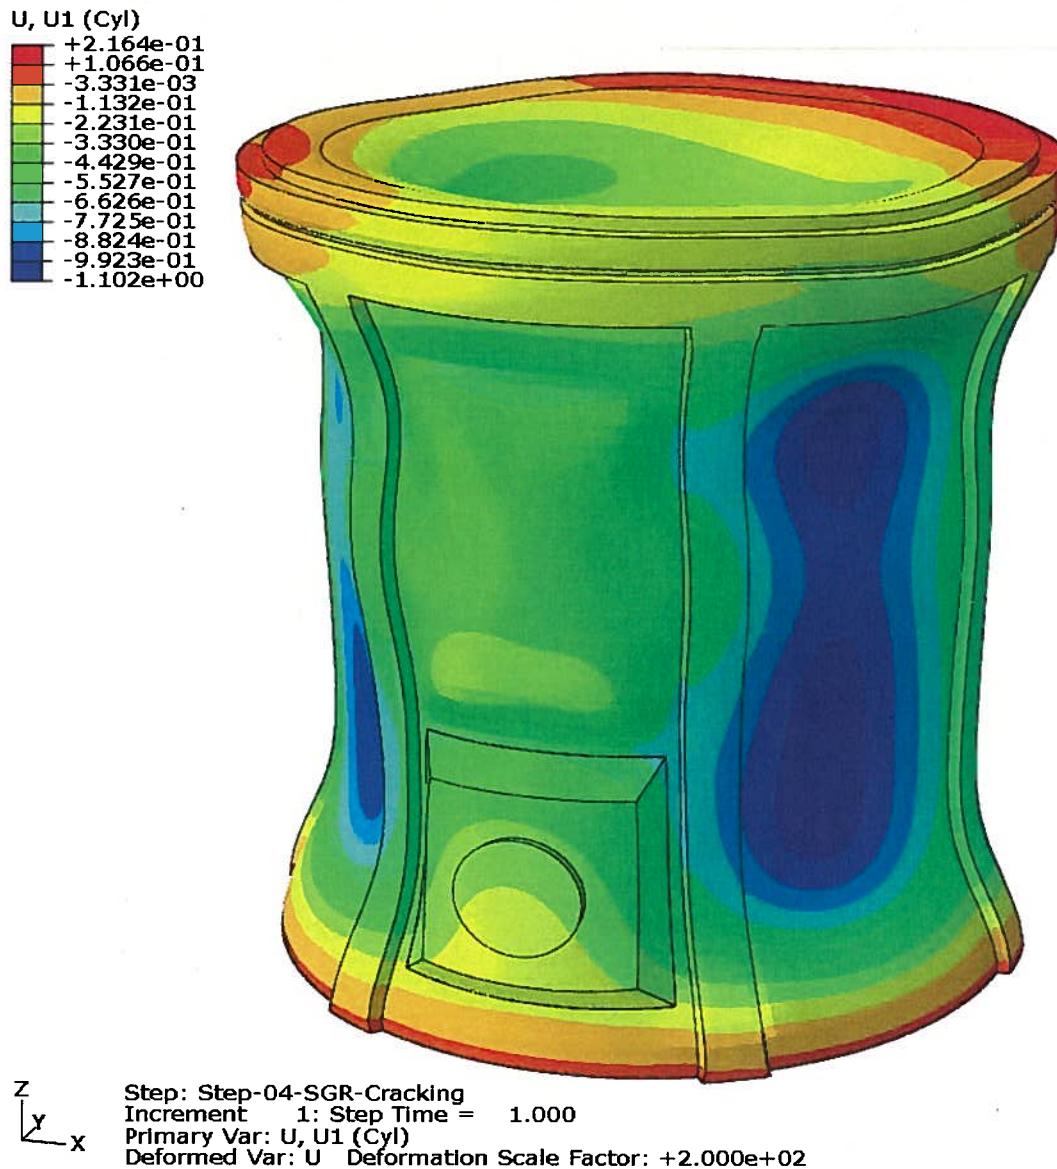
Figure 7.6 CR3 containment radial displacement post SGR de-tensioning

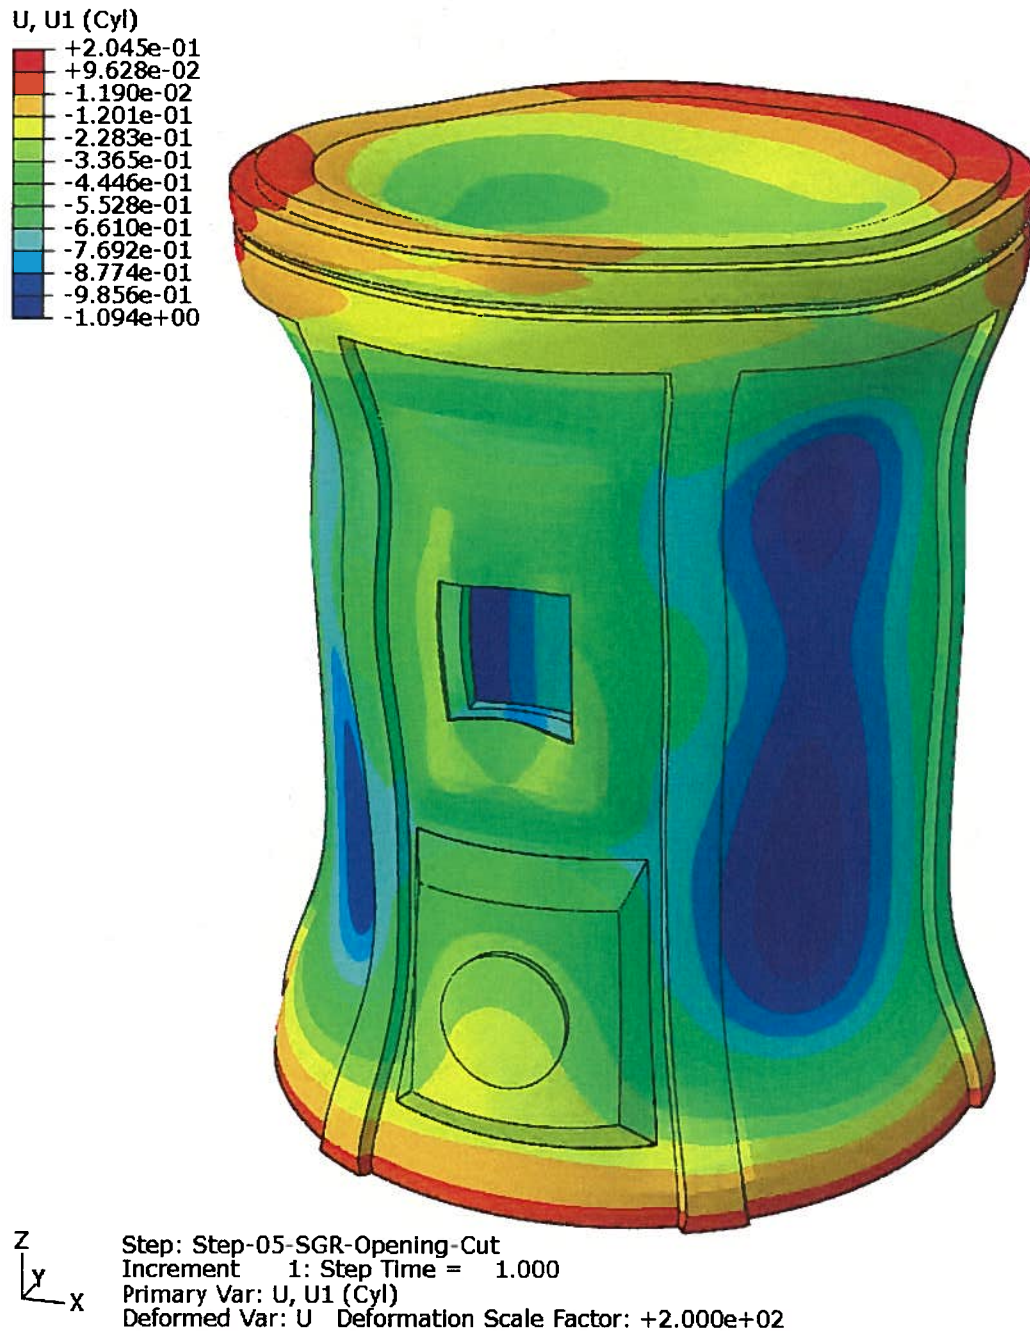
Figure 7.7 CR3 containment radial displacement after SGR opening completion.

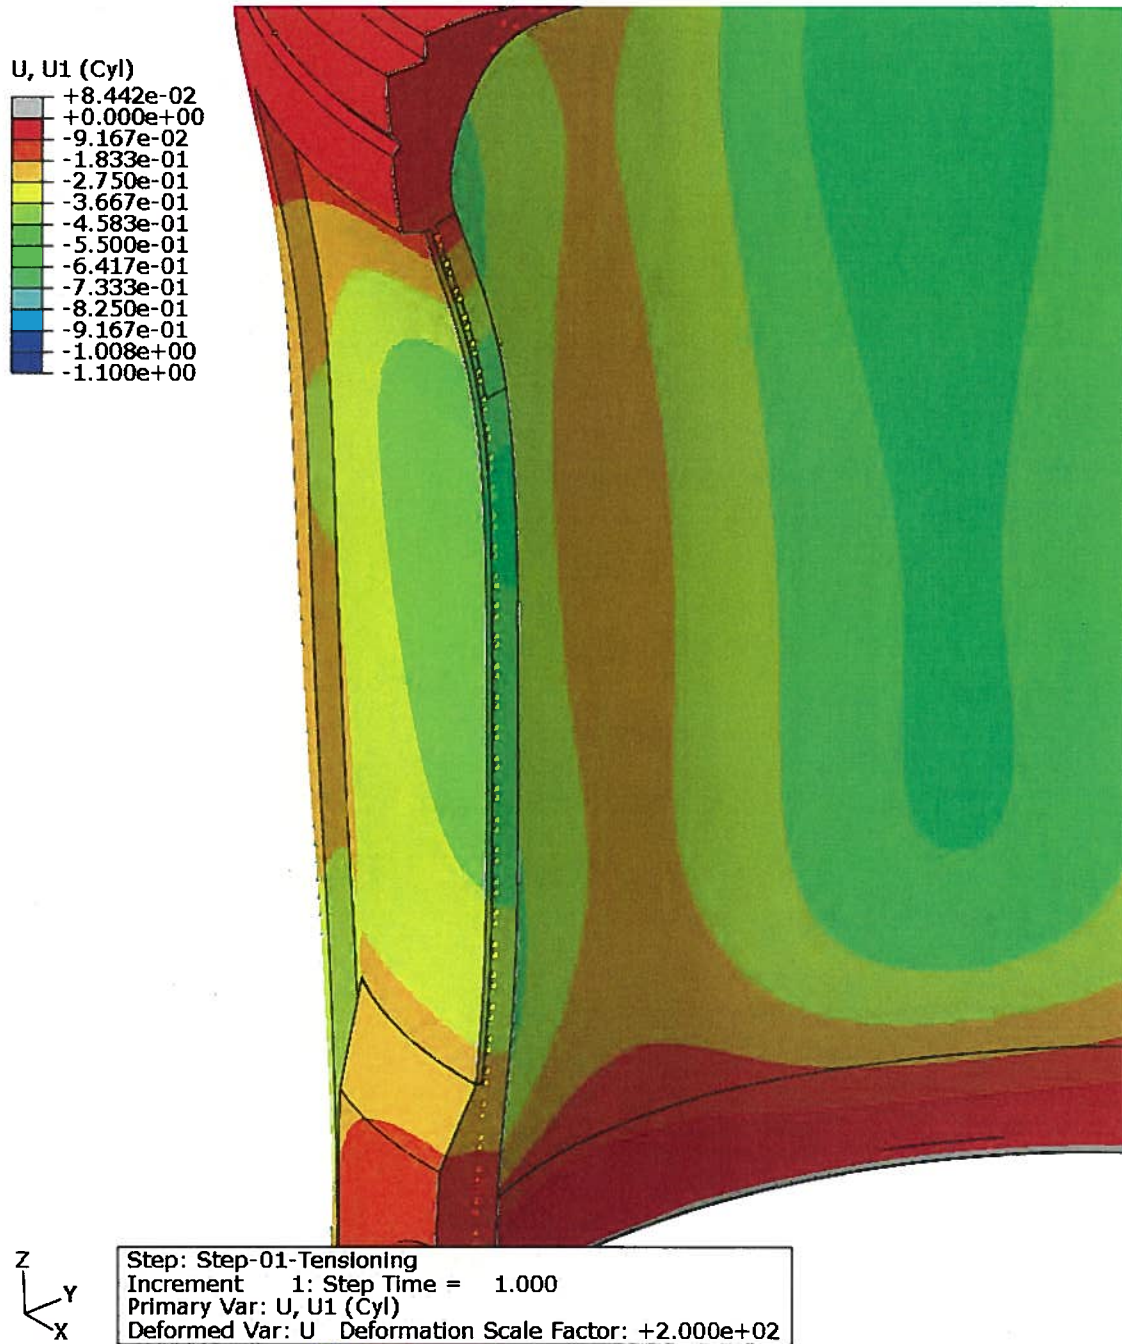
Figure 7.8 CR3 Bay 34 wall profile radial displacement post initial tensioning in 1975. The next milestone is in 2009 after 30 years of creep.

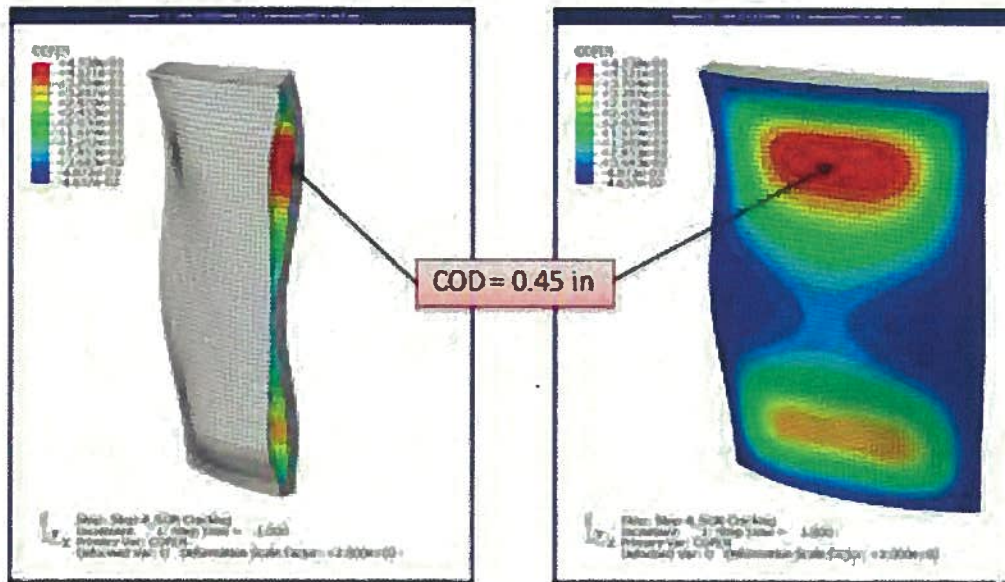
Figure 7.12 The Dimensional response to delamination – Step 4 SGR Cracking
Crack Opening Distance (COD) is the width of the crack that develops. Note the similarity of the pattern in this Figure to that in Figure 7.14.

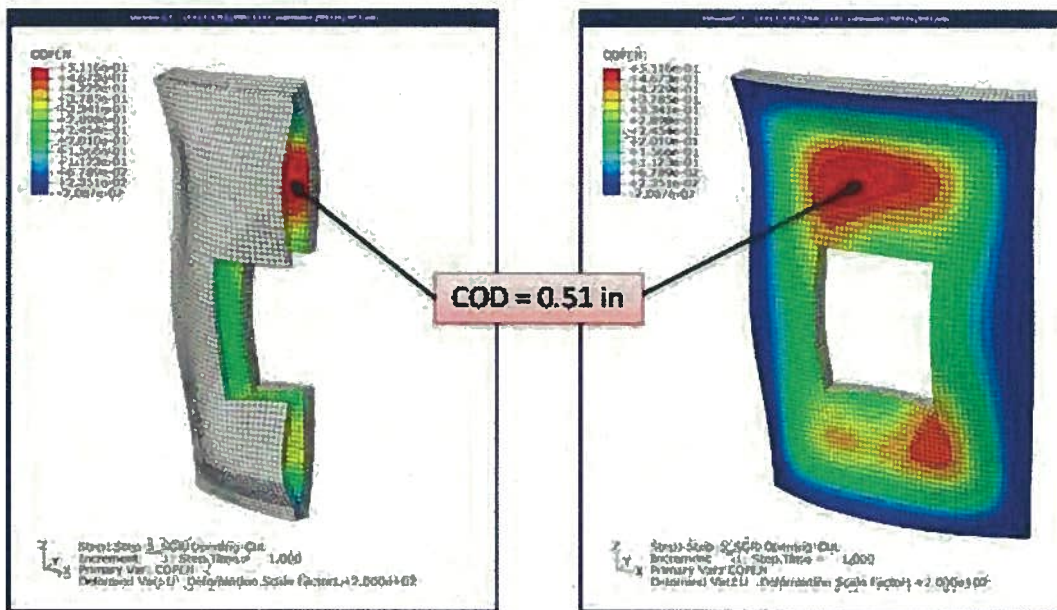
Figure 7.13 Crack Opening Distance (COD) after Concrete Removal – Step 5.
Note the width of the crack increased by about 10% due to concrete removal. Concrete removal does cause an increase but not a significant one.

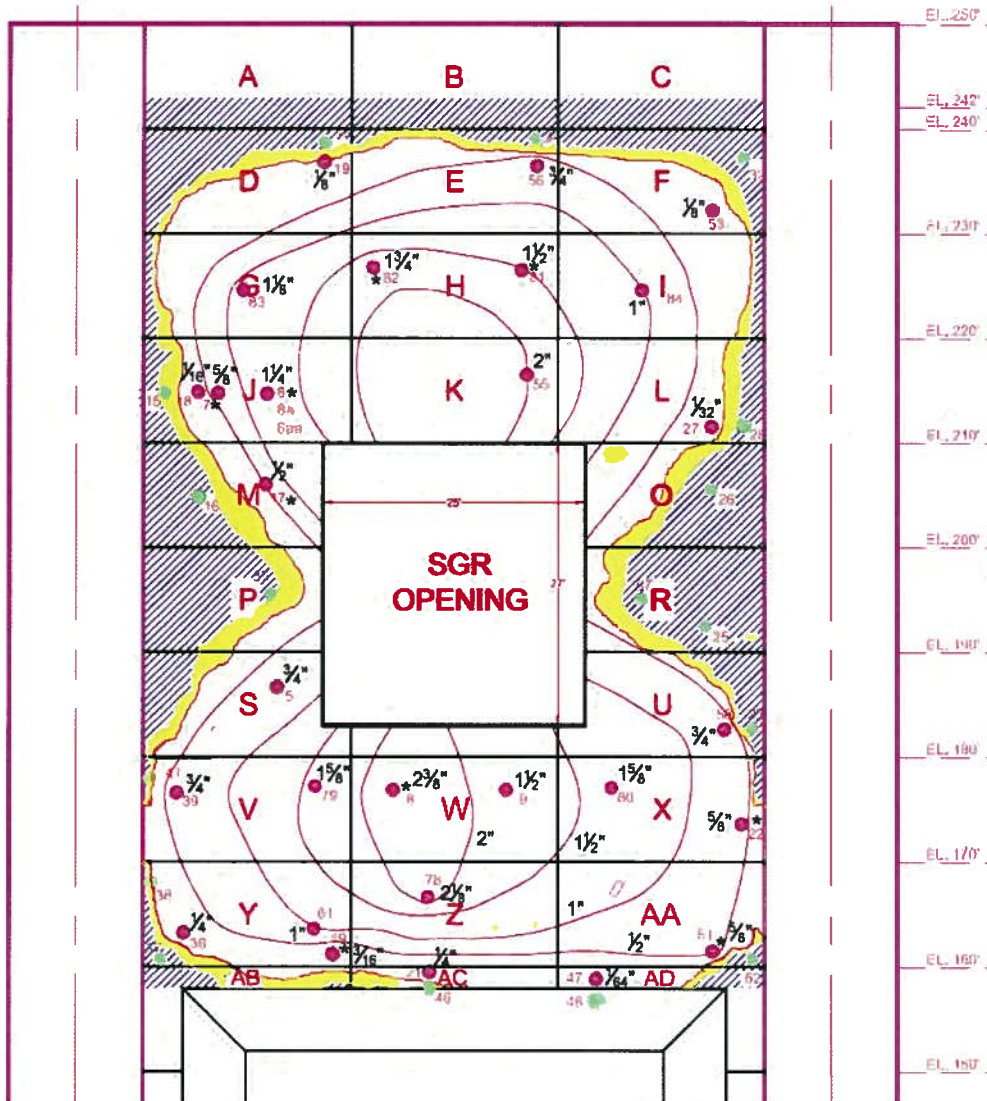
Figure 7.14 Plot of delamination damage in Bay 34. Shown are the measurements of the delamination gap both by impulse response test and by core bores.

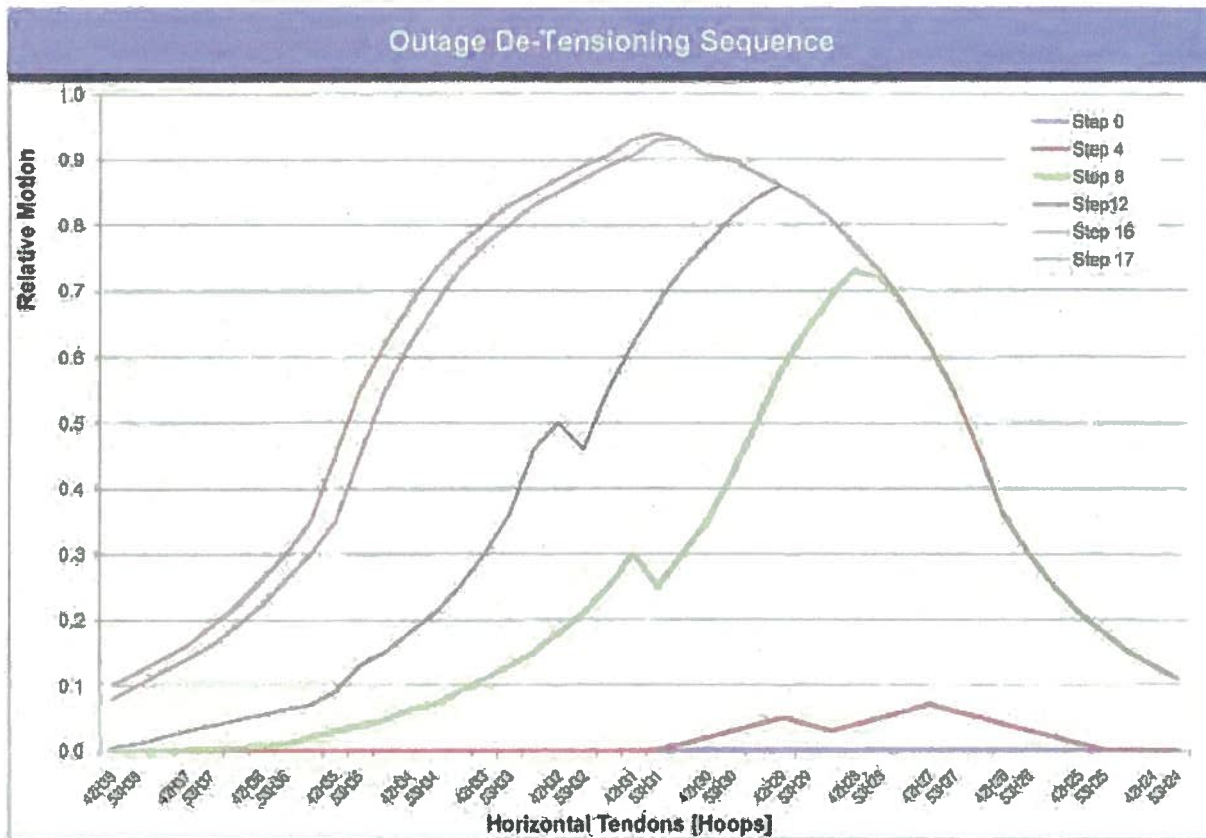
Figure 7.25 A Plot of the radial displacement in Bay 34 as SGR tendon de-tensioning progressed. The full displacement was 0.5”.

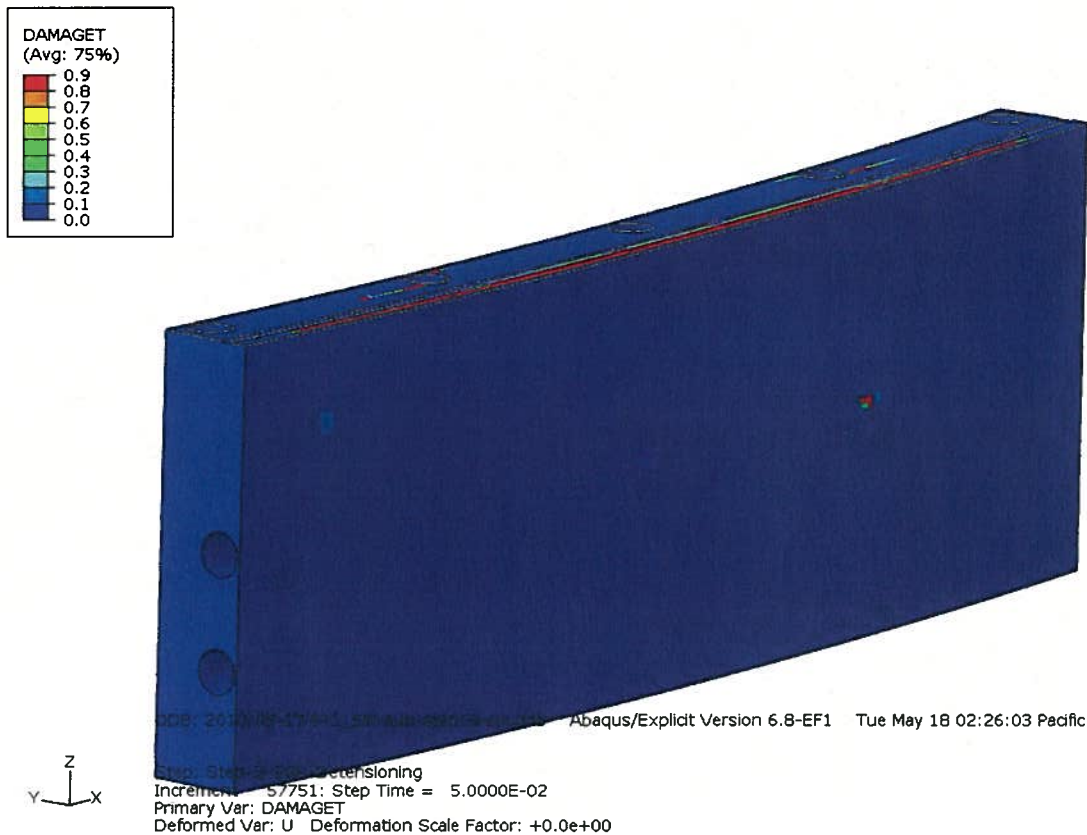
Figure 7.26 A Plot of a bay 34 wall segment approaching delamination.

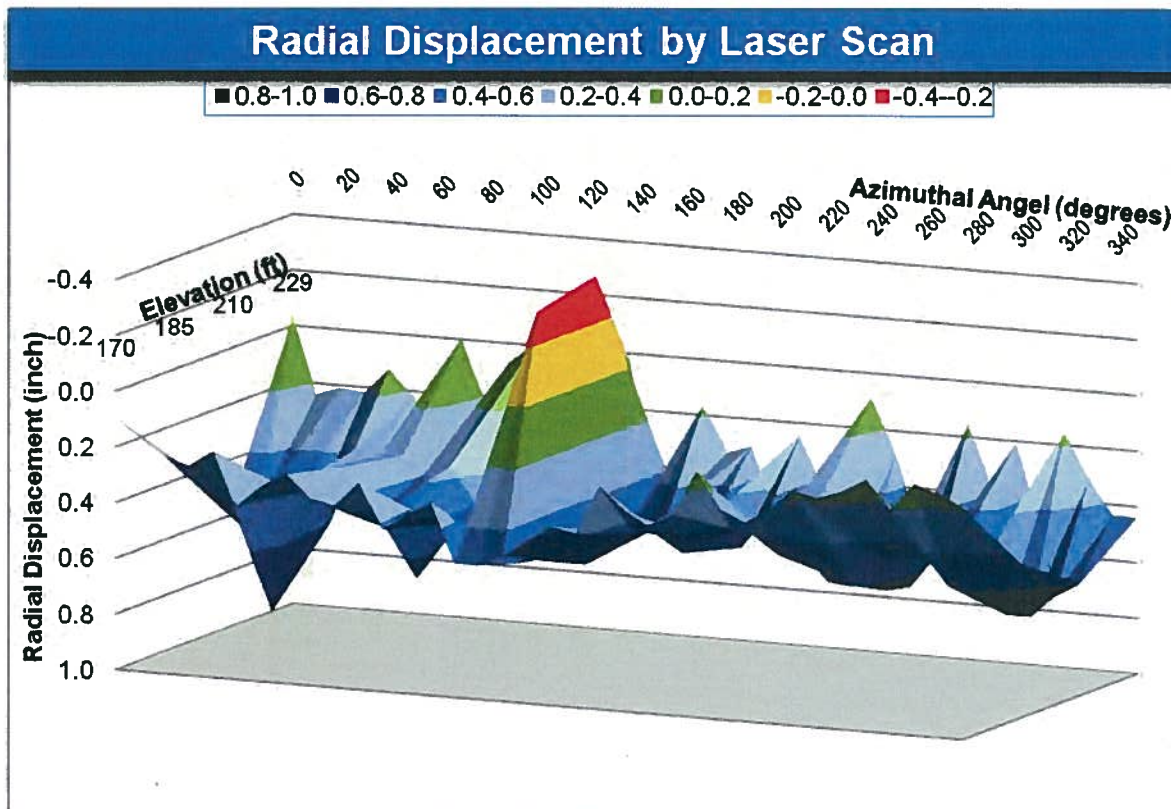
Figure 7.30 Three dimensional representation of radial displacement as a function of azimuthal angle and elevation.

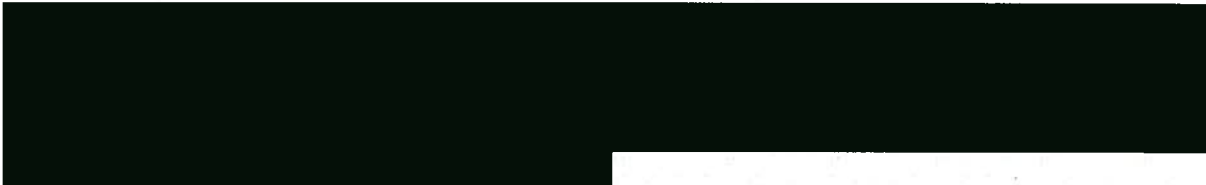
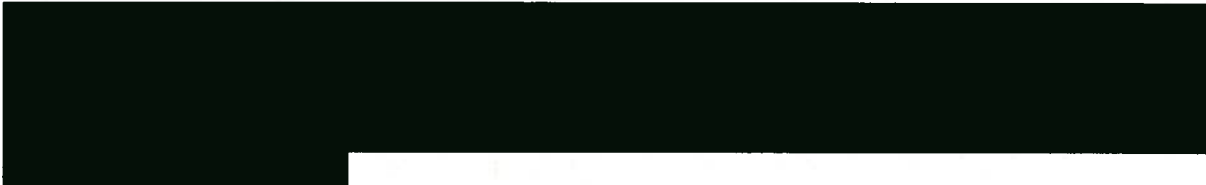
The dome tendon lock-off loads are applied to an angled surface on the outer edge of the ring girder such that the total force balance is properly equilibrated. The angle of the lock-off surface is calibrated to ensure the sum of all the forces is zero.

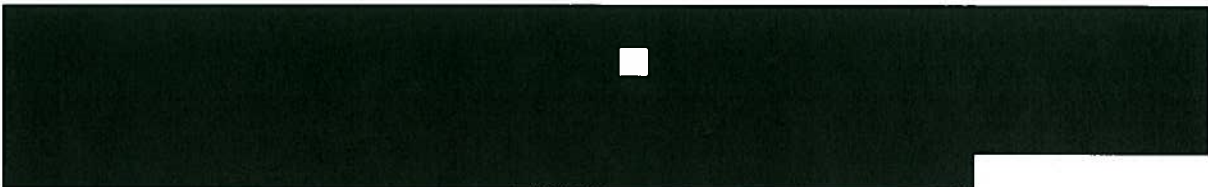
There are a number of ways to address the mesh issue. For radial displacements or general stress calculations, [REDACTED] mesh is sufficient to obtain realistic values. For scenarios which depend heavily on peak stress values one approach is to use a stress concentration factor. Recent comparisons indicate that for global Abaqus that factor would be about [REDACTED]. For the detailed sub-model it would be about [REDACTED]. Another way to achieve exactly the same result is to adjust the tensile capacity of the concrete. For events such as the onset of delamination, the details of the process are very sensitive to the peak stresses involved and fine mesh analysis is the best approach. Once initiated, delamination is less sensitive to peak parameters so the overall extent and width of cracking can be well described by a detailed sub-model or even the normal sub-model.

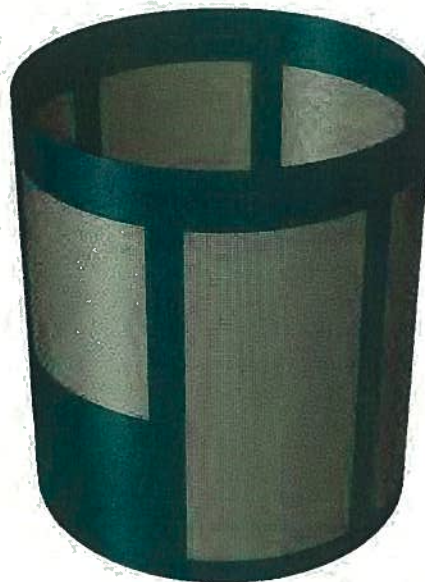
Figure A1.4 Hoop layer for monitoring delamination

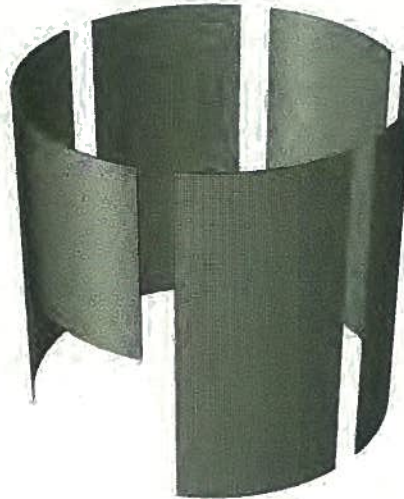
Figure A1.6 Damage material region within the horizontal tendon layer (capable of cracking and delaminating.)

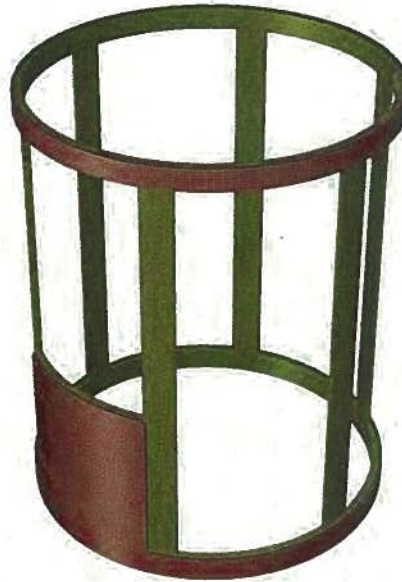
Figure A1.7 The global model provides displacement values which load the driven regions creating boundary conditions for the sub-model.

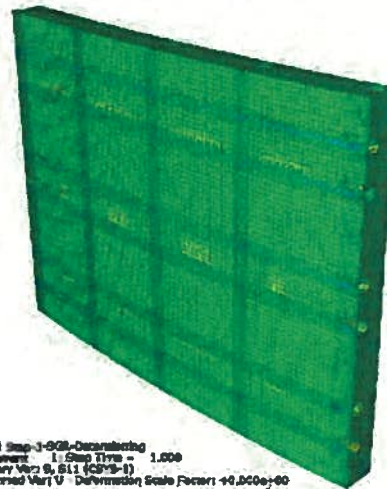
Figure A1.8 Detailed model including 6 horizontal and 3 vertical tendons

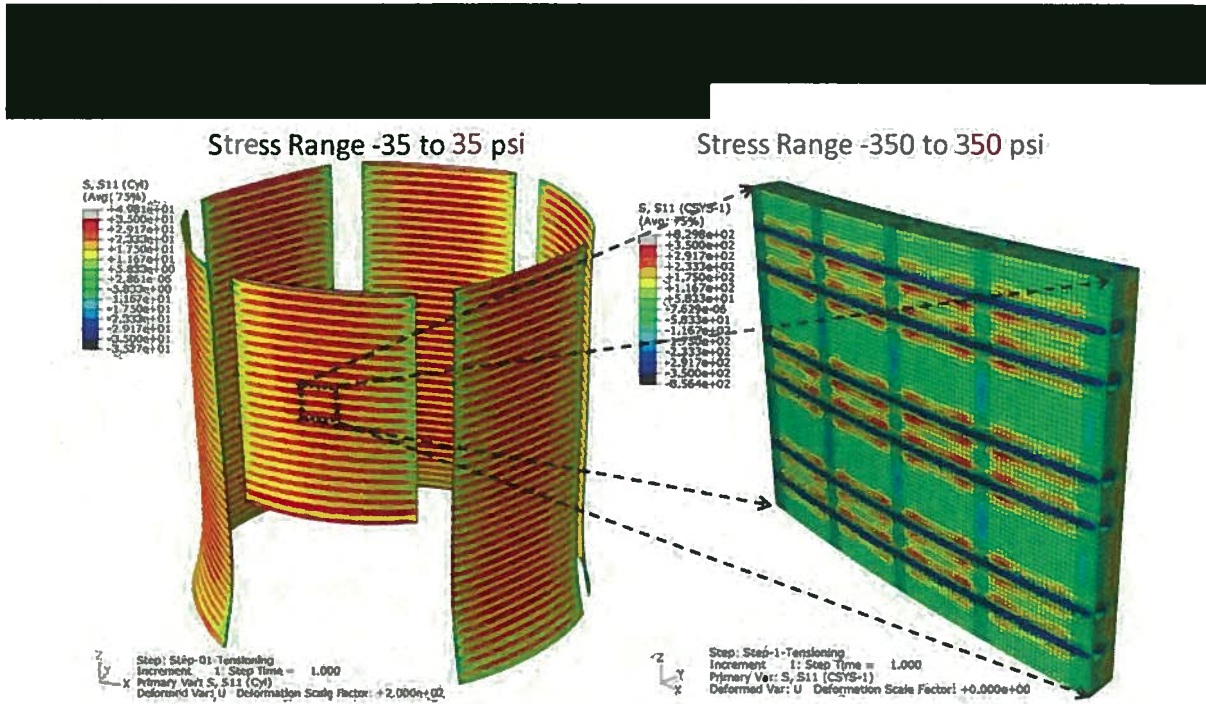
Approximately a factor of 10 difference in peak radial stress on outside of the hoop layer

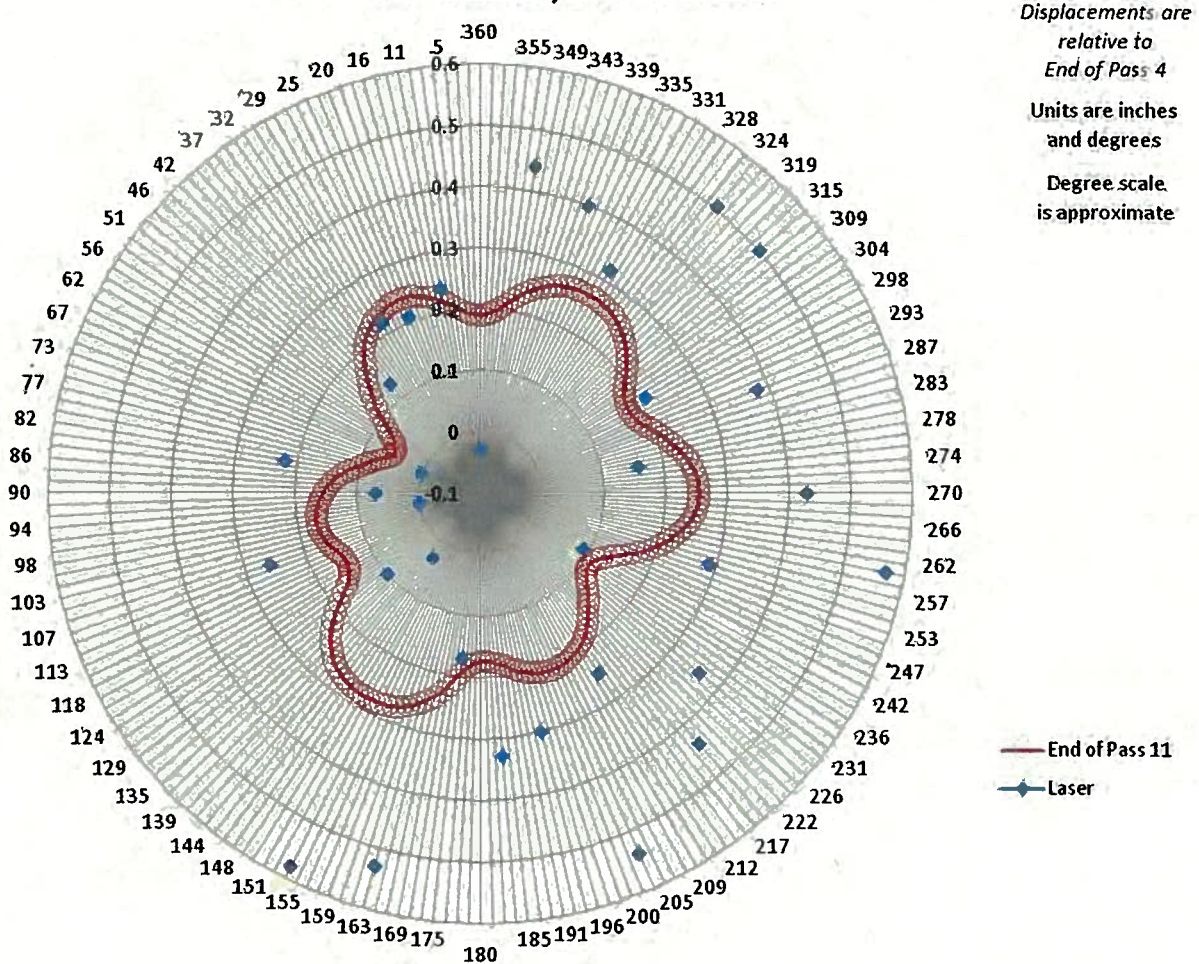
Figure A2.3 Comparison of PII computer model predictions for radial displacement from pass 4 through pass 11 at elevation 229' to the laser scanning data.

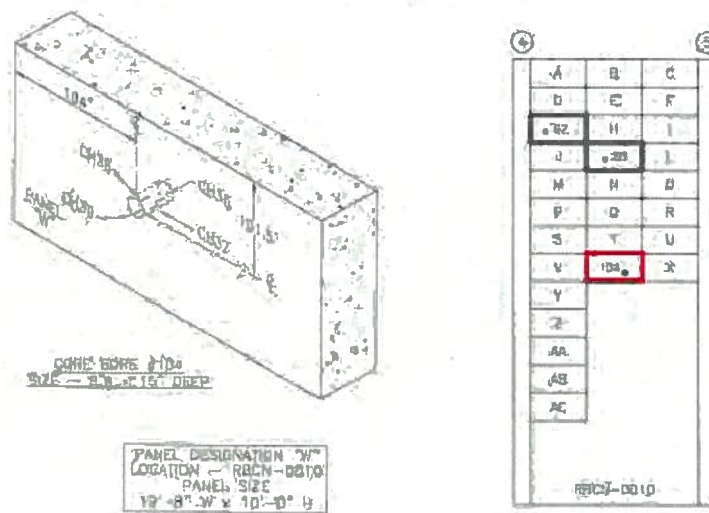
Figure A2.9 Detectors #36 to #39 in bore hole 104 and the location of bore hole 30.

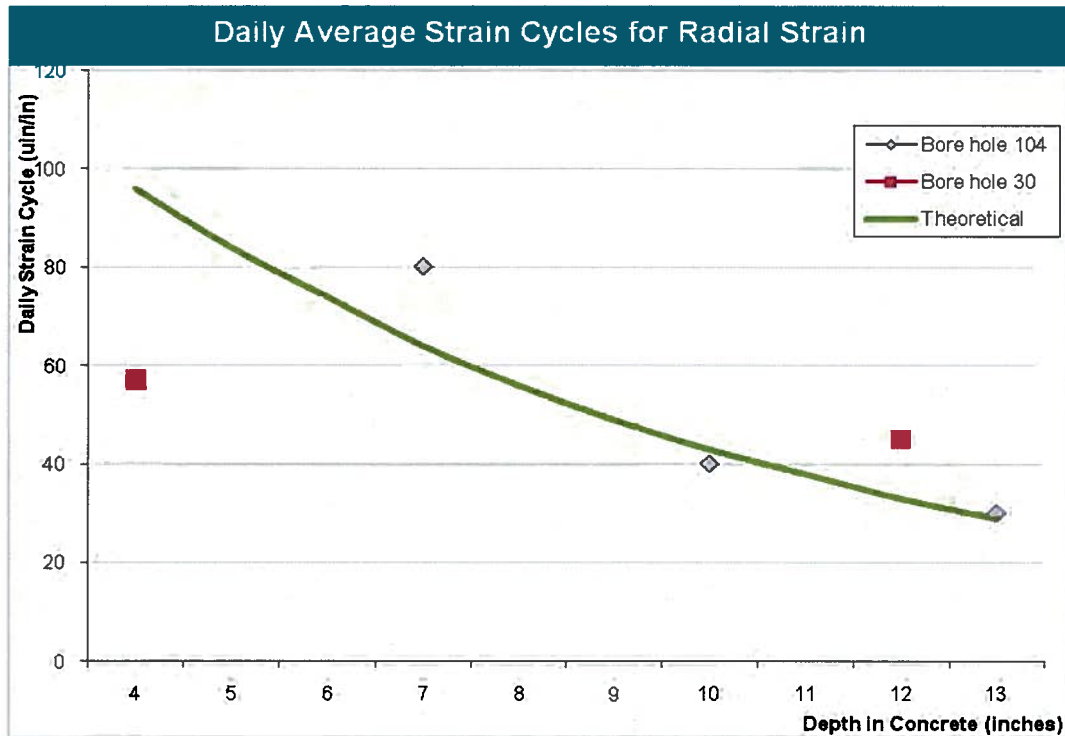
Figure A3.1 Plot of average daily radial strain cycles as a function of depth in concrete

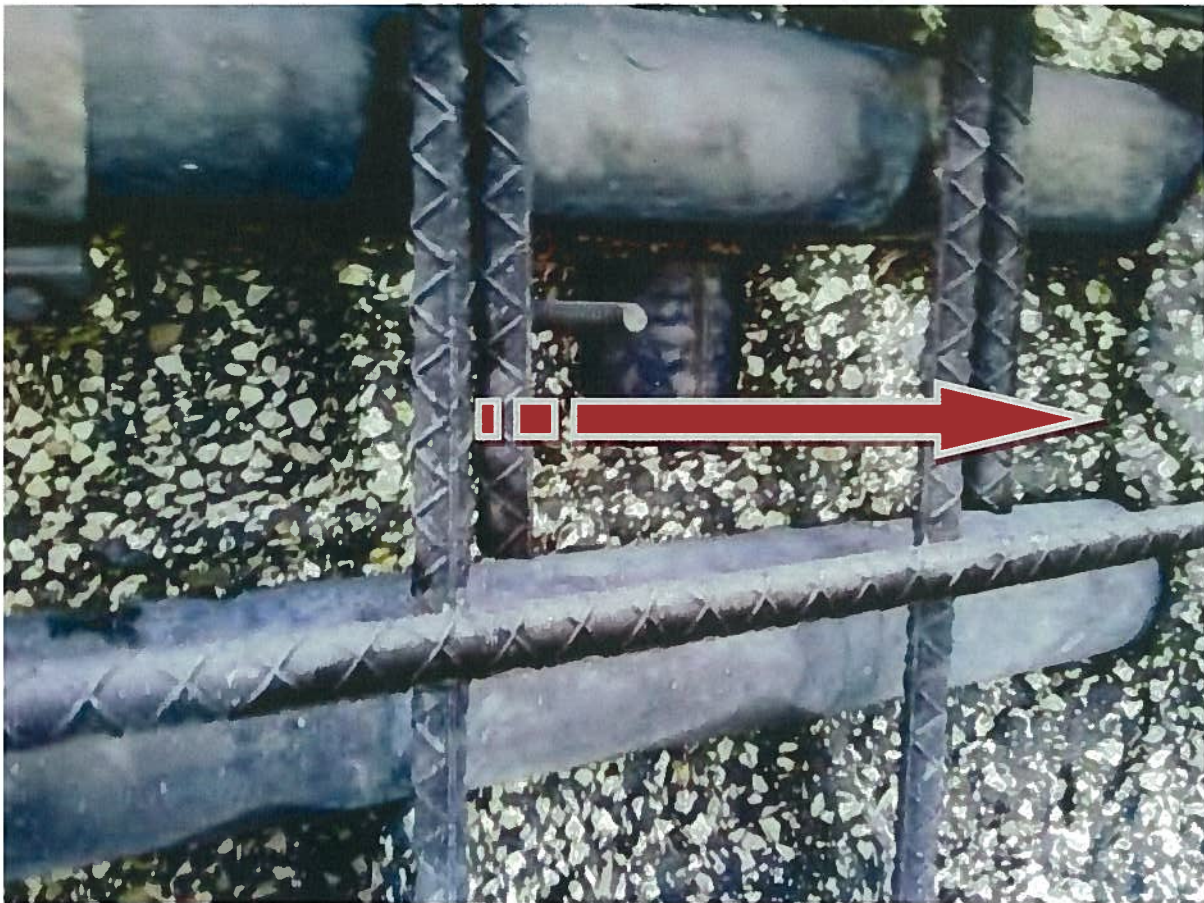
Figure A4.1 The first indication of cracking between horizontal tendons taken on 9/30.

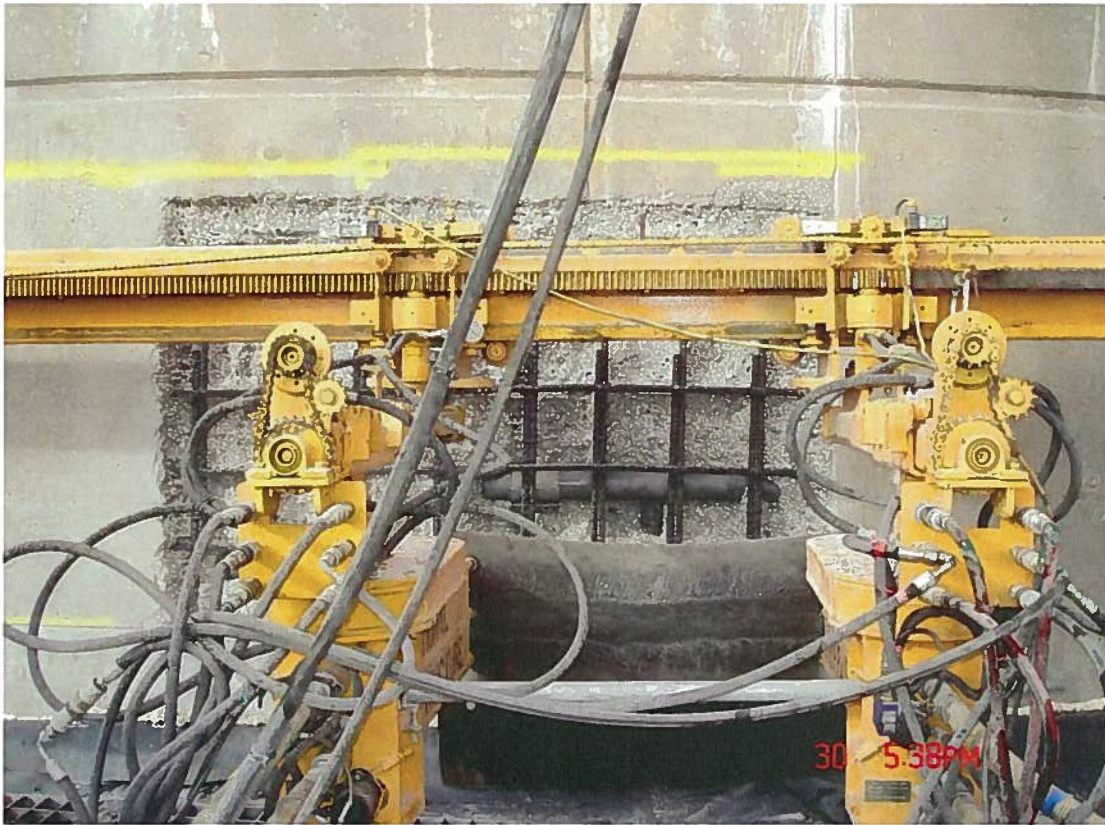
Figure A4.2 Photograph of overall status of demolition taken on 9/30/09.at 17:38

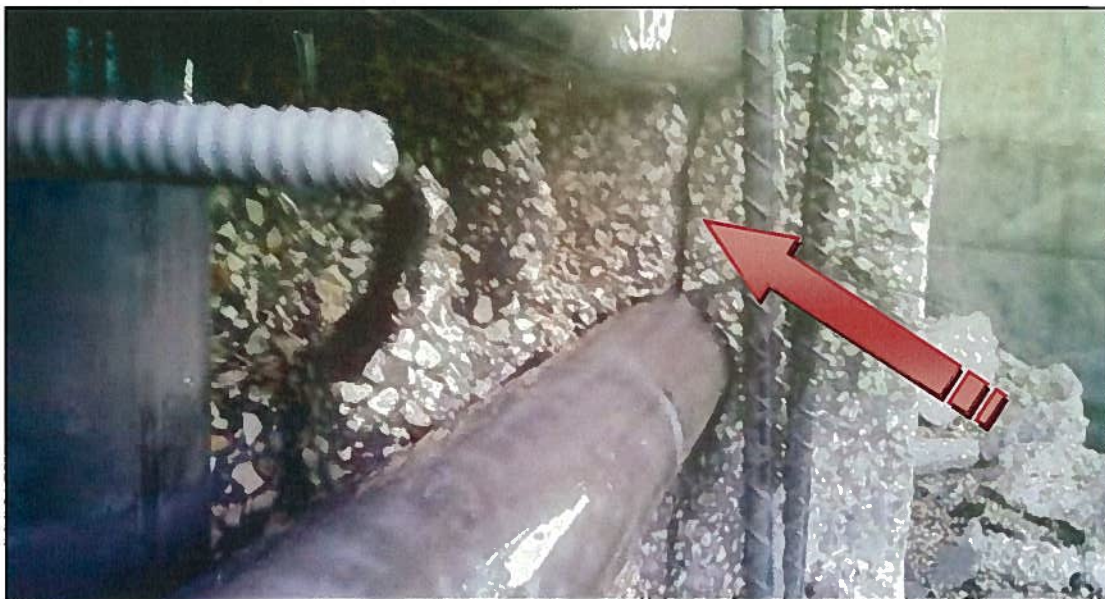
Figure A4.3 Another crack photograph taken on 10/01/09

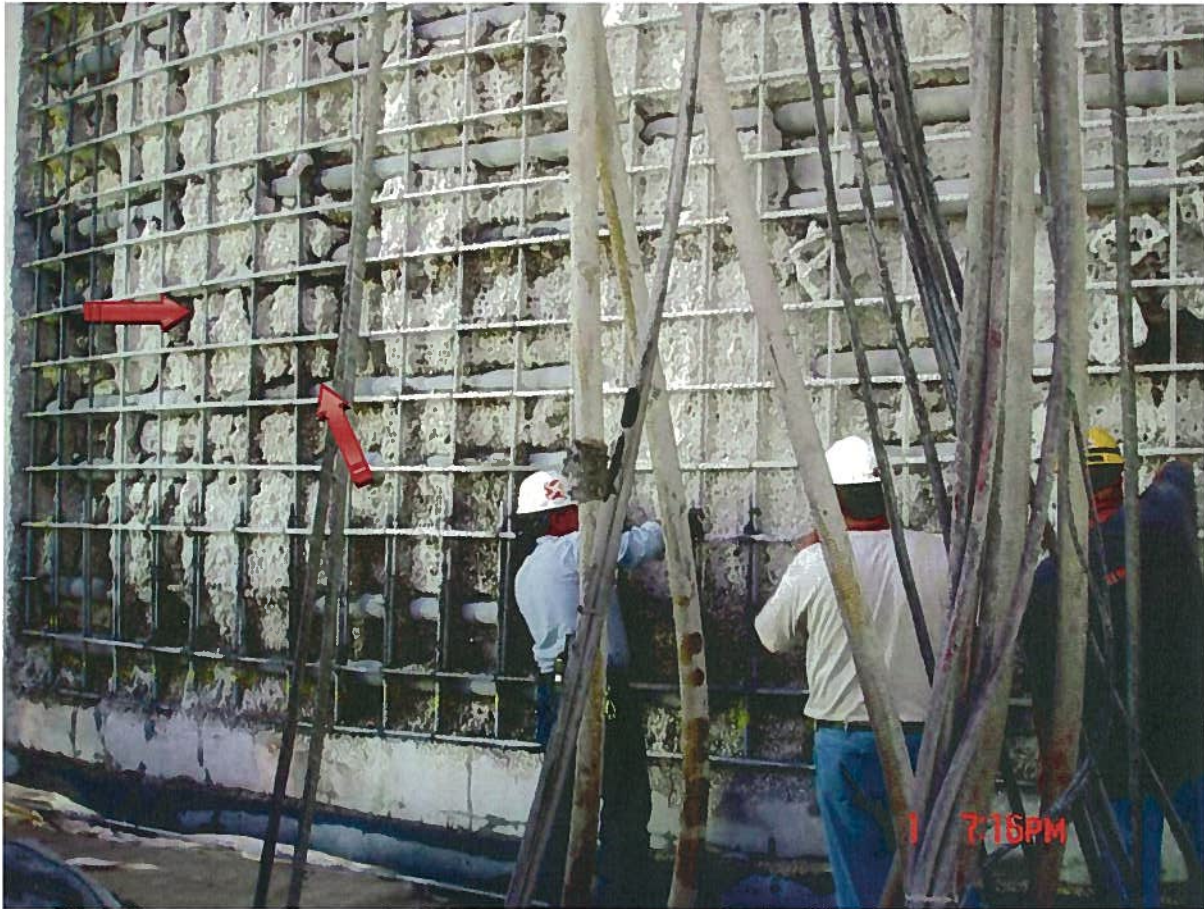
Figure A4.4 Photograph of demolition on the evening of 10/1/09. Note the large blocks of broken concrete in the middle of the opening.

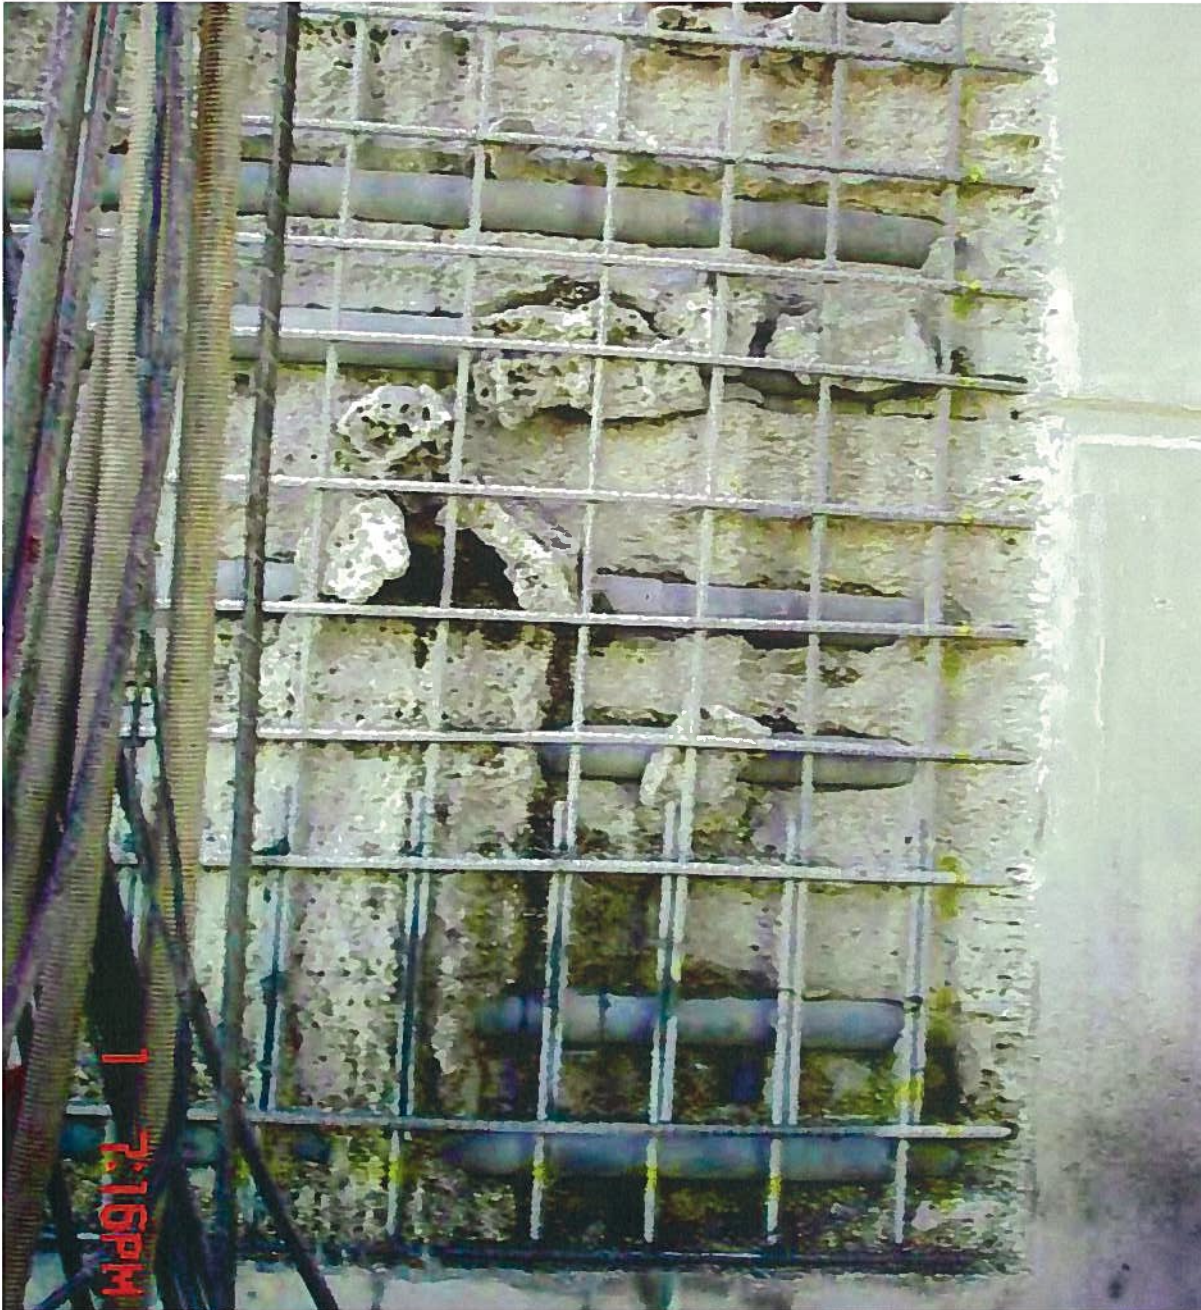
Figure A4.5 Another early photograph (10/1/09) of concrete debris, showing the distribution of horizontal tendons. The horizontal tendons come in pairs centered 13 inches apart. The distance between pairs is 26 inches. The horizontal tendons are outside the vertical tendons and define the transition from radial tension stress to radial compression stress in the concrete.

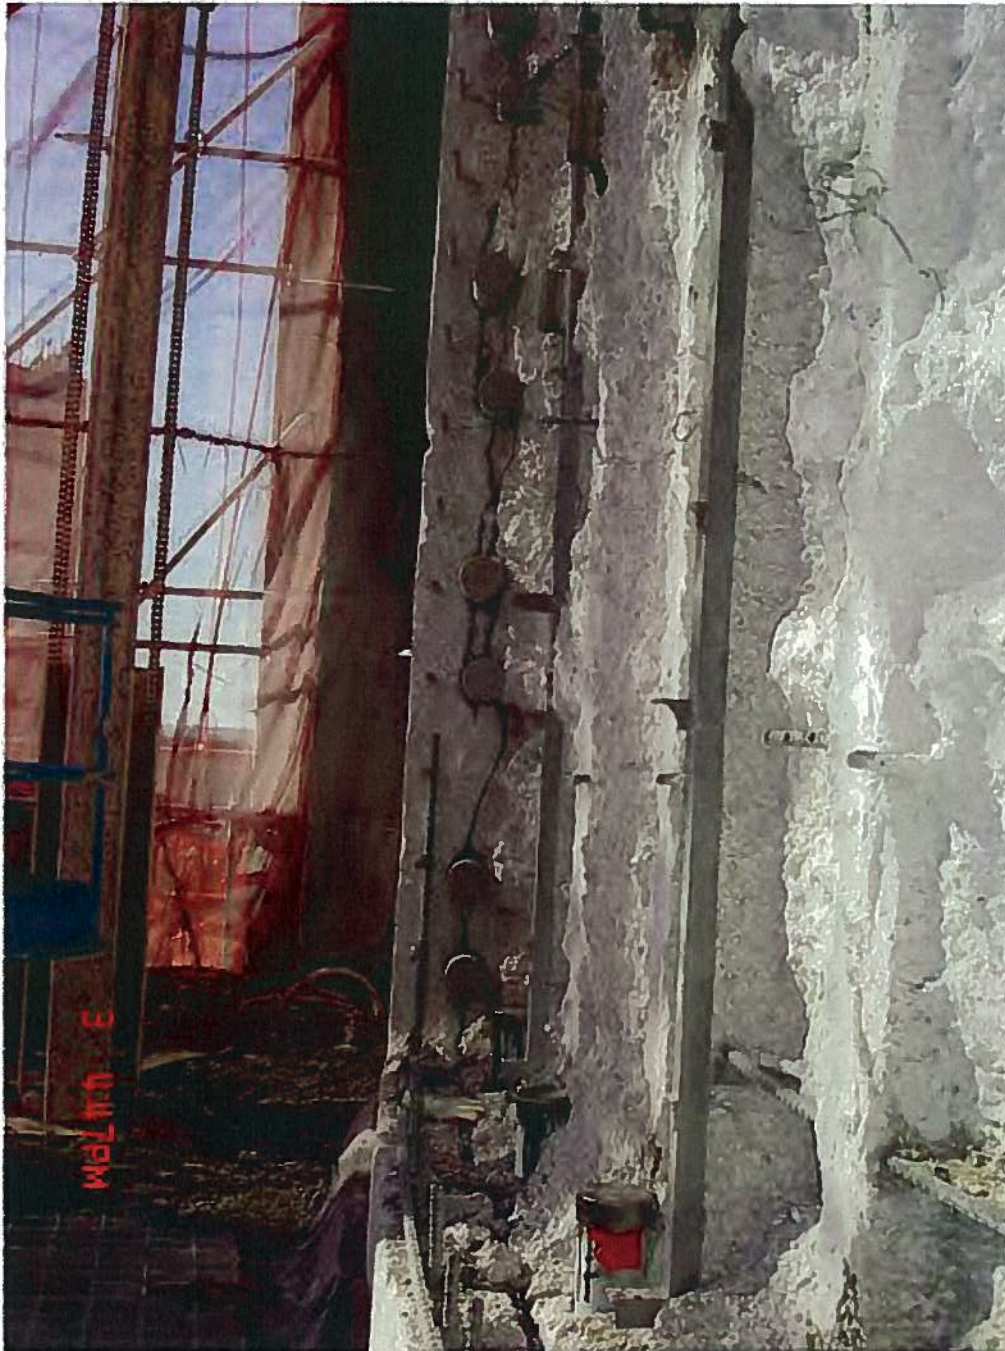
Figure A4.6 Delamination crack running vertically between horizontal tendons about 10" deep.
Taken on 10/3/2009
