**UNITED STATES
NUCLEAR REGULATORY COMMISSION**
REGION II
245 PEACHTREE CENTER AVENUE NE, SUITE 1200
ATLANTA, GEORGIA 30303-1257

October 12, 2010

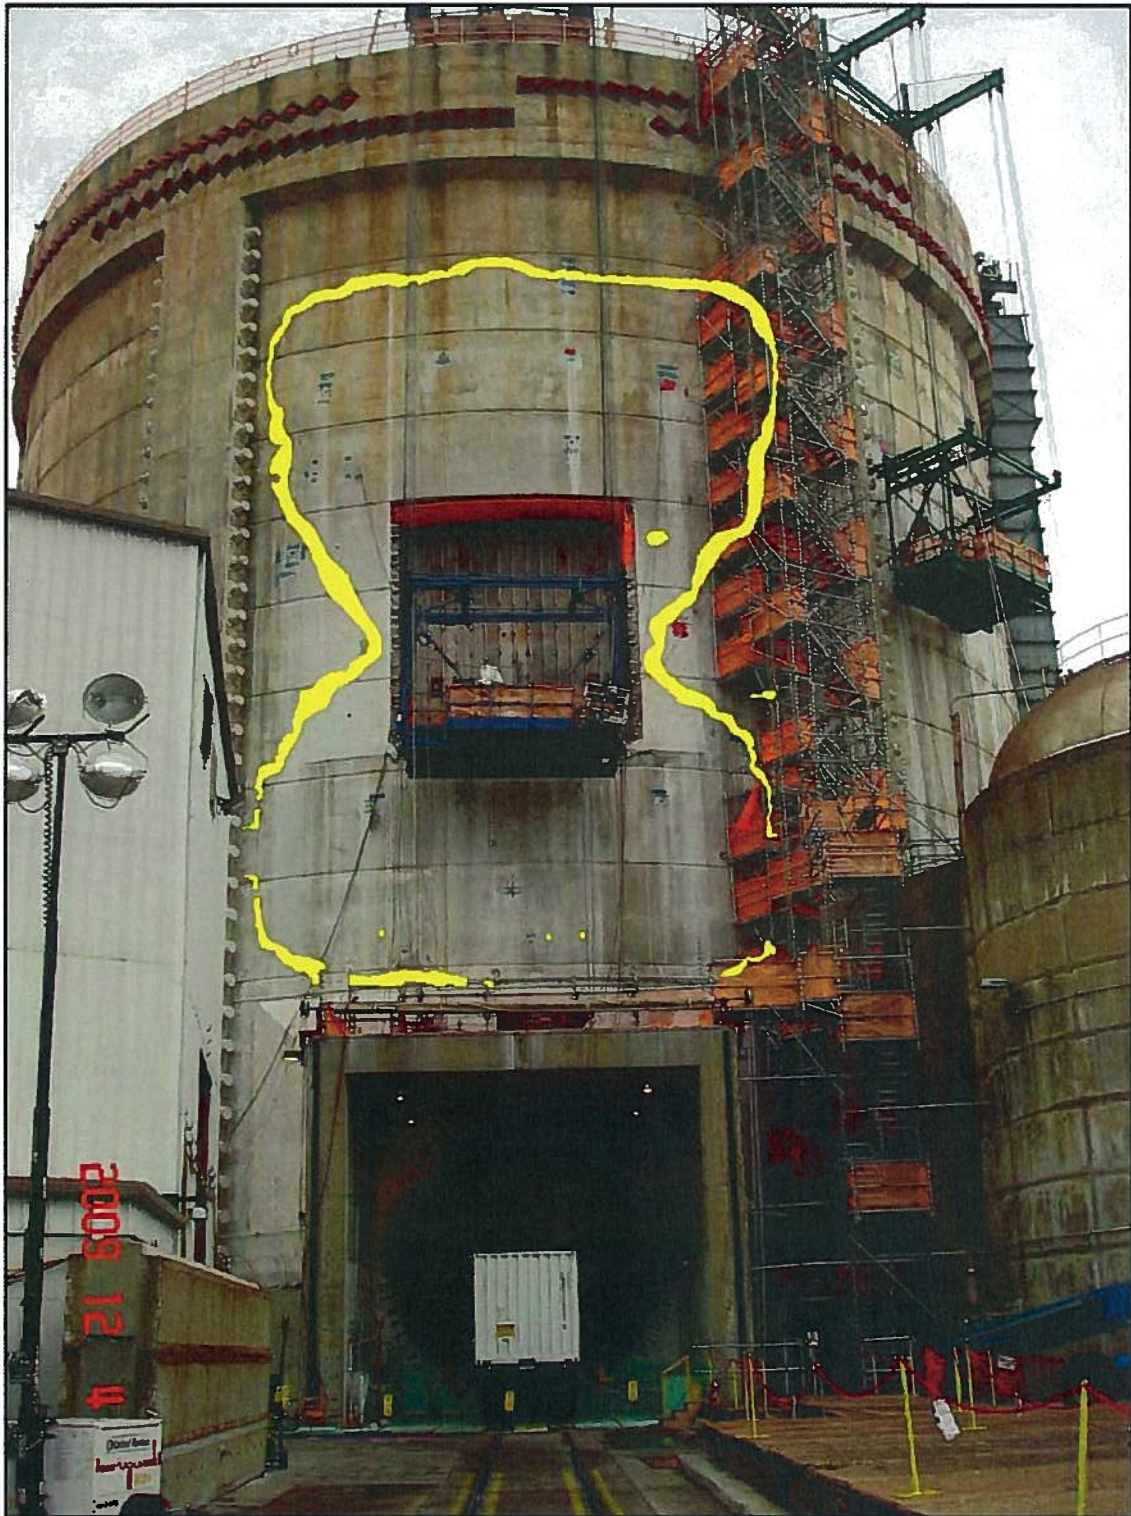
Figure A4.7 Delamination zone outline overlaid on the containment wall above and below the SGR opening

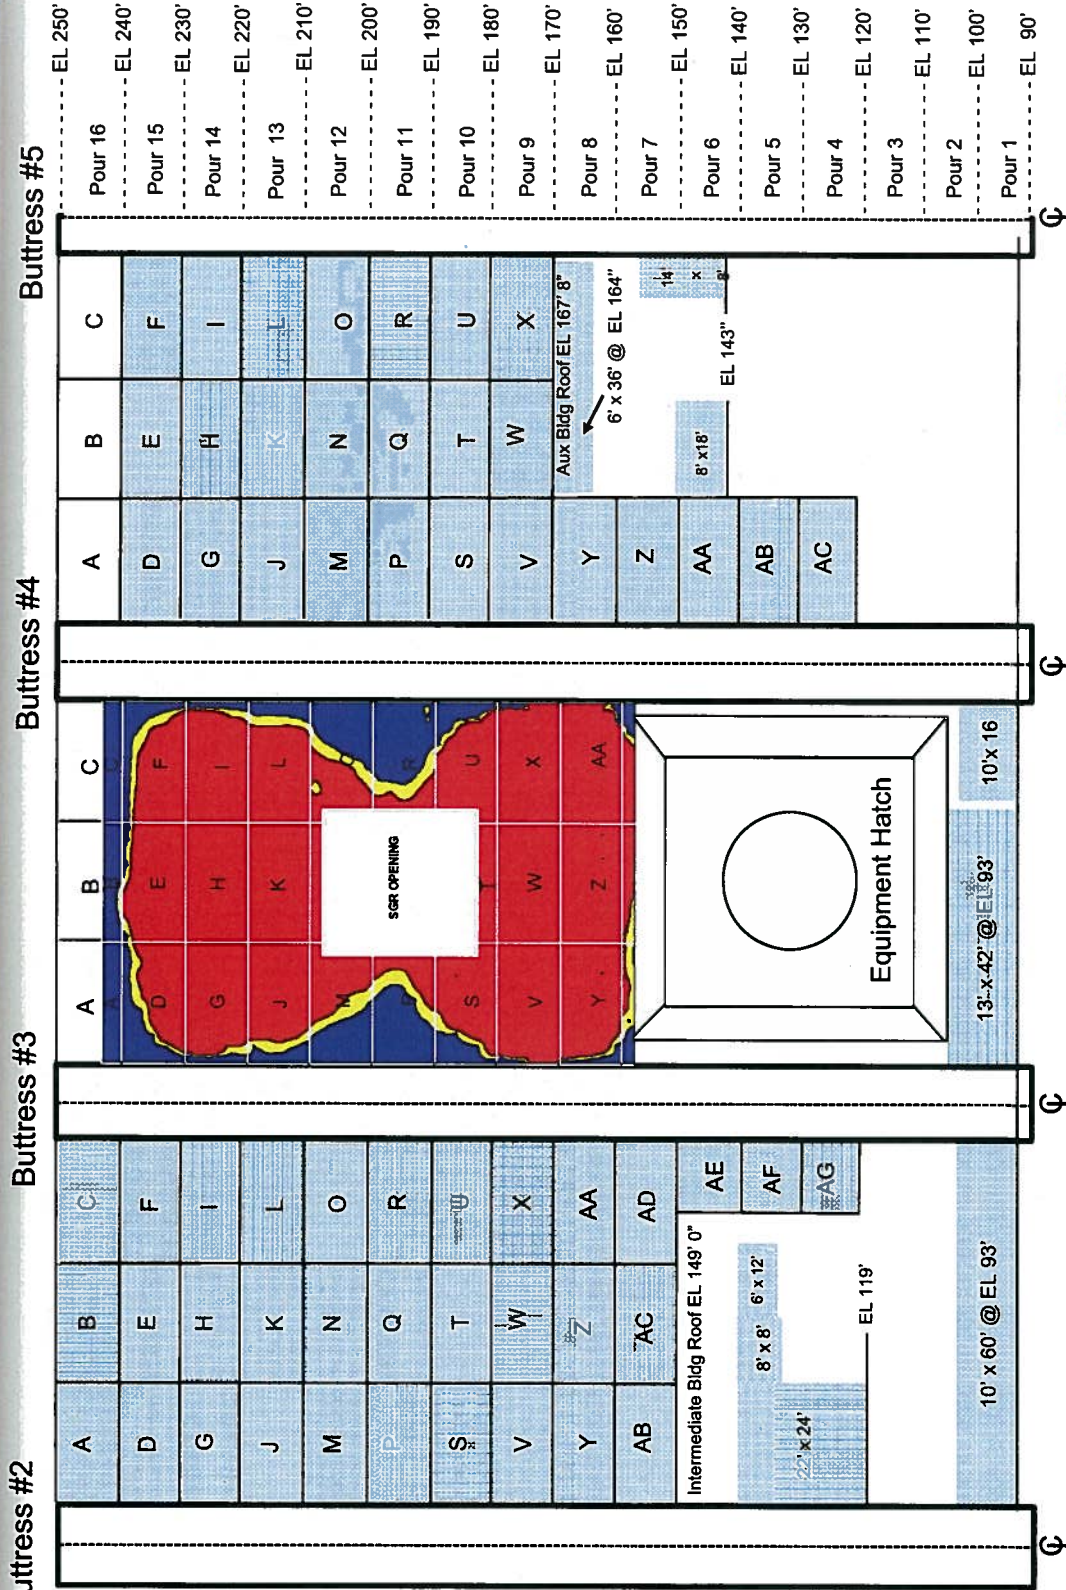
IR scans completed with no delamination
Blue = no delamination
