Enclosure 2
Meeting Summary Handouts
of the January 19, 2012
ROP Public Meeting

Reactor Oversight Process Task Force FAQ Log

**Tentative NRC Response to
FAQ 11-12, FitzPatrick Downpowers**

Plant: James A. FitzPatrick Nuclear Power Plant
Date of Event: June 7, 2011 & June 9, 2011
Submittal Date: Introduced October 26, 2011
Licensee Contact: Gene Dorman 315-349-6810 / gdorman@entergy.com
NRC Contact: Ed Knutson 315-349-6667 / edward.knutson@nrc.gov
Performance Indicator: Unplanned Power Changes per 7,000 Critical Hours
Site-Specific FAQ (Appendix D): YES / NO
FAQ requested to become effective when approved or _____.

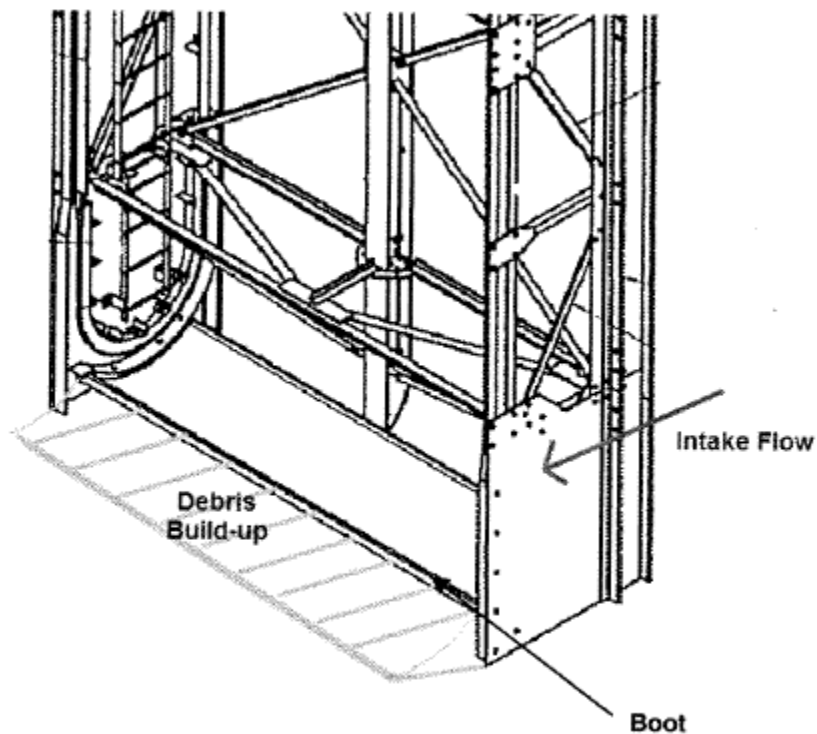
The travelling water screens have a cement filled boot below the screens that runs down to the intake bay (see Diagram 1 below). Due to this design, the annual PM now includes a boot inspection. It was to support this inspection that the gates were inserted.

Based on the need to downpower the unit JAF performed an apparent cause evaluation and determined that the fouling observed was from a previously unidentified source. Based on the design of the boot and the cement, it appears that a low flow area may be forming just past the

boot. There is a possibility for small debris such as silt, sand, and broken zebra mussel shells to settle in this area south of the screens (pump suction side). In this area, the silt may settle out past the boots and build up to a level to meet up with the process flow. This condition would only take a short period of time to build-up and then would remain in the condition until cleaning could remove the debris.

Diagram 1: Low flow area with debris build-up behind Boot

During normal operation, this debris build-up is not a significant threat to fouling because the debris is settled. However, this area becomes vulnerable when the gates are installed because of the change in flow patterns and increased velocity.

During the maintenance activities beginning on 6/6/2011, the south gate was inserted to provide protection for the divers. The installation of the gate caused an increase in flow, which apparently caused the settled debris in the vicinity of the gate to be picked up by localized turbulence, resulting in fouling of the condenser. The apparent cause evaluation postulated

that the turbulence could be reduced by inserting the gate north of the travelling water screens prior to installing the gate south of the travelling water screens.

Based on the apparent cause evaluation corrective actions have been proposed to

1) incorporate additional guidance in OP-4, Circulating Water System regarding the sequence for installing gates; and 2) to evaluate the PM task for scheduling optimization.

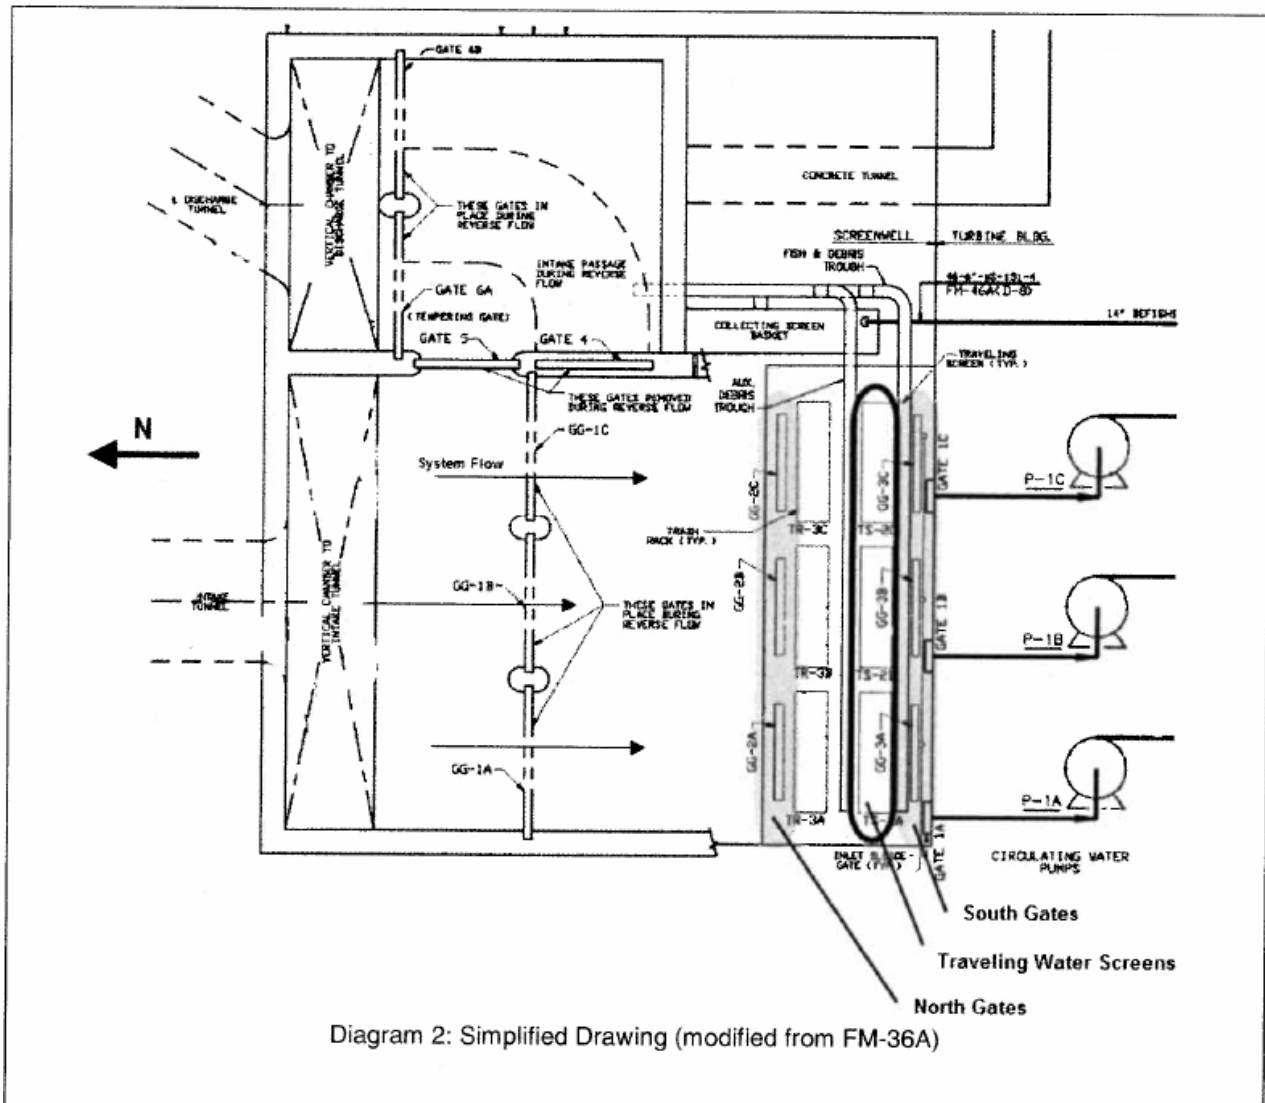
As noted above to minimize the impact of the marine debris buildup in the forebay, the annual cleaning and inspection of the intake canals was performed the week prior to the annual PM to inspect the travelling water screen boot. The cleaning included the areas of the forebay from the tempering gate to the trash racks and the area between the trash racks and the screens. However, due to the configuration of the traveling screens, pump bays, and isolation gates (see Diagram 2 below), the area south of the screens was not cleaned because it is not accessible during operation.
