NLS2012064
June 22, 2012

Subject: Response to Nuclear Regulatory Commission Request for Additional Information
Re: Request for Relief for the Fourth 10-Year Inservice Inspection Program (TAC No. ME7875)
Cooper Nuclear Station, Docket No. 50-298, DPR-46

**Response to Nuclear Regulatory Commission Request for Additional Information
Re: Request for Relief for the Fourth 10-Year Inservice Inspection Program
(TAC No. ME7875)**

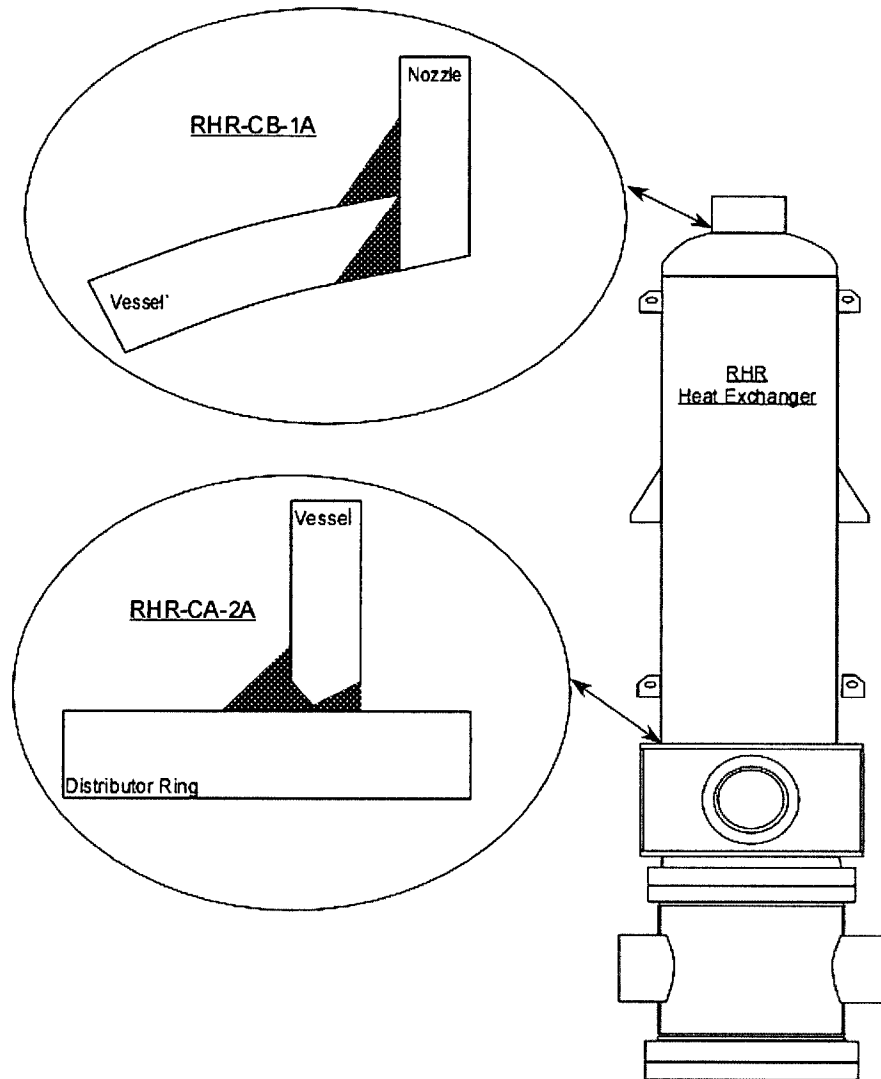
FIGURE

Please provide a diagram of the residual heat removal vessel on which the examinations were performed indicating on the diagram where the welds of interest are located.

See following Figure:
