Bell Bend Project Site: Supplemental Field Assessments for PPL Riverlands

**PPL Bell Bend Nuclear Power
Plant**
Salem Township, Luzerne County,
PA

January
2010

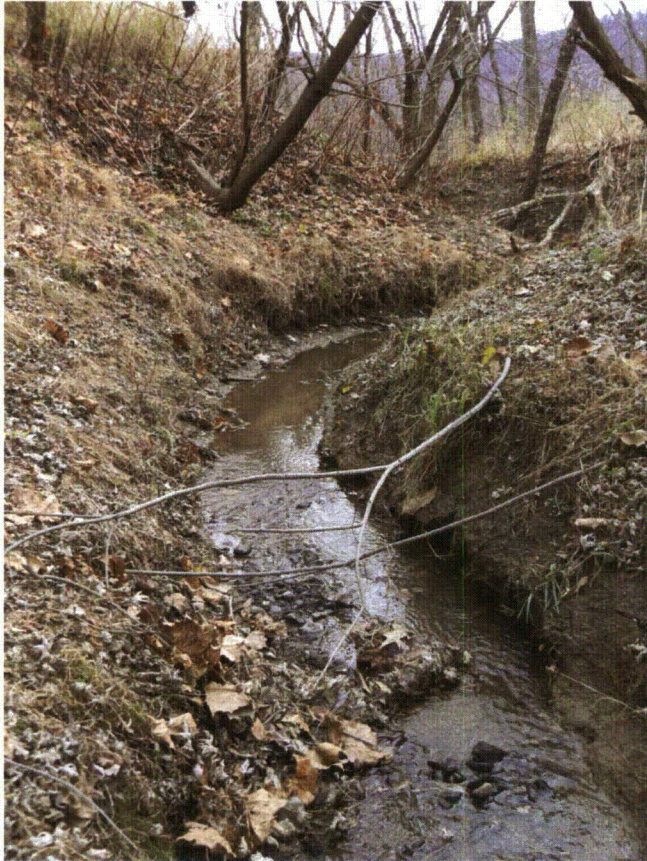
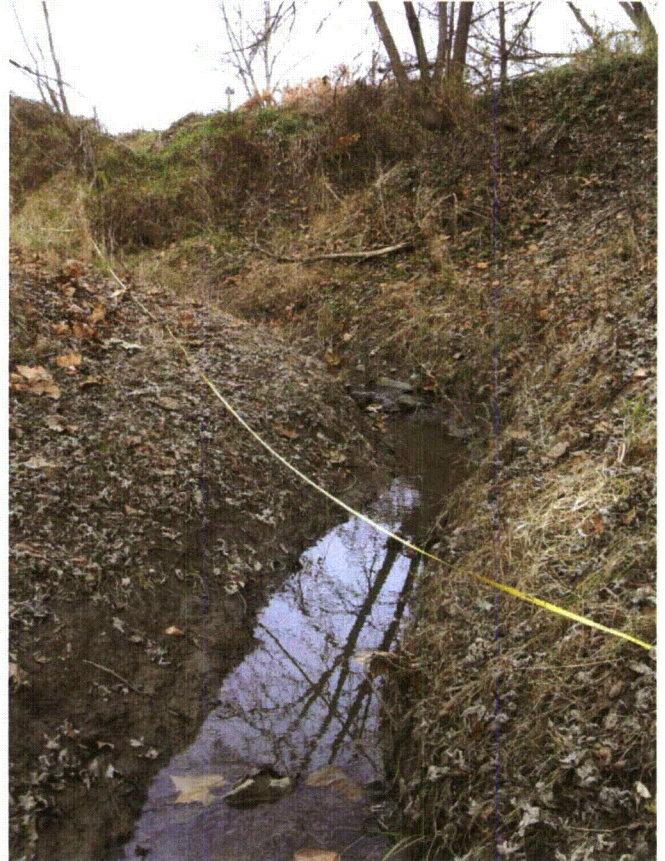
Stream facing downstream towards the Susquehanna River (left)
and upstream towards the North Branch Canal (right).

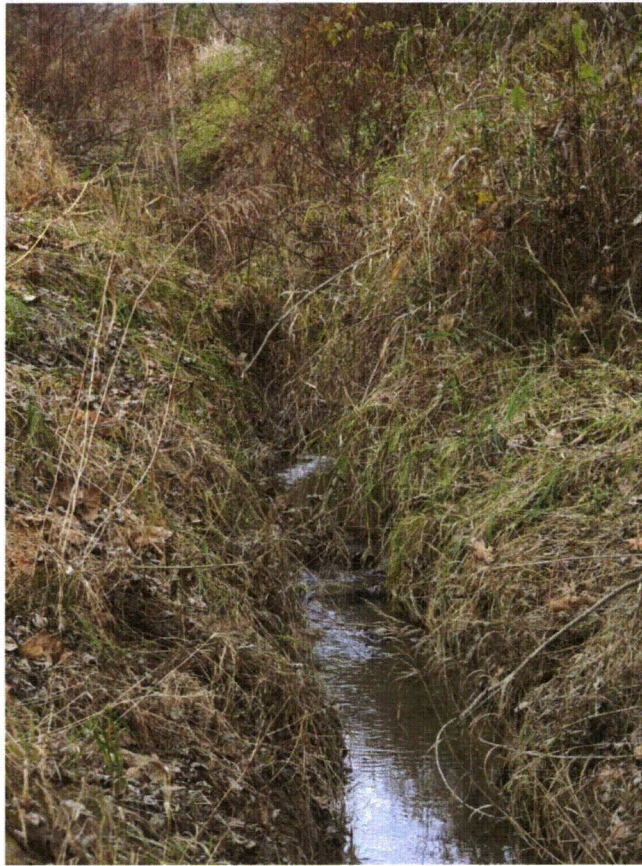
Facing upstream.

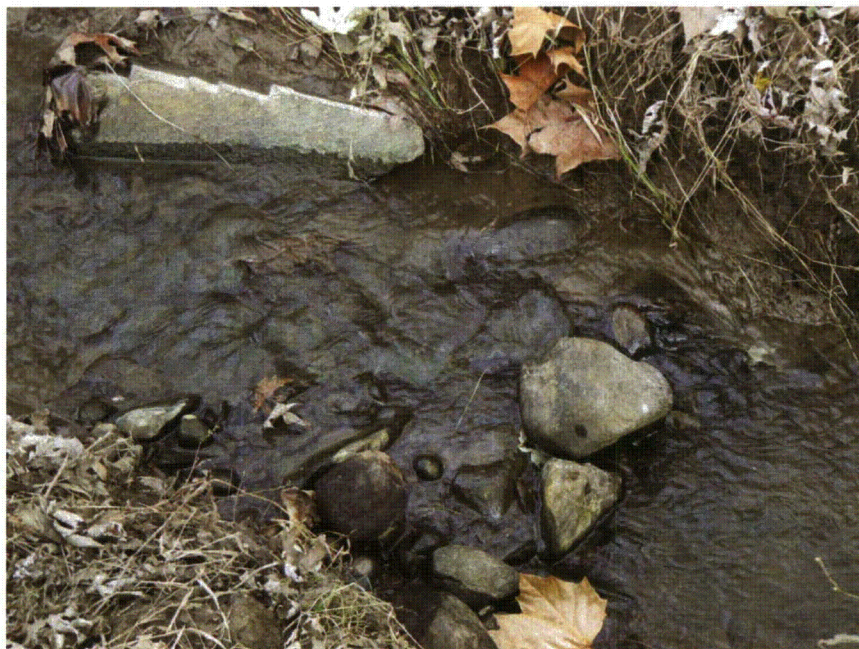
Substrate in riffle.

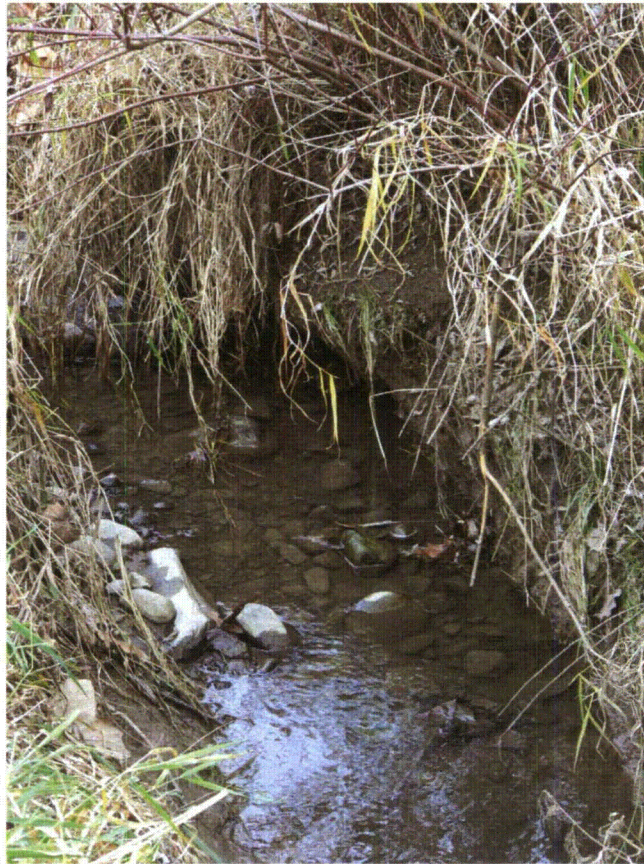
Substrate downstream in the outlet channel.

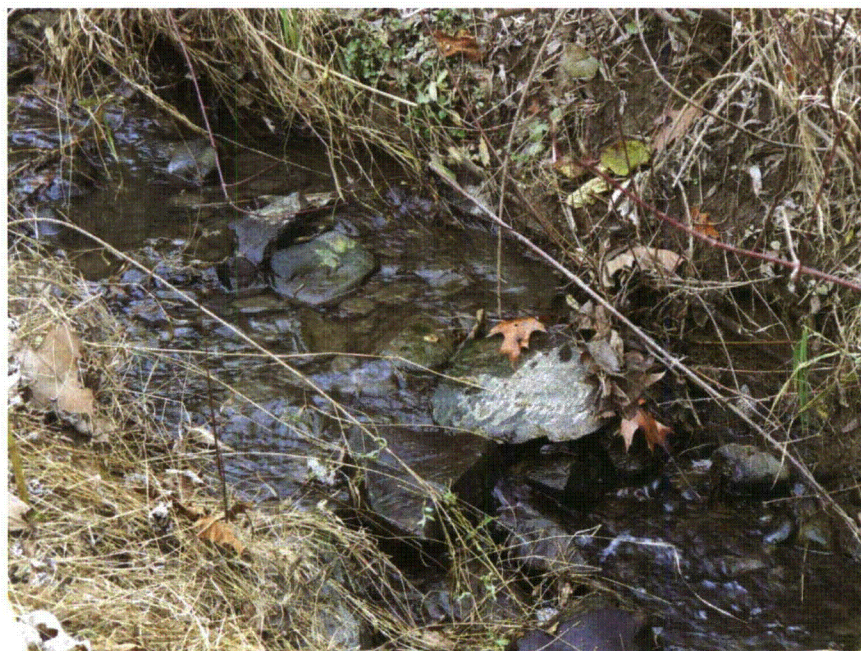
Substrate in riffle.

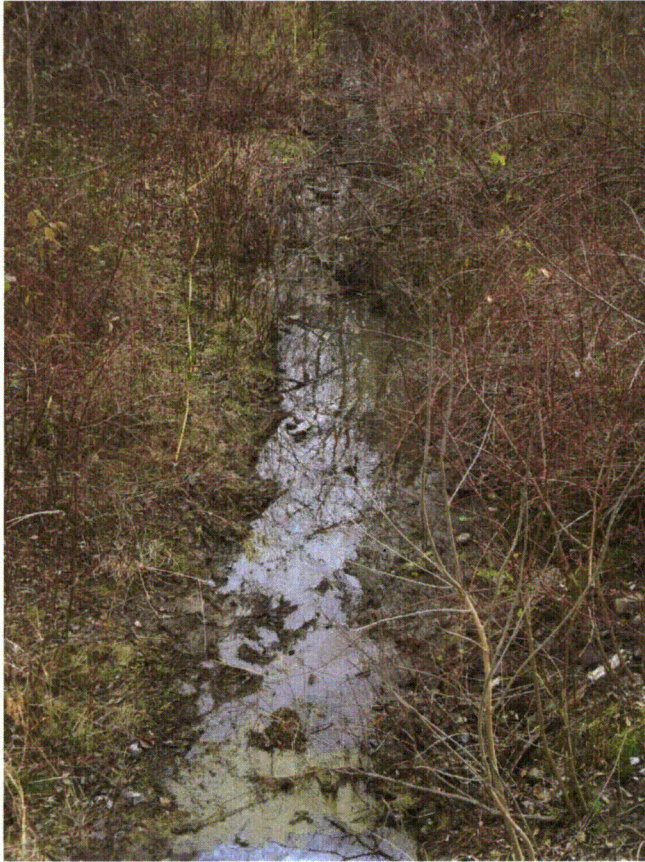
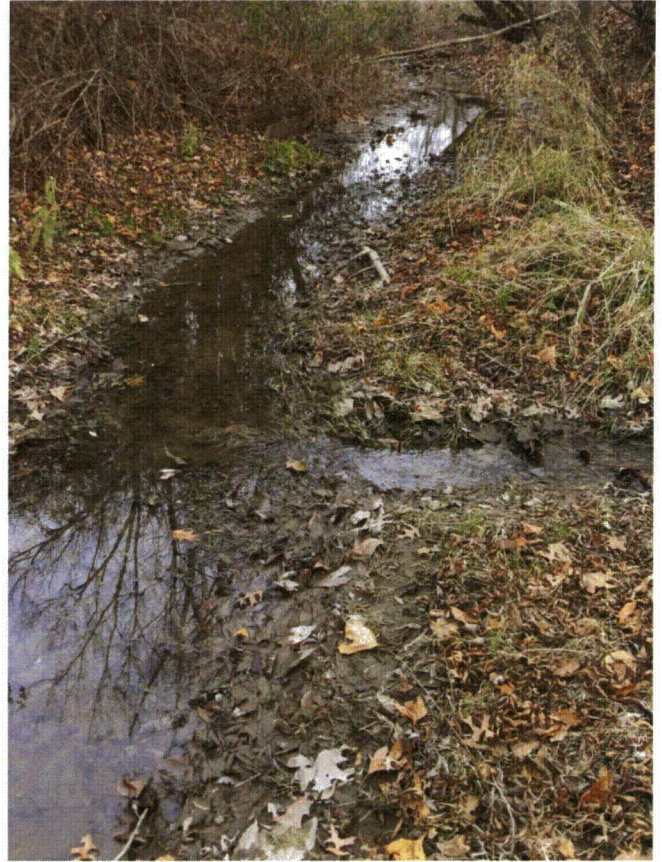
Stream facing upstream (left) and downstream (right). A tributary joins the main channel in the photo on the right. This water is seeping through the earthen dam at the North Branch Canal.

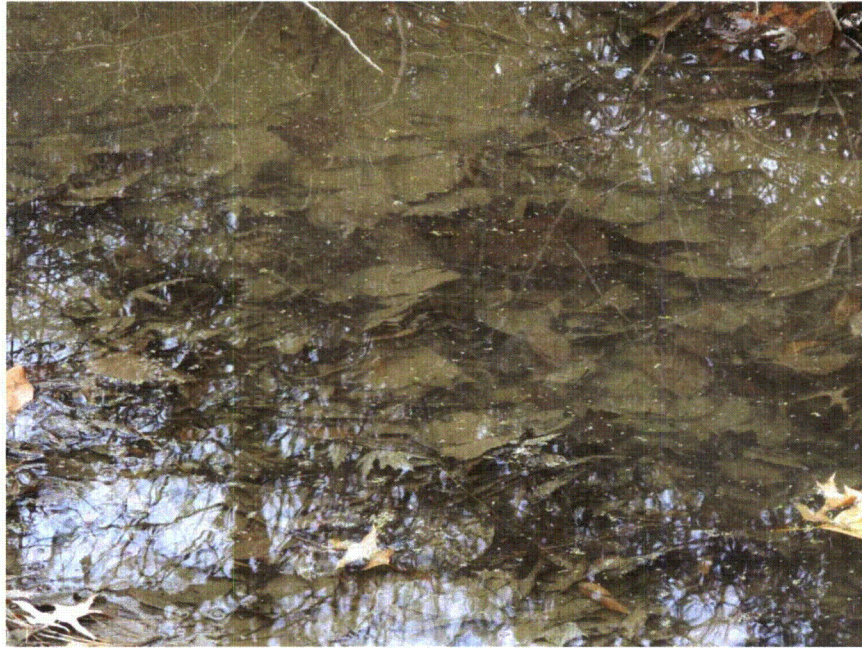
The upper reach of the stream was just below the weir of the discharge canal. This reach was typically run habitat, with an average stream width of 4.3 ft and an average water depth of 0.3 ft. This reach had high substrate embeddedness, with an average embeddedness rating of 1.6 (Table 2). The stream substrate was dominated by a combination of silt and gravel, with sand and clay also present. Gravel and cobble comprised an average of 24.2 percent of the stream bottom.

Substrate characteristic of the upstream section of the outlet channel.

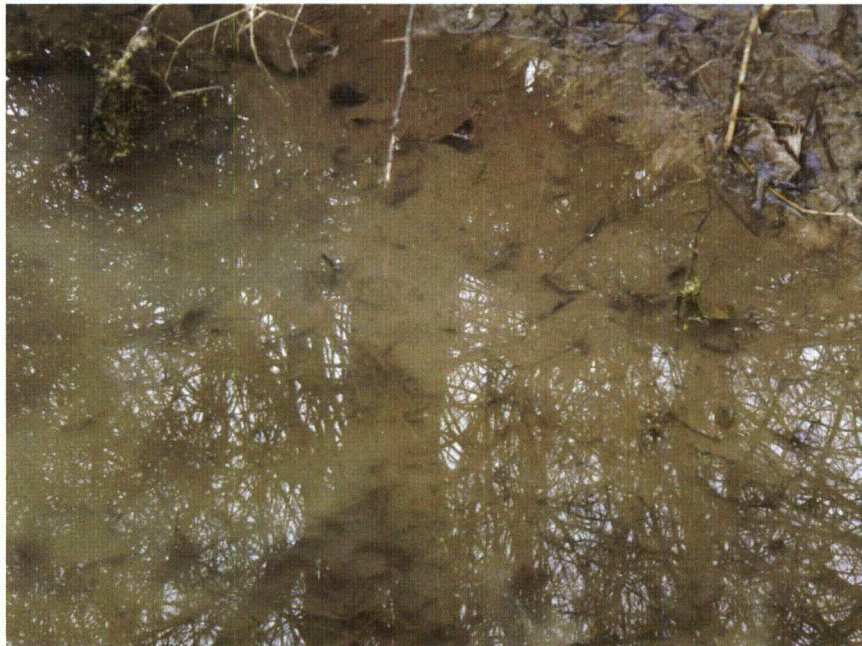
Silt causes turbid water in the upstream section of the outlet channel.

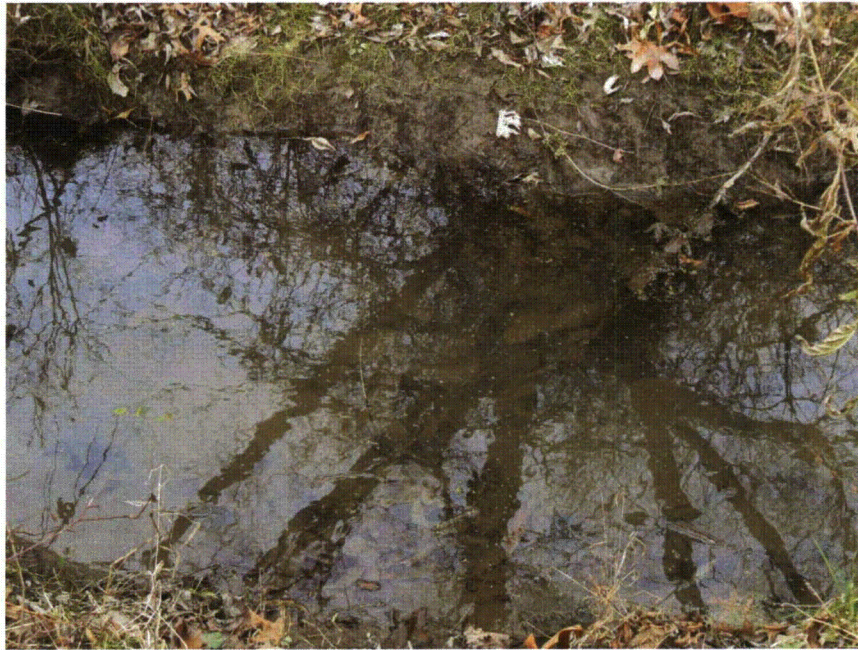
Substrate characteristic of the upstream section of the outlet channel.

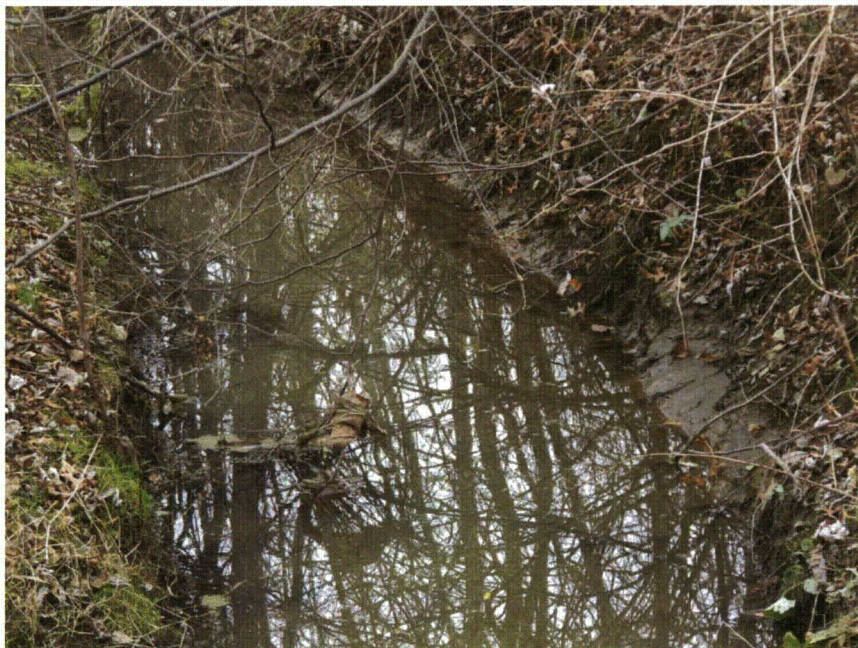
Silt causes turbid water in the upstream section of the outlet channel.

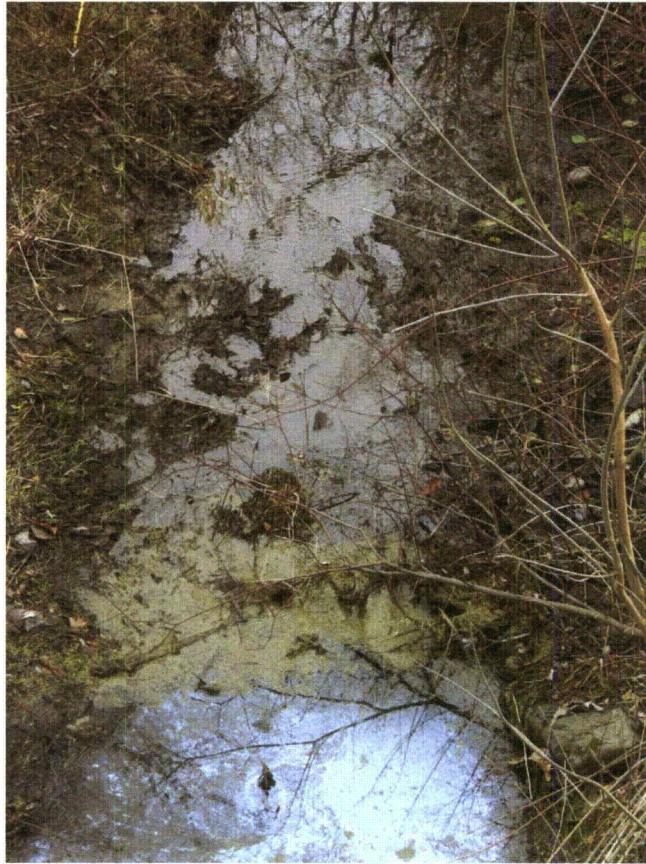
Stream channel just below weir.

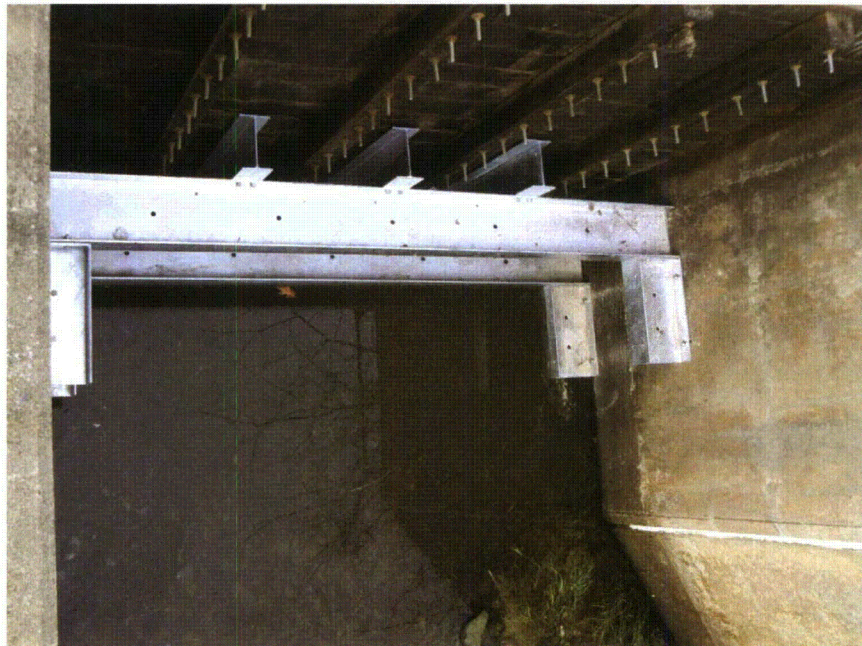
Weir that controls the water level in the canal and the amount of flow in the outlet channel.
