APPENDIX A

Stream and Sampling Photographs During the Fisheries Survey

APPENDIX B

Stream Photos
During the Habitat Assessment Survey

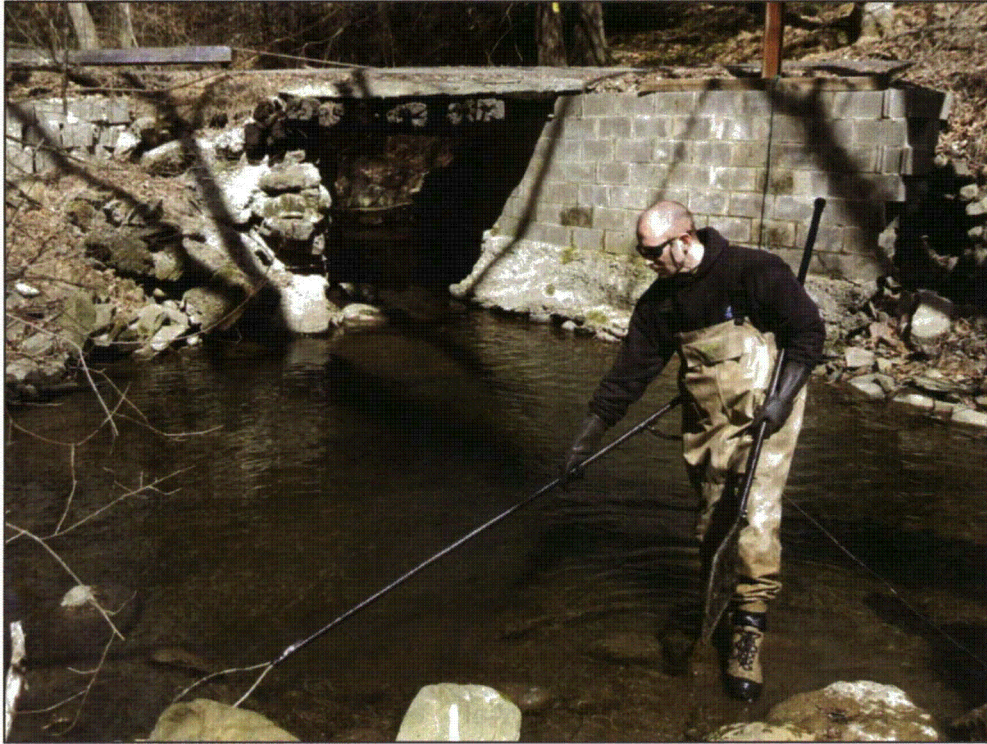
Photo 1. View of Walker Run looking north towards bridge crossing.

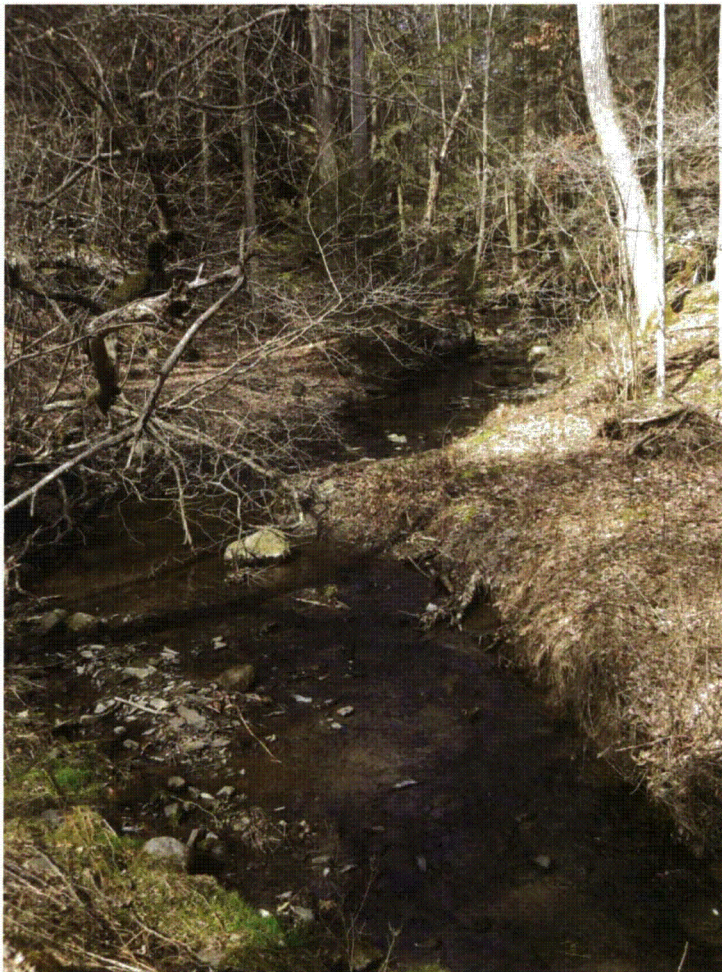
Photo 2. Overview of Walker Run, Reach 1.

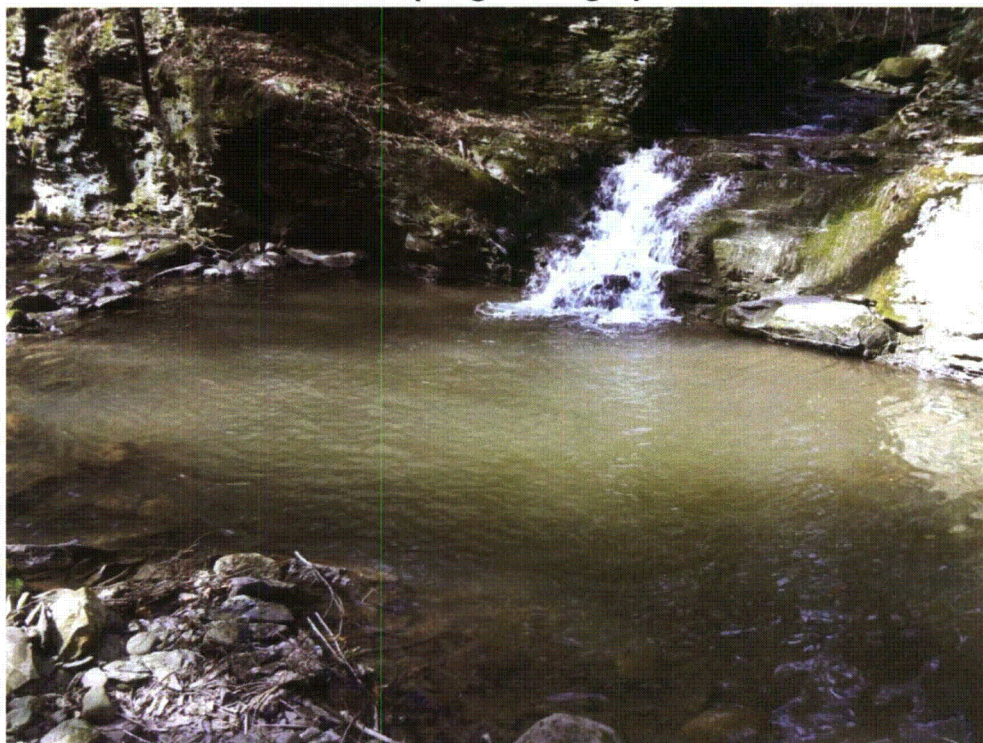
Photo 3. Pool located at the uppermost point of reach 1.

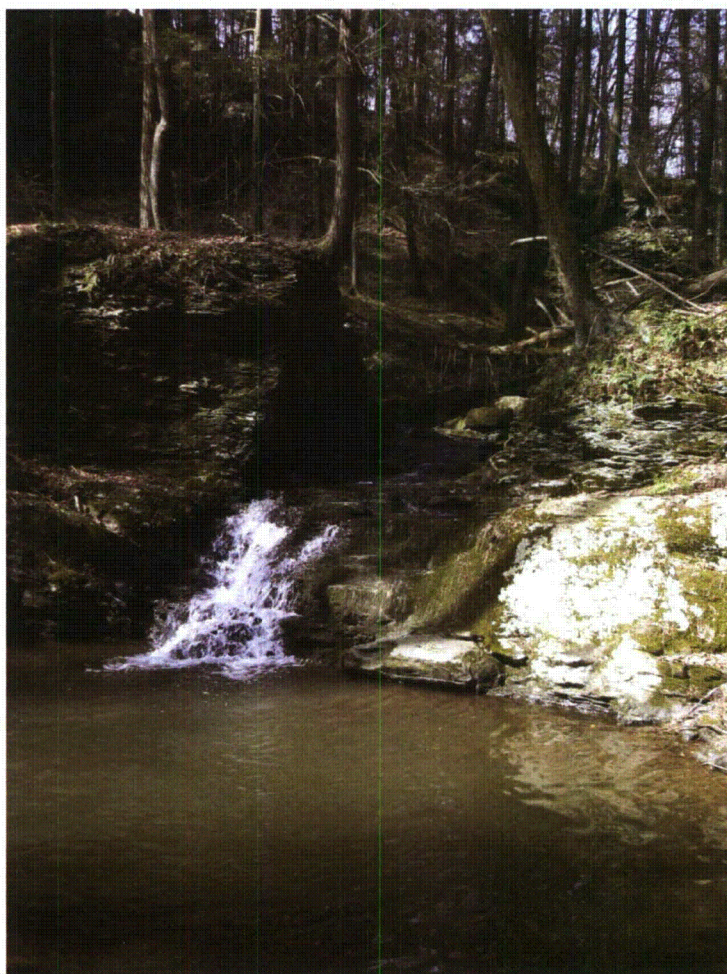
Photo 4. Alternate view of pool shown above with surrounding land use.

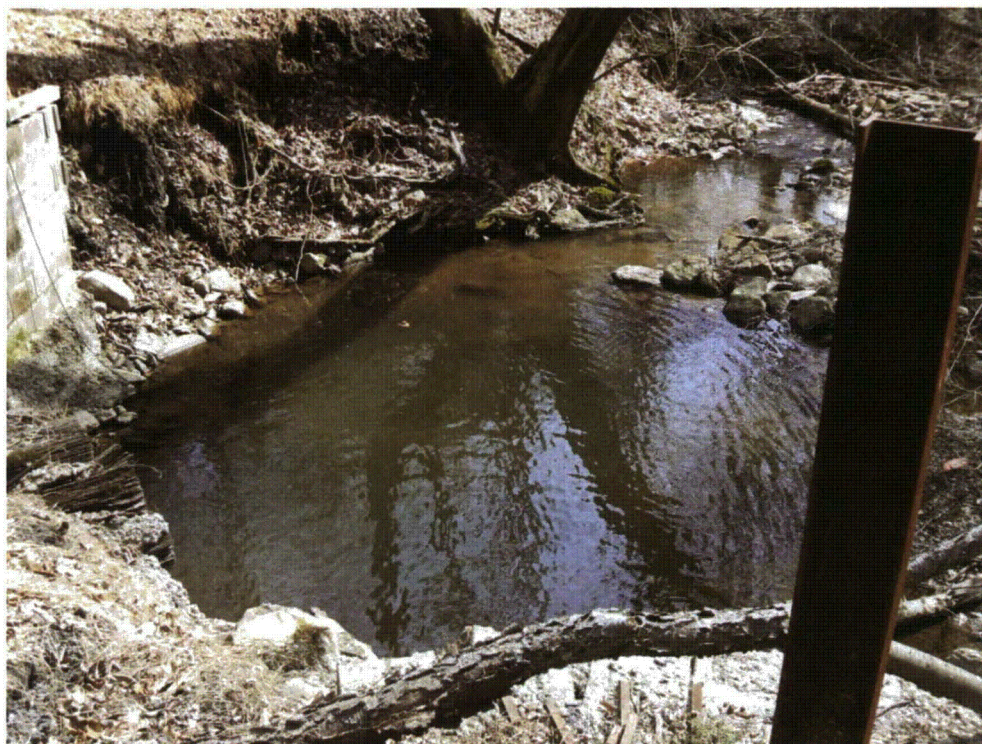
Photo 5. View from bridge looking downstream.

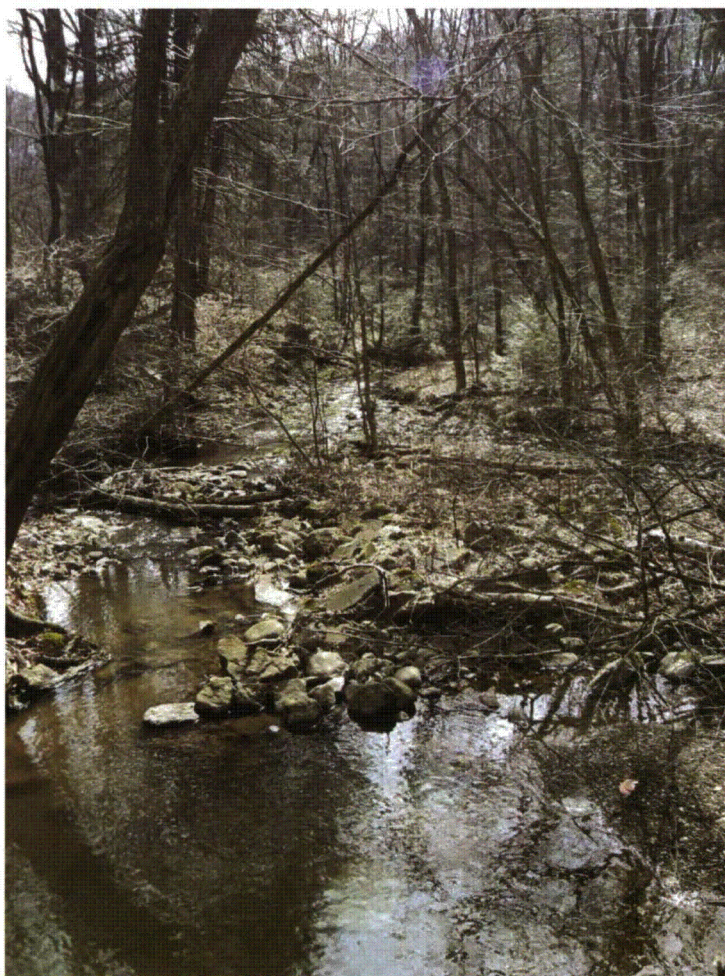
Photo 6. General view of Walker Run, Reach 1.

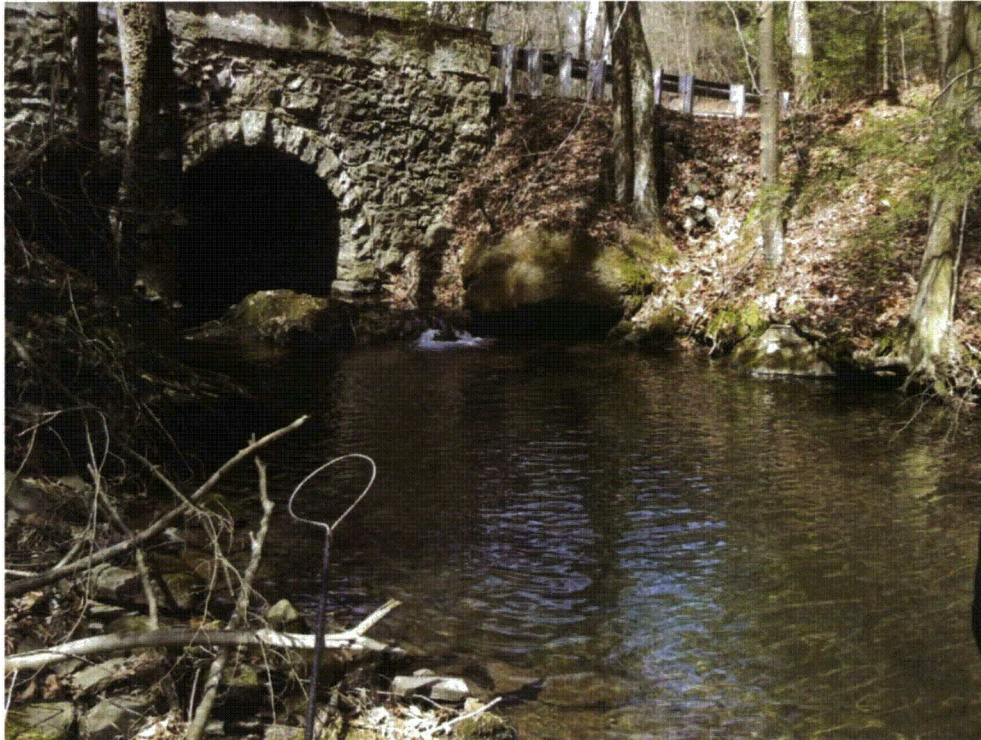
Photo 9. Road crossing at upstream segment of reach 2.

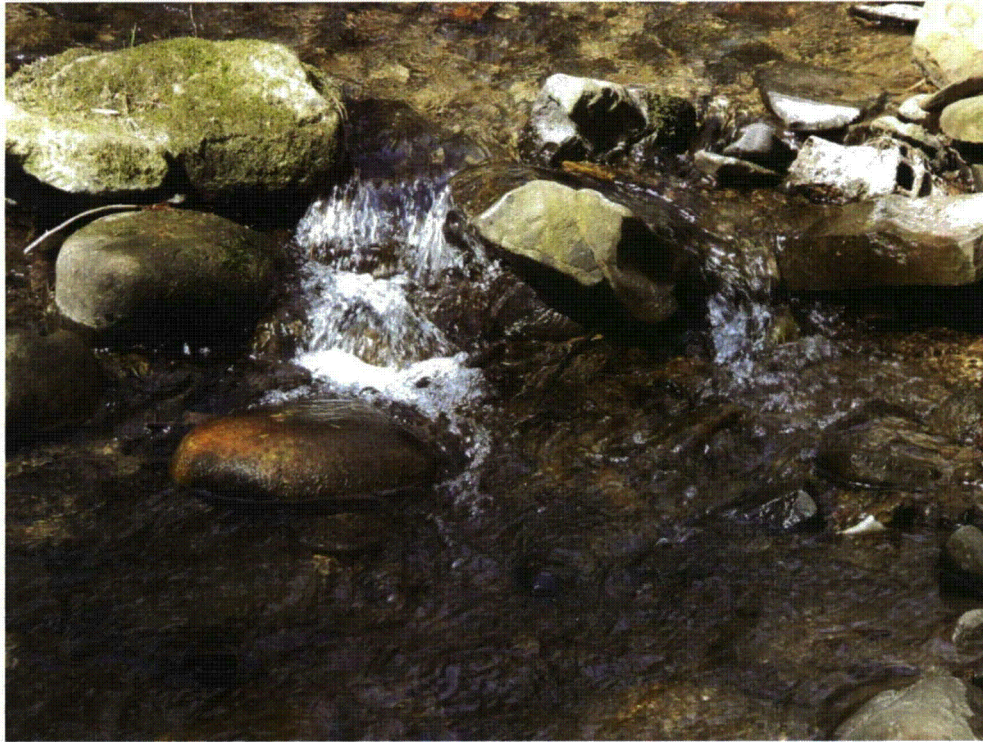
Photo 13. View of substrate.

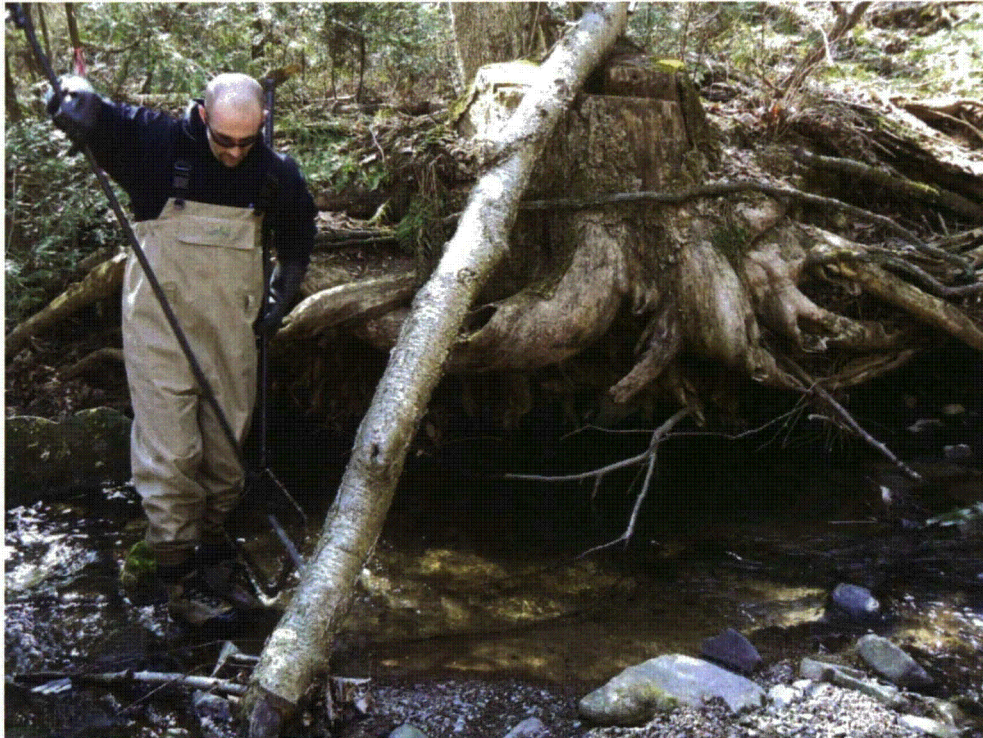
Photo 14. Overhanging roots create ideal habitat for fish.

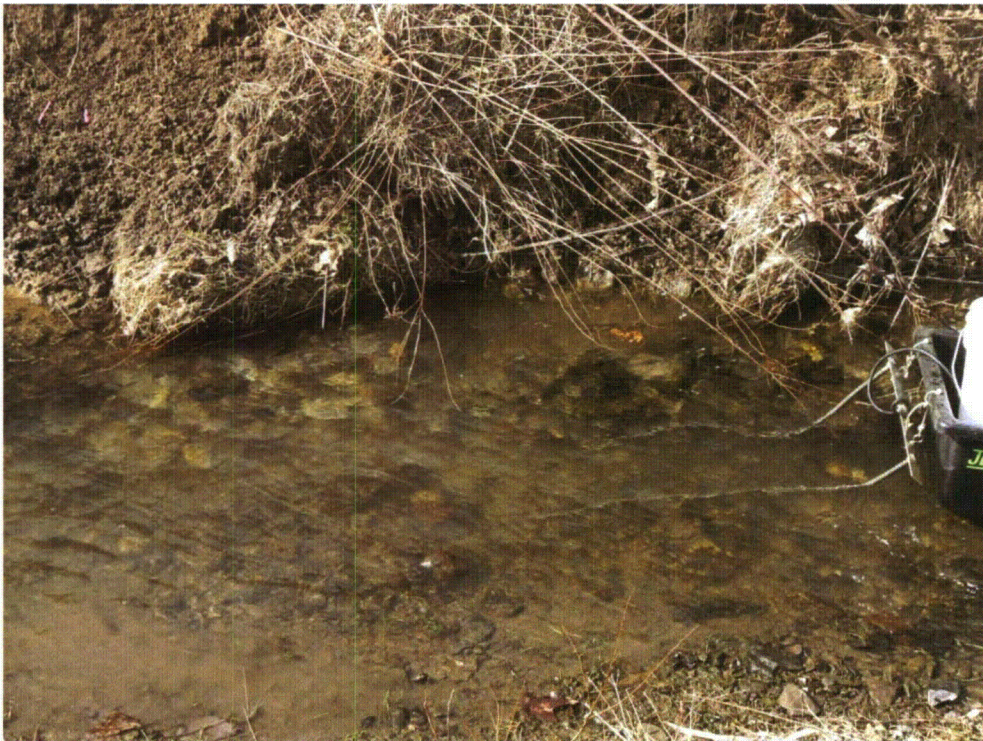
Photo 20. View of substrate at Reach 4.

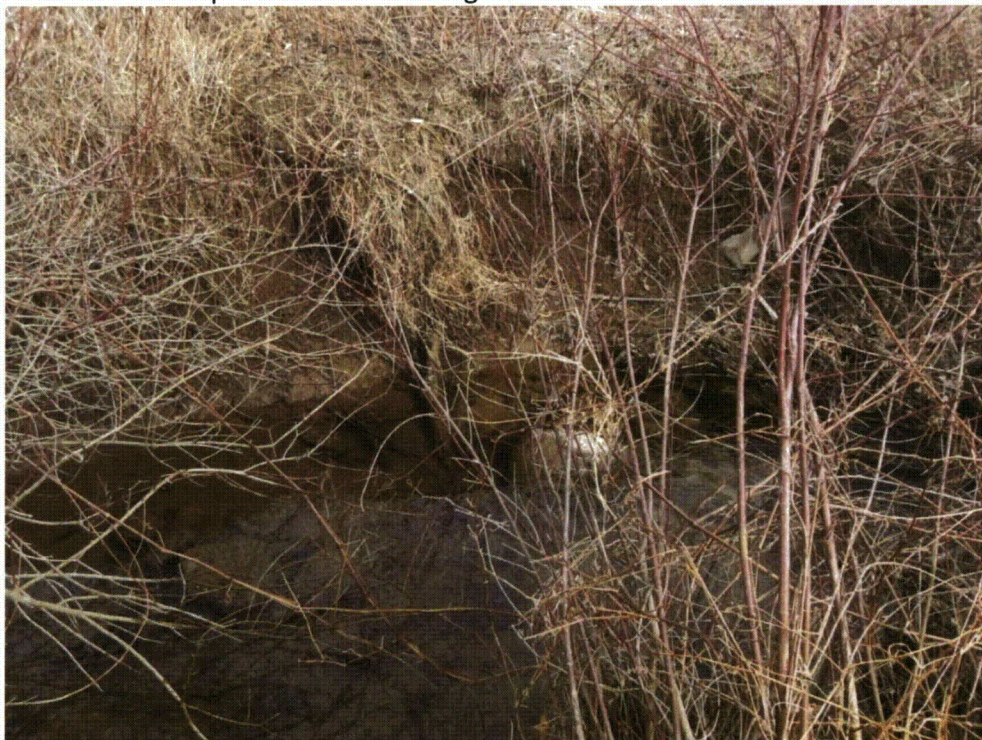
Photo 26. Exposed soil on eroding banks.

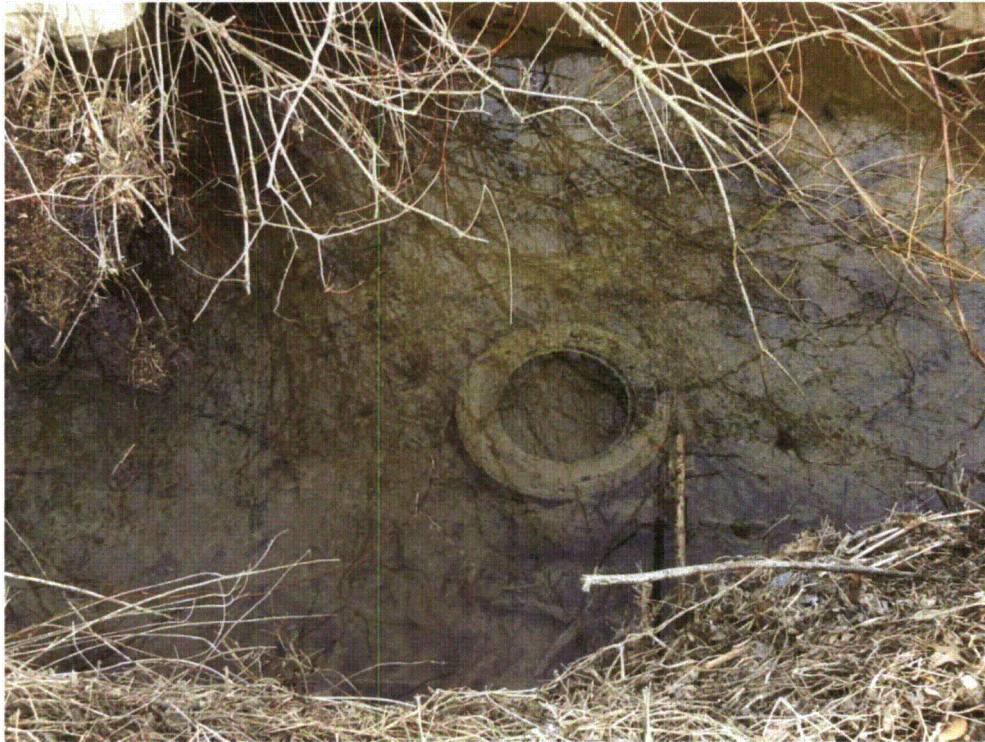
Photo 27. View of mucky and silty stream substrate.

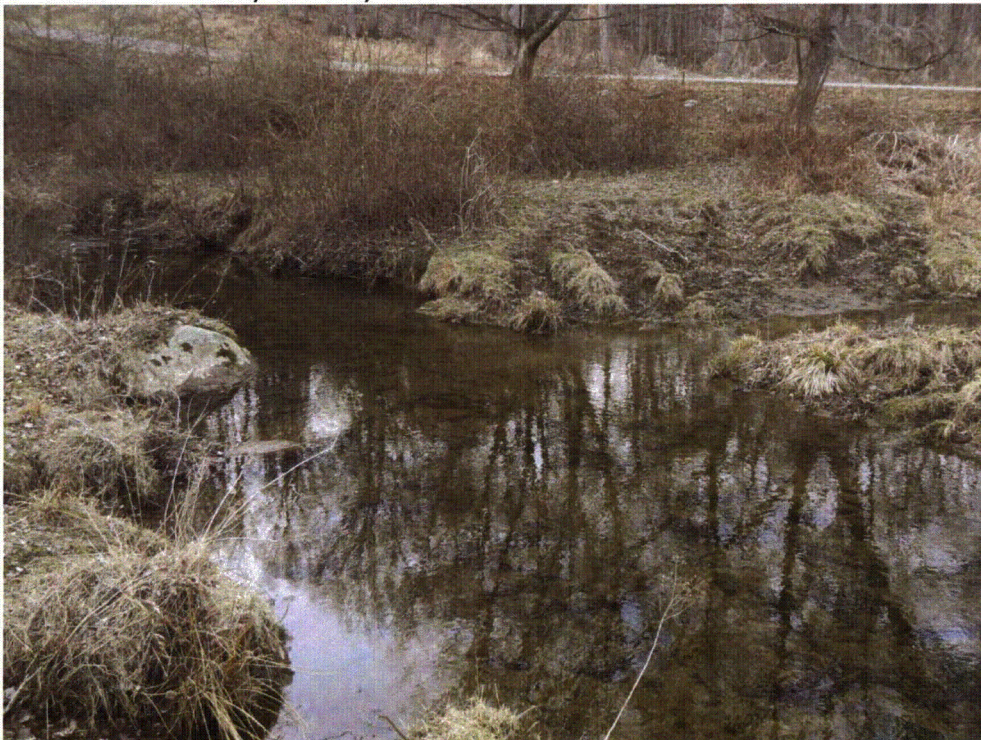
Photo 34. Mucky and silty substrate at Reach 6.

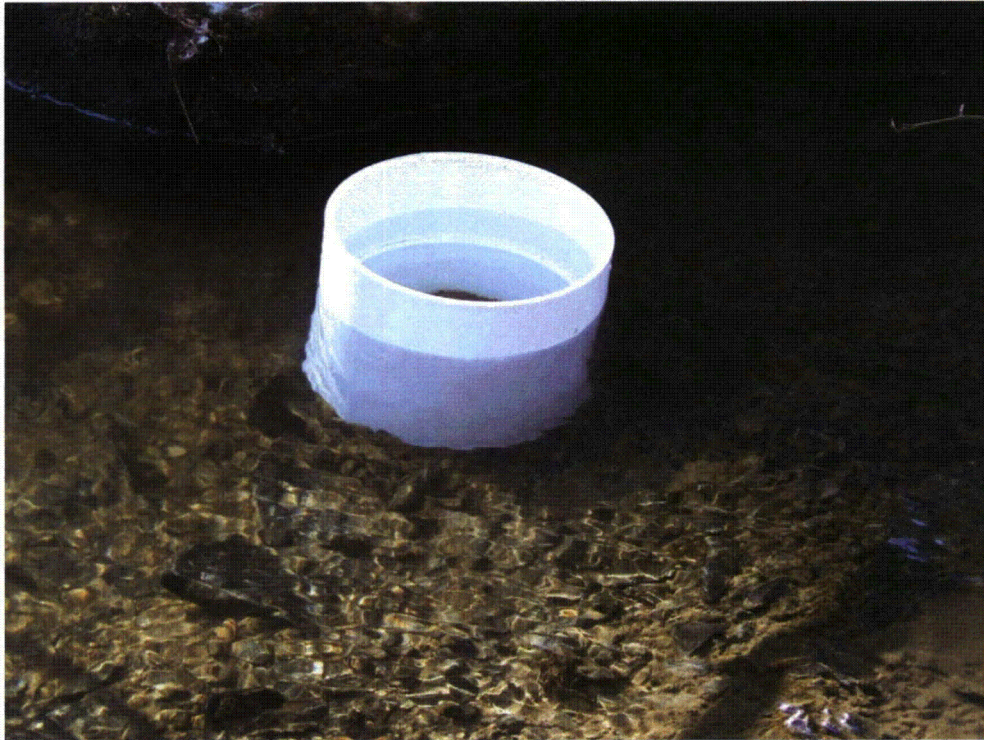
Photo 1. Gravels for trout spawning in Reach 1.

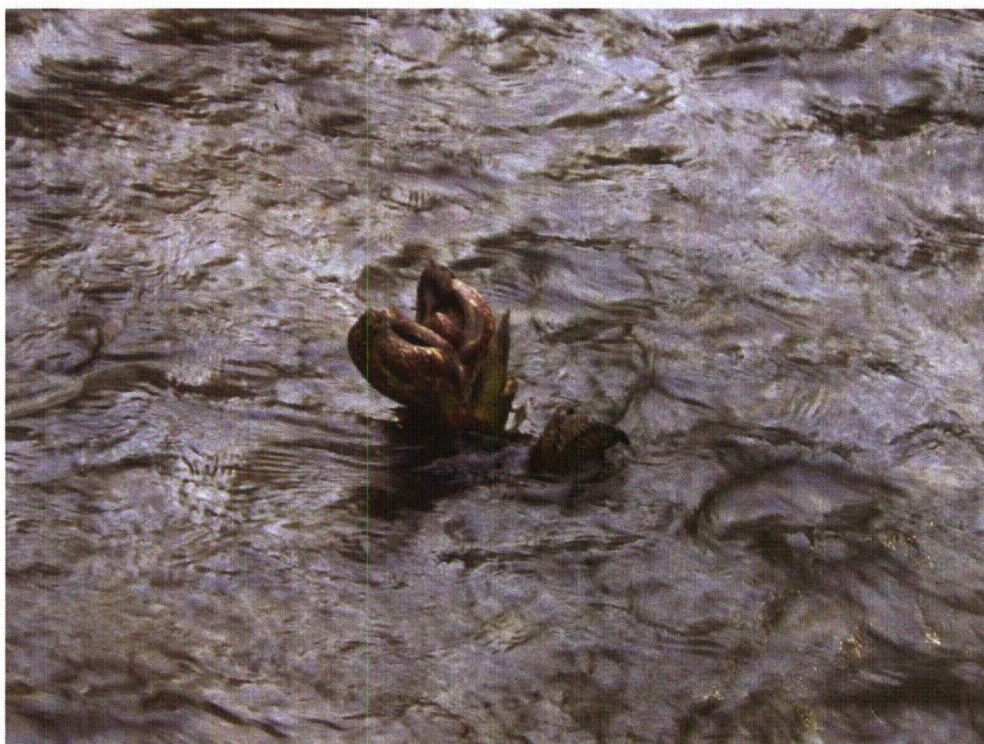
Photo 4. Emergent vegetation in Reach 1, indicating periodic low water periods and stream bottom exposure.

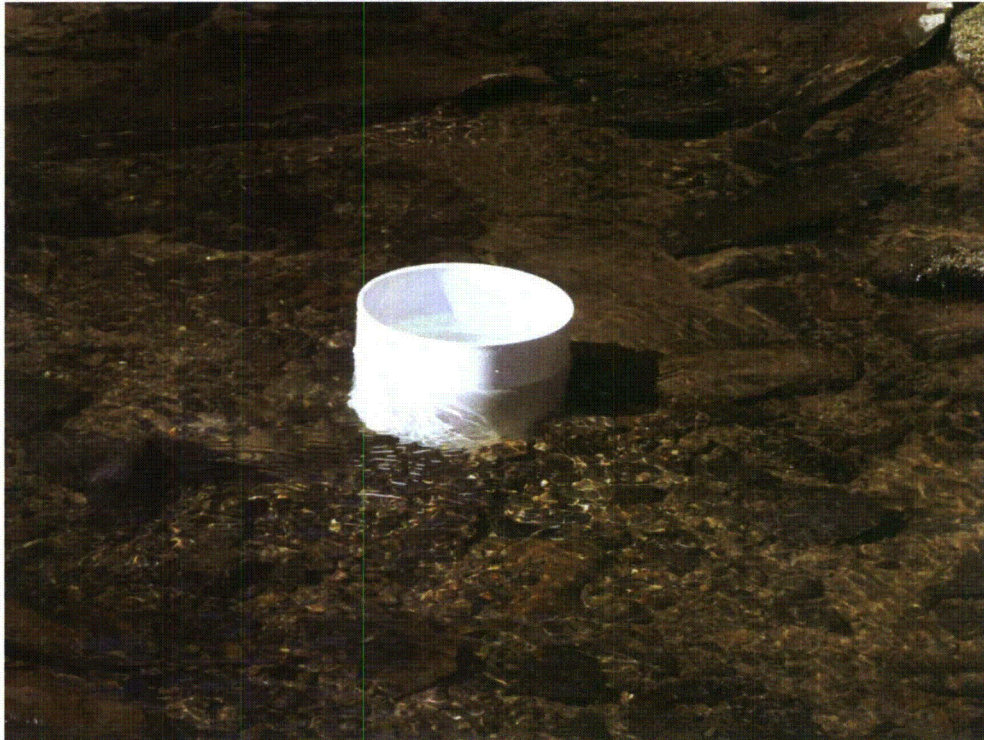
Photo 7. Gravels for trout spawning in Reach 2.

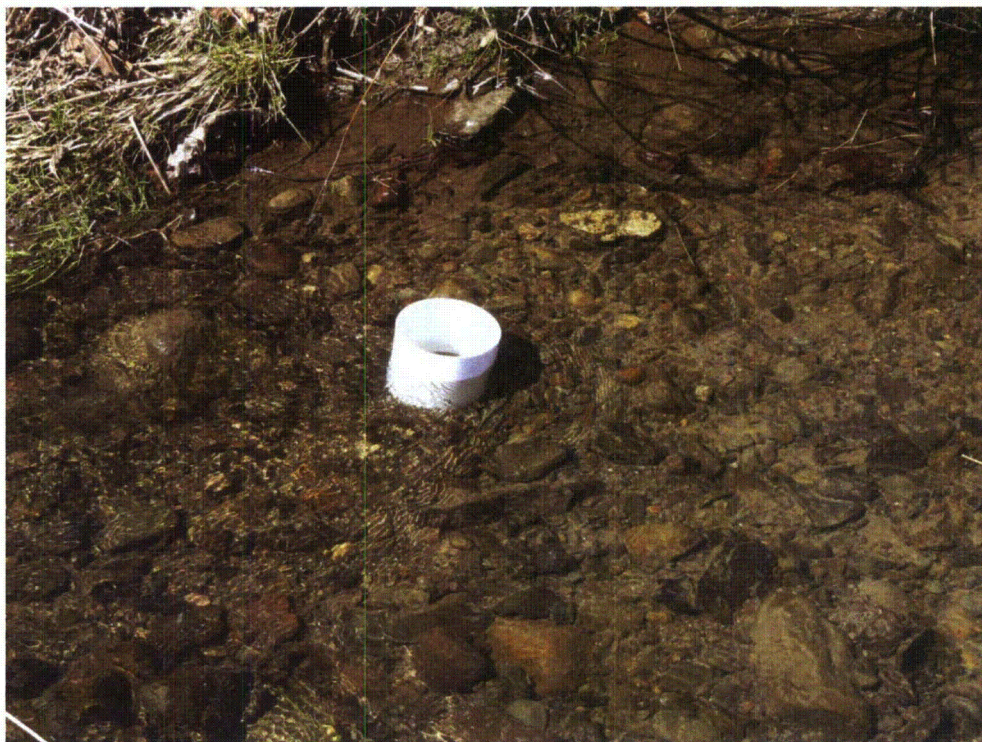
Photo 19. Gravel and cobble in Reach 4.

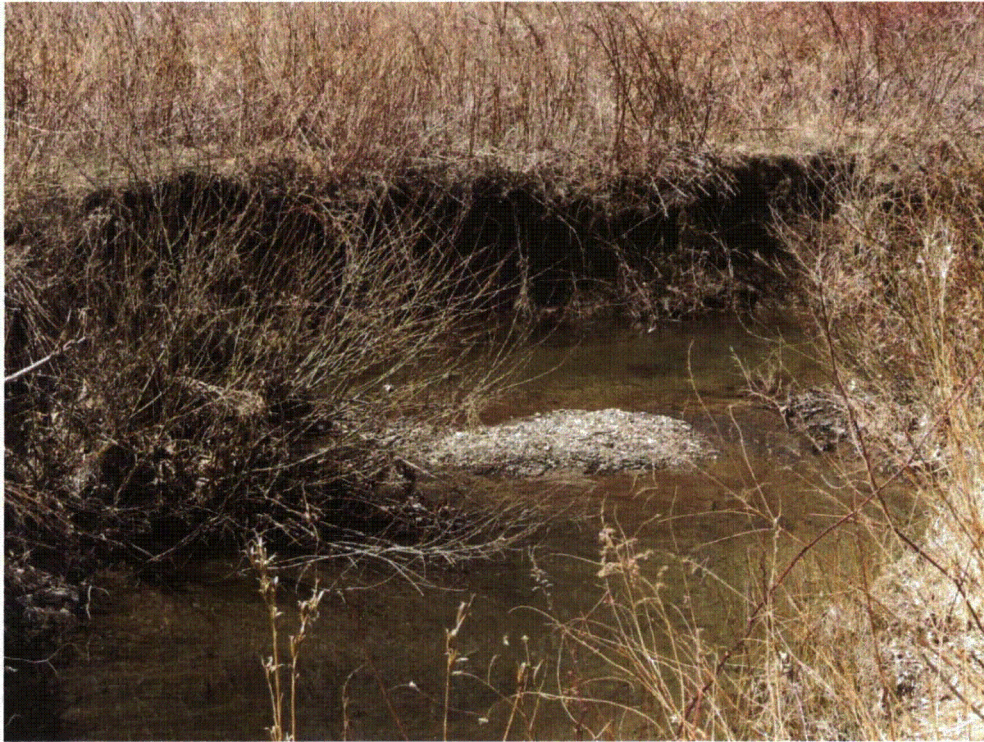
Photo 21. Eroding streambanks in Reach 4.

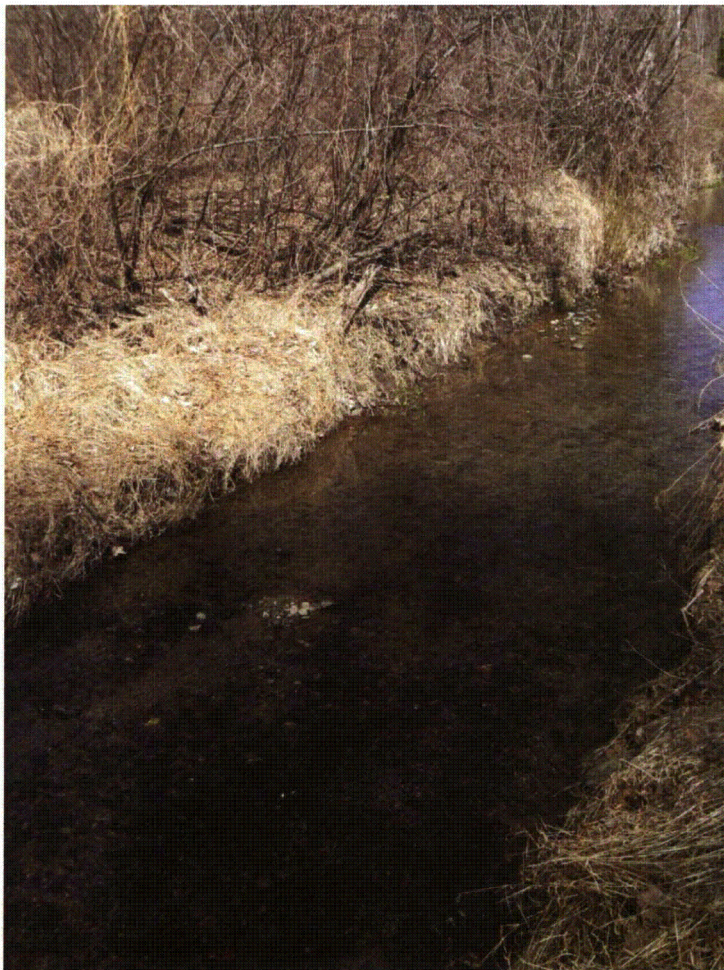
Photo 22. Substrate and bank conditions at Reach 4.

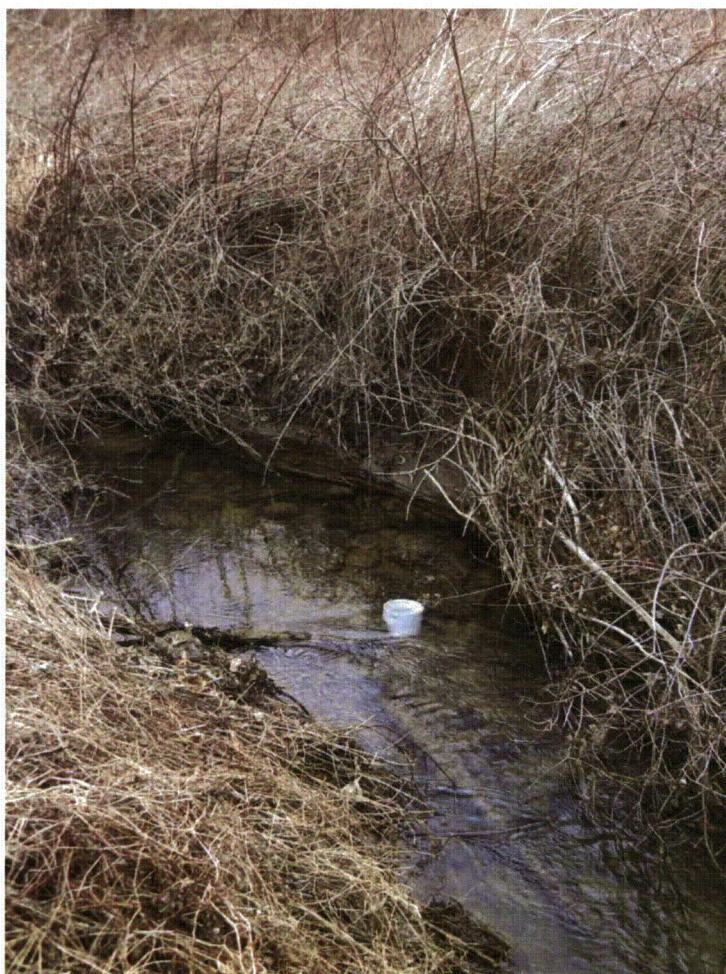
Photo 25. Habitat conditions and streambank erosion in Reach 5.

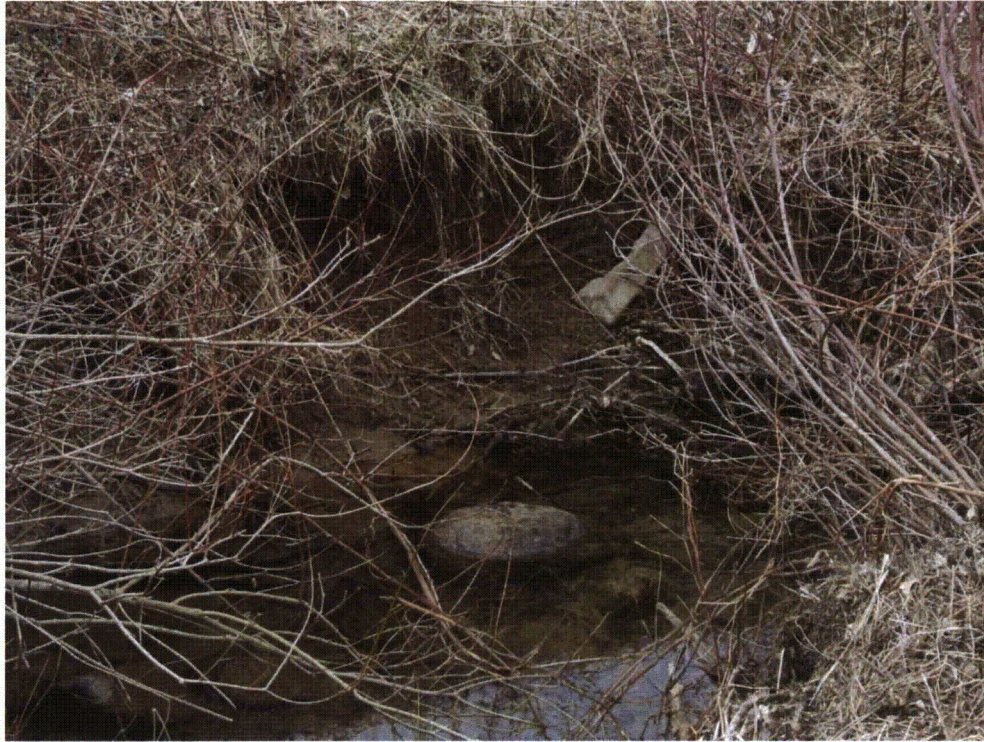
Photo 28. Eroding streambanks at Reach 5.

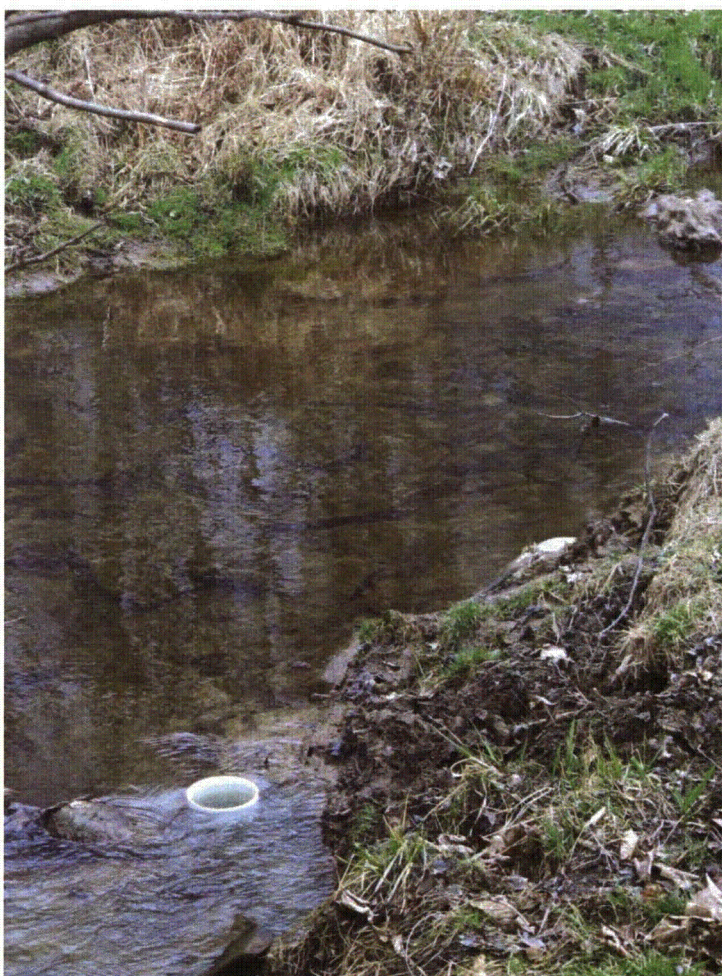
Photo 33. Best available substrate in Reach 5 for trout.

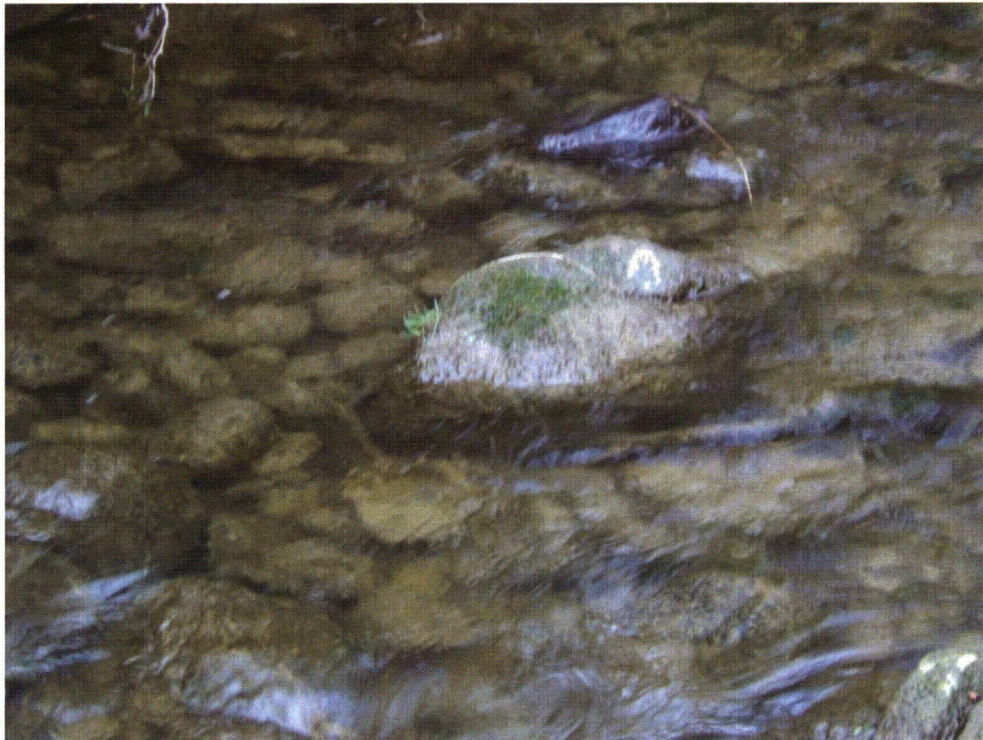
Photo 36. Cobble substrate at Reach 6.
