Steam Generator Tube Degradation

Bill Borchardt
Executive Director For Operations
February 7, 2013

San Onofre Replacement Steam Generator Tube Wear

***SAN ONOFRE:
FAR OUTSIDE THE NORM***

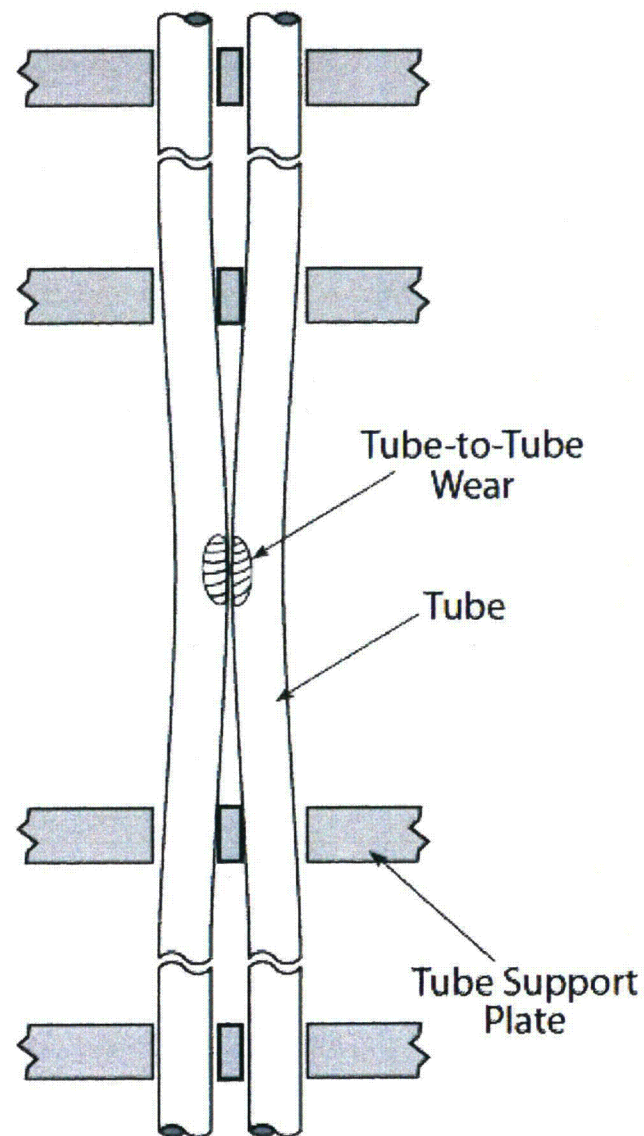
Tube-to-Tube Wear – Once Through Steam Generators

- ***Indications attributed to tube-to-tube contact in Fall 2011***
- ***Wear is shallow and slow growing***
- ***Root cause evaluation underway***

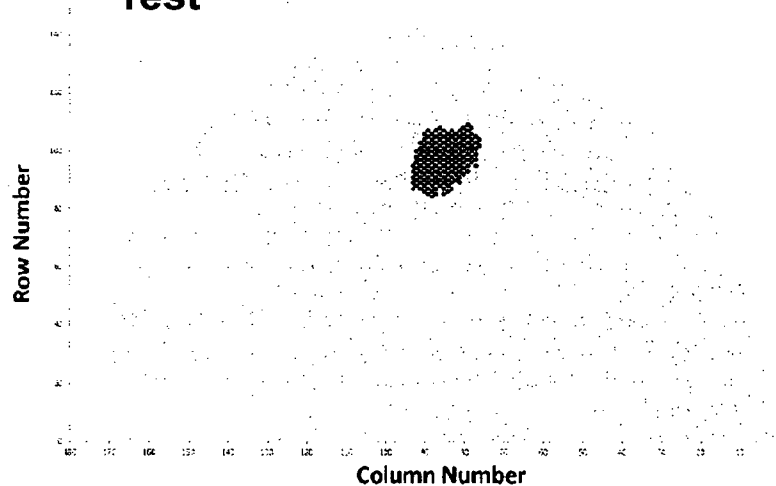
Unit 3

Operating Period 11 months
Maximum TTW Depth 100 %
Maximum TTW Length 41 inches
326 tubes (total in SG 88 and 89)
8 tubes failed In-Situ Pressure Test

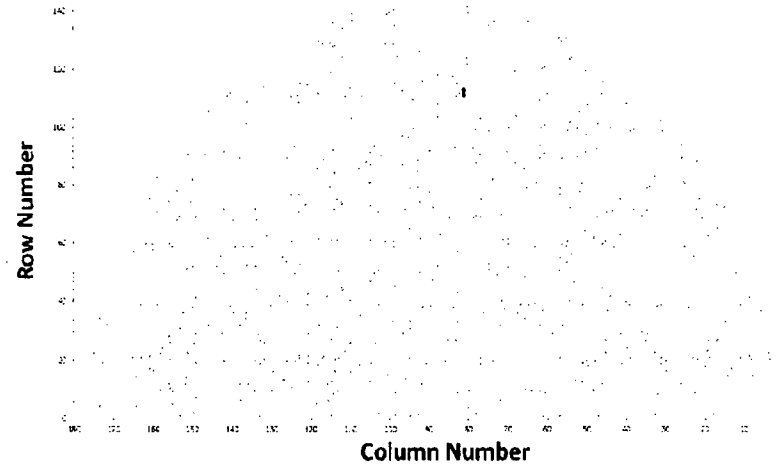
Unit 2

Operating Period 21 months
Maximum TTW Depth 14%
Maximum TTW Length 6 inches
2 tubes (total in SG 88 and 89)
No In-Situ Pressure Tests Required for TTW

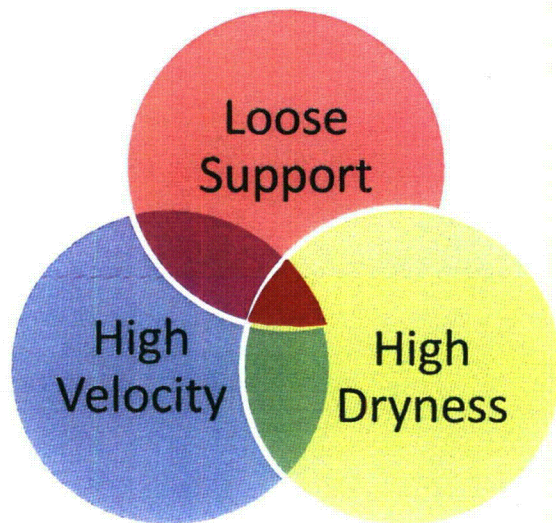
Unit 3

All three conditions required for FEI existed concurrently for many tubes

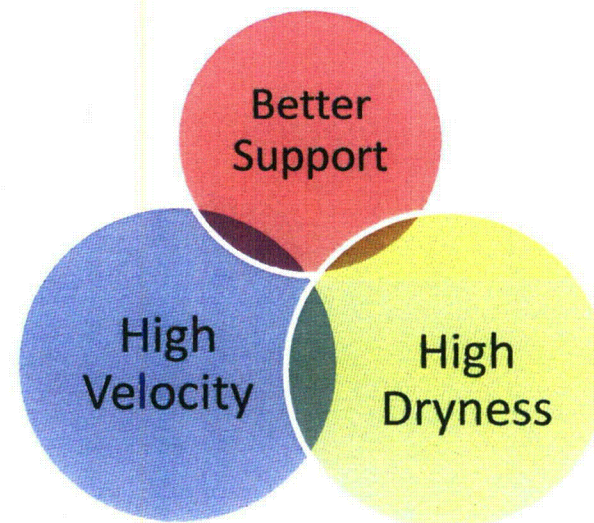
Unit 2

AVB supports are more effective in Unit 2, reducing potential for in-plane FEI

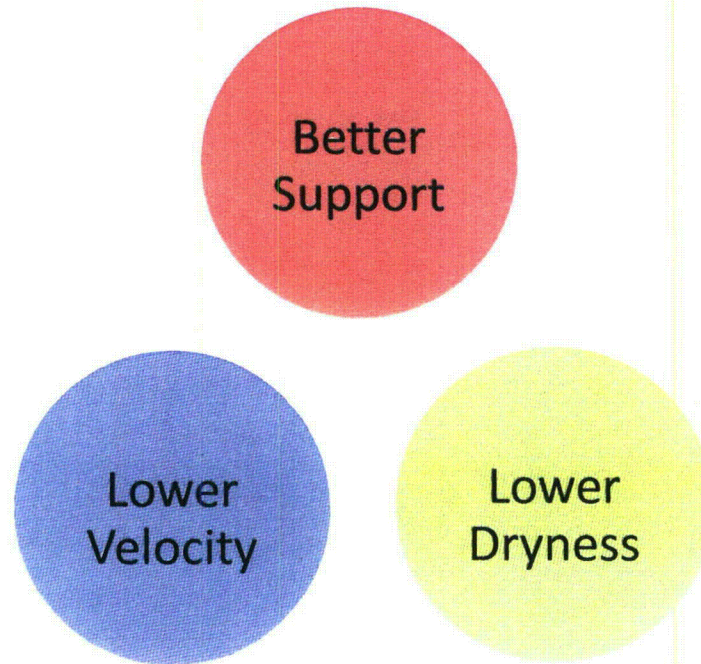
In-plane FEI can be Precluded

Eliminating the concurrent combination of high velocities, high dryness and inadequate support can preclude FEI

- Assure adequate support
- Reduce velocity
- Increase damping by decreasing dryness
(insure adequate moisture levels in bundle)
- Demonstrate acceptable in-plane FEI stability ratios based on conservative assumptions
- Compare and justify the operating conditions based on those of satisfactory service in existing steam generators

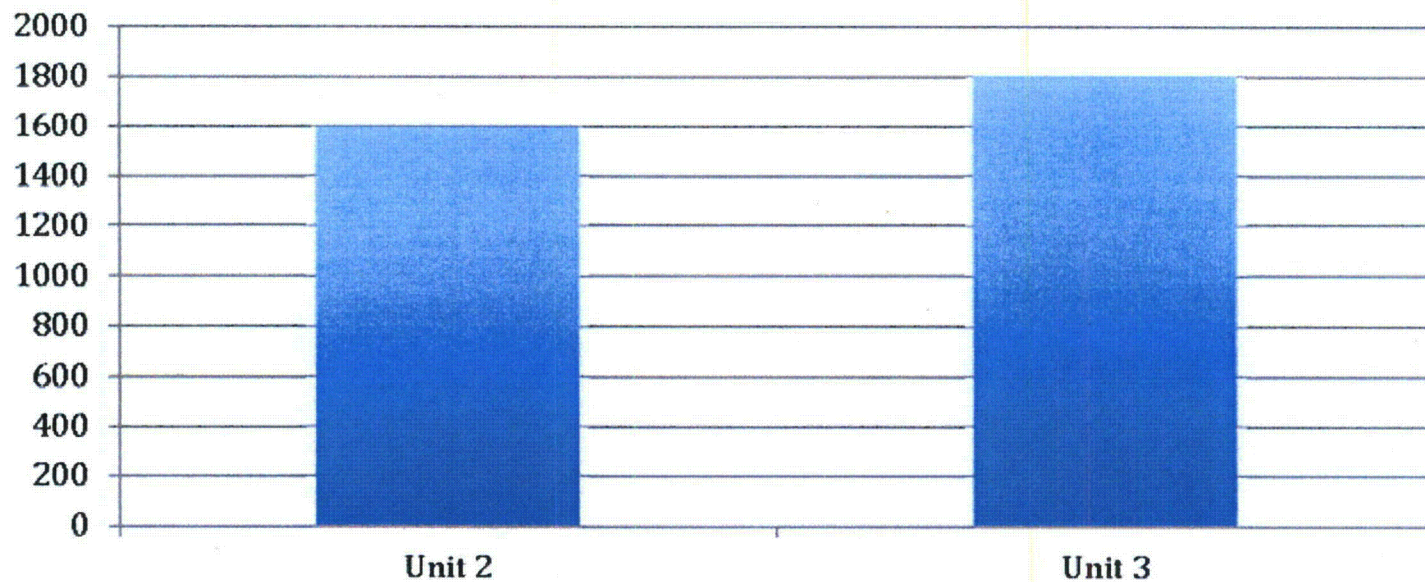
Damaged Steam Generator Tubes at San Onofre

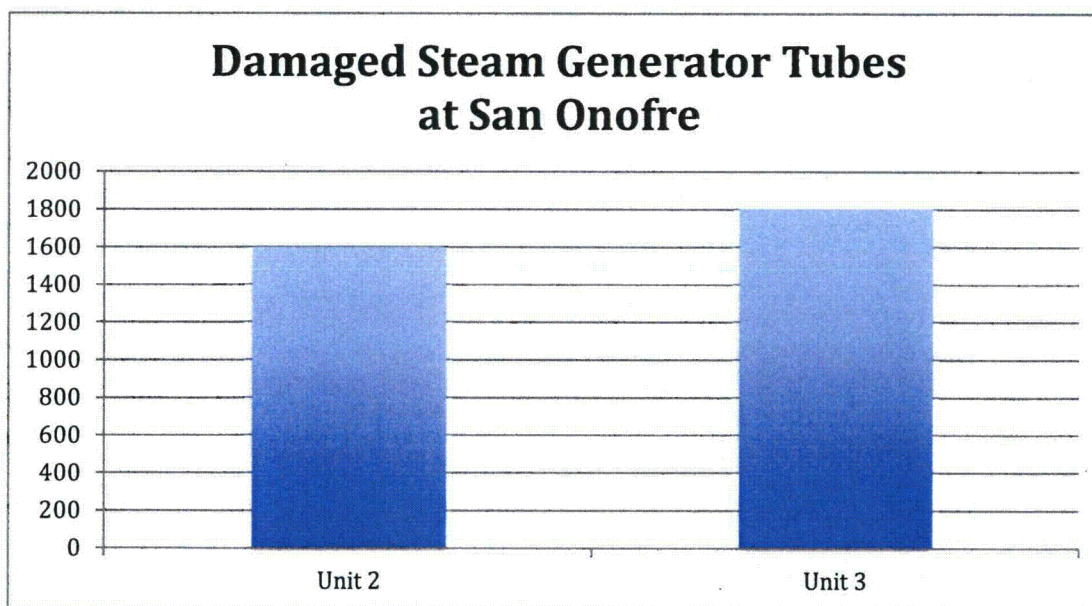
Figure 2

The data tables posted by NRC show similar numbers of damaged tubes in the two units. Unit 2 has 1,595 tubes with wear, Unit 3 has 1,806.
