FOIA/PA NO: _____2013-0250_____

From: Sanchez Santiago, Elba
Sent: Friday, May 03, 2013 2:14 PM
To: Orth, Steven
Cc: Hills, David
Subject: Palisades Report
Attachments: Palisades Input to DRP Report 2013 002 URI EMS.docx

.3 Selected Issue Follow-up Inspection: Through Wall Leakage of CRDM-24 (This inspection is part of the additional inspections included in the Palisades Deviation letter)

.1 Failure to Take Corrective Actions to Prevent Recurrence of CRDM Housing Cracking and Leakage

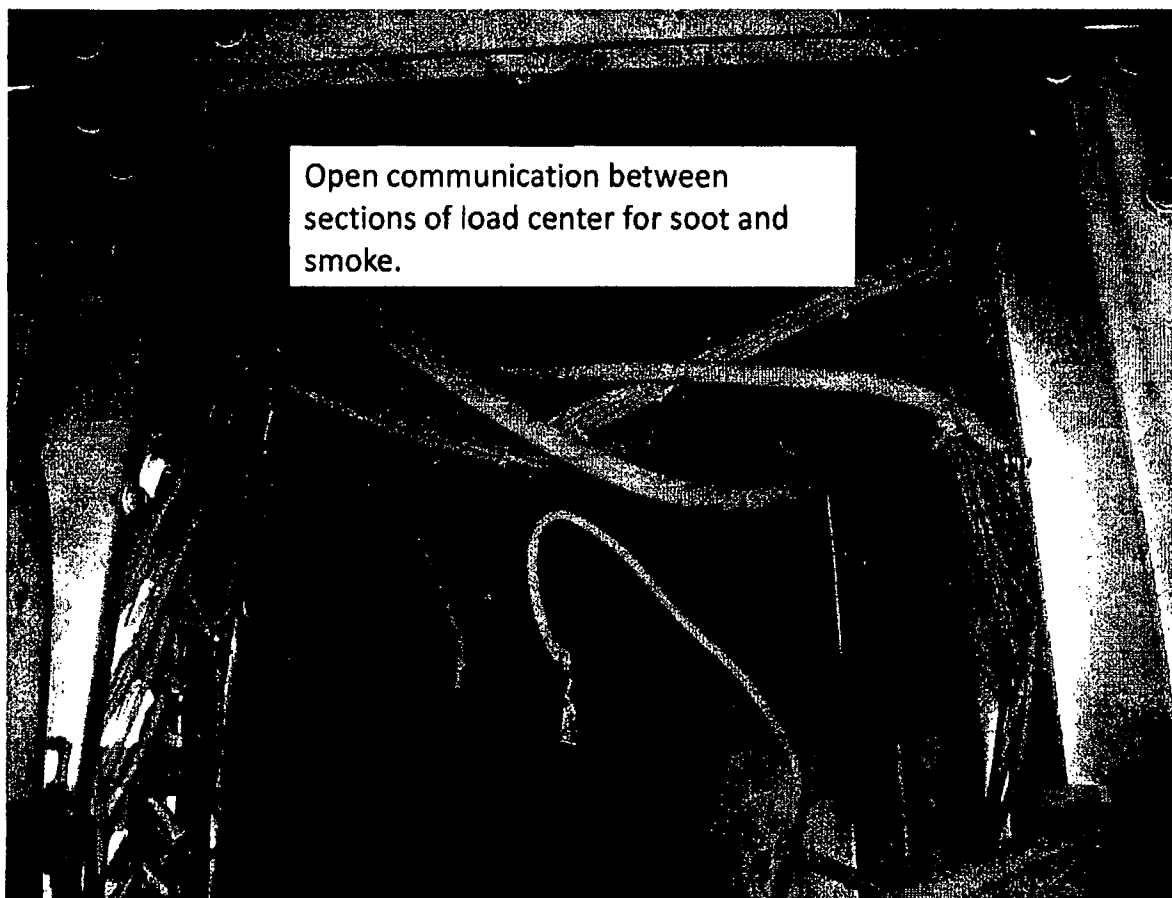
Figure 17: Internal View of Upper Section

Open communication between
sections of load center for soot and
smoke.
