SUBJECT: Forwards list of attendees & handouts from util 810915 meeting w/NRC re final design for feedwater ring mods & basis for not repeating feedwater hammer test & procedure for feedwater ring/auxiliary piping integrity test.

September 16, 1981 meeting - San Onofre Units 2 and 3 Steam Generator
Feedwater Ring Modifications

SAN ONOFRE 2 STEAM GENERATOR FEEDWATER SPARGER DAMAGE MECHANISM

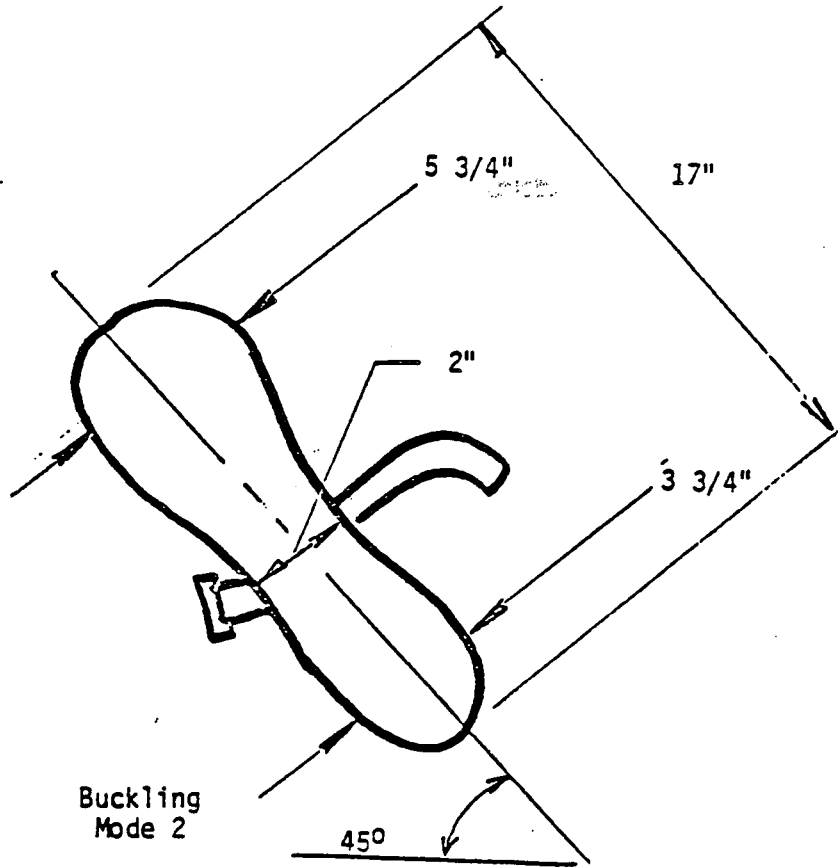
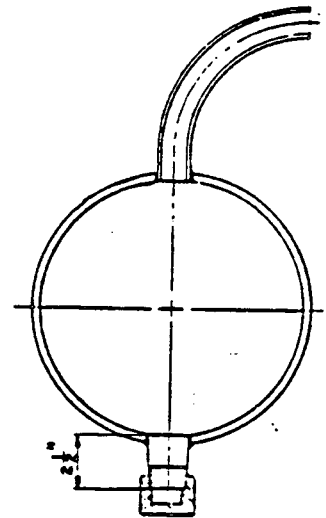
FEEDWATER SPARGER COLLAPSE MODE

- (1) Collapse of the feedwater sparger ring between the distribution box and the first set of U-bolt supports, in both the 90° and the 270° leg of pipe.
- (2) Failure of the distributor box supports, in the form of bolt shear for the lower support and axial buckling for the upper support.
- (3) Failure of the U-bolts (4) at both sparger supports in the 270° leg of pipe (tensile failure) and stretching of the U-bolts at the 90° position support.

The presence of 78 two-inch diameter holes periodically spaced in both the top and bottom of the sparger pipe (bottom holes are capped), provide preferential locations for two of the four plastic hinges required to form before the pipe can collapse. This is substantiated by observing the principal collapse modes of the damaged pipe in the north SONGS 2

SECTION VIEW
TYPICAL 76 PLACES

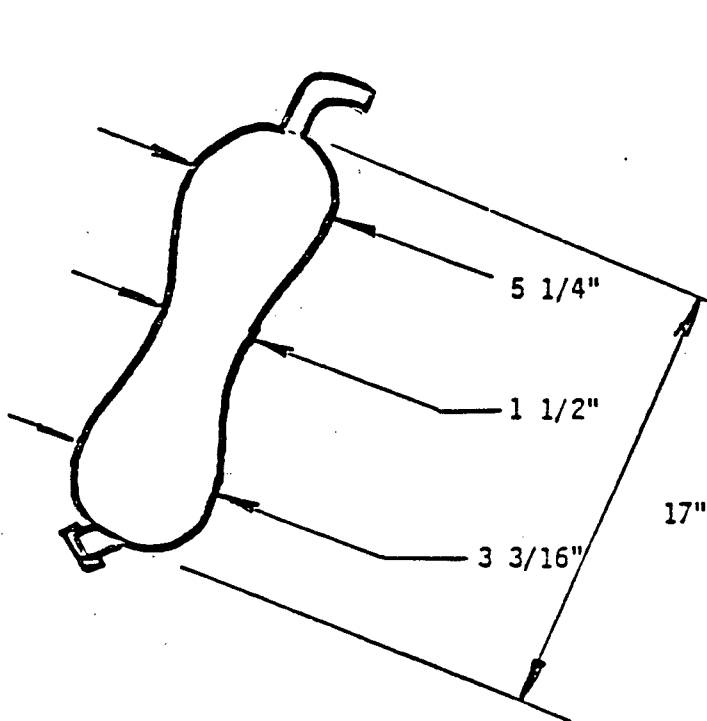
BUCKLING MODE 1

In summary, a suddenly applied external differential pressure on the sparger ring is the principal cause of sparger damage. Other factors which reduce the load carrying capacity of the sparger against collapse are: (1) a 2% ovality in the as formed sparger ring, (2) the holes in the pipe, both top and bottom and (3) the unbalanced pressure loading on the feedwater distribution box. Considering all the above and allowing for some variation in the quantification of the various factors involved, it is concluded that a dynamically applied external pressure differential of between 500 psi and 800 psi was sufficient to collapse the feedwater sparger pipe.

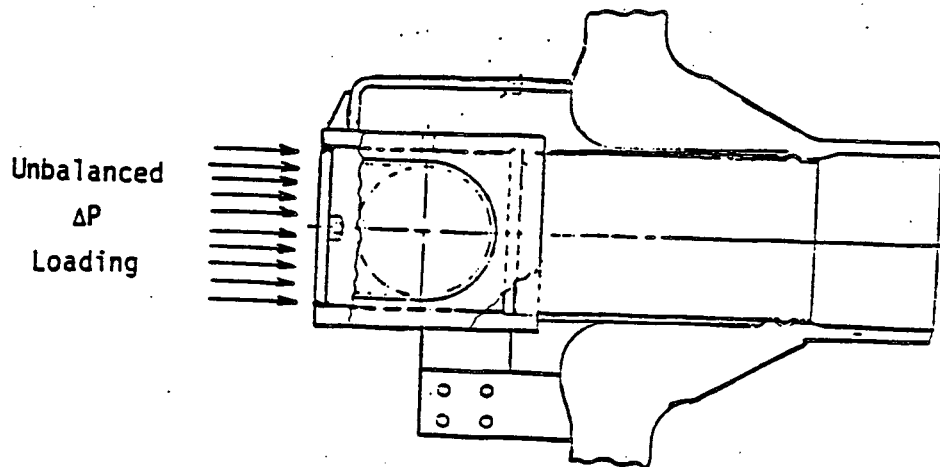
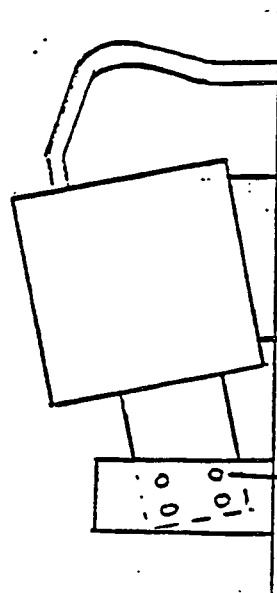
FEEDWATER DISTRIBUTOR BOX SUPPORTS AND LOADING

The unbalanced pressure loading was responsible for the failure of the distributor box supports. The failure of the U-bolts was probably due to a combination of loads induced by distortion of the collapsed sparger and reactions to the unbalanced pressure loading.

The significance of the unbalanced differential pressure loading on the feedwater distributor box is obvious with regard to the box supports but difficult to quantify with regard to the sparger collapse. The immediate effect of the load was to shear the four bolts in the lower bracket and then to simultaneously buckle the upper support bracket and pivot the box about the upper connection point. These motions caused the sparger assembly to translate (note the sheared bottom pipe caps at the sparger brackets) and to twist (not the final position of the distribution box). In order to load the sparger, however, reactions to the translational and torsional components of the unbalanced pressure loading must be developed at the sparger supports. The failure of the U-bolts is a measure of the inability to completely develop these reactions. In addition, there is evidence that the feedwater nozzle thermal liner carried a portion of the unbalanced pressure loading. Finally, it is not possible to relate the time sequence between the application of external pressure on the sparger and the unbalanced pressure load reactions. Thus the unbalanced pressure loading probably enhanced the collapse of the sparger but the degree cannot be quantified.

Original condition

Rotation in the
plane of the
paper. (Note: the
rotation is greatly
exaggerated)

deformed condition

All four bolts sheared off.

MODIFY FEED WATER DISTRIBUTION BOX (FIGURE II)

- STRONGER SUPPORTS CAPABLE OF WITHSTANDING LARGER COMPRESSIVE LOADS
- ADD 6.6 SQ. INCH VENT
