# Alloy 152-LAS Dilution Zone PWSCC Testing

***Mychailo Toloczko, Matt Olszta,  
Nicole Overman, and Steve Bruemmer***

*Pacific Northwest National Laboratory*

*ICG-EAC 2015*

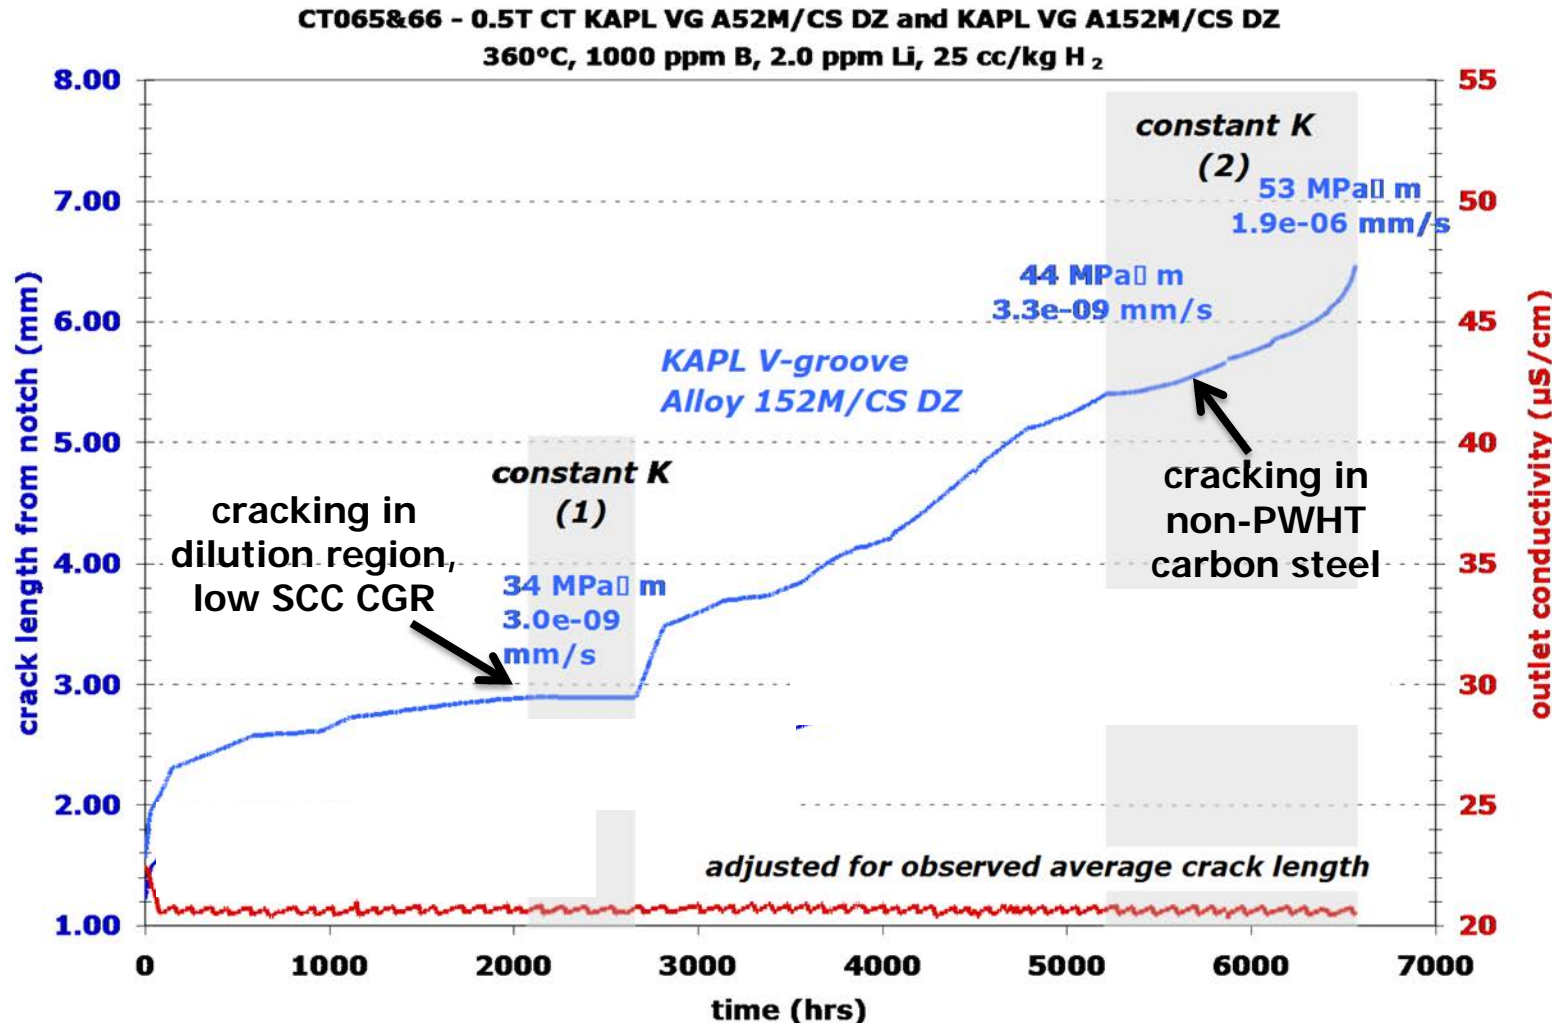
*Low SCC CGRs seen during constant K testing in a 20Cr dilution zone region. GBs were unfavorably aligned, a problem that is common to testing LAS/CS dilution zone regions.*

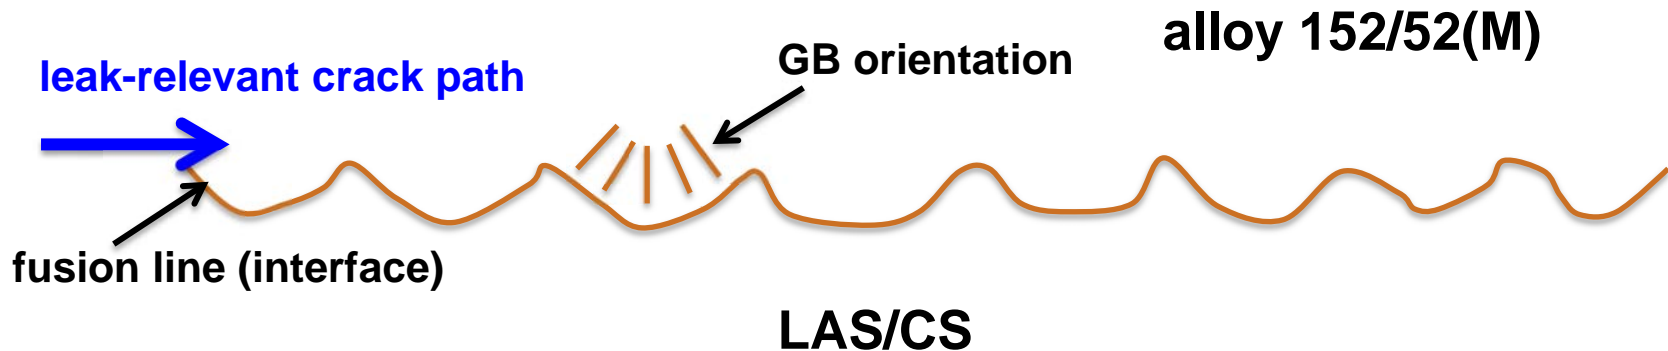
- ▶ *Weld grains are predominantly needle-shaped with long axis parallel to the weld-LAS interface normal.*
- ▶ *Leak-relevant crack path is parallel to interface and is roughly perpendicular to needle orientation.*
- ▶ *Leak-relevant crack path is unfavorable for IG cracking along these weld grain boundaries.*

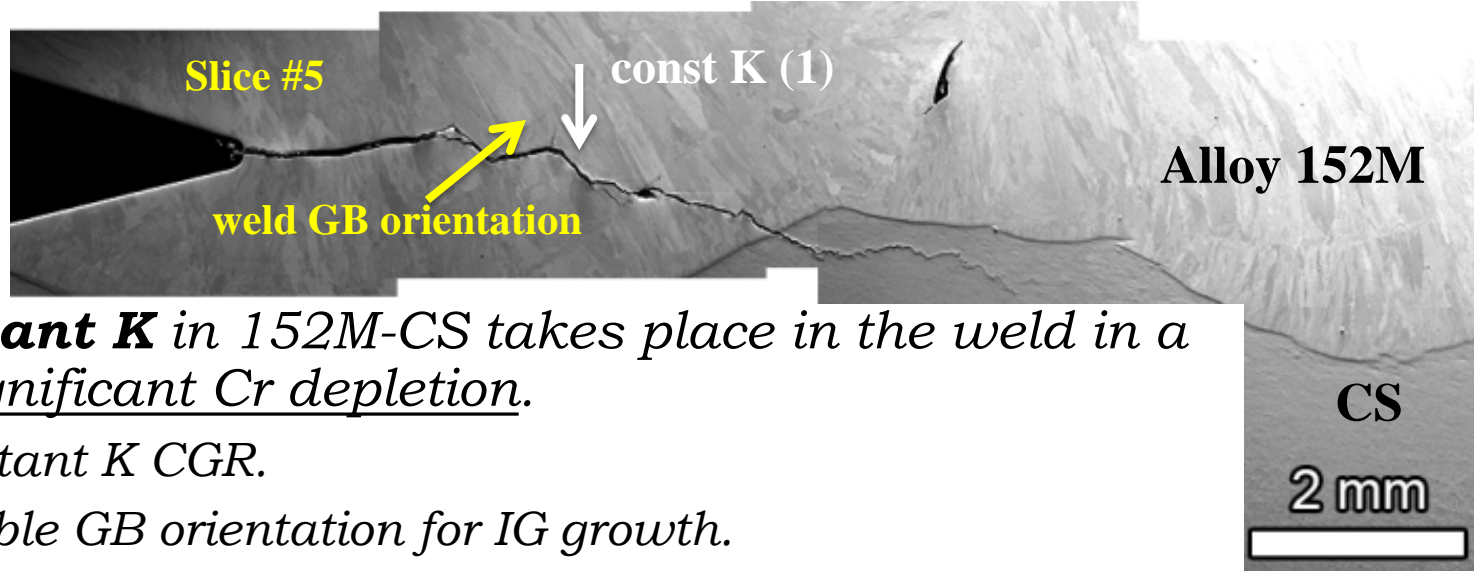
SEM BSE  
Image

► **First constant  $K$**  in 152M-CS takes place in the weld in a region of significant Cr depletion.

- Low constant  $K$  CGR.
- Unfavorable GB orientation for IG growth.
- Exams of crack surface showed predominately TG cracking.

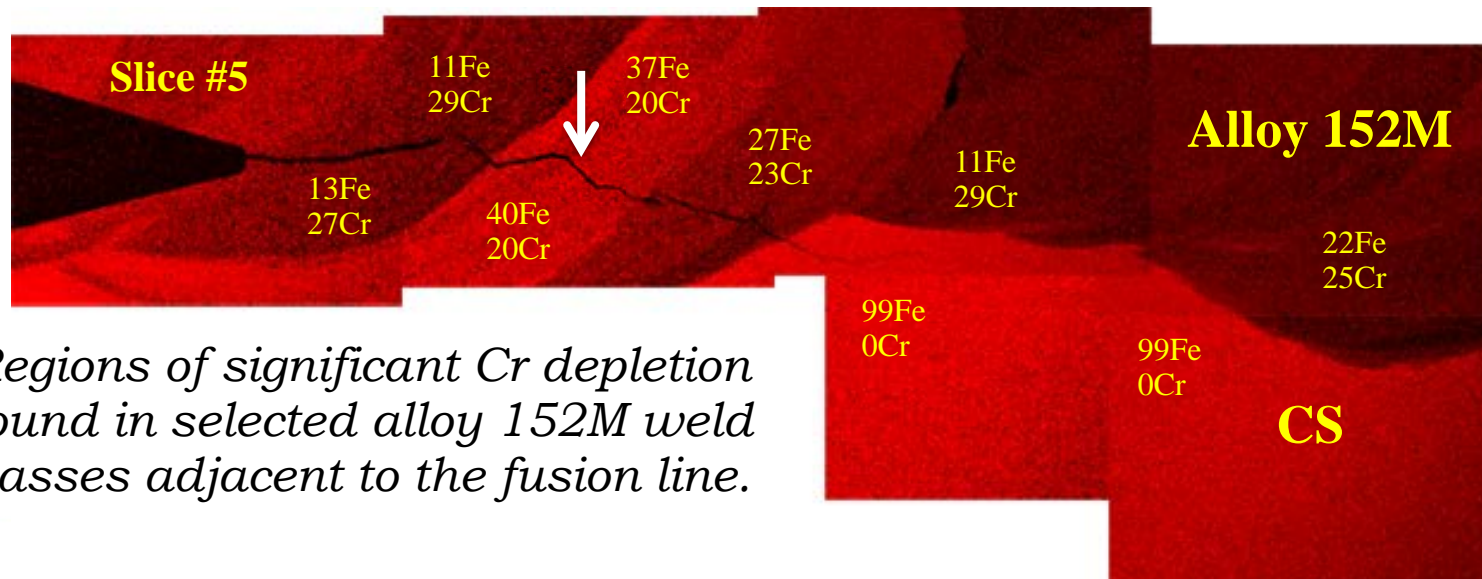
Companion  
SEM Fe-K  
EDS Map

*Regions of significant Cr depletion found in selected alloy 152M weld passes adjacent to the fusion line.*

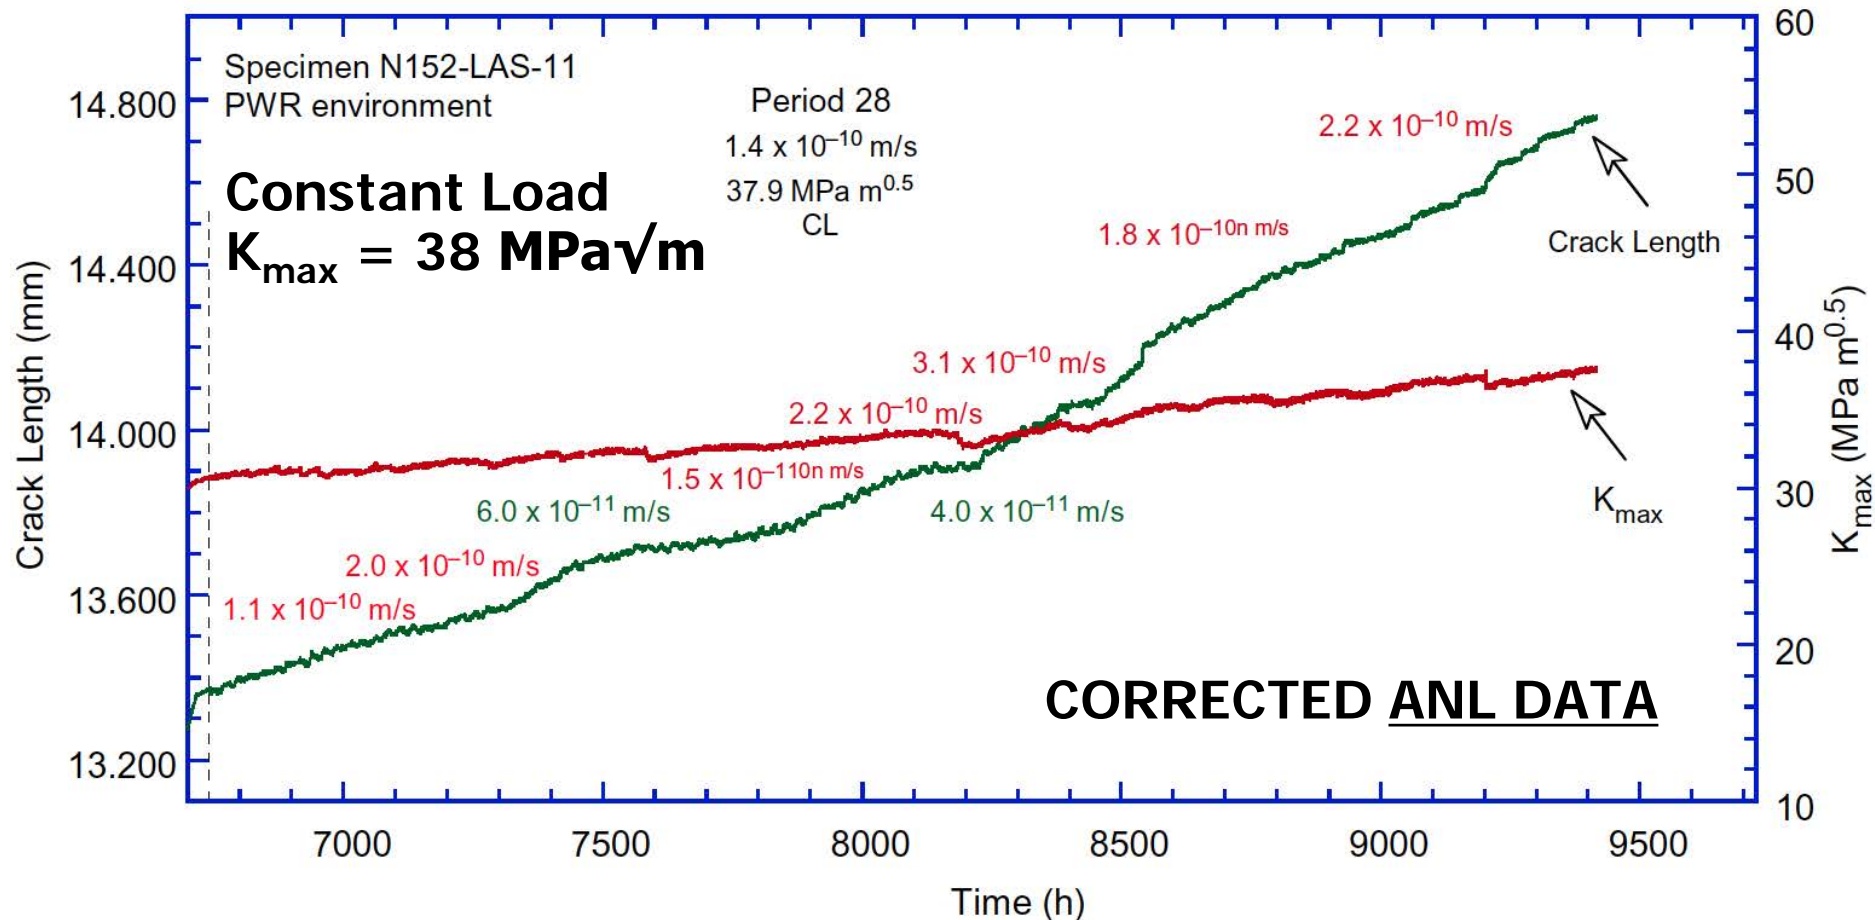
*Post-test corrected average constant load CGRs is  $>1 \times 10^{-7} \text{ mm/s}$ .*

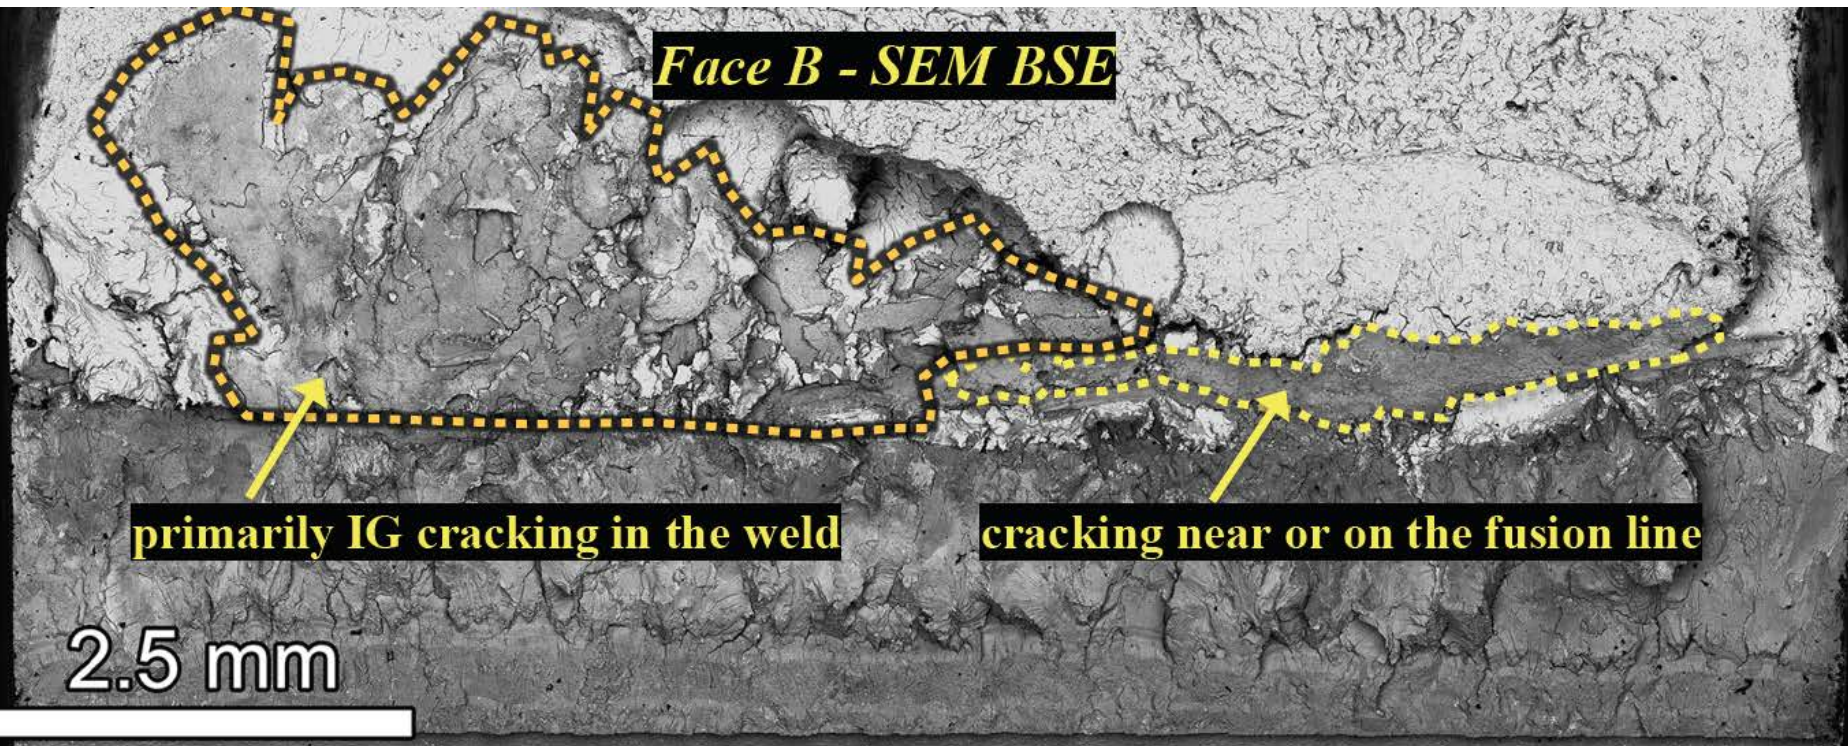
- ▶ Region on left is main area of interest. Cracking is in the weld and appears to be responsible for high SCC CGRs.
- ▶ Region on the right is cracking on or near the fusion line.

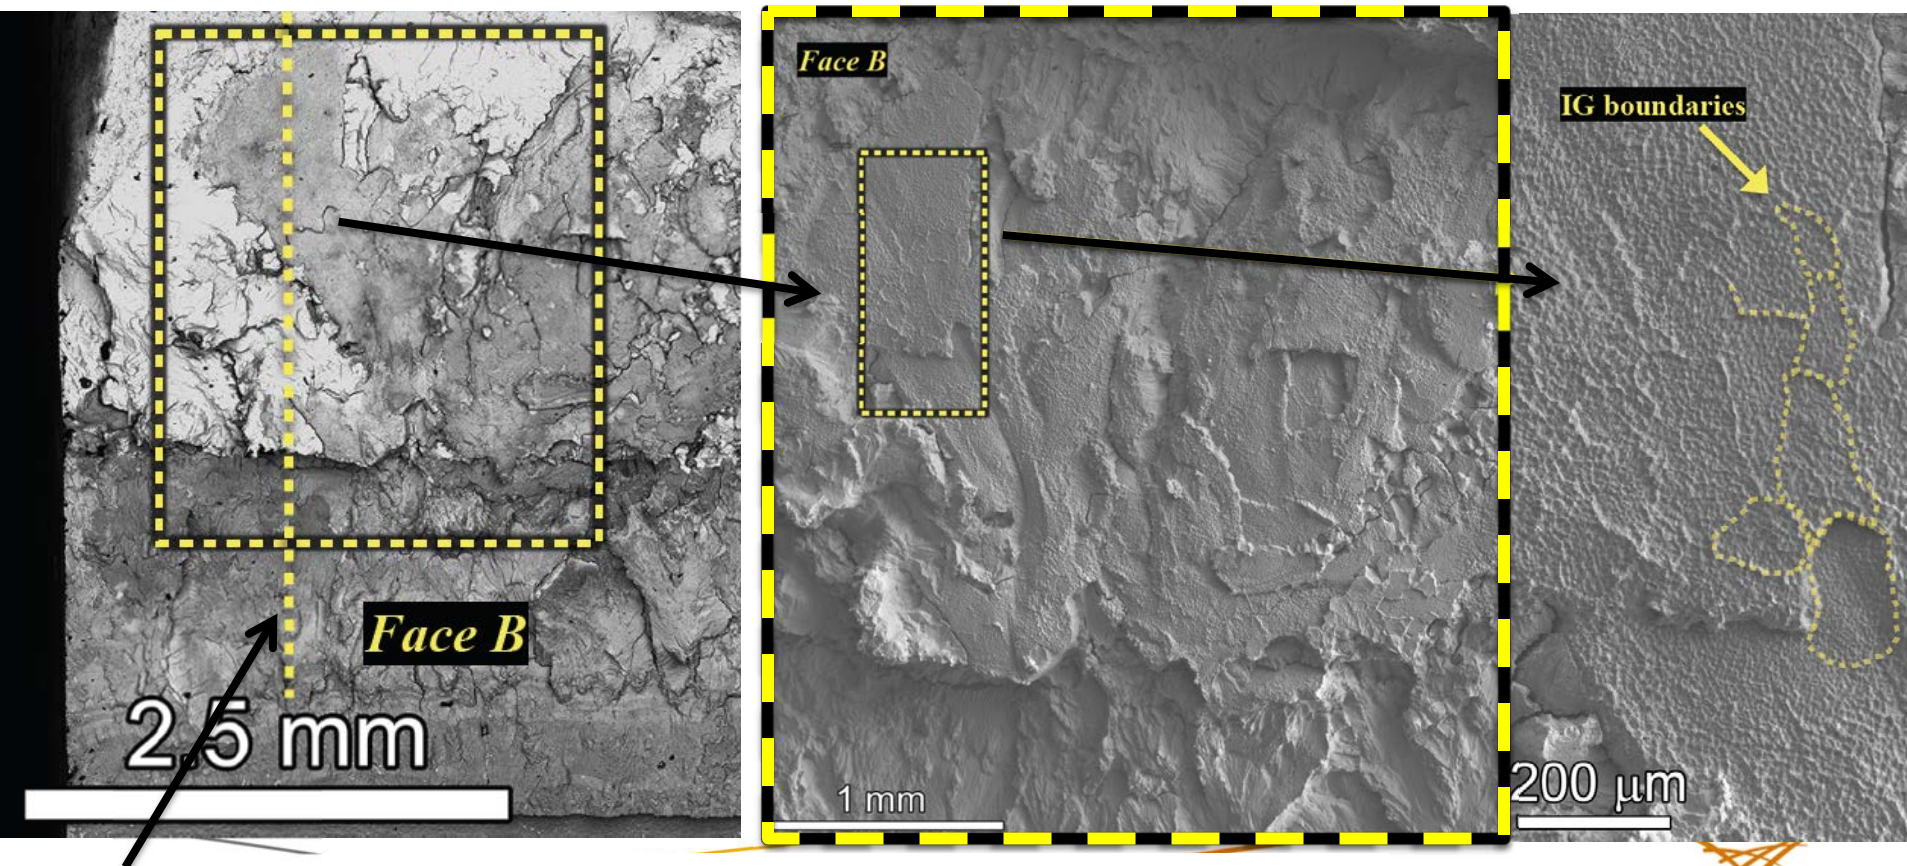
- Crack surface in the weld does not appear transgranular. Has an unusual intergranular appearance. Very flat surface.

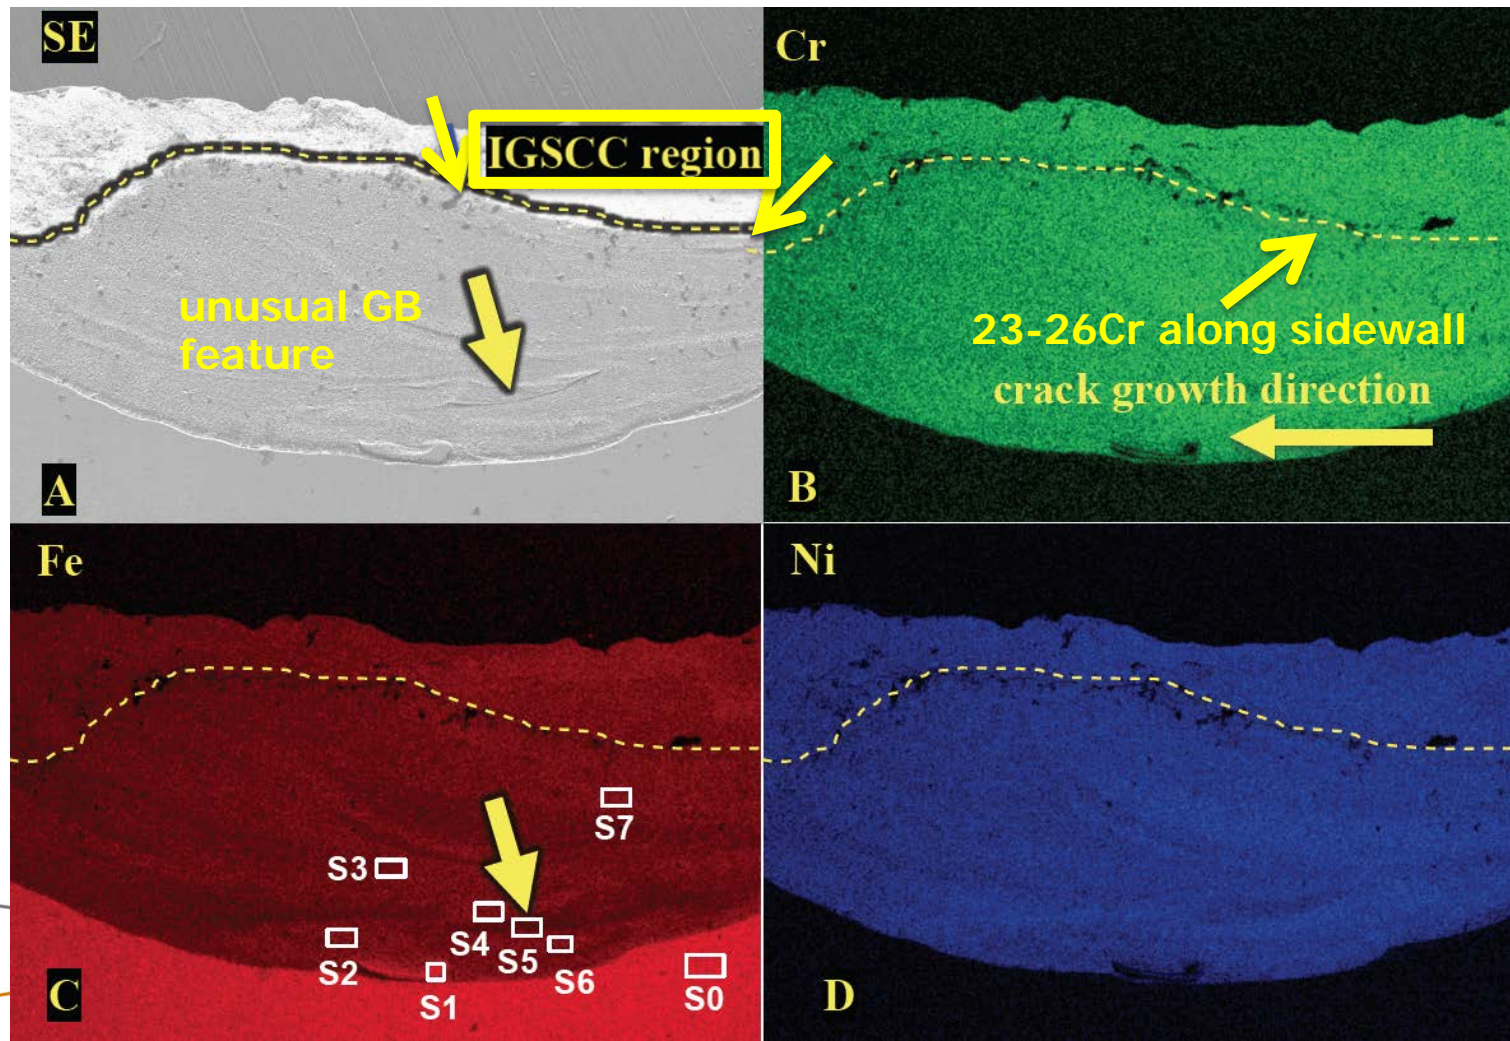
## Cross-Section Observations EDS Region 2

- ▶ *SEM-EDS exams indicate that Cr levels near SCC region are 23-26% on this side of the crack.*

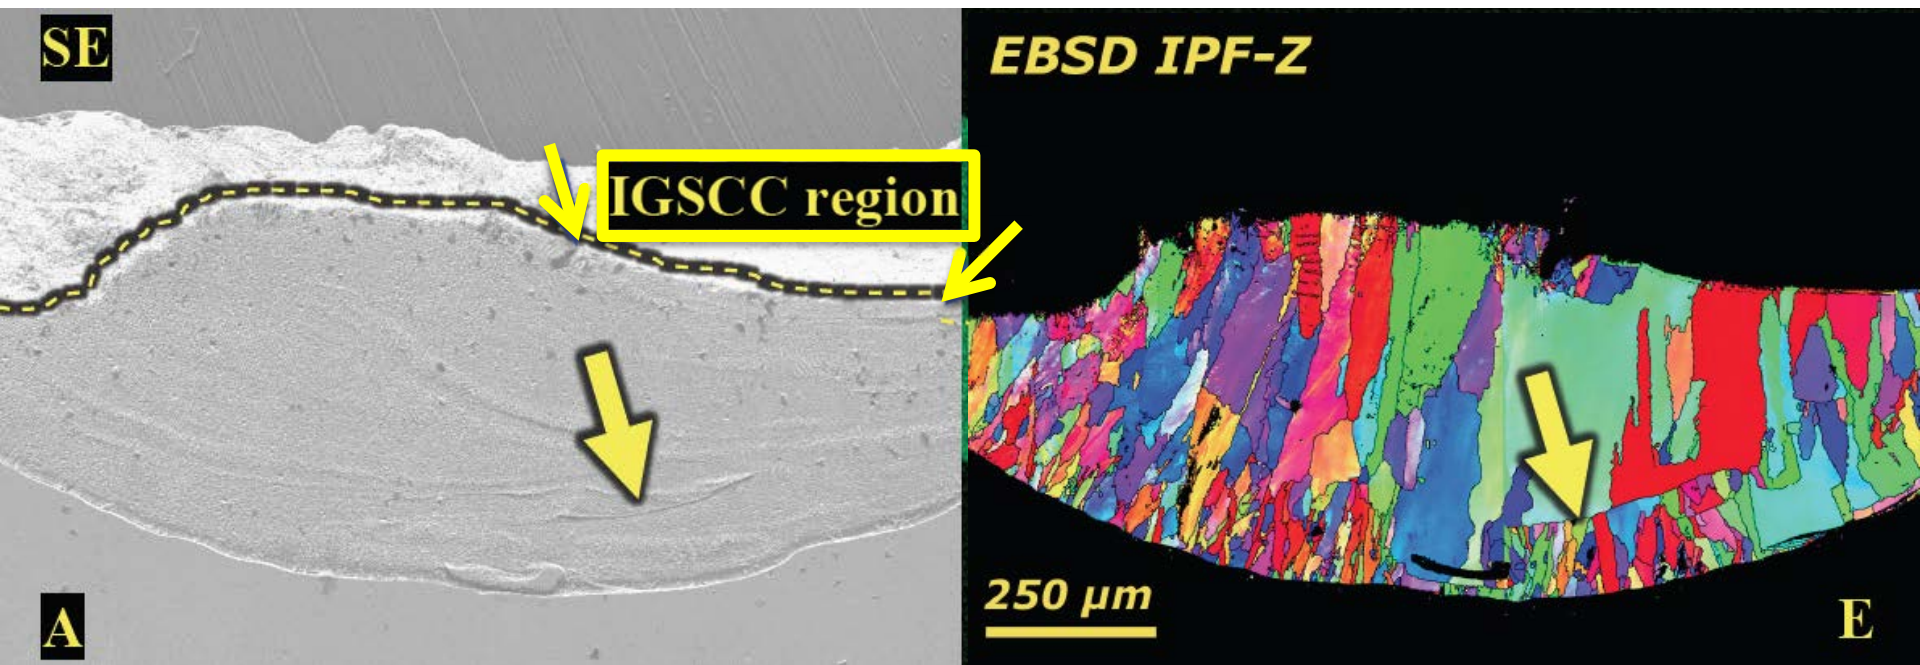
- ▶ *SEM-EBSD exam shows the crack plane to be perpendicular to the long axis of the grain boundaries.*
- ▶ *Did it crack on a weld interpass boundary?*
- ▶ *An unexpected interface was seen that is aligned similar to that of the SCC crack path.*
- ▶ *Could this be the source of the crack path?*

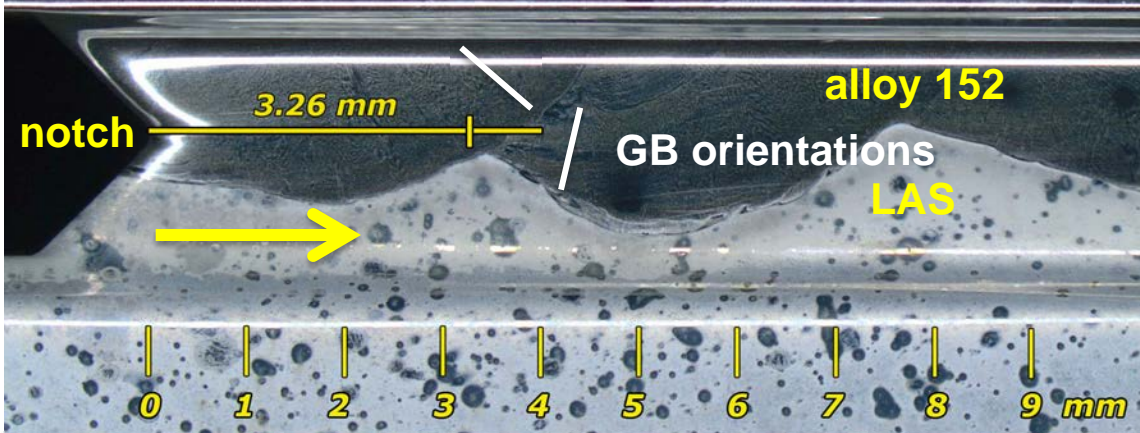
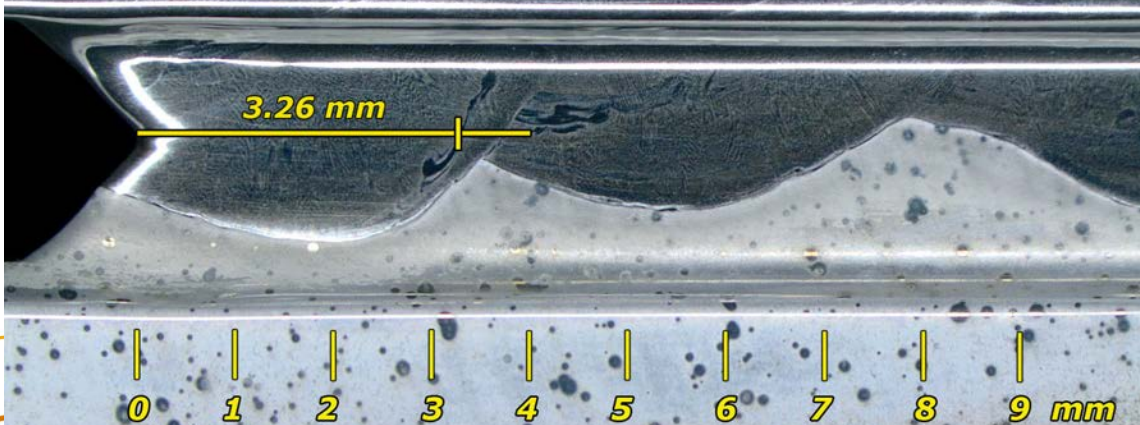
- ▶ Same region as ANL N152-LAS-11 specimen.
- ▶ First weld pass has dilution near interpass boundary as indicated by etching contrast.
- ▶ Second pass also has dilution near the same interpass boundary.
- ▶ Poor orientation to typical weld GBs.
- ▶ Crack front is currently in the second weld pass.

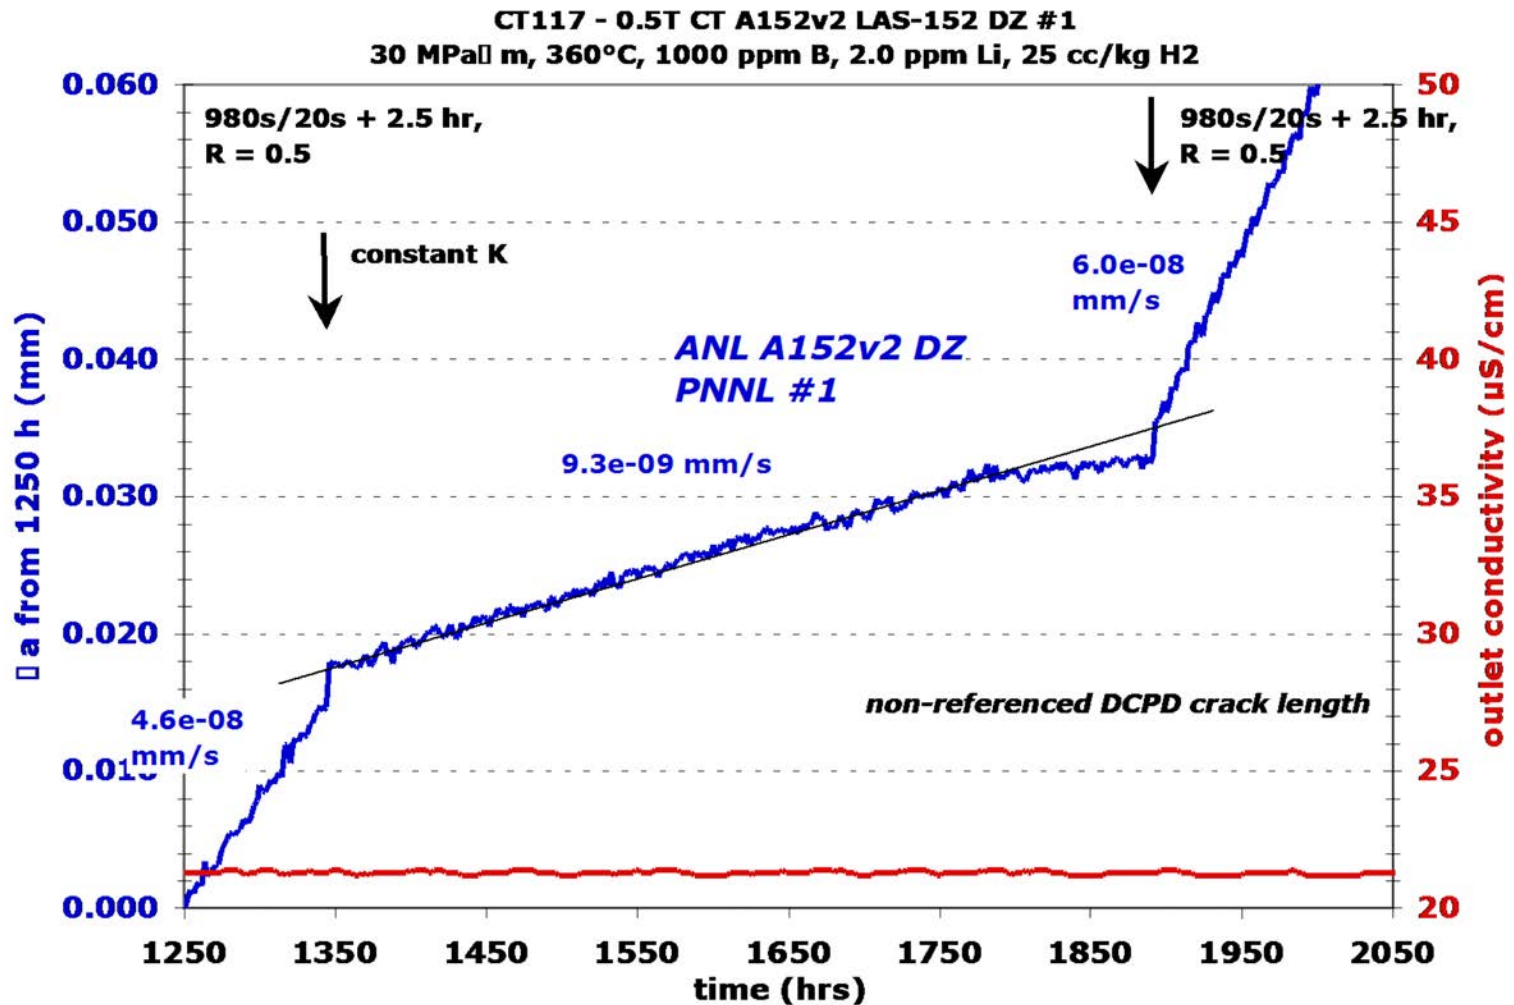
- ▶  $\sim 1 \times 10^{-8}$  mm/s observed during first constant K.
- ▶ Some indication of ligaments.
- ▶ Decreasing CGR in later observations to  $\sim 3 \times 10^{-9}$  mm/s.

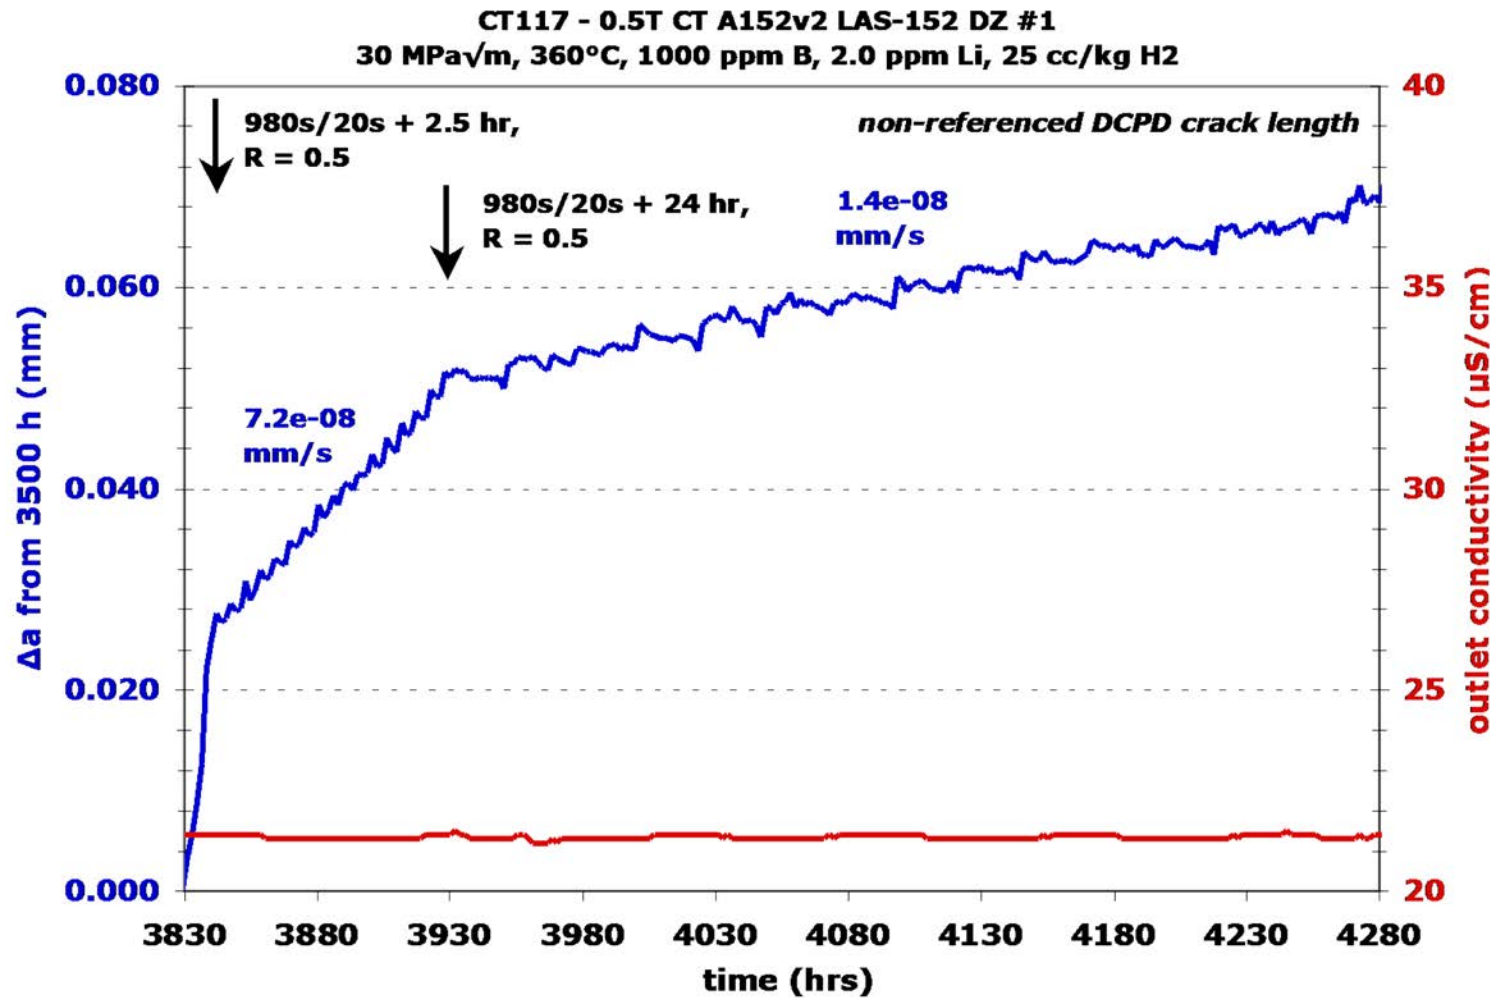
- ▶  $2\text{--}7 \times 10^{-9}$  mm/s CGRs for non-engaged alloy 152/52.
- ▶  $0.8\text{--}1.4 \times 10^{-8}$  mm/s observed for this specimen.
- ▶ Serrated response suggests ligament breakage.

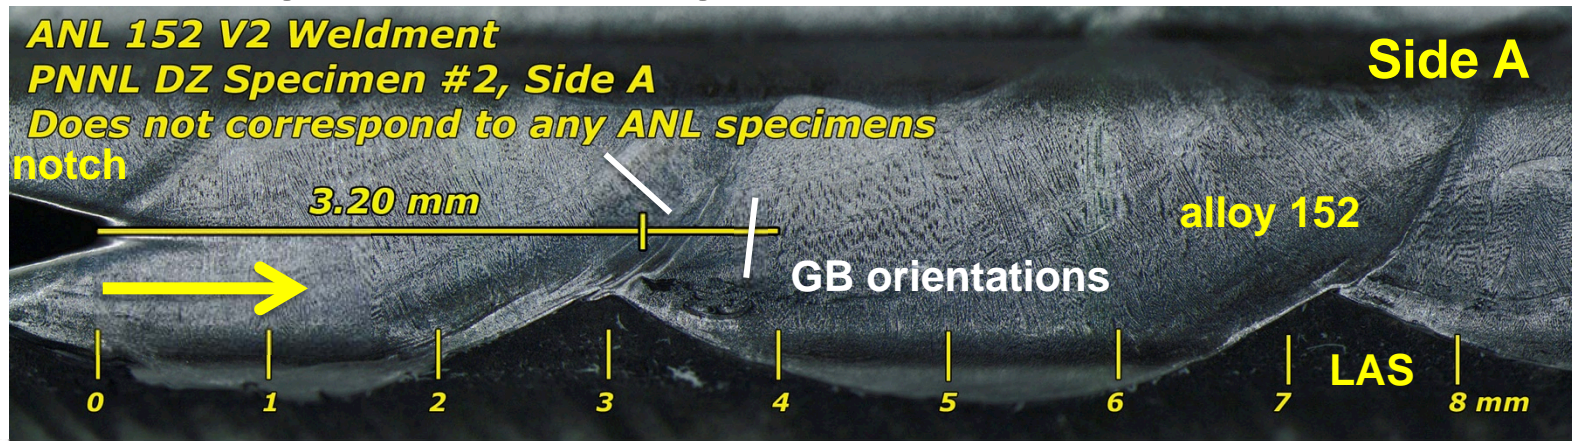
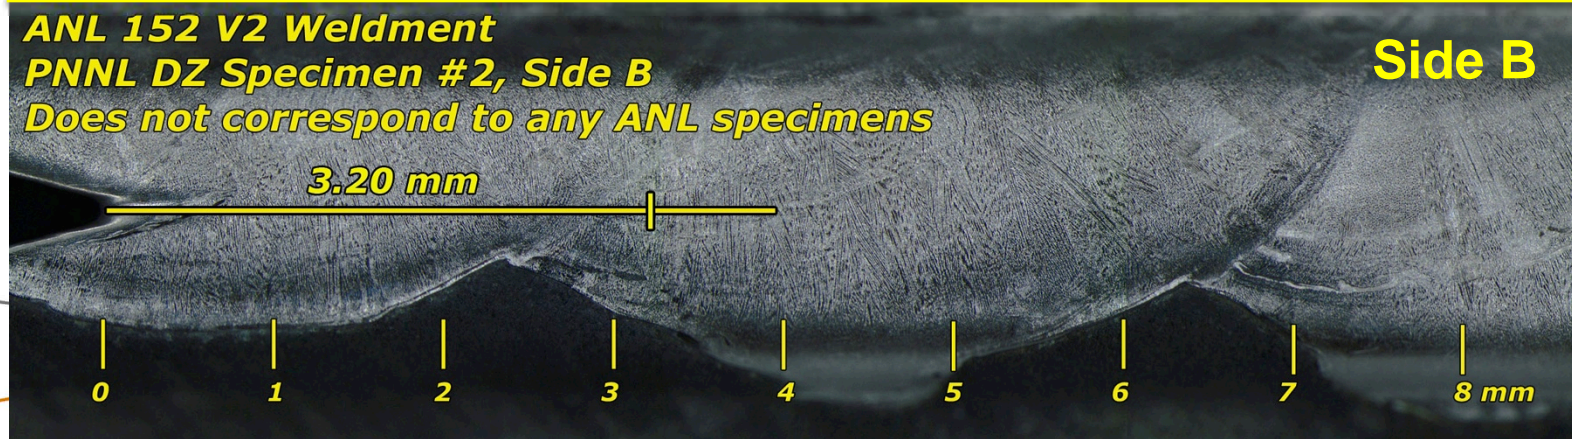
- ▶ Crack in this specimen also currently positioned to assess dilution zone near interpass boundary.
- ▶ Crack front on Side A is in the first pass while on Side B it is in the second pass.
- ▶ Not well aligned to weld grain boundaries.

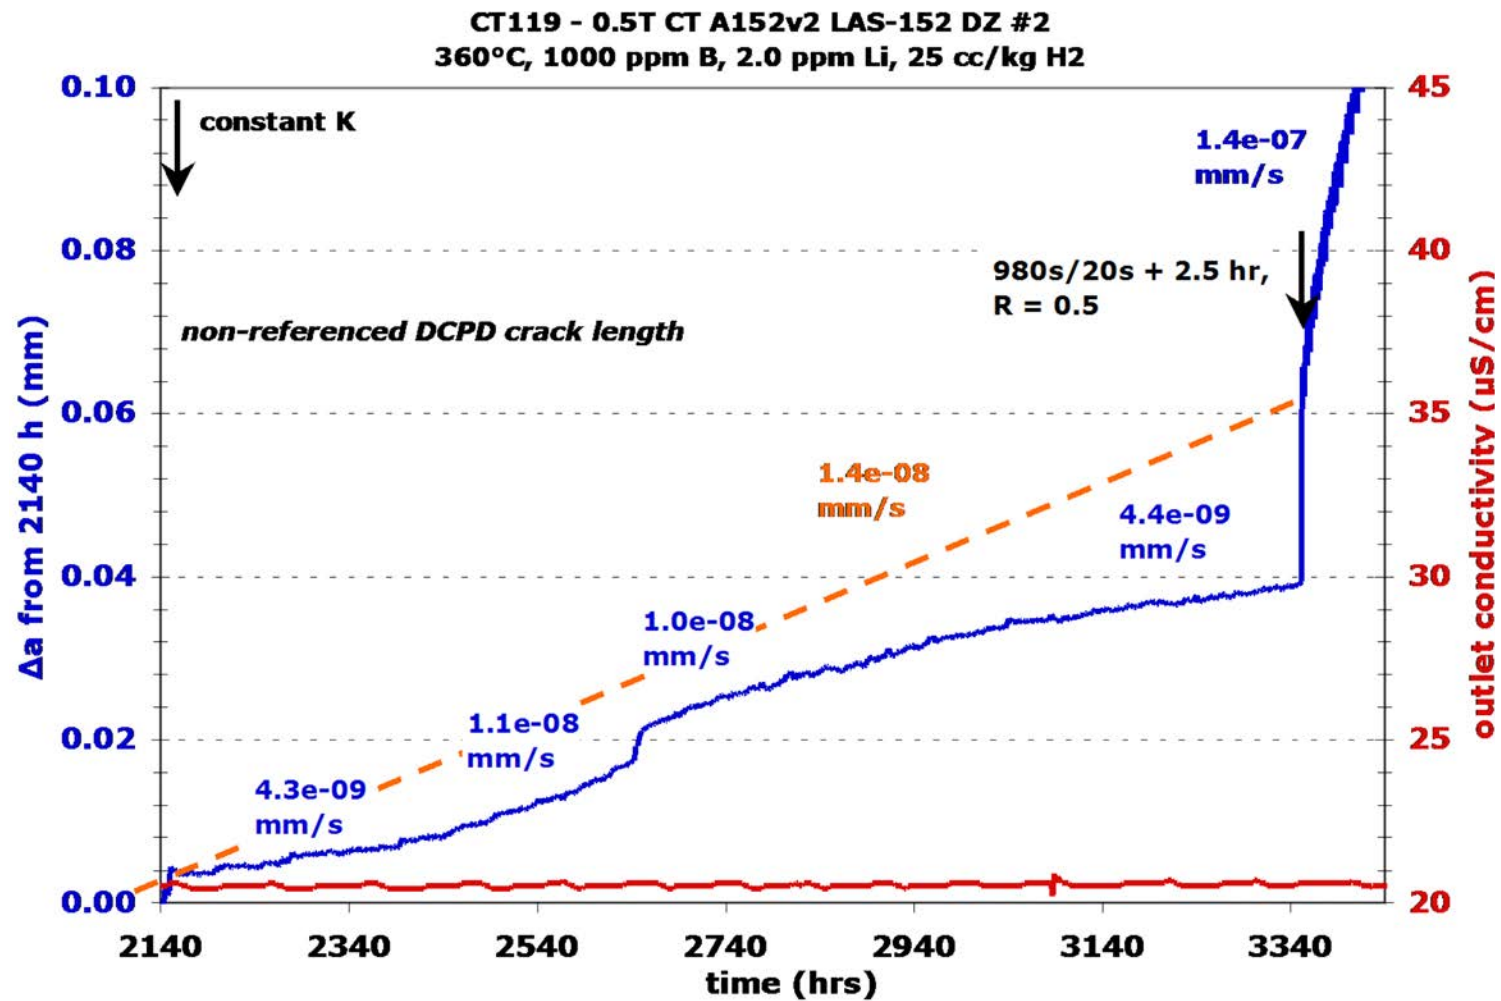
- ▶ Variable response at constant  $K$ . Some no growth by DCPD.
- ▶ Strong indication of ligament or partial engagement. Estimated CGR is  $\sim 1.4 \times 10^{-8}$  mm/s for this observation.

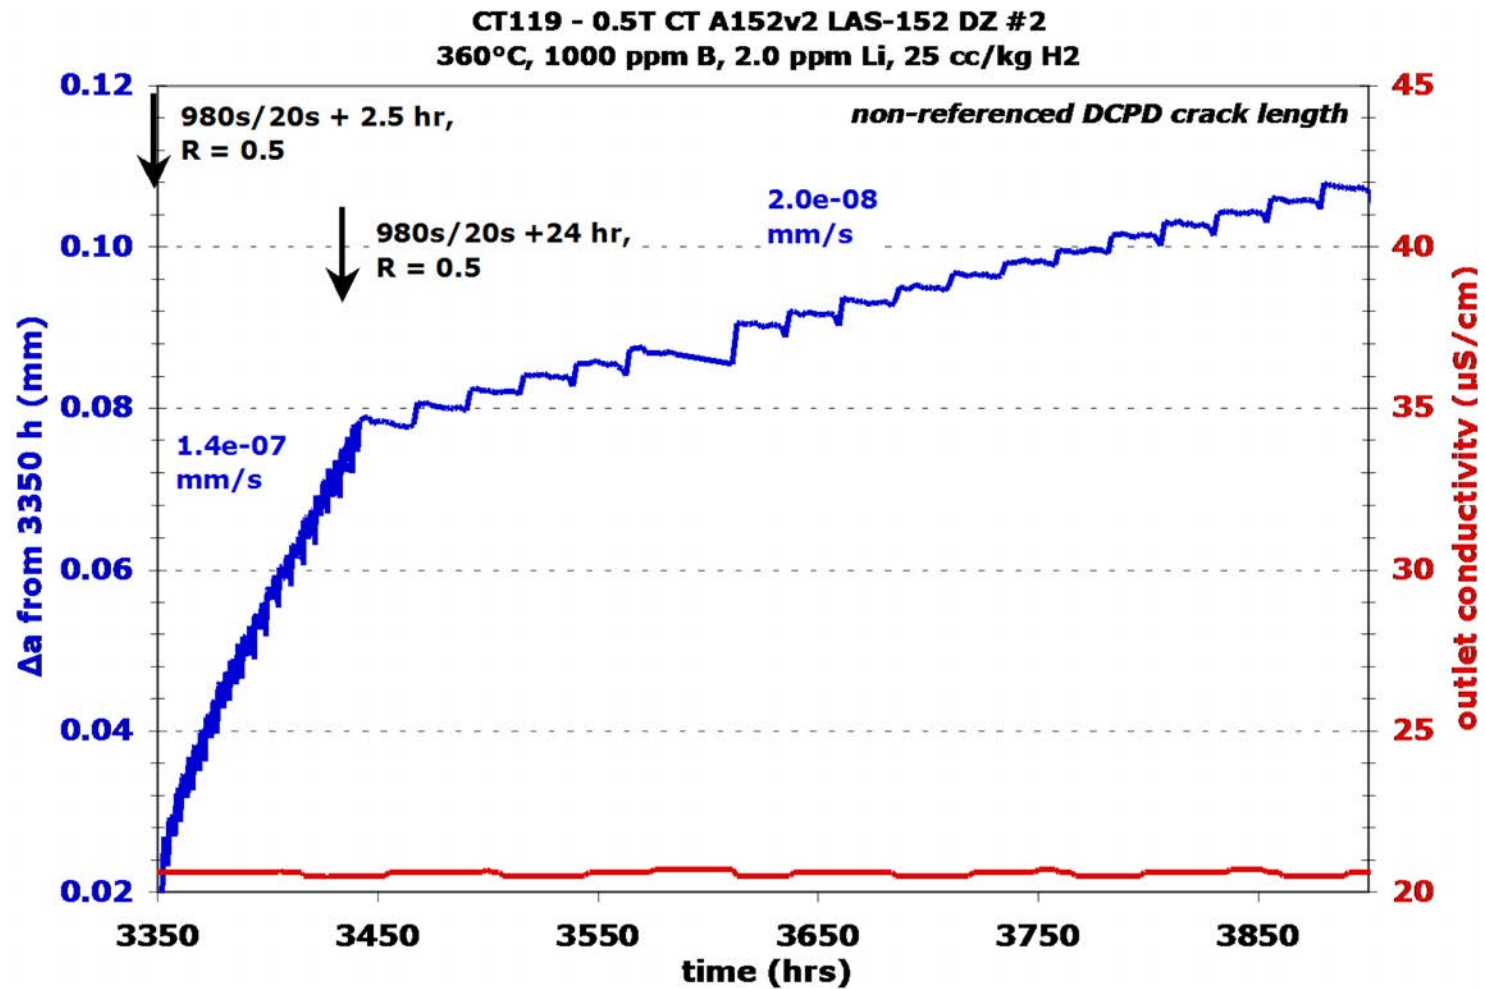
- ▶  $2-7 \times 10^{-9}$  mm/s CGRs for non-engaged alloy 152/52.
- ▶  $1.1-2.0 \times 10^{-8}$  mm/s observed for this specimen.
- ▶ Serrated response suggests ligament/contact breakage.
