RE: Florida Power and Light Company
Turkey Point Units 3 and 4
Docket Nos. 50-250 and 50-251
Fifth Ten-Year Inservice Inspection (ISI) Interval Relief Request No. 2

**TURKEY POINT UNITS 3 & 4
FIFTH INSERVICE INSPECTION INTERVAL
RELIEF REQUEST NO. 2**

ALTERNATIVE EXAMINATION FOR THE REGENERATIVE HEAT EXCHANGER

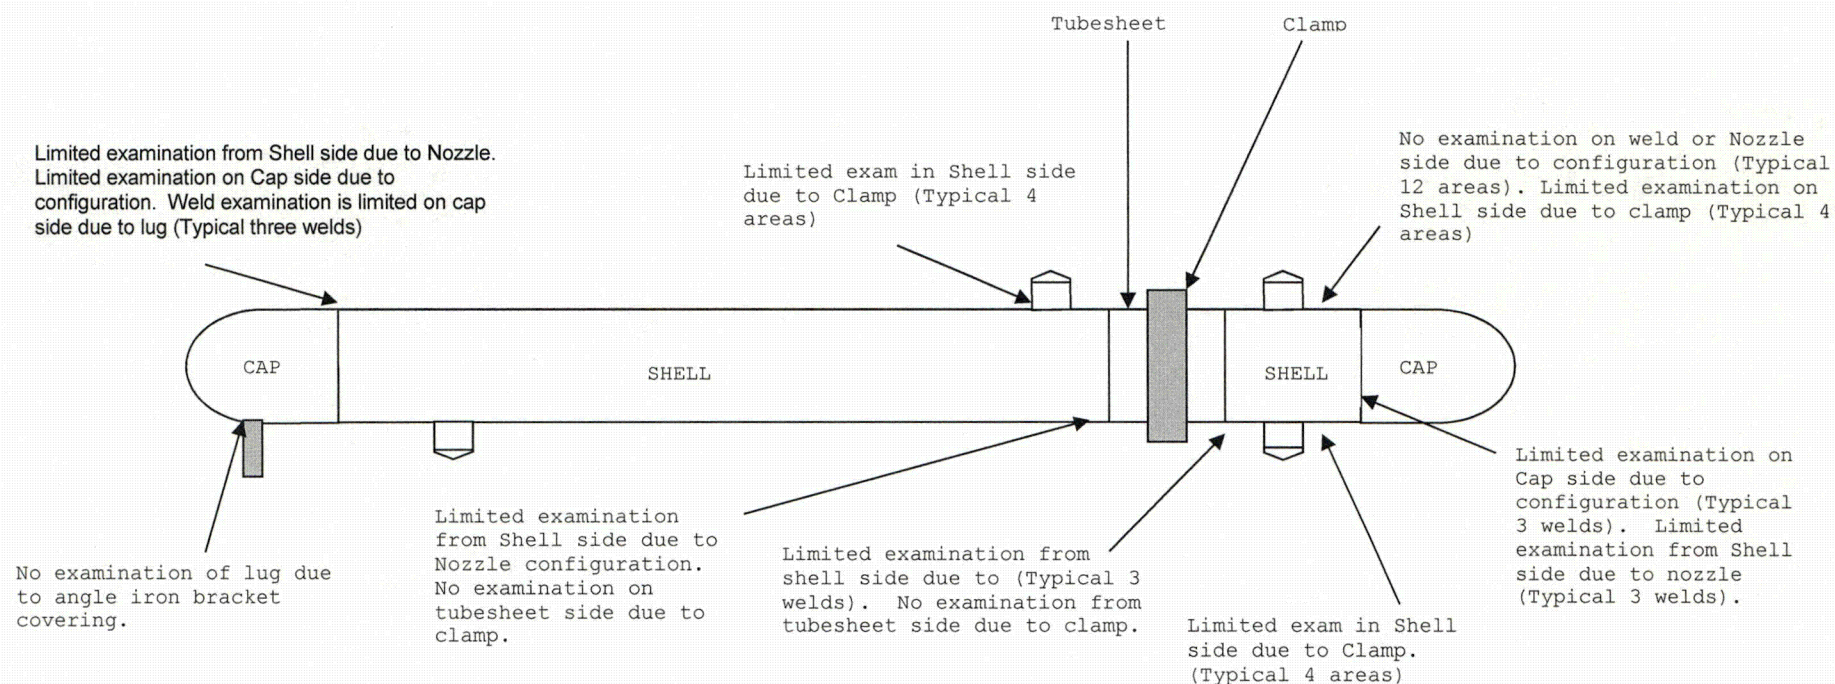
**Figure 1
Examination Area Limitations**

Pursuant to 10CFR 50.55a (z)(1), FPL requests relief from the Code required examinations on the Regenerative Heat Exchanger shell welds, support welds, and component supports. Refer to Figure 1 and 2 for Regenerative Heat Exchanger components and examination limitations.

Regenerative Heat Exchangers are located in locked high radiation areas. These areas typically have a general radiation field of 2 Rem/hr and are highly contaminated. Other conditions include limited accessibility to examination areas due to close proximity of the adjacent wall and floor, limited work area due to cubicle walls built to shield personnel in adjacent areas, and interference from other lines and supports in the immediate area.

FPL has performed examinations on the Regenerative Heat Exchangers for both Turkey Point Units 3 and 4 during the first inspection interval (approximately early 1972 through late 1983) before the original relief request was approved. This experience showed that the design arrangement and accessibility are not conducive to meaningful examinations. The configuration, limited accessibility, high radiation levels, and interference from supports, walls, and the floor do not support Code required examination coverage for volumetric and/or surface examinations.

FPL will perform a VT-2 visual examination at the beginning of the outage for leakage and boric acid accumulation and a VT-2 visual examination at startup during the system leakage test.
