Sequoyah Nuclear Plant, Units 1 and 2
Facility Operating License Nos. DPR-77 and DPR-79
NRC Docket Nos. 50-327 and 50-328

Subject: **Response to NRC Request for Information regarding the Review of the Sequoyah Nuclear Plant, Units 1 and 2, License Renewal Application, Set 25 (TAC NOS. MF0481 and MF0482)**

**Responses to NRC Requests for Additional Information regarding Sequoyah
Nuclear Plant Unit 1 License Renewal**

RAI 3.0.3.2.17-1a (Surveillance Capsule Operating Experience Followup)

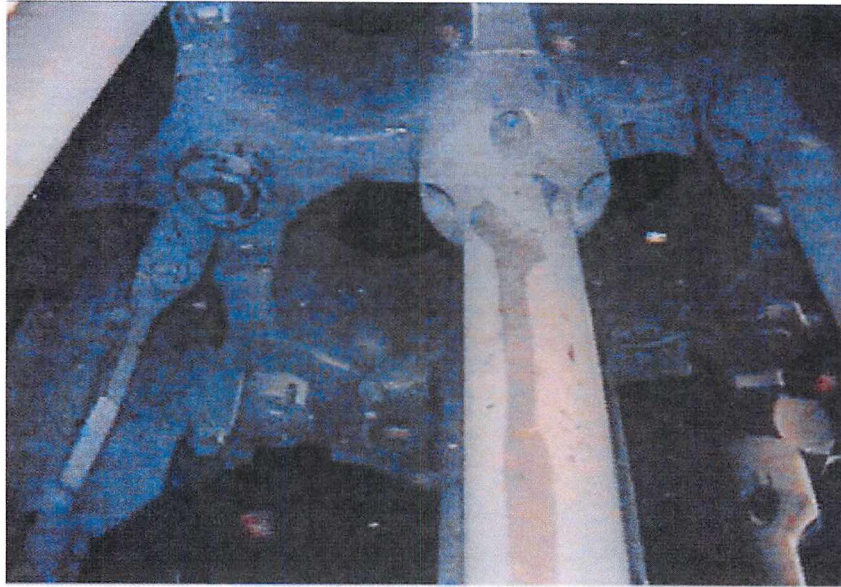
Figure 1

- Deep rub marks may have left slightly more surface cold work behind, depending on how they were formed. However, the deep rub marks discovered in the SQN Unit 1 RVI components were located at low stress locations. Even considering the possible localized loss of component cross-sectional area and the potential slight increase in cold work, cracking is not expected and the likelihood of failure considered in MRP-191 is unchanged. The following details are provided regarding the specific deep rub marks:

- The stress at the location of the rub mark on the instrument guide extension G-5 (see Figure 1) was evaluated. The stress was calculated to be well below 5 ksi even if a hypothetical reduction in depth of 5% is assumed along with a conservative stress concentration factor. Thus, the rub on the instrument guide extension would not have an impact on the potential for cracking in this component.

Deep rub shown on instrument guide extension G-5.

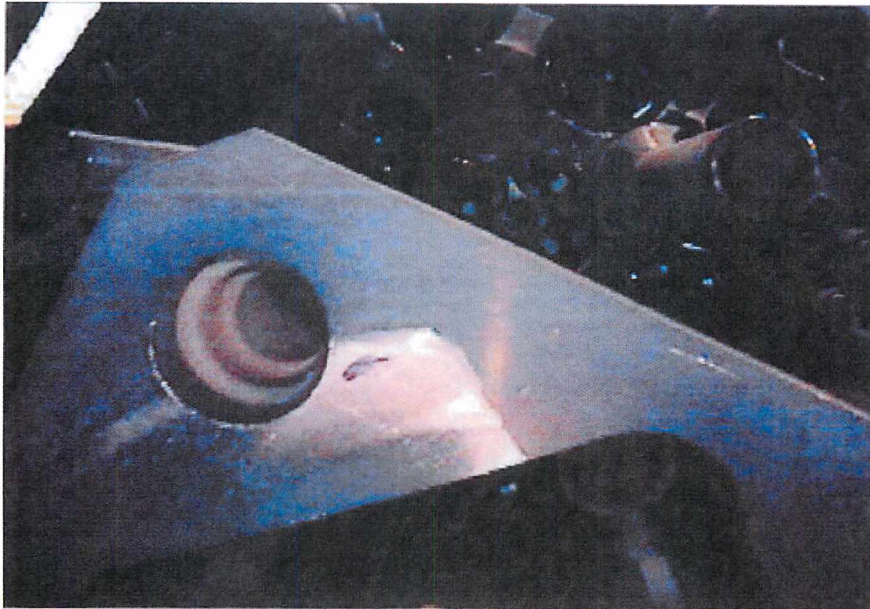
Figure 2

- The location of the rub mark on the bottom plate of the energy absorber (see Figure 2) is an area of low stress because of the geometry and function of the component. Structurally, this plate only supports its own weight and is subject to minimal effects from thermal or flow-induced stresses during operation. Thus, the rub on the plate would not have an impact on the potential for cracking in this component.

Deep rub on bottom surface of energy absorber ~180°.
