**Savannah River
Remediation**

Saltstone Disposal Facility SDU Cell 2A Core Drill Summary

SRR-CWDA-2015-00087

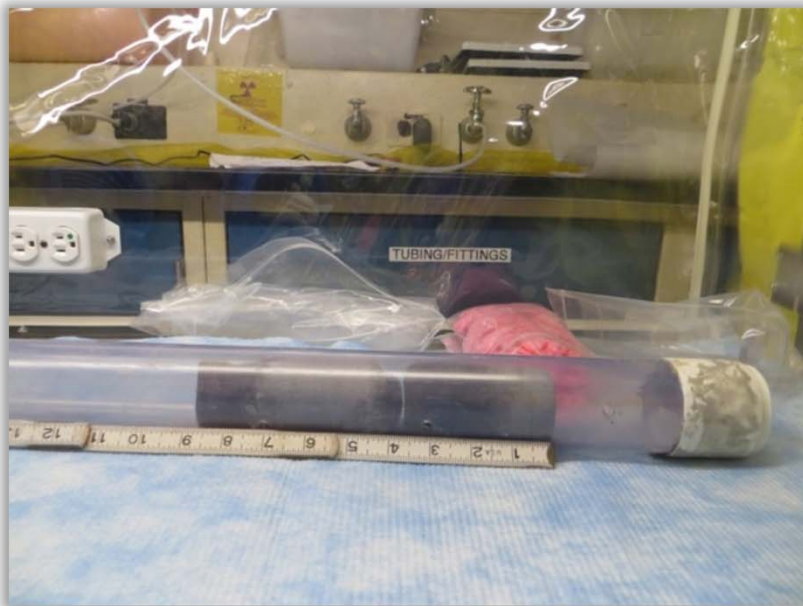
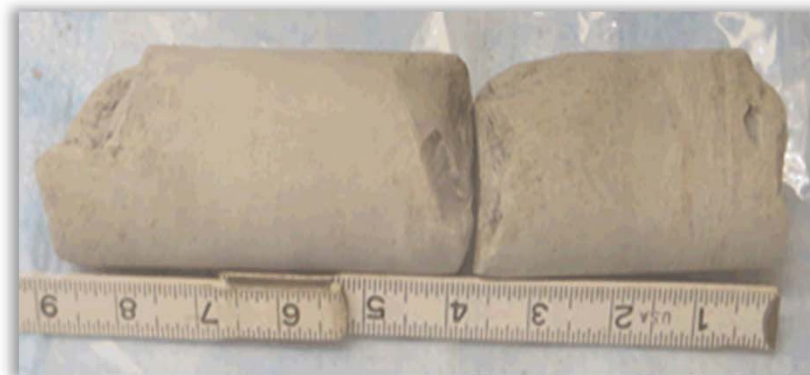
Port B, Hole #2

22-Apr	4-6.5	Intentionally decreased drill traverse speed, drill motor laboring then "popping" and resumption of normal drill operation	Extraction tube encountered considerable resistance. Operators described the feel as "gravelly"	9

- Core Material Extracted from Hole # 2
 - Approximately 16.5' - 17.25' elevation

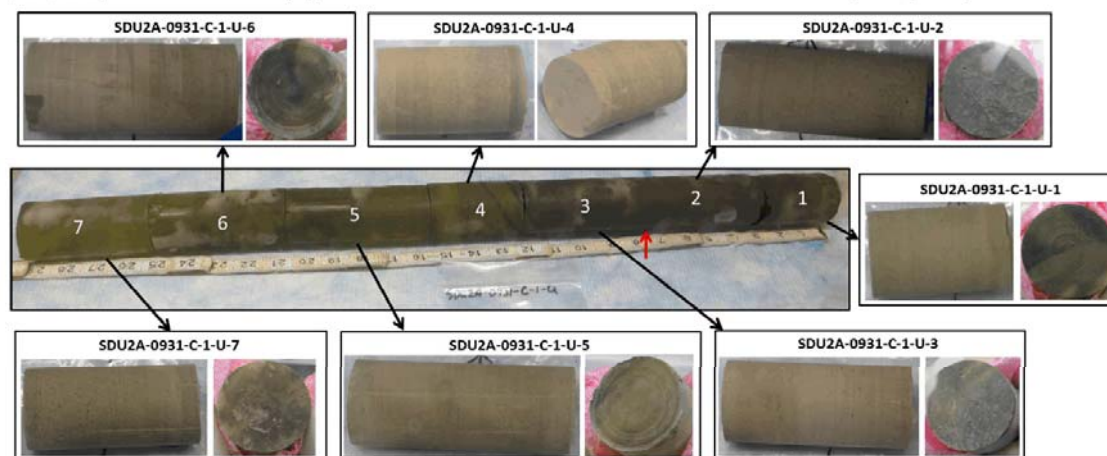
Sample ID: SDU2A-0931-C-1-U (Upper Core Portion Extracted from Port C – Drill Position 1 on April 28, 2015)

#	Approx. Pour Date	Physical Appearance	Possible Test(s)
1	6/9/14	• Intact	• Spare
2	6/5/14	• Intact – sample broken at cold joint to produce samples 2 & 3	• Spare
3	6/3/14 & 6/5/14		• Spare
4	5/29/14	• Intact	• Spare
5	5/28/14 & 5/29/14	• Intact	• Tc total activity, Tc K _d , & Tc(VII) conc. – for K _d and Tc(VII) conc. material must be removed from sample interior
6	5/20/14 & 5/21/14	• Intact	• Total activity and K _d (except Tc) – for K _d material must be removed from sample interior
7	5/19/14 & 5/20/14	• Intact	• SHC – ensure 2" sample sectioned for SHC does not include a cold joint • Density, porosity, & moisture content on one end section removed during SHC sample cutting • pH / E _s – for E _s material must be removed from sample interior
