United States Nuclear Regulatory Commission Official Hearing Exhibit In the Matter of:	CROW BUTTE RESOURCES, INC. (License Renewal for the In Situ Leach Facility, Crawford, Nebraska)
	ASLBP #: 08-867-02-OLA-BD01 Docket #: 04008943 Exhibit #: NRC-054D-00-BD01 Admitted: 8/18/2015 Rejected: Other:
 	Identified: 8/18/2015 Withdrawn: Stricken:

25DW360 (2368-S005)

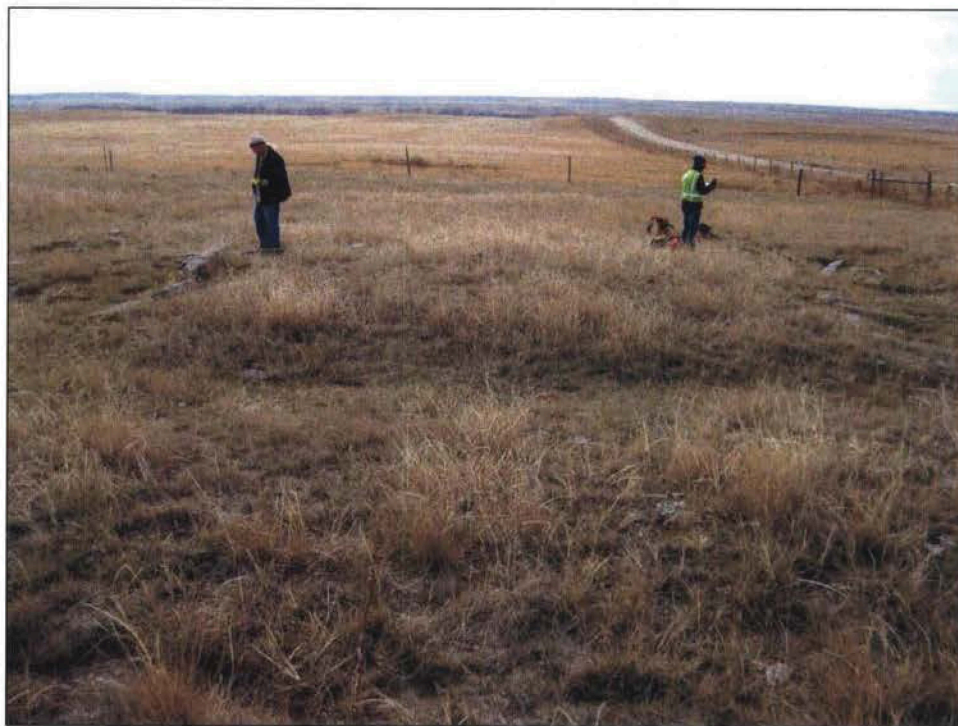
Figure 21. Site 25DW359, Feature F1, facing south. Photograph taken by Shane Rosenthal, on 1/19/2011.

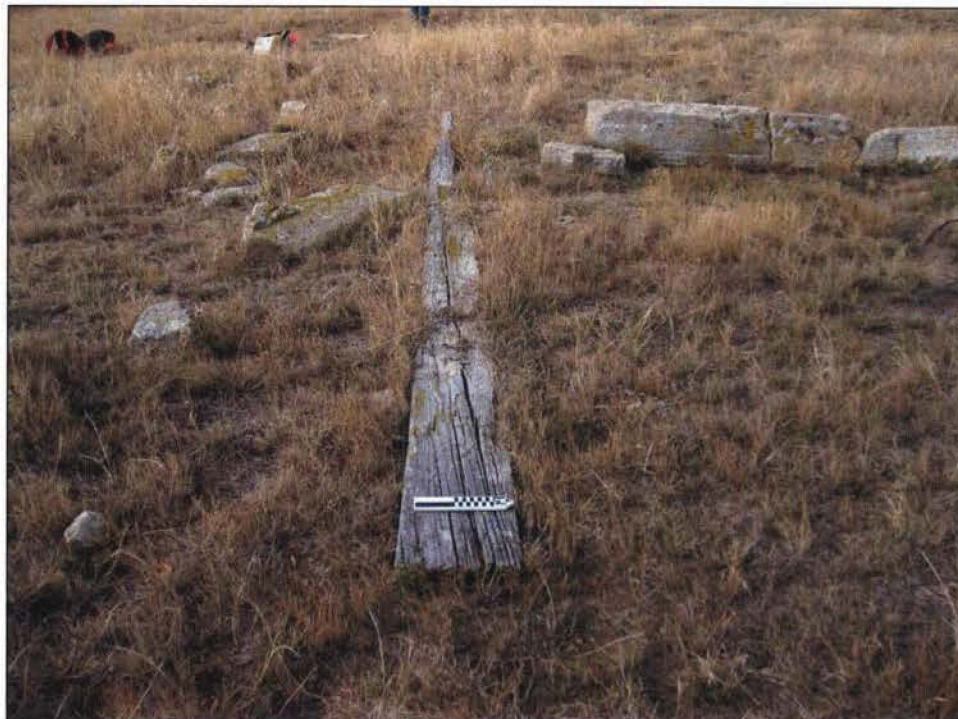
Figure 22. Site 25DW359, Feature F1, debris scatter with concrete foundation and milled lumber, facing west. Photograph taken by Shane Rosenthal, on 1/19/2011.

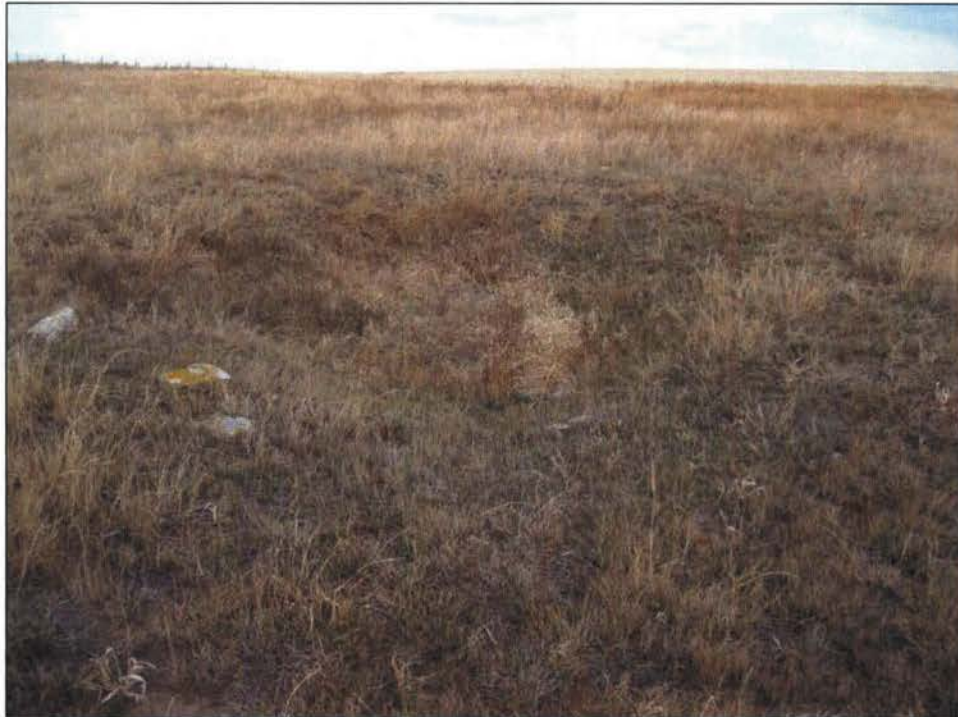
Figure 24. Site 25DW359, Feature F2 dugout, facing north. Photograph taken by Shane Rosenthal, on 1/19/2011.

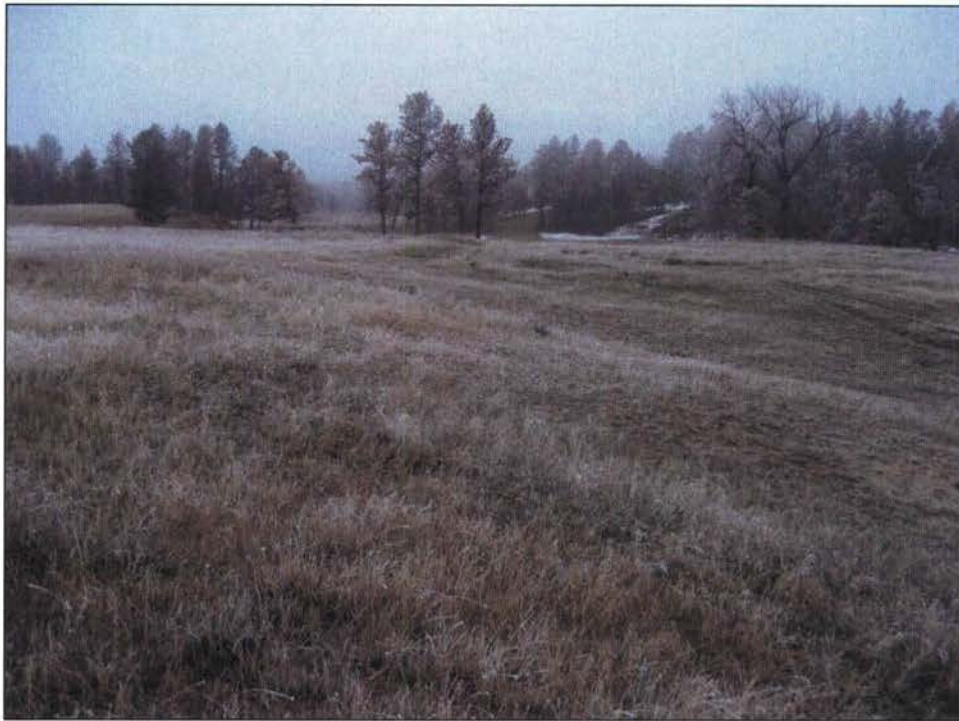
Site 25DW360 is a historic homestead located in Section 26 T30N R51W on the northeastern slope of a drainage cut (**Figures 26 and 46**). An ephemeral drainage runs through the site. The site measures 840 feet by 410 feet and covers an area of 261,200 square feet. Vegetation consists of ponderosa pine forest and mixed grasses affording variable visibility that averaged between 50 to 80 percent bare ground visibility. Impacts to the site include historic ranching and farming activities throughout the area, wind and water erosion, and grazing. The site datum is a GPS point taken at the SE corner of the Feature F1.

Figure 26. 25DW360, site overview from Feature F6, facing south. Photograph taken by Shane Rosenthal, on 11/20/2010.

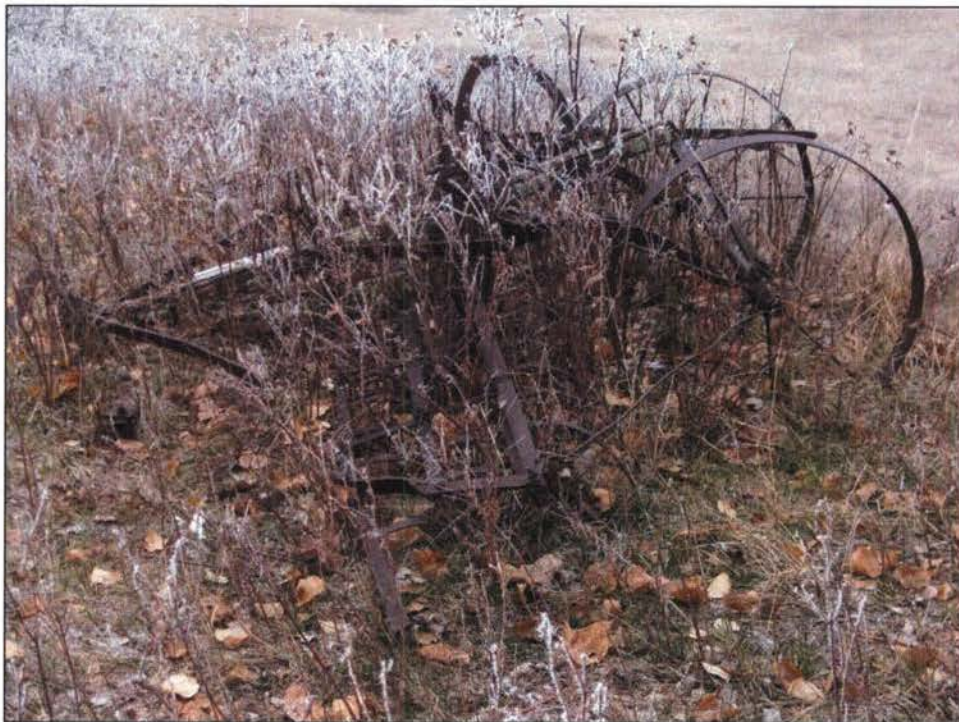
Cultural materials consist of four historic foundations (Features F1, F4, F8, and F9), two depression features (Features F5 and F7), one dugout (Feature F3), one cellar (Feature F2), one cistern (Feature F6), and an extensive historic debris scatter. Artifacts and features were observed within the drainage bottom, along the northeast slope, and across the ridge top to the north and northeast of the features. Domestic, ranching, and farming, debris is scattered across the site, and includes over 100 common red fired-clay bricks, three water pumps bearing the company stamps "Barnes MFG. Co.," "Dempster Mill MFG. Co.," and "Red Jacket," a lawn mower, a bed frame, wash room items that included a bath tub, toilet, and sink, poultry cage wire, numerous barbed wire rolls, a ripper (**Figure 27**), and other assorted household goods.

Figure 27. 25DW360, ripper, facing west. Photograph taken by Shane Rosenthal, on 11/20/2010.

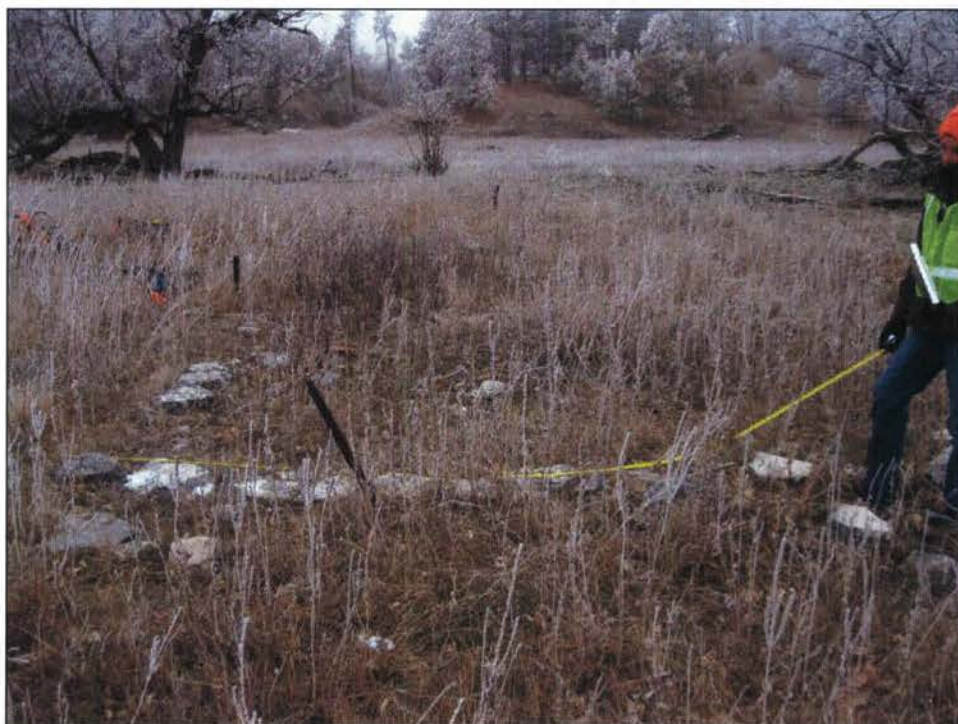
Feature F1 is a house foundation composed of at least two rooms measuring 20 feet east to west and 25 feet north to south, with a single room extending west from the center of the primary rooms measuring 18 feet east to west and 10 feet north to south (**Figures 28 and 29**). The foundation walls consist of linear arrangements of sandstone stones that were locally acquired undressed sandstone boulders and cobbles. The remnants of a brick chimney are located along the south wall of the largest southeastern room, and a low dirt berm running north from the chimney divides this room into two shallow depressions. Brick scatters are concentrated within these depressions, though it is unclear if erosion or architectural elements caused these depressions. A third brick concentration is located in the western room. Few artifacts were observed within the foundation, though a three inch-diameter upright pipe was buried in the southwest corner of the west room. Another six inch-diameter pipe, scrap metal, and a "Barnes MFG. Co." water pump (**Figure 30**) were observed northwest and north of the foundation. A poured concrete sidewalk measuring four feet wide intersects the west room from the south, and continues south for 41 feet, where a cottonwood tree and the remains of a sink and toilet tank were observed (**Figures 31 and 32**). Additionally, a metal concrete-filled ring and a concrete-filled spoked wagon wheel are located to the east of the foundation, and may have been used as a well cover.

Figure 29. 25DW360, Feature F1, facing west. Photograph taken by Shane Rosenthal, on 11/20/2010.

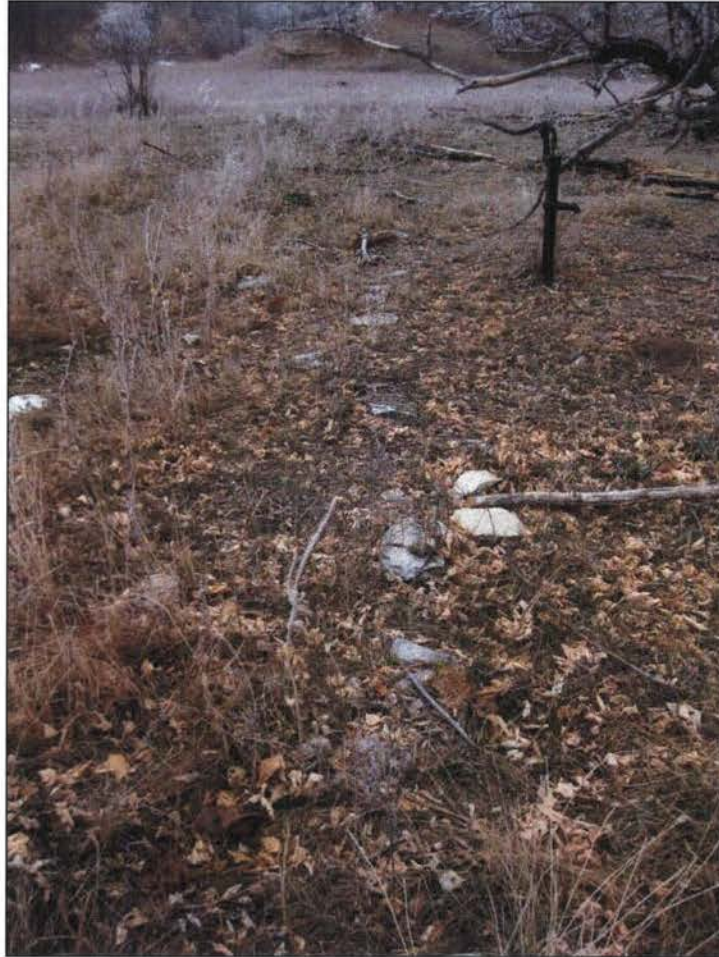
Figure 30. 25DW360, Feature F1, north wall with water pump, facing west. Photograph taken by Shane Rosenthal, on 11/20/2010.
