From: Bower, Fred
Sent: Friday, April 29, 2016 1:18 PM
To: Finney, Patrick; Ziedonis, Adam
Subject: FW: Neil's blog post on the subject is on the NRC website

From: Barkley, Richard
Sent: Friday, April 29, 2016 12:10 PM
To: Bower, Fred <Fred.Bower@nrc.gov>; Draxton, Mark <Mark.Draxton@nrc.gov>; McHale, John <John.McHale@nrc.gov>; Wengert, Thomas <Thomas.Wengert@nrc.gov>
Subject: Neil's blog post on the subject is on the NRC website

An Outage Twist: Degraded bolts at New York Nuclear Plant Warrant Attention

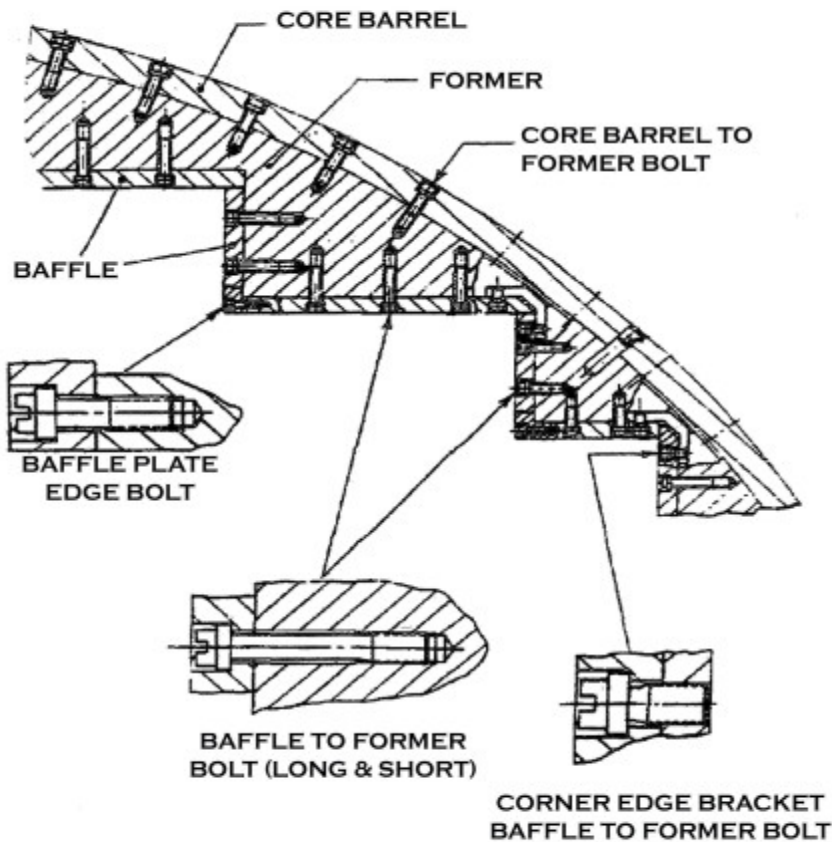
Baffle-Former Assembly Bolts

As far back as the late 1980s, cracking was identified in baffle-former bolts – the bolts securing the baffle plates to the baffle-former plates — in pressurized-water reactors (PWRs) in France. (Both Indian Point Units 2 and 3 are PWRs.) The degradation is caused by what is known as irradiation-assisted stress corrosion cracking.

former bolt cracking reported in foreign PWRs had occurred at the juncture of the bolt head and the shank, a location not accessible for visual examination.

This is exactly what was being done at Indian Point Unit 2 during the current outage. It was adhering to the standards of MRP-227-A. In the course of this review, it was determined that 227 of 832 baffle-former bolts at the plant were degraded, which means any indication of cracking. What's more, two bolt heads were missing.

Entergy, Indian Point's owner, is in the process of analyzing the condition and replacing the degraded bolts. It will also assess any implications for Indian Point Unit 3, though that reactor is believed to be less susceptible to the condition for several reasons, including fewer operational cycles.
