Alloy 152/52-LAS Dilution Zone and Interface/Fusion Line PWSCC Testing

***Mychailo Toloczko, Matt Olszta,
Nicole Overman, and Steve Bruemmer***
Pacific Northwest National Laboratory

EPRI 690/ 152/ 52 PWSCC Research Collaboration Meeting
Nov 29 to Dec 1 • Tampa, FL

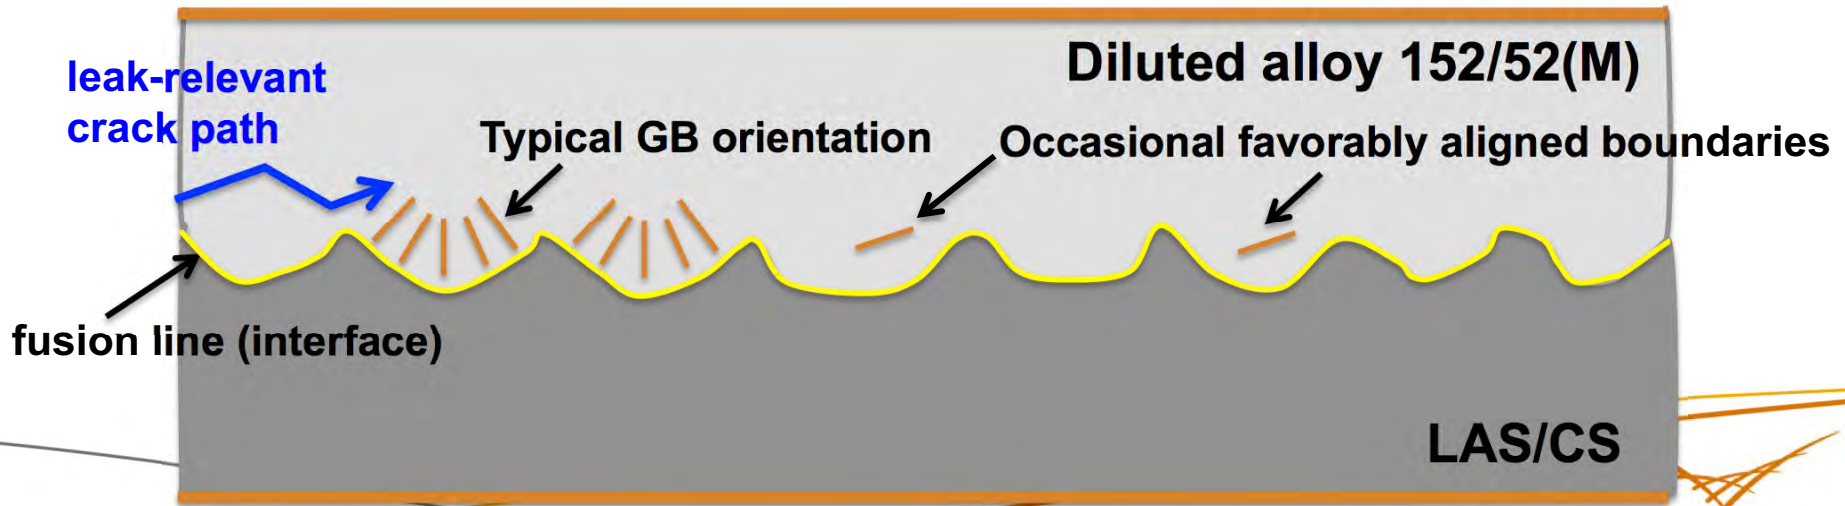
Grain Boundary Alignment in DZ

- ▶ Weld grains are predominantly needle-shaped with long axis parallel to the weld-LAS interface normal, $\sim 300\ \mu\text{m}$ dia. $\times \sim 0.5\text{-}3\ \text{mm}$.
- ▶ Leak-relevant crack path (parallel to fusion line) is not aligned to the needle orientation.
 - Unfavorable for IG cracking along these typical weld grain boundaries.
- ▶ Low density of favorably aligned boundaries have been observed.
 - Can be $>1\ \text{mm}$ from the fusion line. Much further from the fusion line than typical Type II boundaries.
 - SCC growth on these boundaries has been observed.

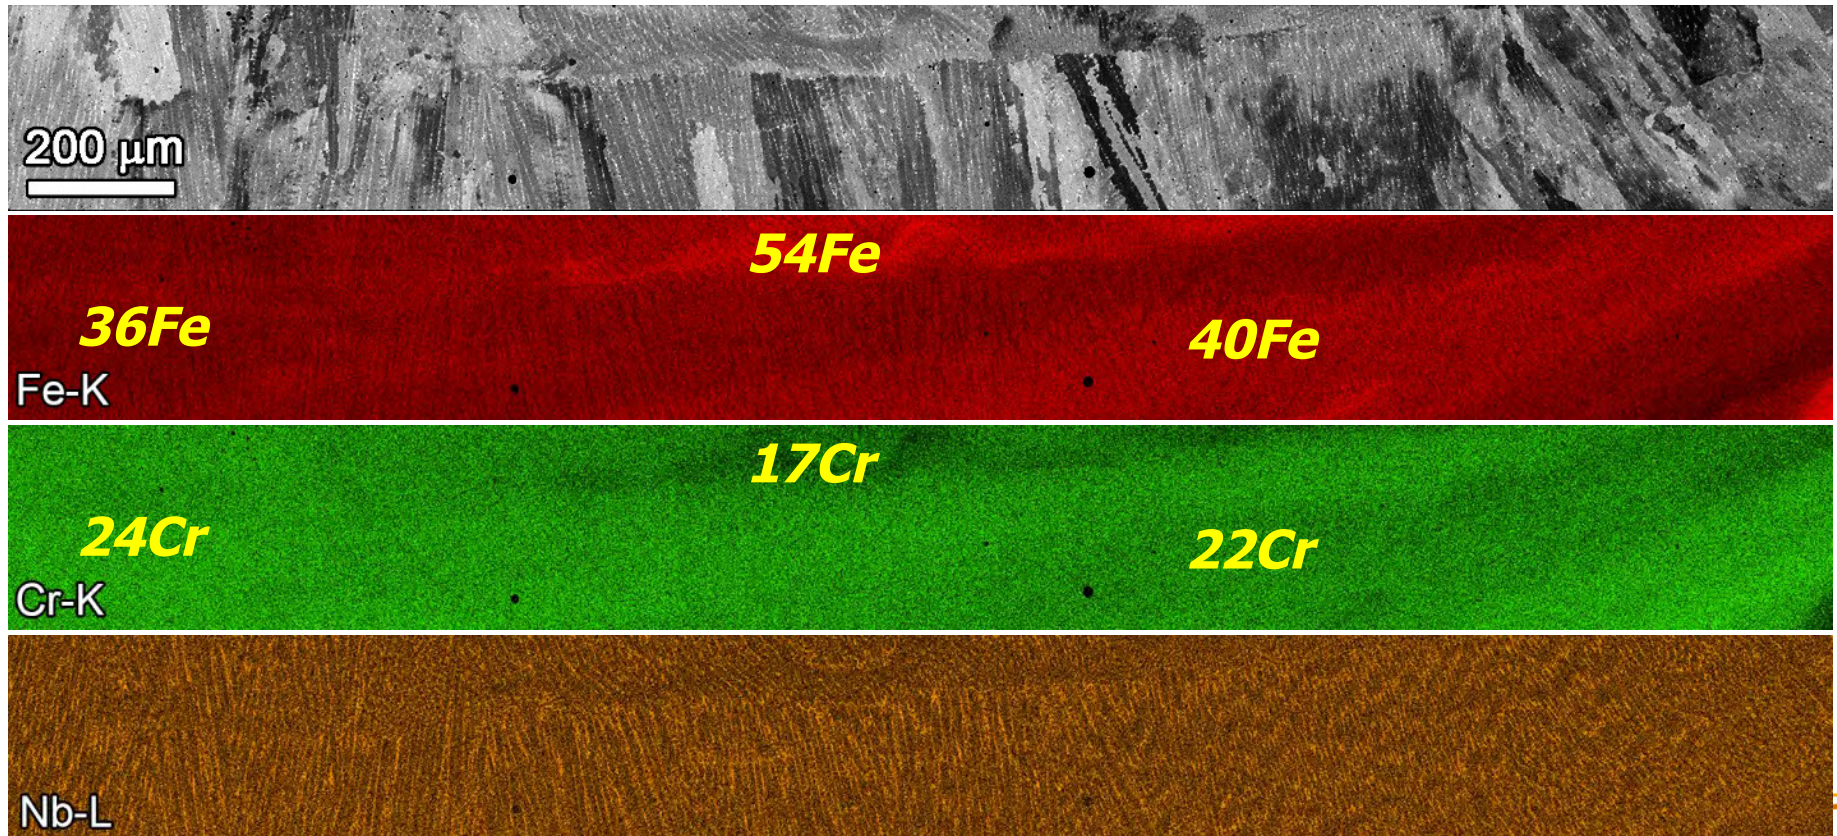
Aligned Boundary #1

- ▶ 2-2.5 mm in length.
- ▶ Fe enrichment and Cr depletion directly above the boundary.
- ▶ Nb carbides density changed in vicinity of the boundary.

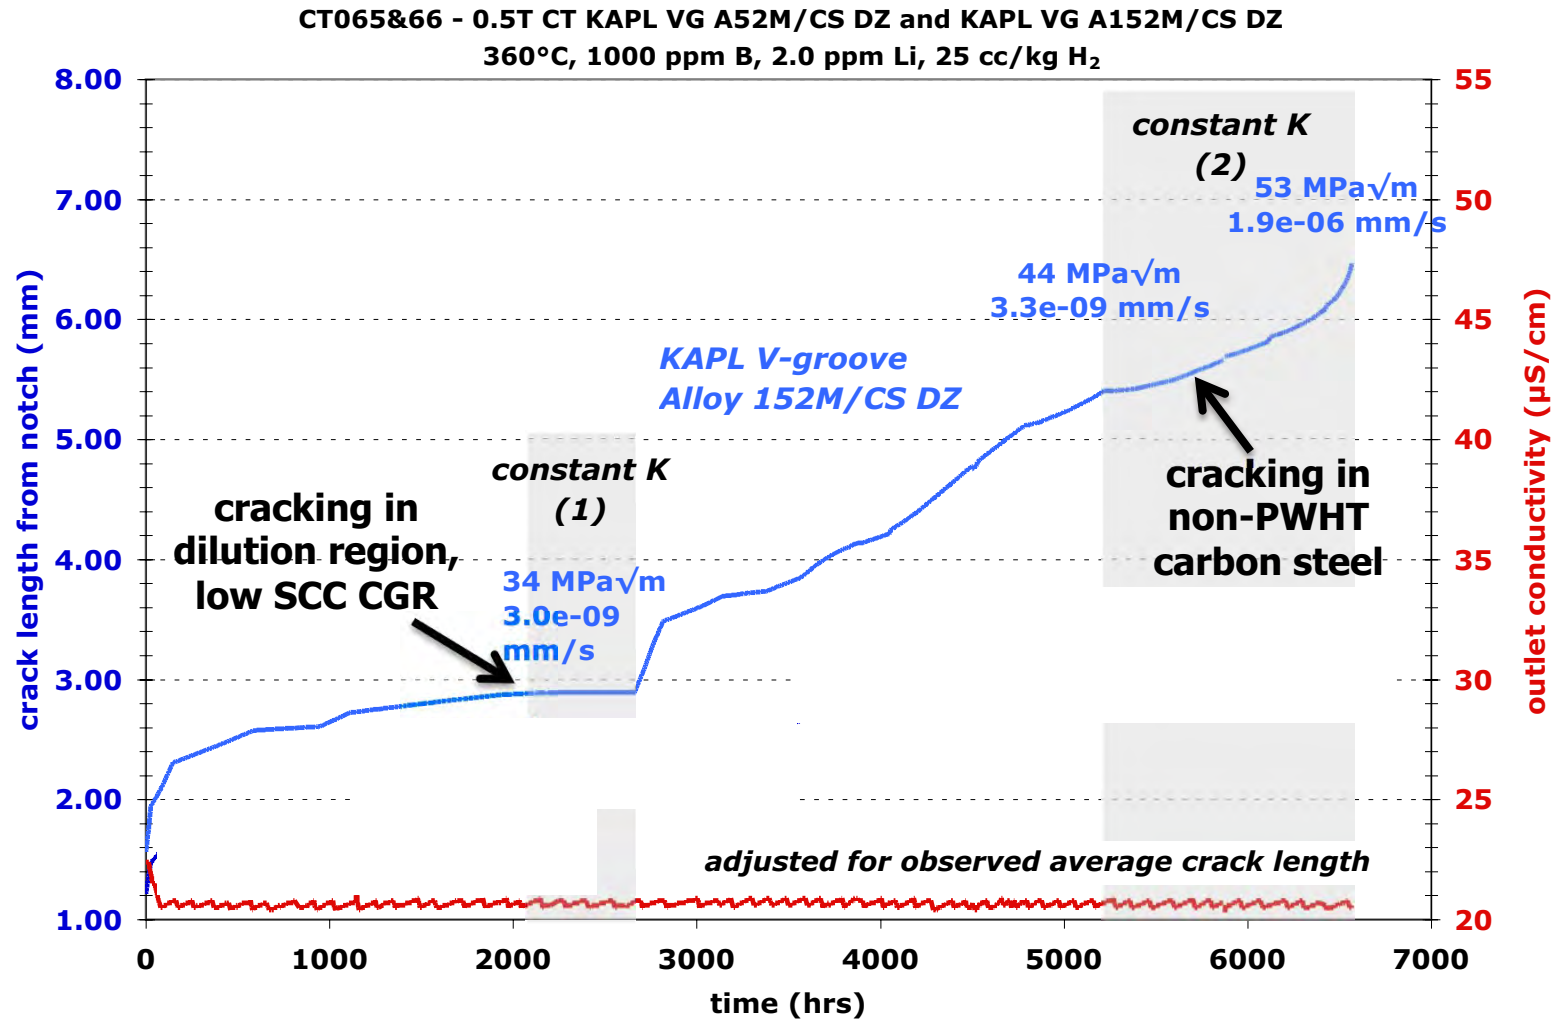
Crack Growth Test on KAPL Alloy 152M-CS Dilution Zone Specimen

Low SCC CGRs seen during constant *K* testing in a 20Cr dilution zone region. GBs were unfavorably aligned, a problem that is common to testing LAS/CS dilution zone regions.

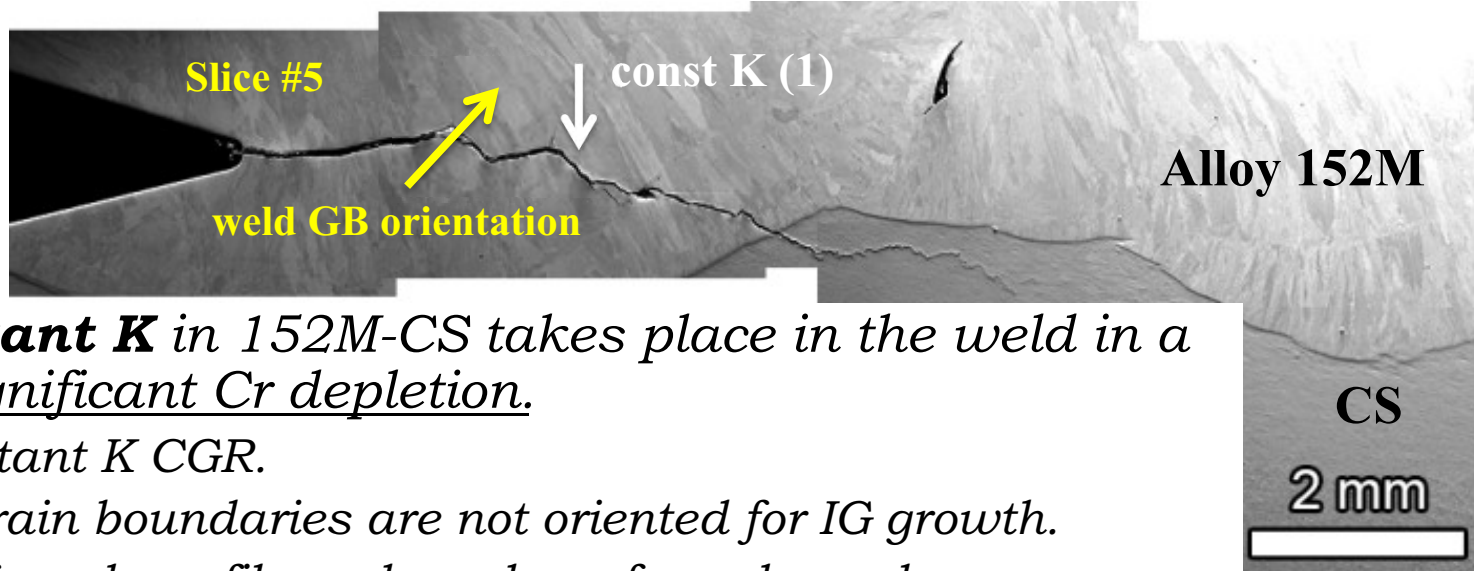
CT066 KAPL Alloy 152M-CS Dilution Zone Specimen: Cross-Section

► **First constant K** in 152M-CS takes place in the weld in a region of significant Cr depletion.

- Low constant K CGR.
- Typical grain boundaries are not oriented for IG growth.
- Exams of crack profile and crack surface showed predominately TG cracking.

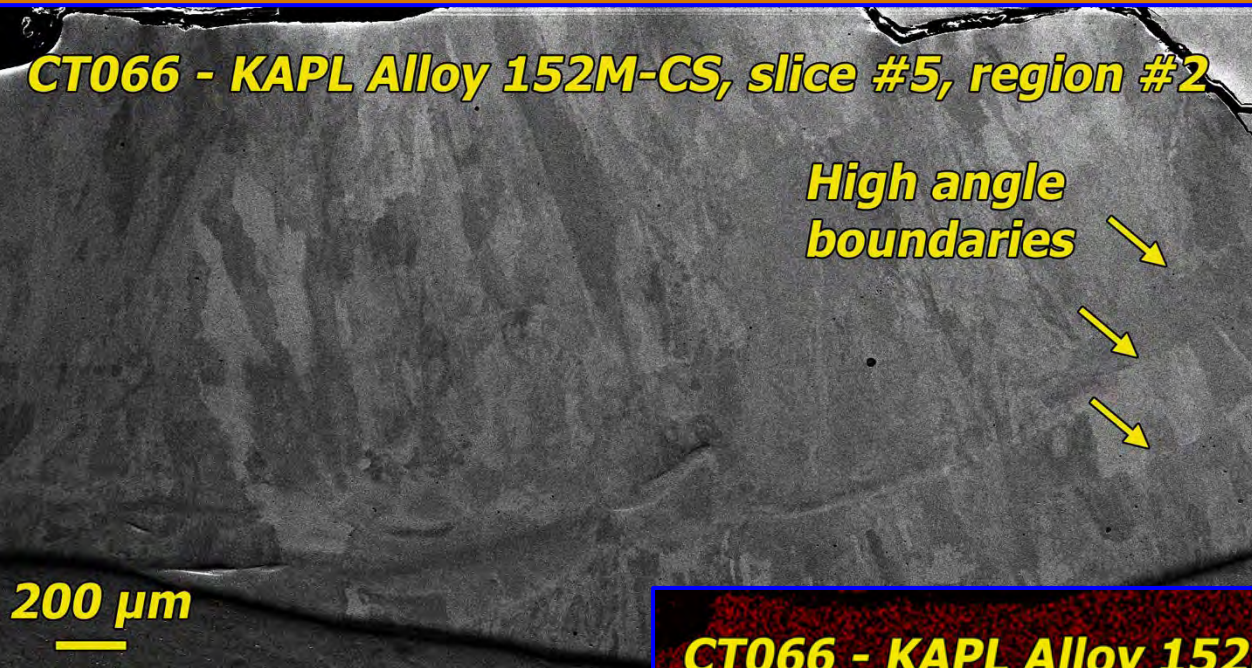
Grain Boundaries in CT066 KAPL Alloy 152M-CS Cross-Section

- ▶ *Aligned high angle boundaries were observed in vicinity of crack path (see Region #2), but crack did not turn on to these boundaries.*

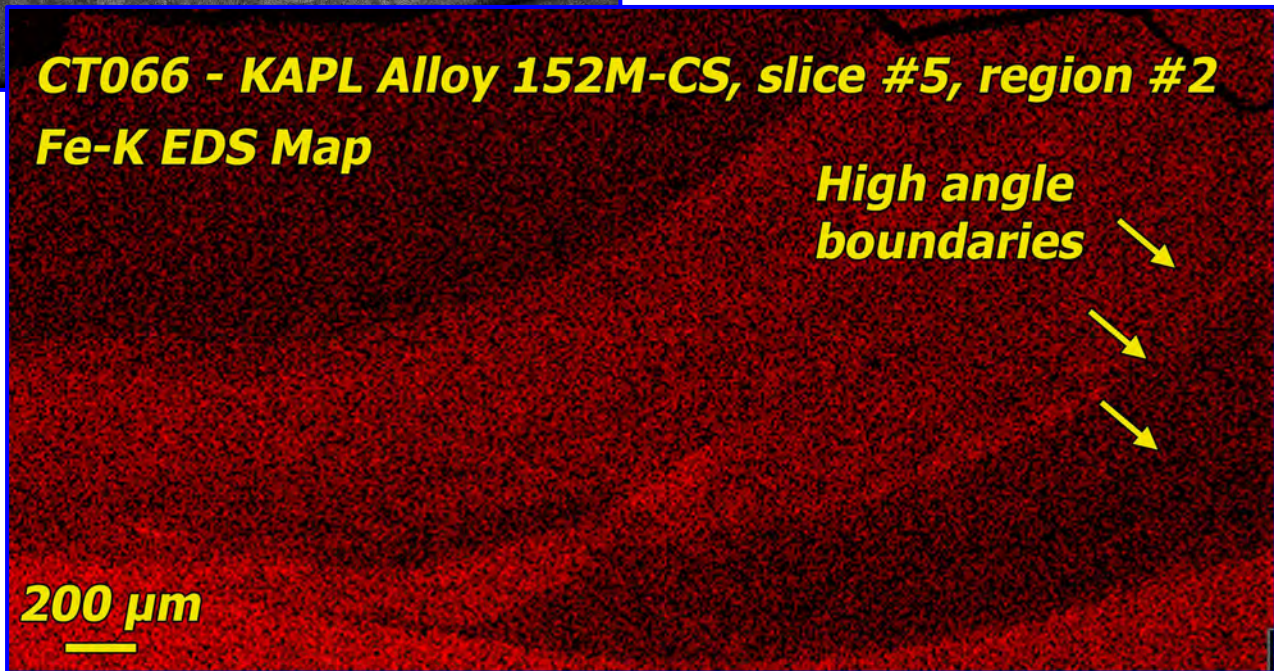
Region #2

- ▶ *Boundaries are not as long or as apparent.*
- ▶ *No obvious Fe enrichment for this EDS map.*
 - *Higher resolution mapping may reveal enrichment.*

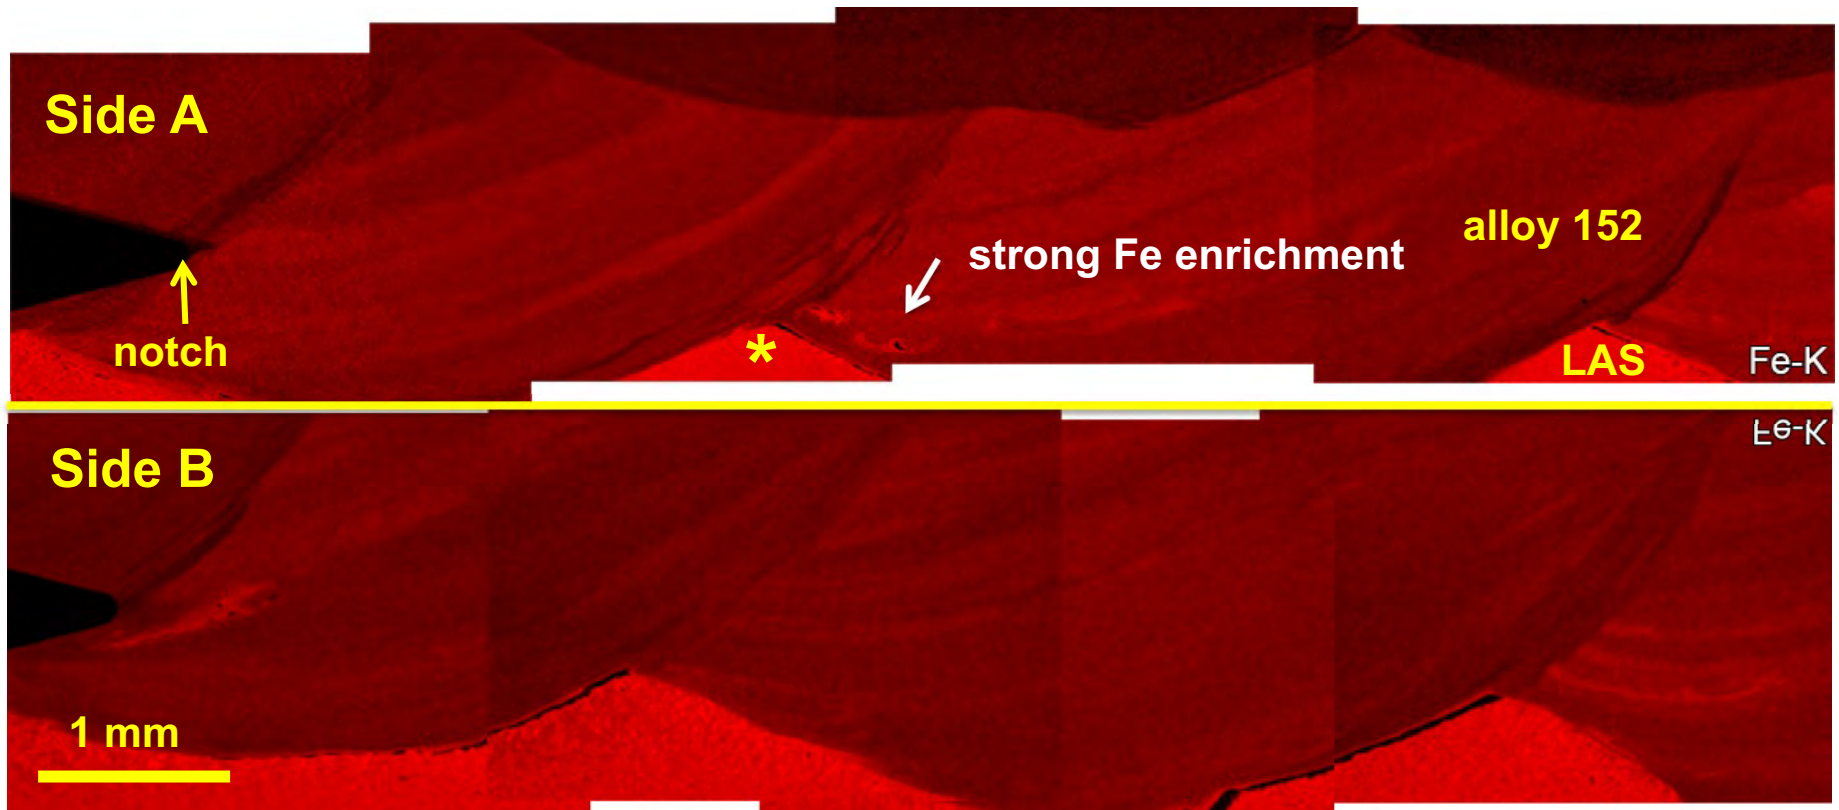
Side Groove SEM EDS Fe-K Images

- ▶ *Pre-test SEM EDS examination of the side grooves.*
- ▶ *Regions of Fe enrichment are present in side groove A.*

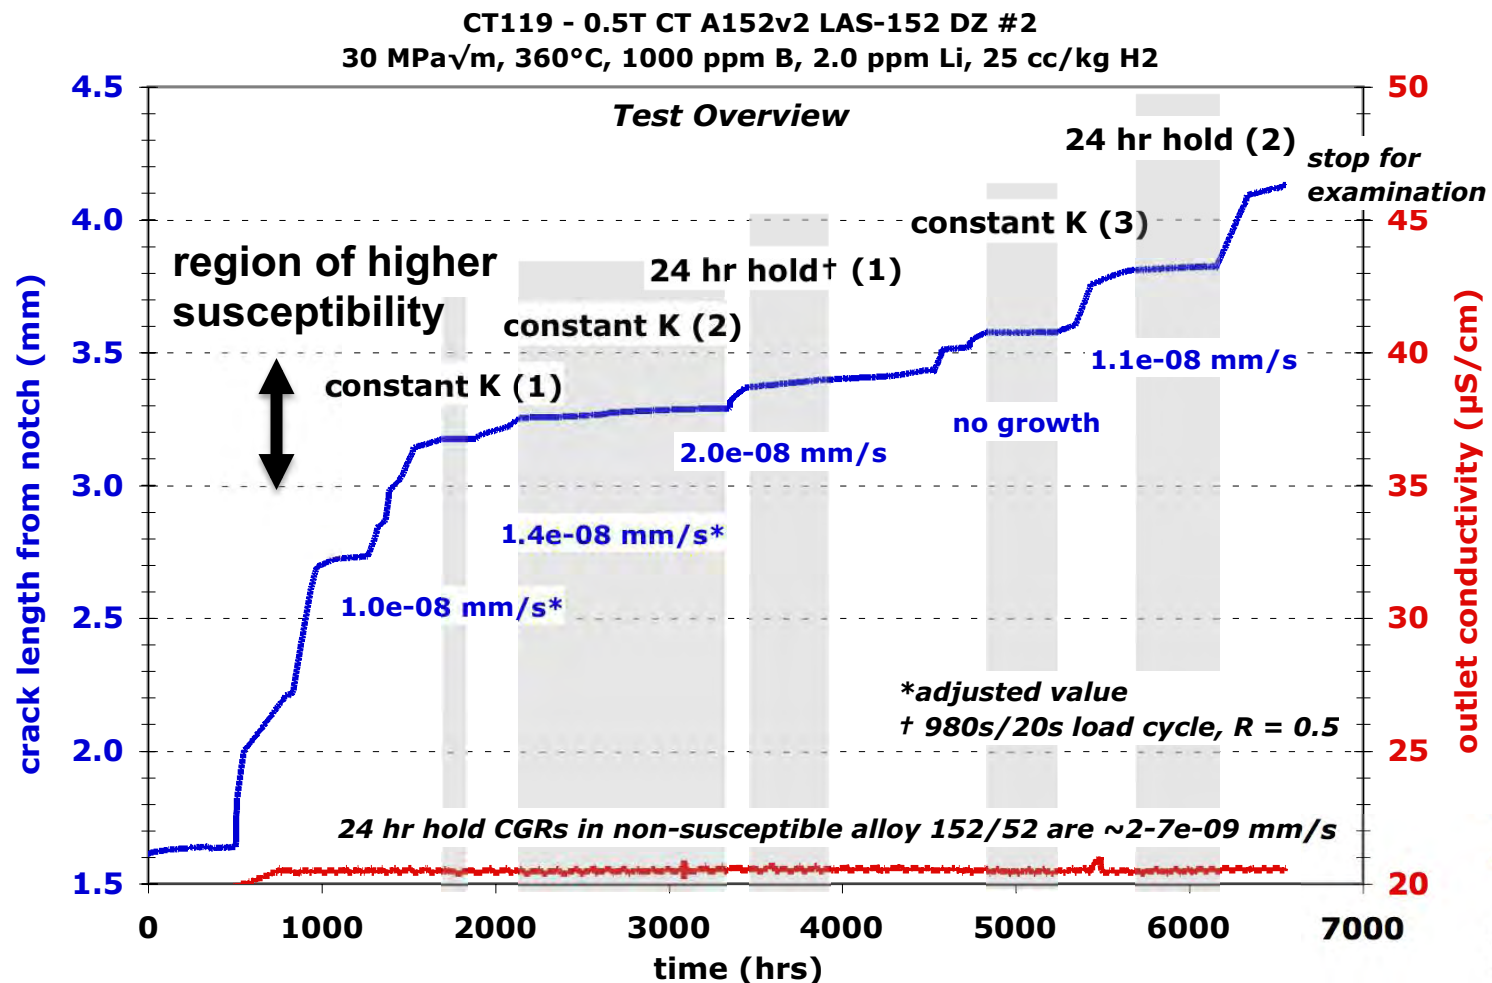
Test Overview – Part 1

- Enhanced susceptibility during early constant K and 24 hr hold observations at DCPD-indicated 3-3.5 mm from the crack notch.

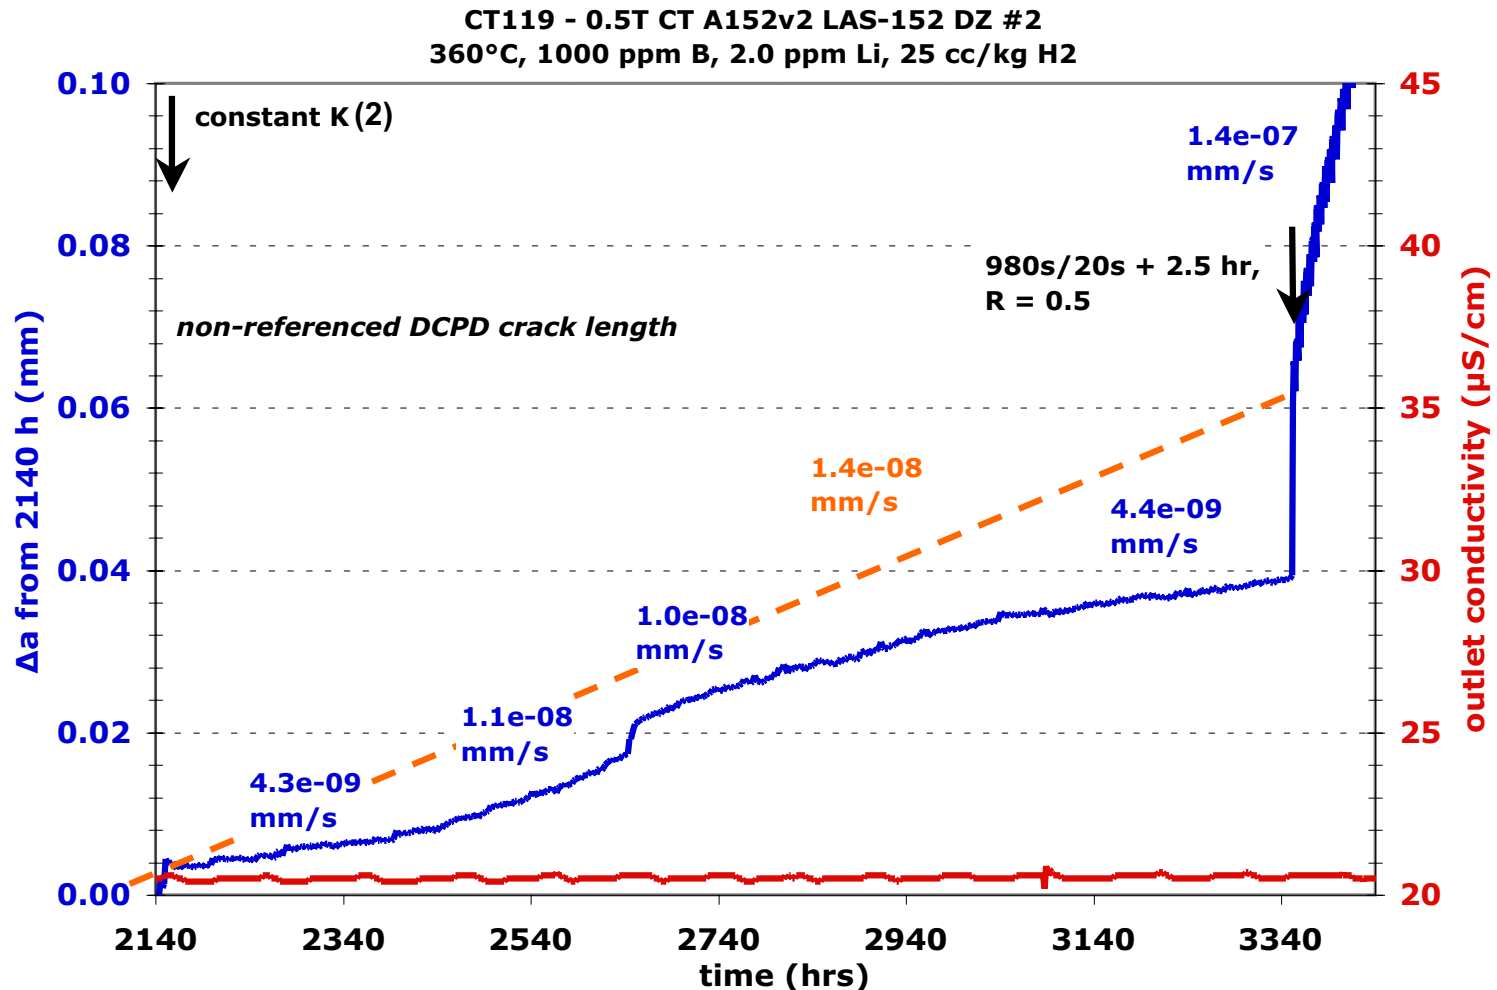
Constant K CGR

- ▶ Variable response at constant K .
- ▶ Strong indication of ligament or partial engagement. Estimated CGR is $\sim 1.4 \times 10^{-8}$ mm/s for this observation.

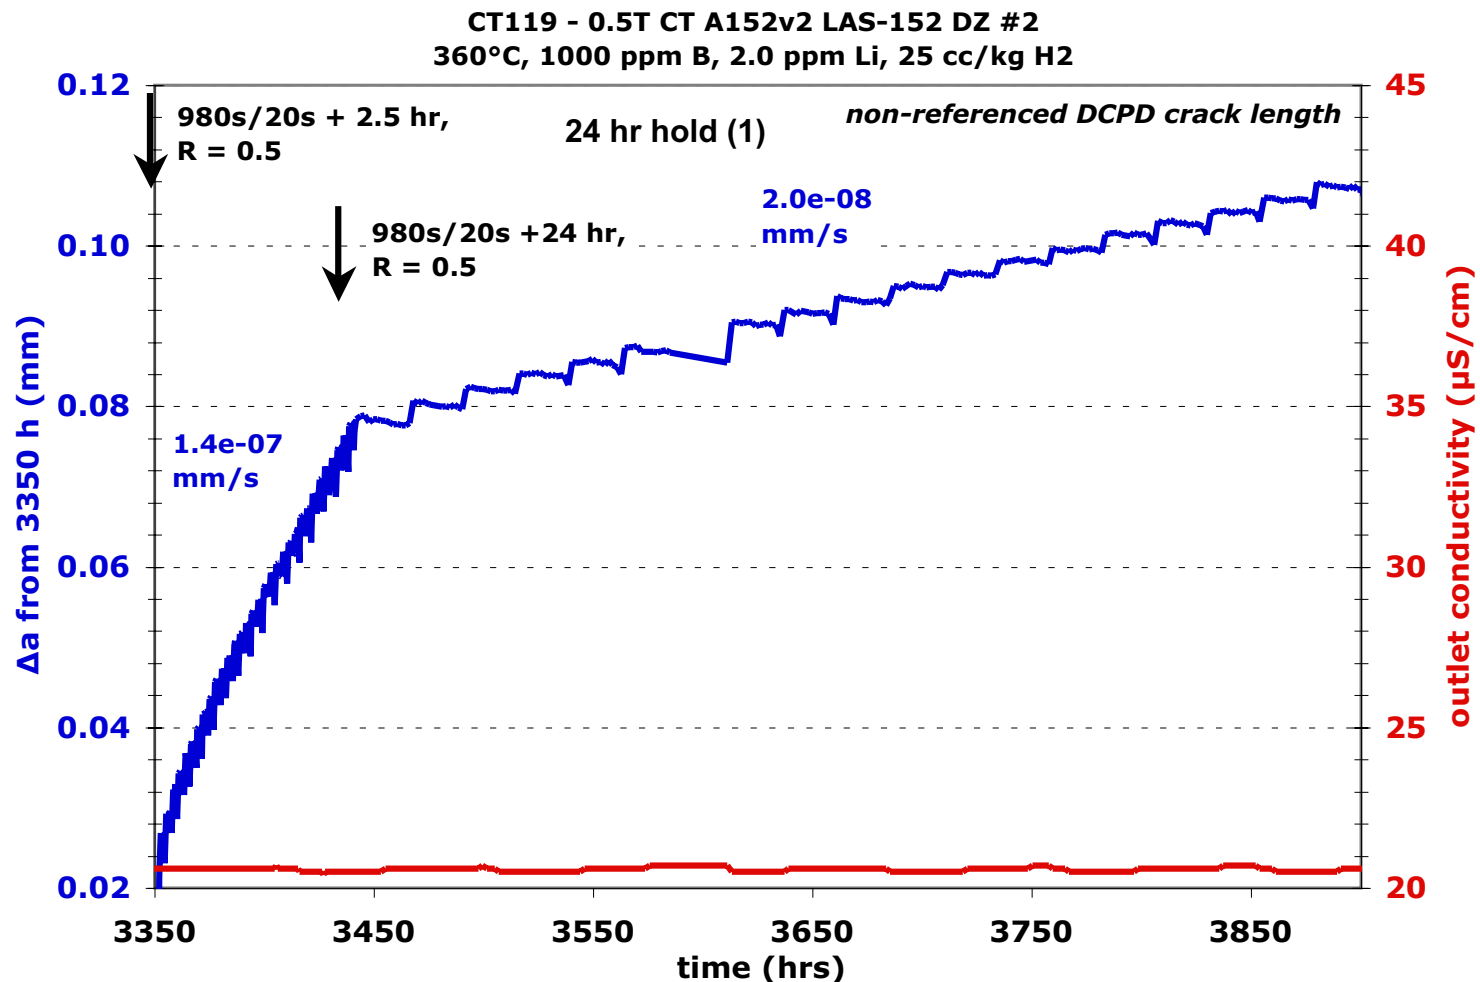
24 Hour Hold Response

- ▶ $1.1\text{-}2.0 \times 10^{-8}$ mm/s observed for this specimen.
- ▶ $2\text{-}7 \times 10^{-9}$ mm/s CGRs for non-engaged alloy 152/52.
- ▶ Serrated response suggests ligament/contact breakage.

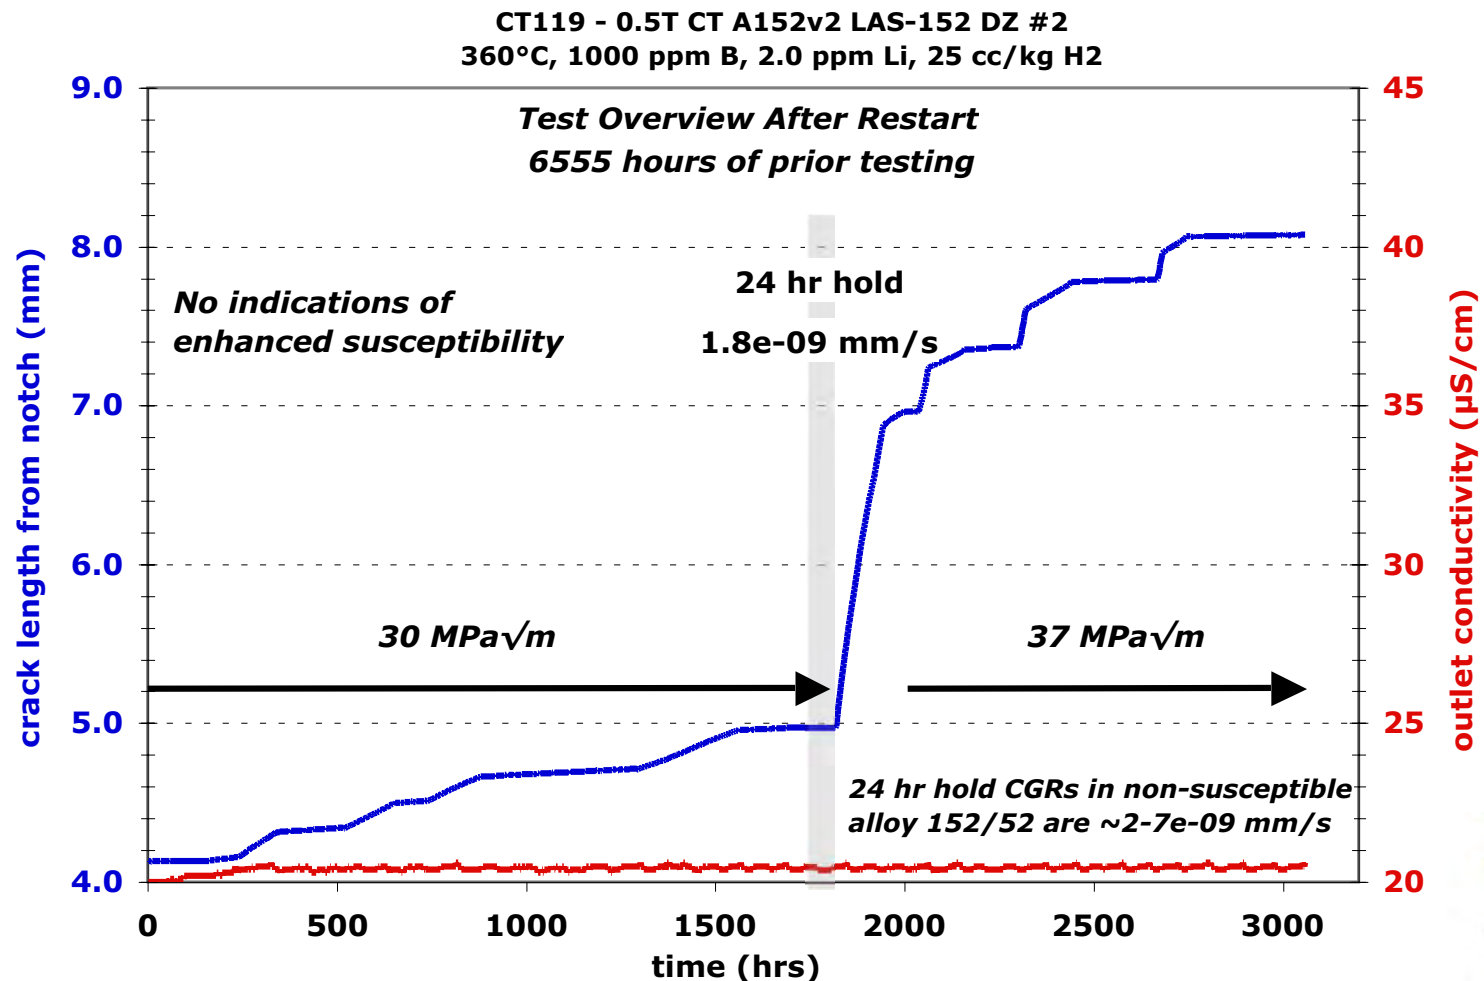
Test Overview – Part 2

- ▶ Test interrupted at 6555 h to observe crack path in side grooves.
- ▶ Observed crack length in side grooves was comparable to DCPD.
- ▶ After restart of test, no indications of enhanced susceptibility.

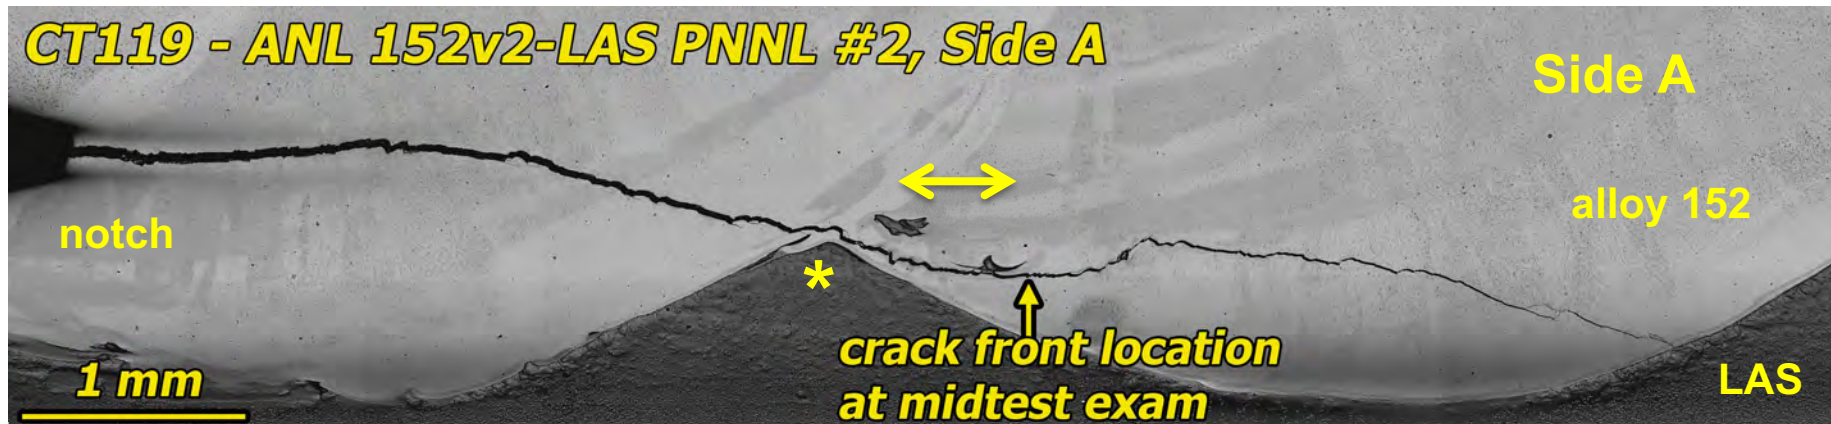
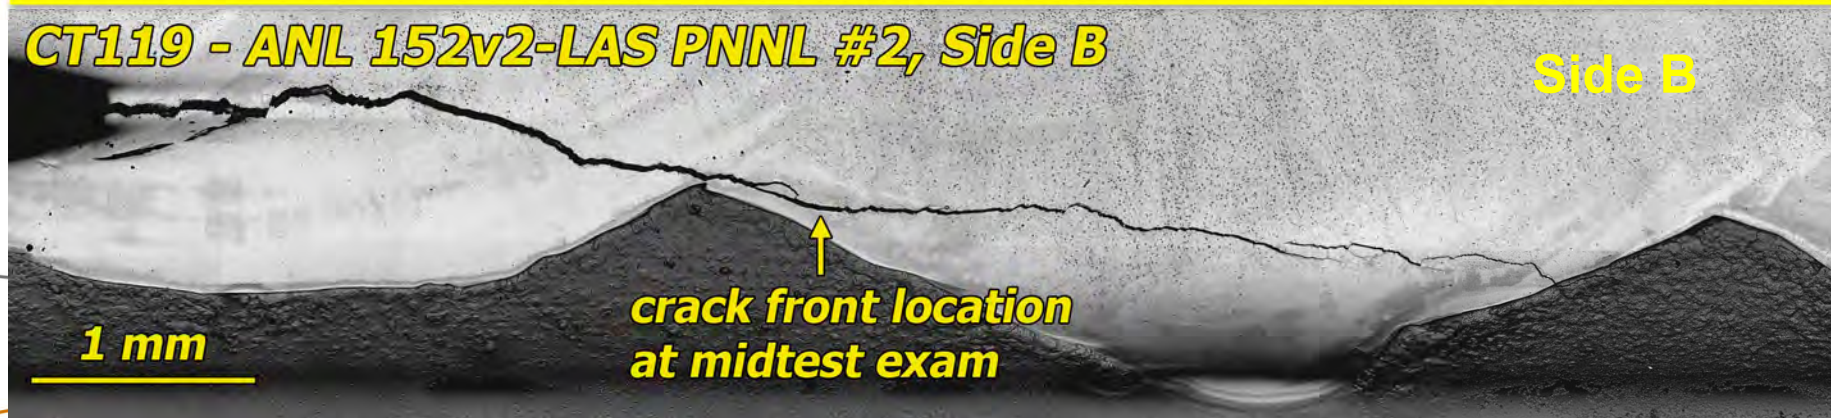
Post-Test Side Groove Images

- ▶ Post-test SEM images of side grooves.
- ▶ As with many other dilution zone tests at PNNL, crack moves toward the fusion line.
- ▶ What region along the crack path corresponds to the higher susceptibility seen in the SCC CGR test?

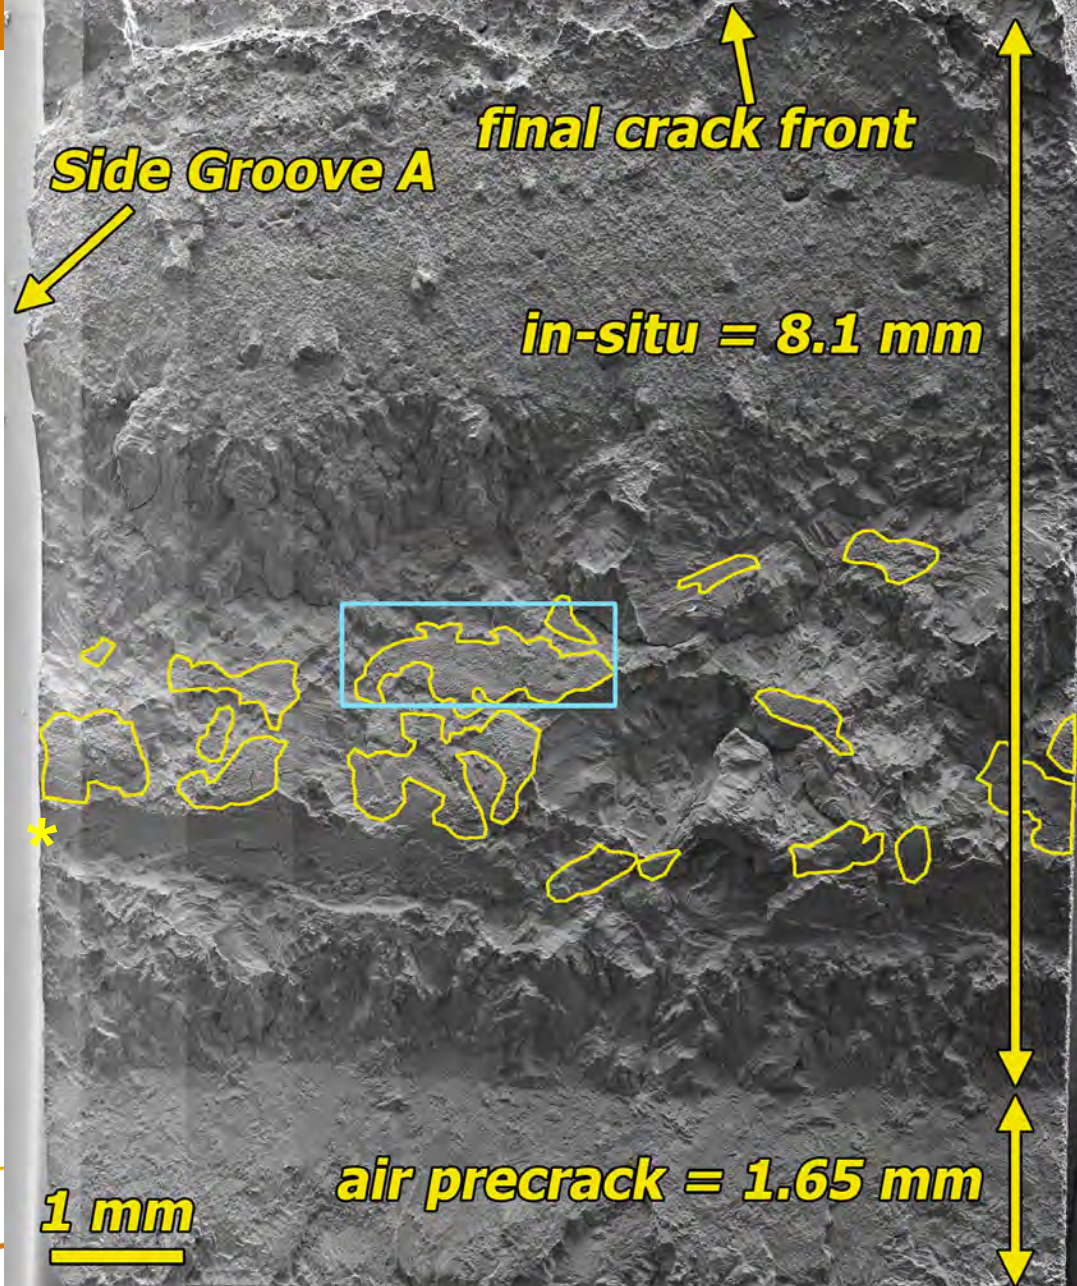
CT119 - ANL 152v2-LAS DZ PNNL #2
2/3 of thickness of specimen

- ▶ Many patches of IG cracking identified in second weld pass.
- ▶ Surface texture has appearance of the end of a dendritic packet.
- ▶ Some IG patches more than 1 mm in size.
- ▶ Distance from notch corresponds to early part of test where higher susceptibility was observed.

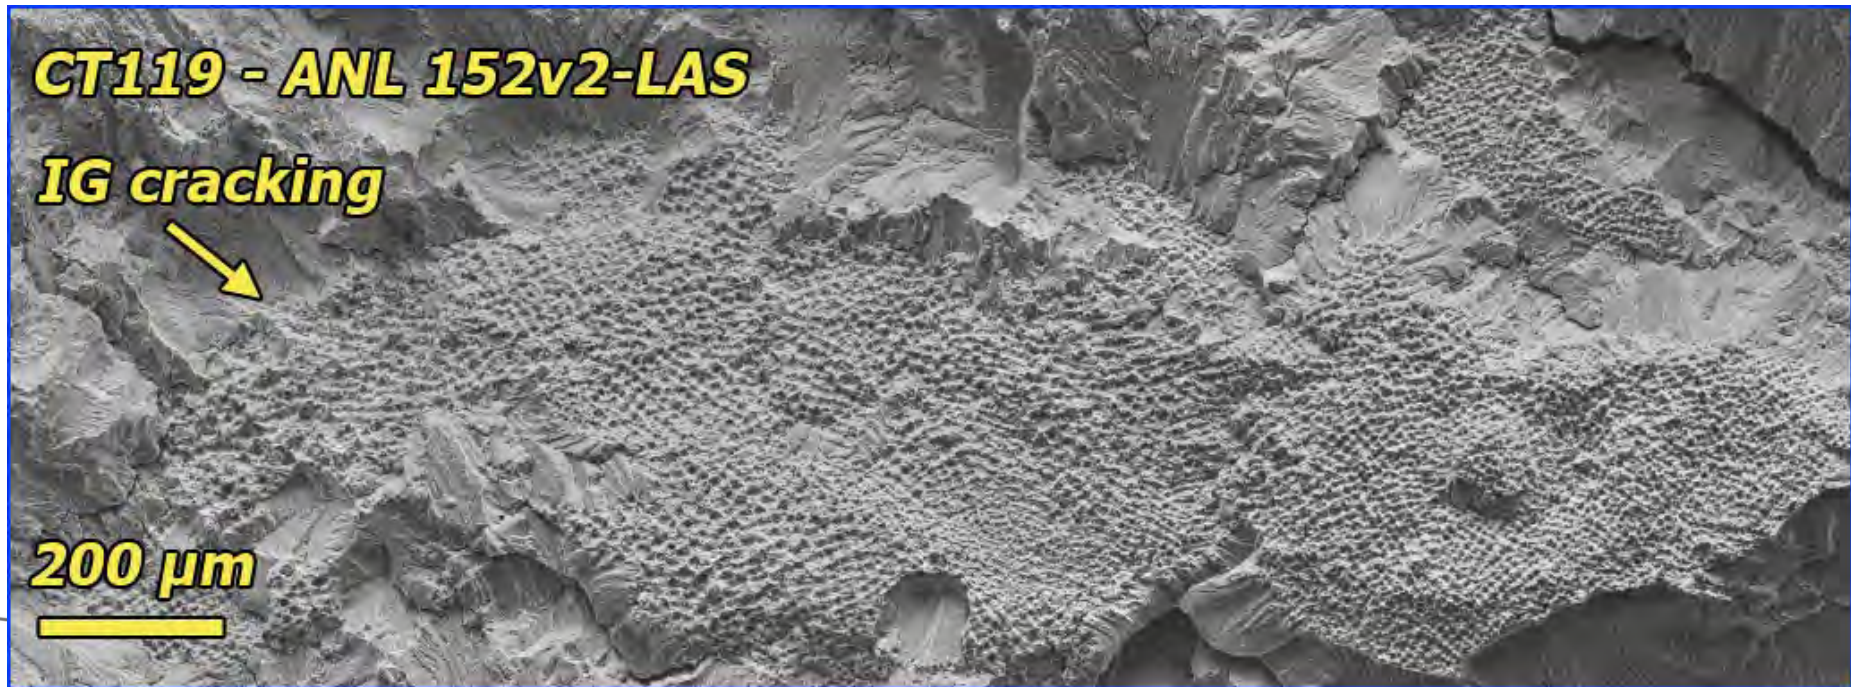
Crack Surface

- ▶ *Region of IG cracking along aligned high angle boundary.*
- ▶ *Texture has appearance of the termination of a forest of dendrites. Represents the ends of dendrite packets*

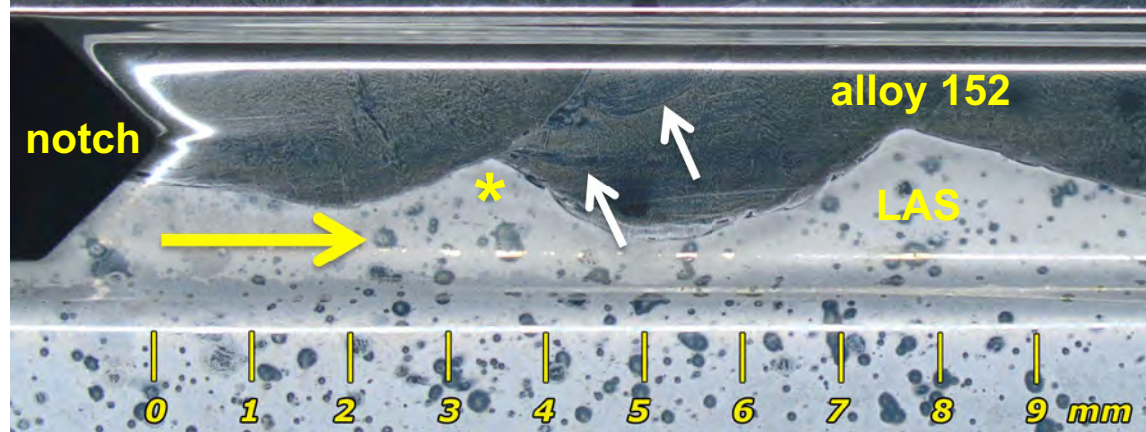
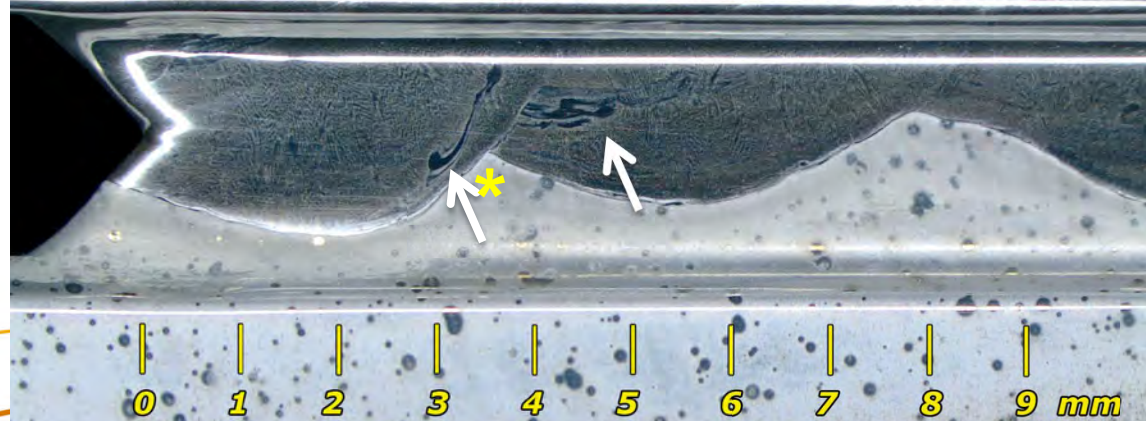
Side Groove Images

- ▶ Arrows indicate regions of dilution at 3-3.5 mm and 4-5 mm.
- ▶ Test strategy was to assess both regions of dilution.
- ▶ Same region as ANL N152-LAS-11 specimen.

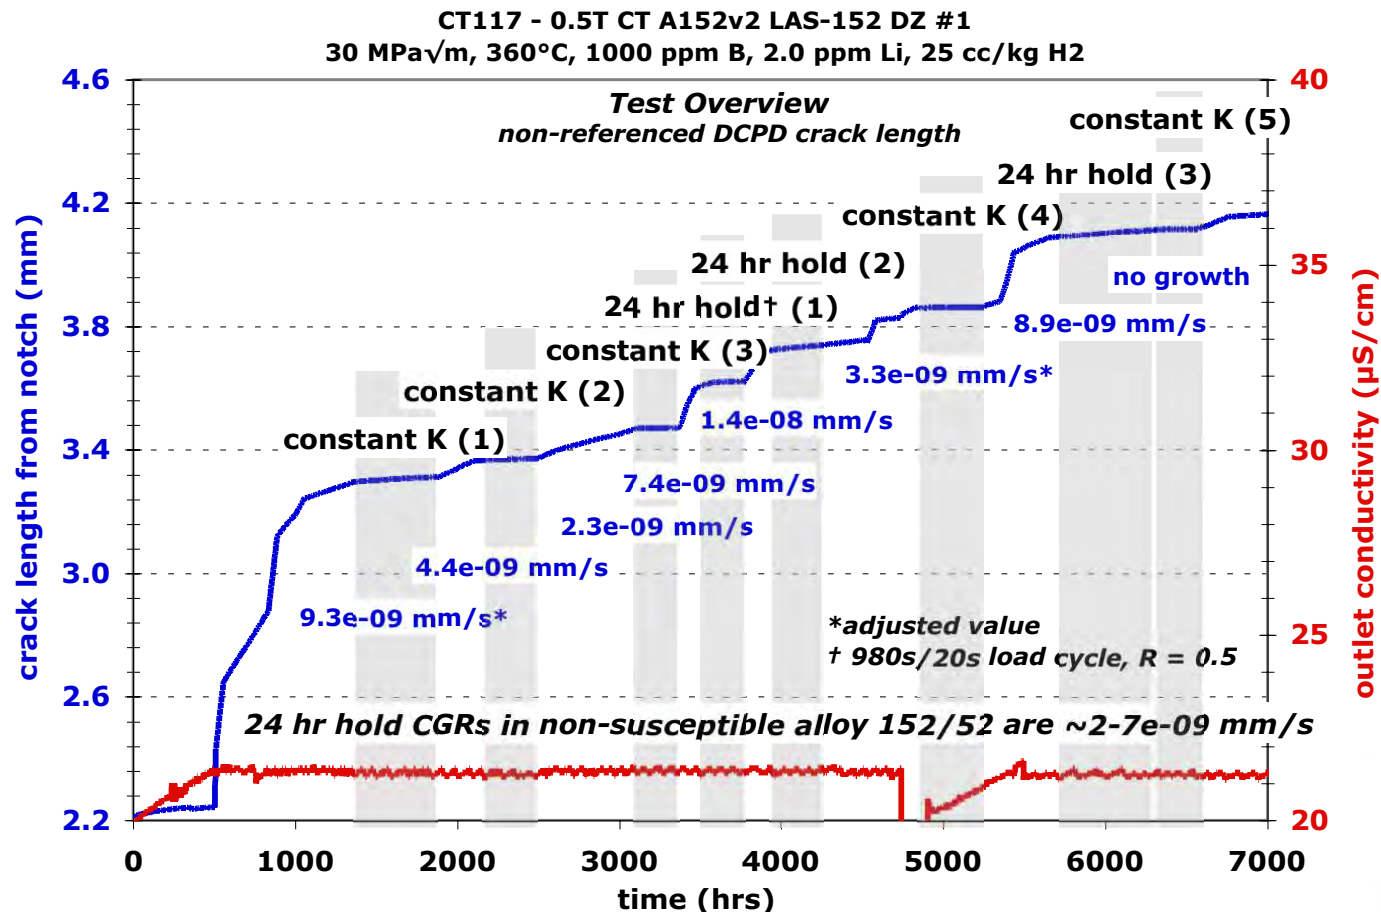
Test Overview - Part 1 - 0-7K Hours

- ▶ Using constant K and 24 hr hold loading to evaluate SCC.
- ▶ SCC susceptibility observed at crack depth of ~ 3.3 mm corresponding to first region on dilution.
- ▶ Some reduction in susceptibility at ~ 3.8 mm of crack extension.

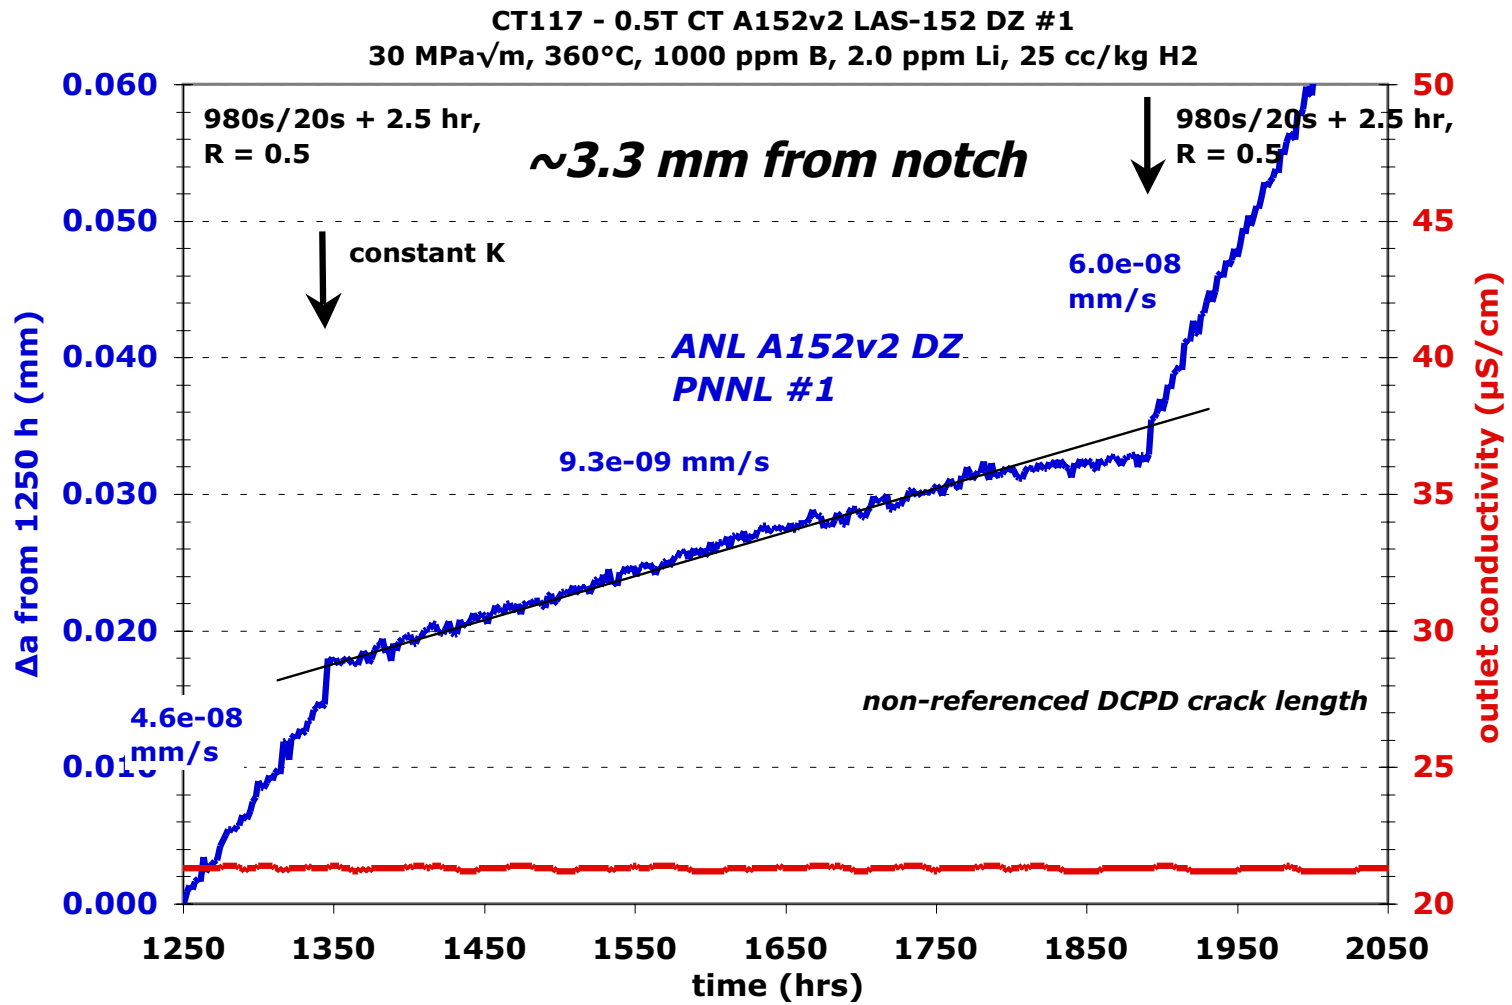
Constant K Response

- ▶ $\sim 1 \times 10^{-8}$ mm/s measured during 1st constant K – highest observed constant K for this test.
- ▶ Small jump after constant K suggests ligament breakage.
